## SECTION 14 INCIDENT REPORT (*Waste Management and Pollution Control Act*)

<b>Date and Time of Notification:</b>	Thursday 20/03/2020 08:30hrs
<b>Person / Company:</b>	Power and Water Corporation ( <b>PWC</b> )
<b>Incident:</b>	Discharge of raw sewage from sewerage network (no gross pollutants)

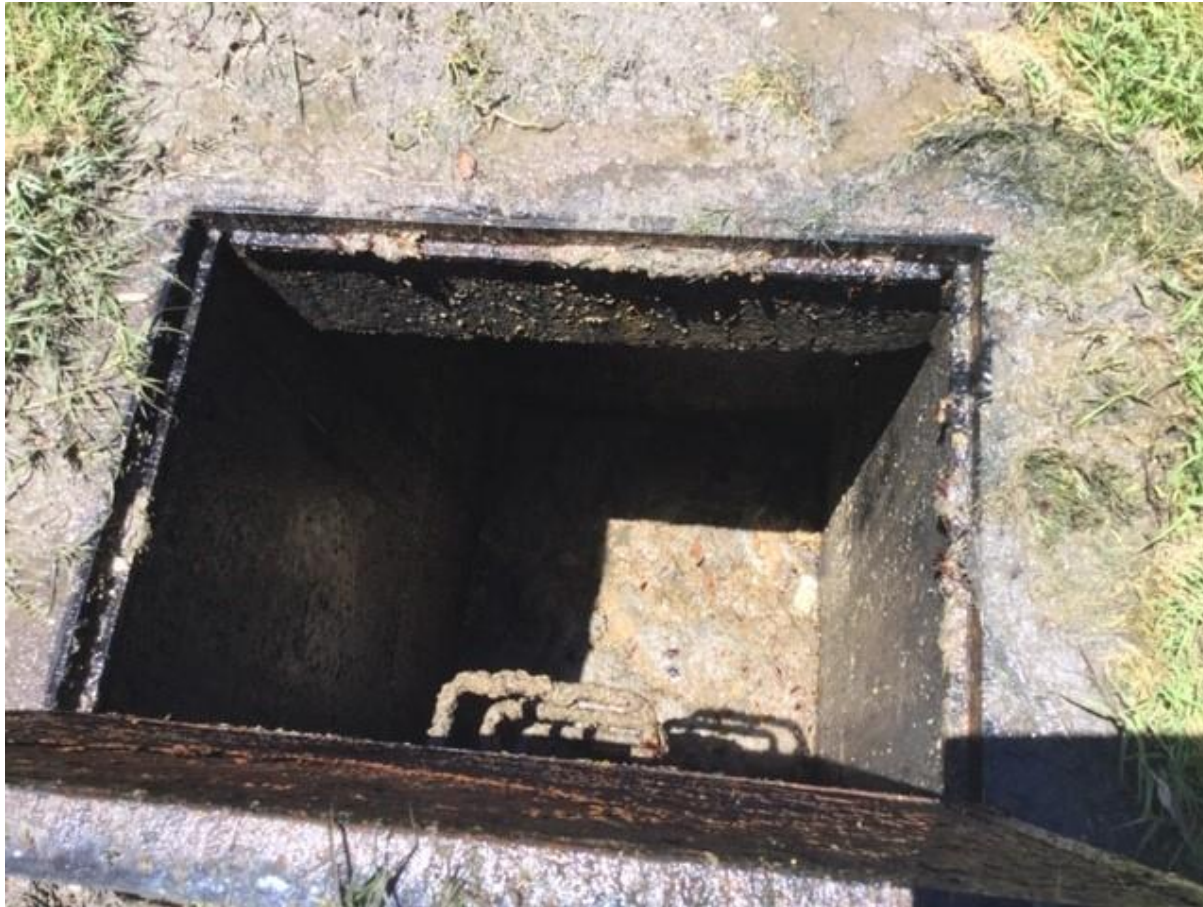
<p><b>(d) how the pollution has occurred, is occurring or may occur</b></p>	<p>As per (c) iii &amp; (c) iv.</p> <p>In addition to the above, with the recent shortages of toilet paper, due to panic buying as a result of the CONVID-19 virus, residents have resorted to using items such as baby wipes, wet wipes and kitchen paper towels, which do not break down like toilet paper does, exacerbating the problem of residents disposing of fats and oils into the sewer system. This will most likely remain an issue for PWC for the foreseeable future.</p>
<p><b>(e) the attempts made to prevent, reduce, control, rectify or clean up the pollution or resultant environmental harm caused or threatening to be caused by the incident</b></p>	<p><i>i. Confirmation signage and fencing has been erected, as appropriate.</i></p> <p>The spill area had been thoroughly cleaned up using a vacuum truck and disinfected as per Sewage Spills/Overflow Response Work Instruction - Attachment 1- Receiving environment and clean-up procedures - Unsealed land ( beaches, parks, open land and gardens) and public footpaths.</p> <p><i>ii. Decontamination of the site as appropriate.</i></p> <p>Clean up consistent with Sewage Spills/Overflow Response Work Instruction as appropriate to the location, and to minimise risk to public health and the environment. The crew contracted to conduct the unblocking of the sewer network and the clean-up and disinfection on behalf of PWC was Mick Excavations Pty Ltd. All waste from the clean up was taken to the East Arm bio-solids facility.</p> <p>Further targeted education campaigns on inappropriate items being disposed of into the sewer system is currently being contemplated by PWC and will be rolled out in a month or two, subject to funding approval.</p>

Appendix B – Photograph of the cause of the spill – combination of fats, grease and non-disintegrating rags, prior to clean up.

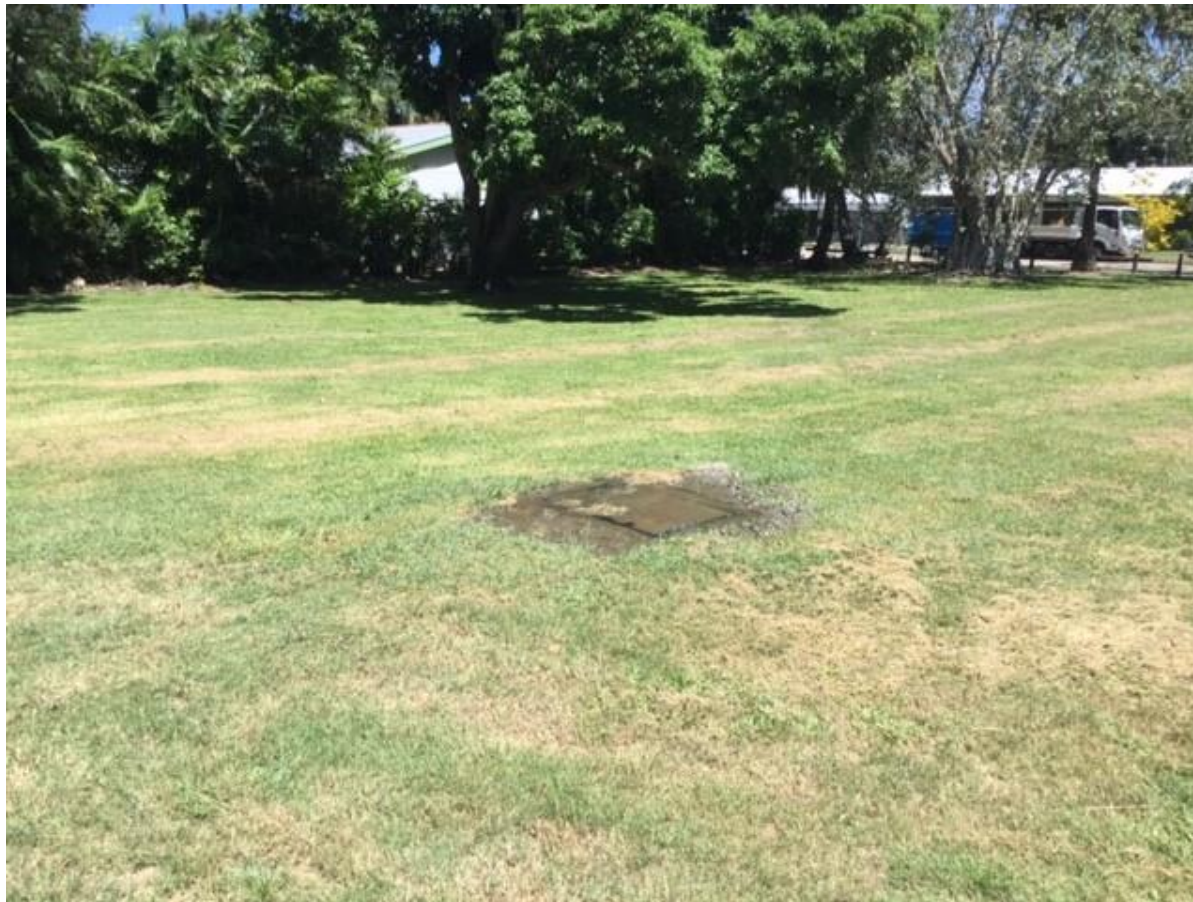
<p>Final discharge point was the grass surrounding the sewer manhole cover as per the above co-ordinates.</p> <p><i>iii. Indicate any locations nearby to the discharge point where public can gain ready-access, such as public open spaces through which the discharge moves.</i></p> <p>Access to the public is possible, as the manhole cover is in the middle of Mullen Gardens park. The affected area has been thoroughly cleaned via vacuum truck from Mick Excavation Pty Ltd, who are suitably licenced for this activity under EPL 232, and disinfected the area as per the PWC Sewage Spills/Overflow Response Work Instruction Attachment 1- Receiving environment and clean-up procedures - Unsealed land ( beaches, parks, open land and gardens) and public footpaths. Any pooling wastewater and gross pollutants were vacuumed up, followed by liming of the area to disinfect the area. This will be followed up within 5 days time with the addition of 50mm of clean topsoil.</p>

Appendix C – Photograph of the spill site, upon arrival, prior to clean up.

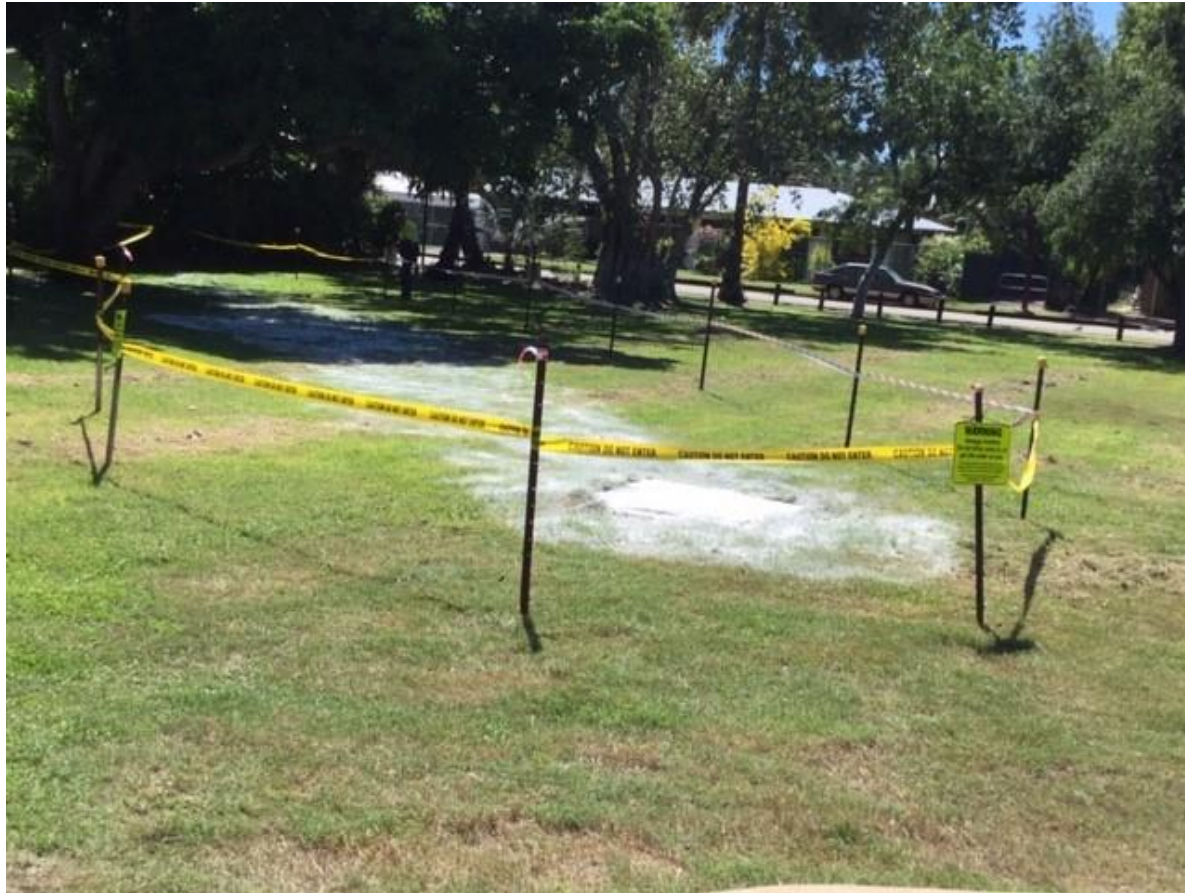
Appendix D – Photograph of the spill site, post clean up showing barricading, applied lime and warning signage.
