# WDL 249 Environmental Monitoring Report

22 December 2023- 21 December 2024

Toms Gully Mine Project Area

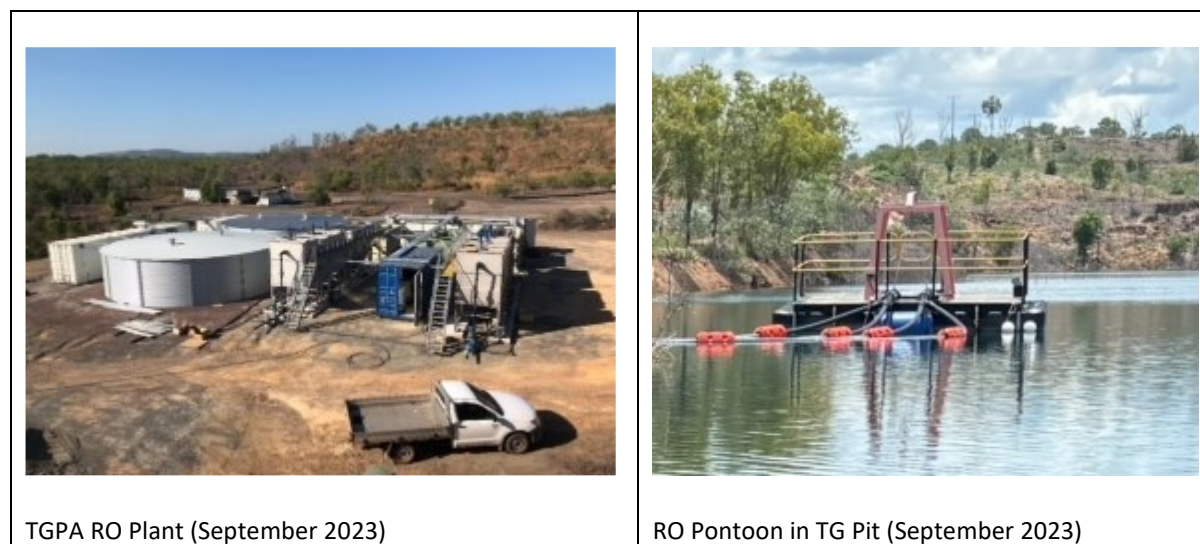
**Photo 1-1 TGPA Reverse Osmosis Plant and Pump Pontoon**

TGPA remained in care and maintenance during 2023-2024 reporting period and has been since PGO's purchase of tenements in 2013. No exploration activities occurred at TGPA during this reporting period. The EIS for TGPA was formally approved in 2020 under the *NT Environmental Protection Act 2019*. The Reverse Osmosis (RO) water Treatment Plant received approval from the Department of Infrastructure, Tourism and Trade (DITT) in December 2022 under the *Mining Management Act 2001*. Construction of the plant and auxiliary infrastructure (including reconnection of mains power) occurred during 2023 with commissioning of the RO Plant in October 2023 (Photo 1-1).

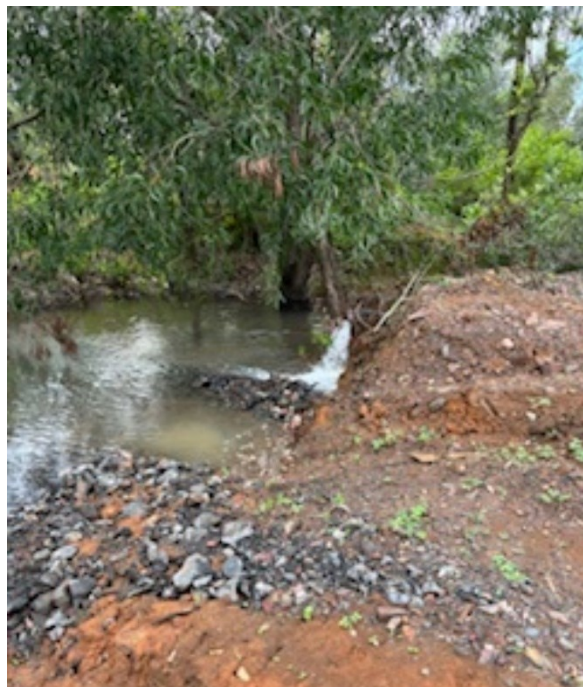
TGPA ADP1 (January 2024)

### **Photo 1-2 Authorised Discharge Point 1 and Compliance Point Telemetry Station**

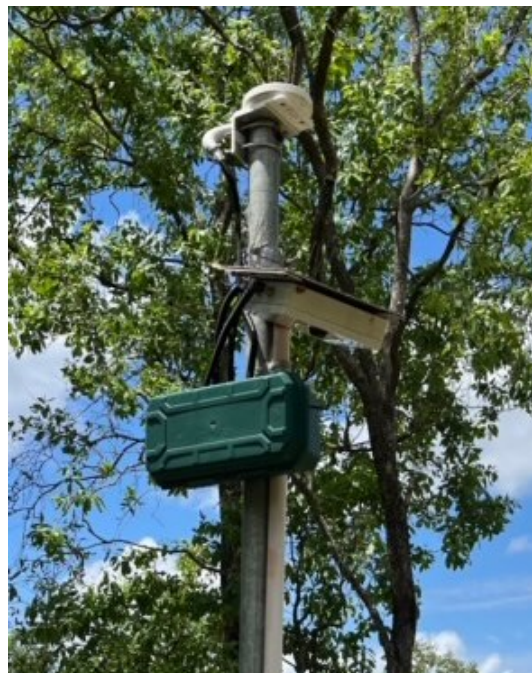
SWTG2 WDL 249 Compliance Point, telemetry station

A solar powered telemetry station is situated at the Compliance Point (SWTG2) to continuously monitor physical water quality during creek flow and wastewater discharge as per License conditions. Information provided by the logger is invaluable during controlled/no controlled site discharge events to gain a clearer understanding of creek flows and water quality fluctuations particularly when site access was limited.

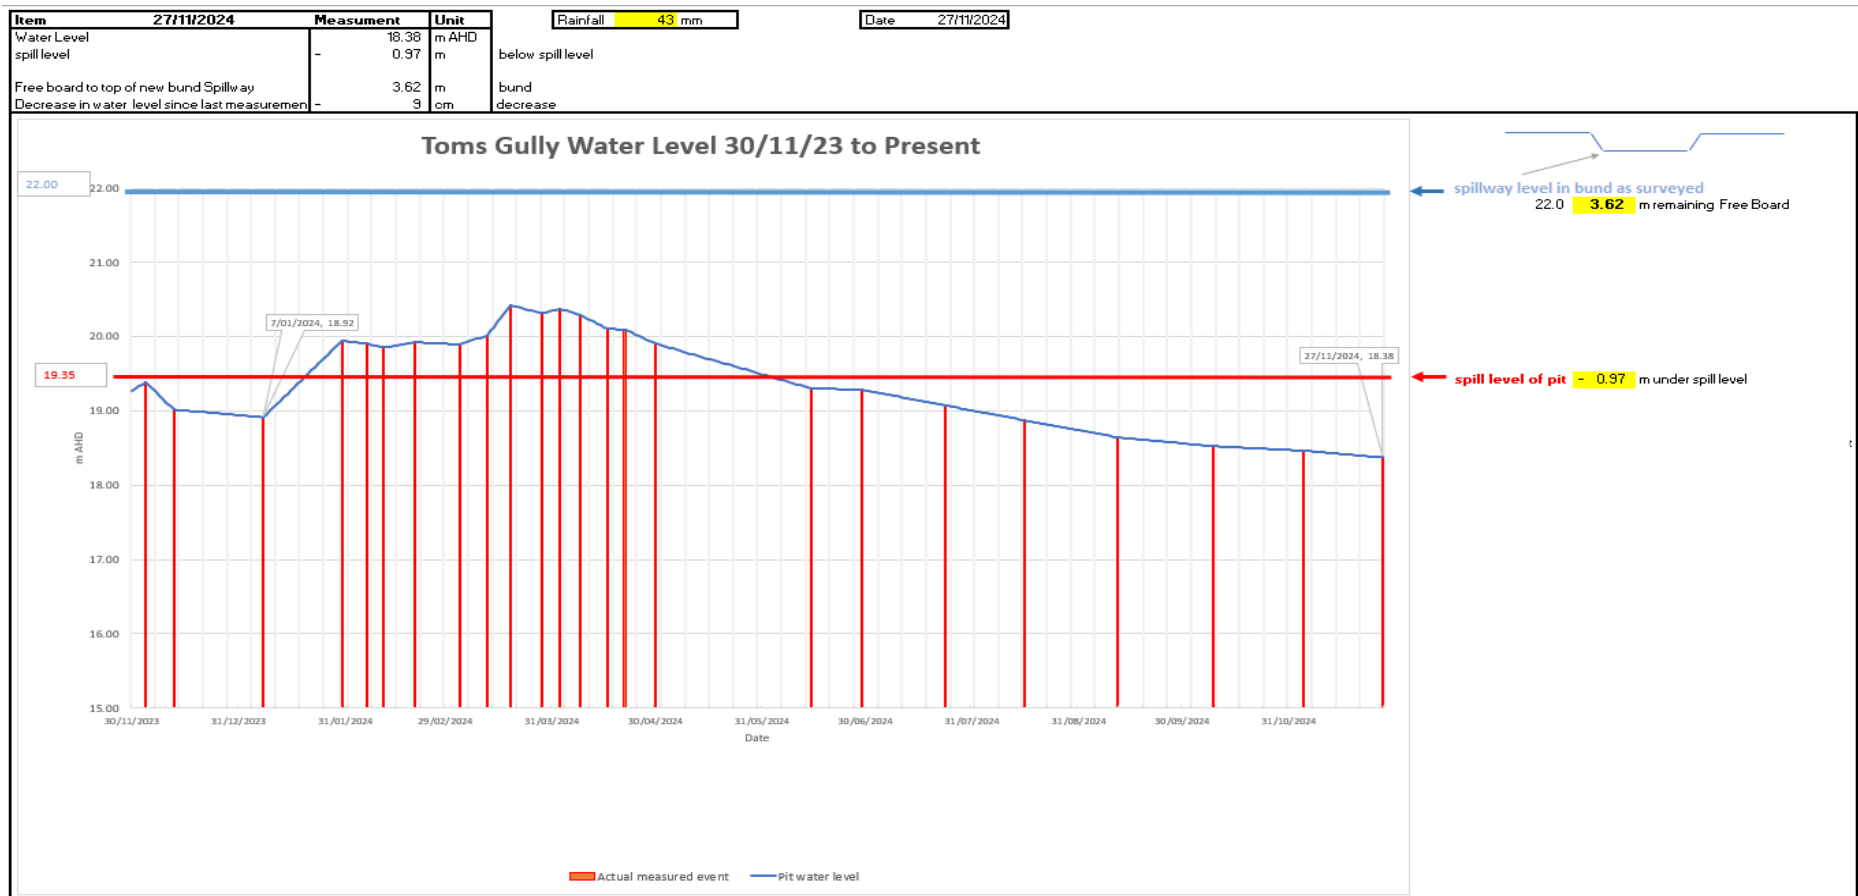
Figure 1-2 Toms Gully Mine Pit Water Level (2023- 24)

TGPA Pit water levels were recorded weekly during routine monitoring, which is above the monthly requirement as per Appendix 2 of the Licence. Water levels were recorded using relative levels off a surveyed marker. Figure 1-2 shows levels of the Pit since 30 November 2023. Current levels of 18.38 mRL as of 27 November 2024 compared to this time 11 months ago with an overall reduction of -0.54m.

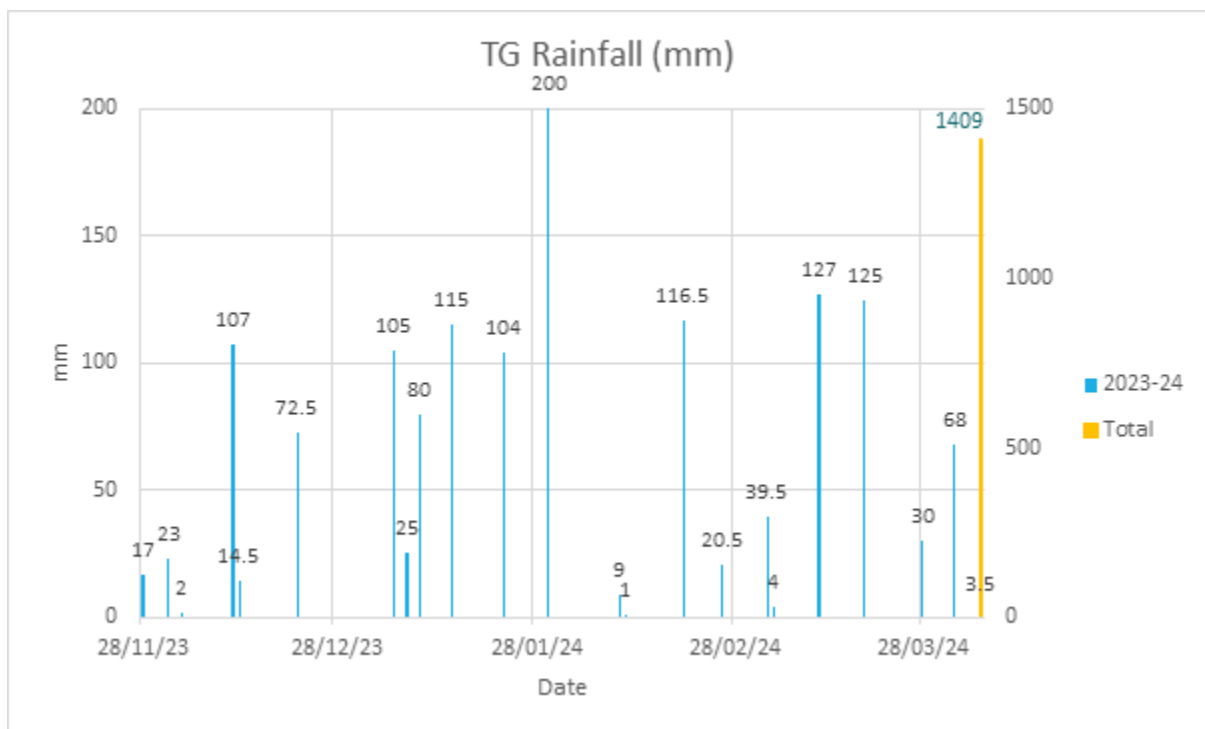
Figure 2-3 Toms Gully Rainfall (mm) for 2023- 24 Wet Season

Quest 29 Project Area recorded 739 mm and Rustlers Roost Project Area recorded 987mm with the highest rainfall recorded in February 2024 for both sites.

Rainfall generally aligns with creek water level fluctuations (level data recorded at the SWTG2 compliance point telemetry station) and upper catchment only rainfall events.

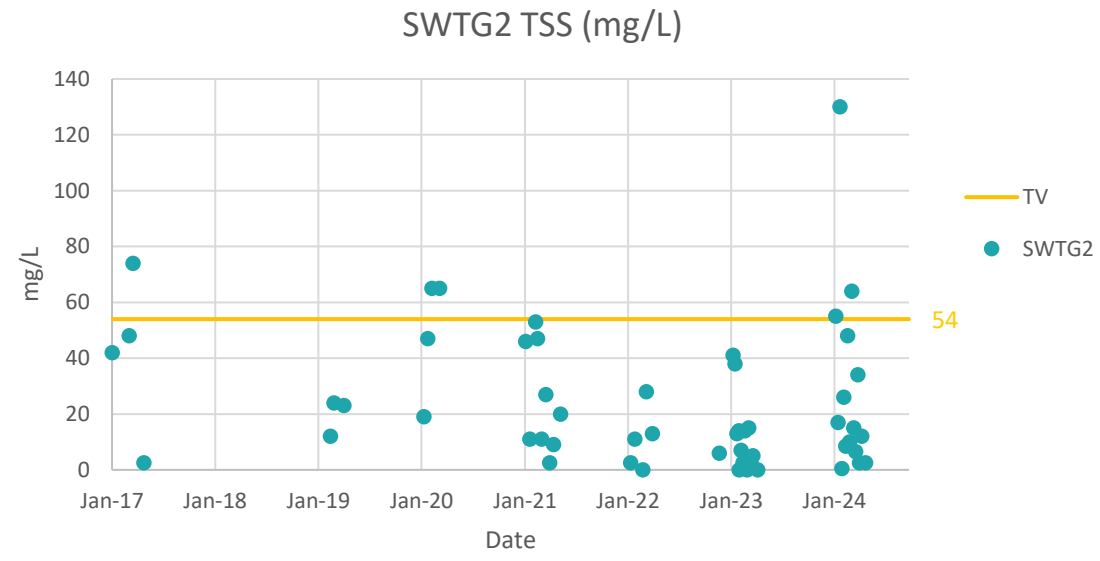
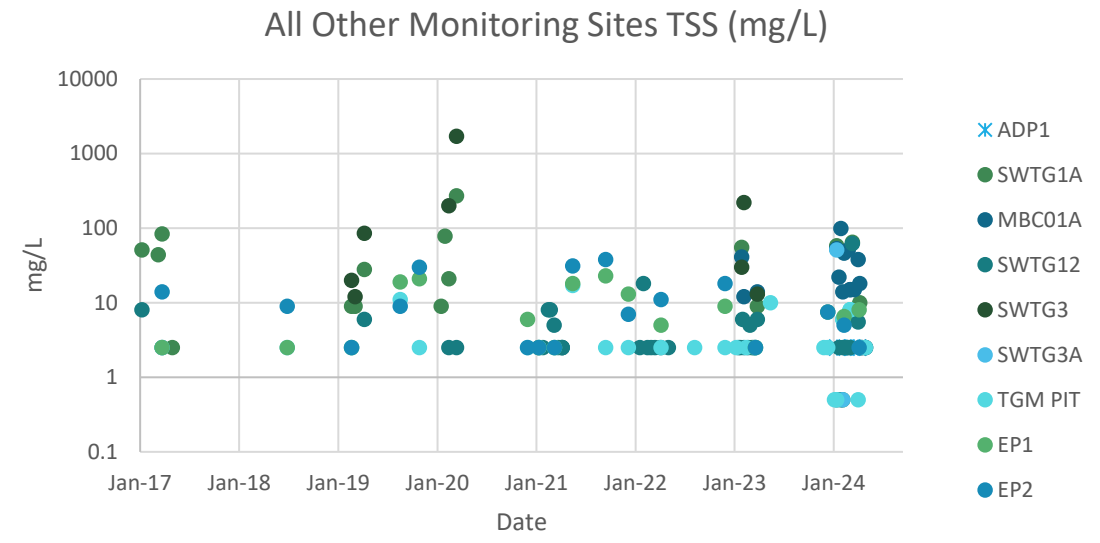
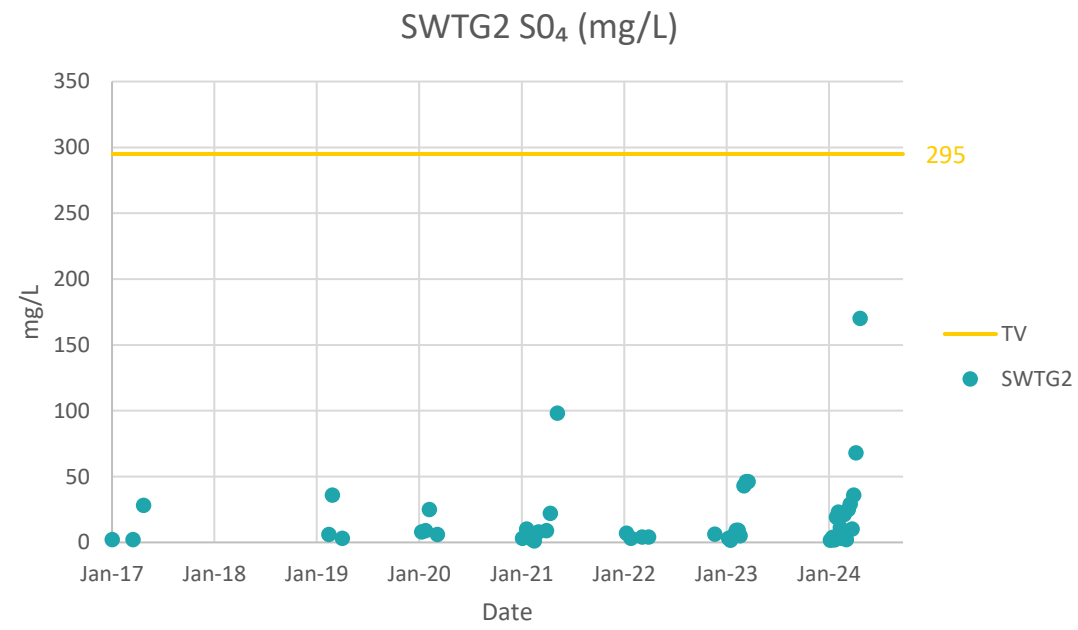
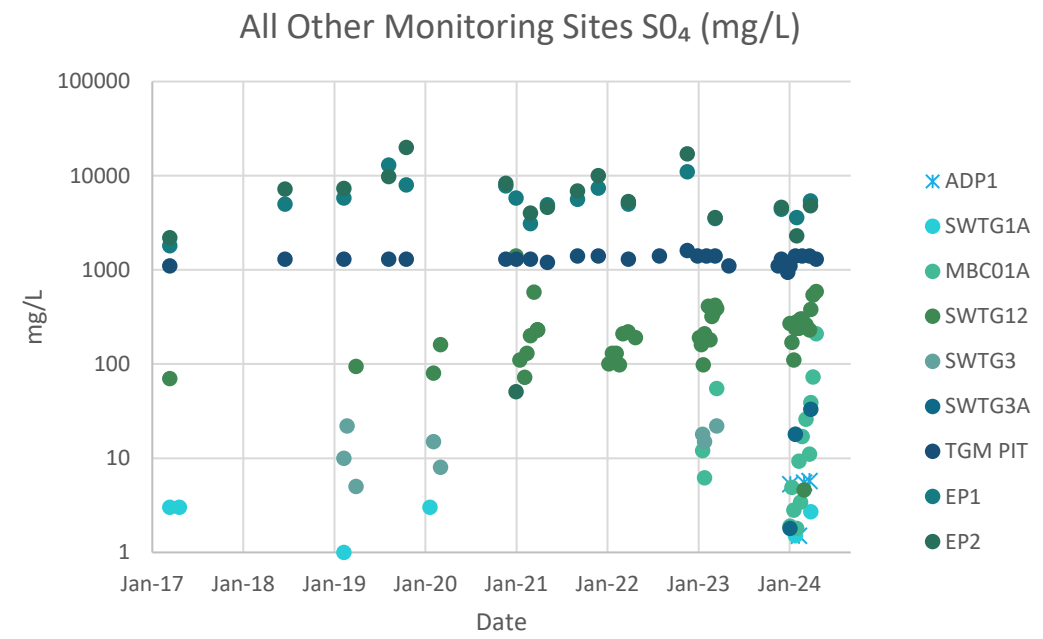
Figure 4-3 SWTG2 and other monitor sites Trend Analysis for General Chemistry

General chemistry analytical results from field sampling temporal and spatial trends at all creek sites for the reporting period are presented below. Appendix A includes all monitoring data. General chemistry data points (from 2017-2024) are presented in the following graphs. SWTG2 (compliance) data is presented separately from the other monitoring sites and compared to the respective WDL 249 TV's and all other monitoring sites data are presented in Figure 4-3.

- Total suspended solids (TSS mg/l) short- and long-term median trends were within respective WDL 249 GV's . TSS analytical results (N=15) were outside of WDL 249 TV guidelines at SWTG2 (compliance point) on three separate sampling occasions during the reporting period.
- Sulfate ( $\text{SO}_4^{2-}$  mg/l) short- and long-term median trends and analytical results (N=15) were within respective WDL 249 TV guidelines of 295mg/L at SWTG2 (compliance point) during the reporting period.

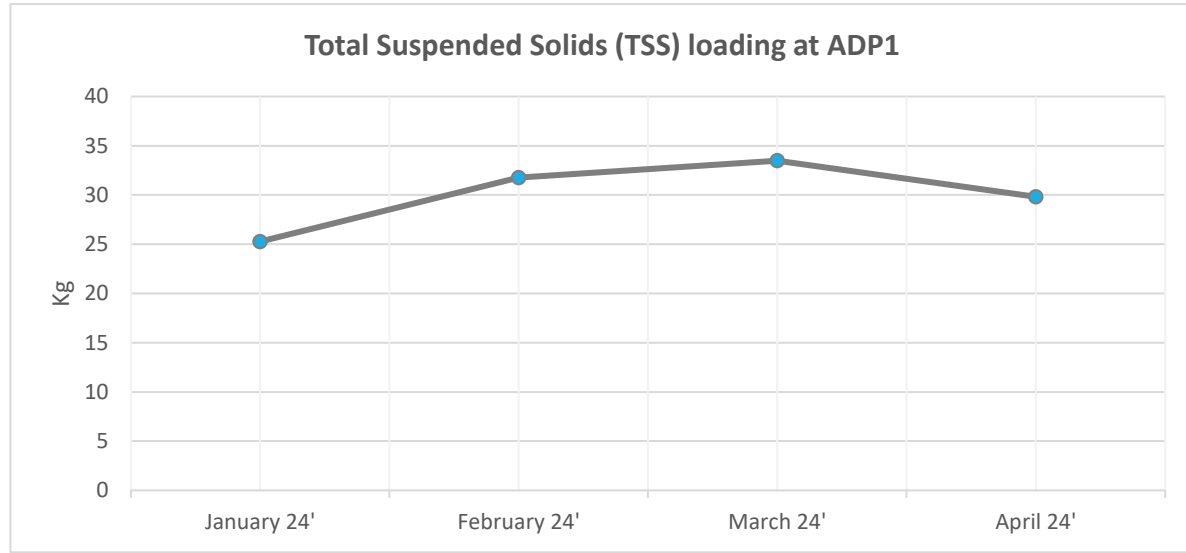
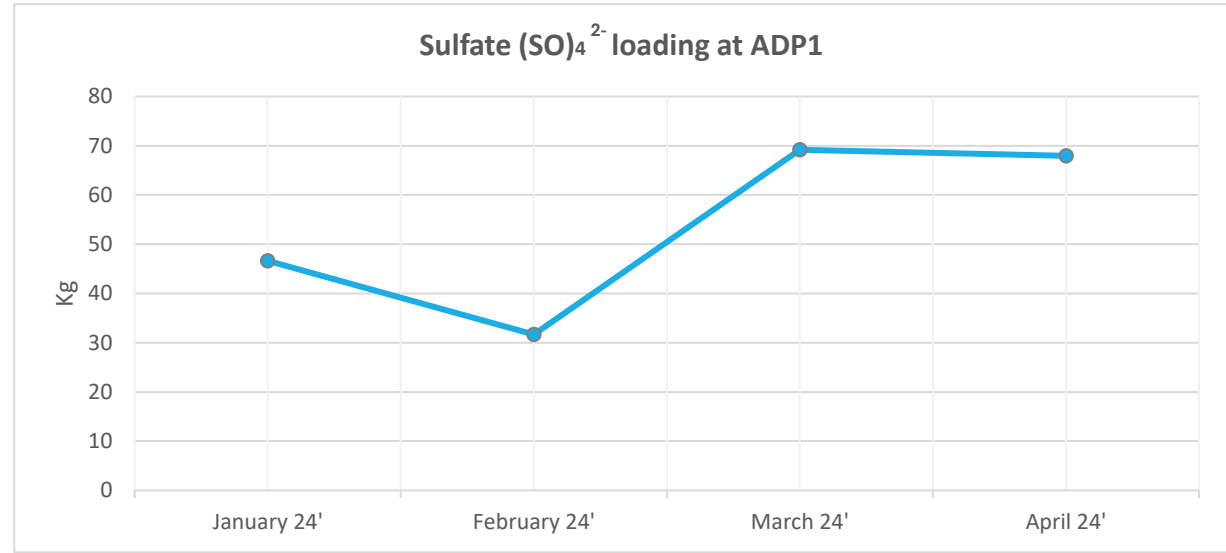
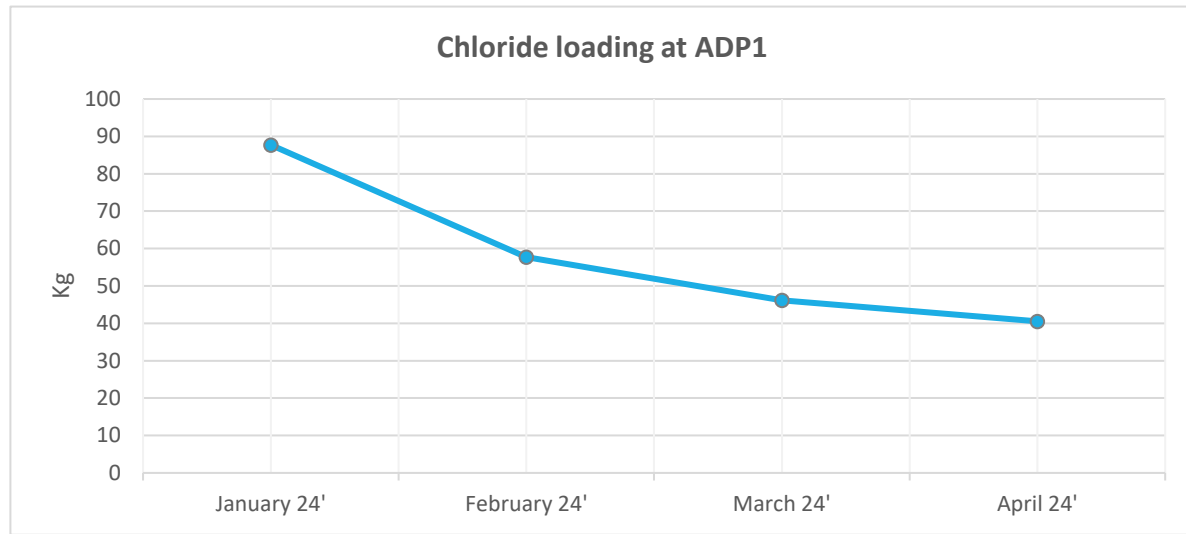
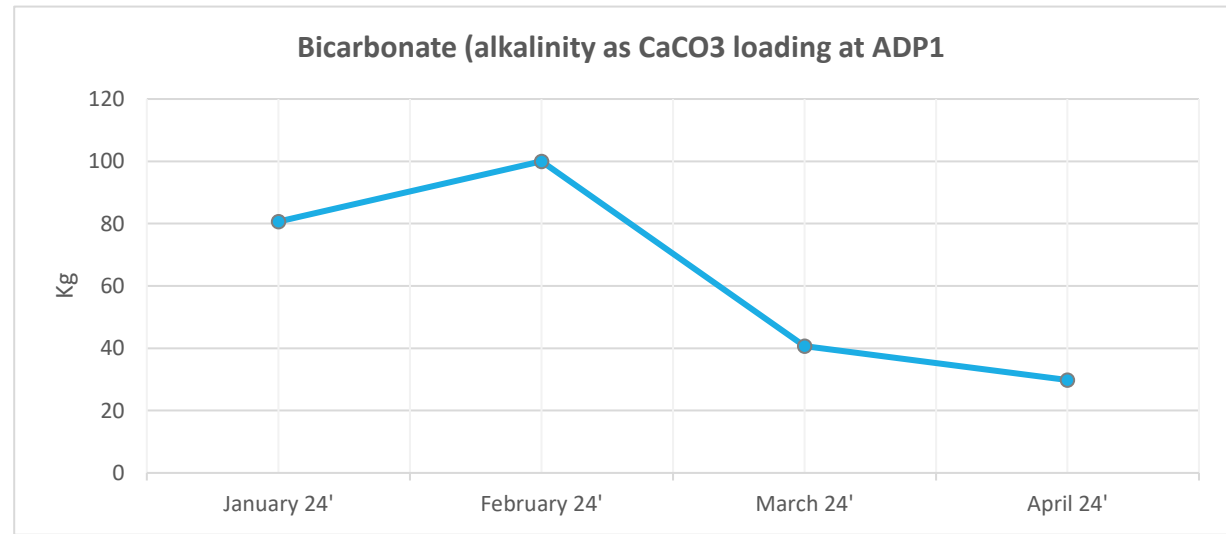
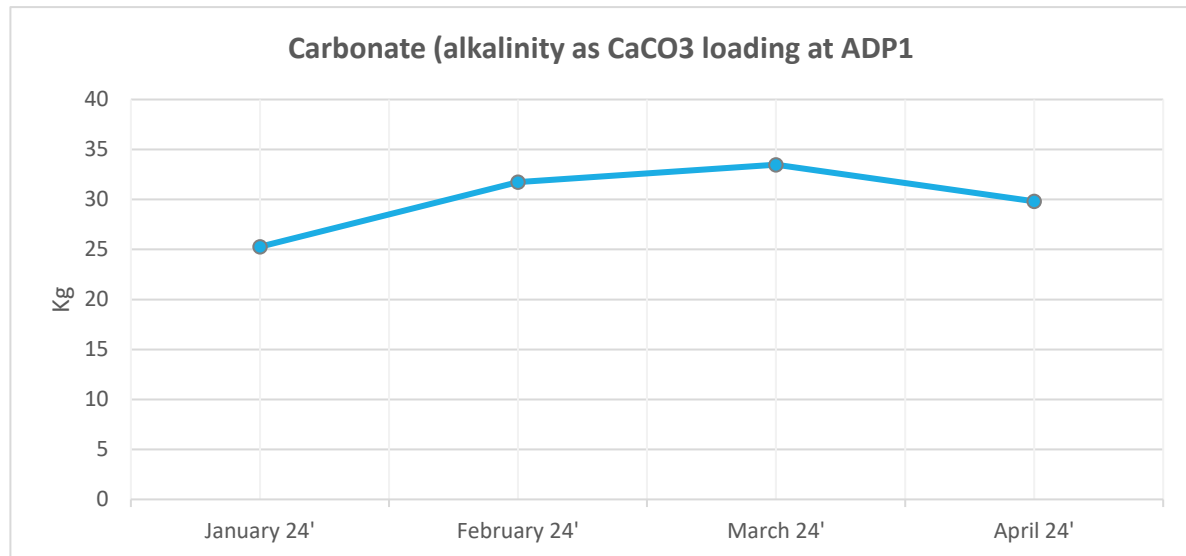
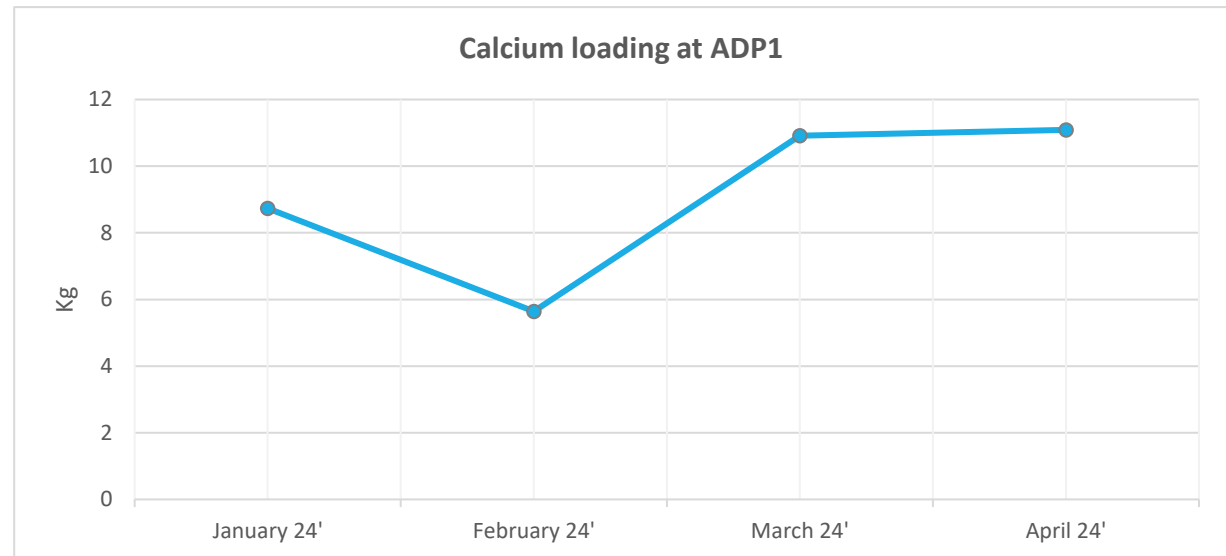
Figure 4-6 ADP1 General Chemistry Loadings

- There were no exceedances of the WDL249 discharge trigger values for major chemistry. Total loads concentrations at ADP1 with the highest concentration of bicarbonates (250kg), with cation loads dominated by sodium (150kg) followed by calcium (36kg). Chloride (232kg) load were slightly higher load compared to sulphates (215kg).
- There were no exceedances of the WDL249 discharge trigger values for dissolved metals, with the exception of cadmium on 02/04/2024, which slightly exceeded the respective GV's. Total load concentrations at ADP1 with the highest concentration included Aluminium (1.2kg), followed by Zinc (0.7kg), Aluminium (0.5kg) and Iron (0.2kg).
- Analytes that exceeded respective WDL 249 T.V's at SWTG2 and required external reporting had concentrations of Zinc (0.7kg), Cadmium (0.01kg), Cobalt (0.04kg), Copper (0.02kg), and Nickel (0.14kg).

ADP1 total loadings for general chemistry are provided in Figure 4-6. Total loadings for metals/metalloids from ADP1 are provided in Figure 4-7.

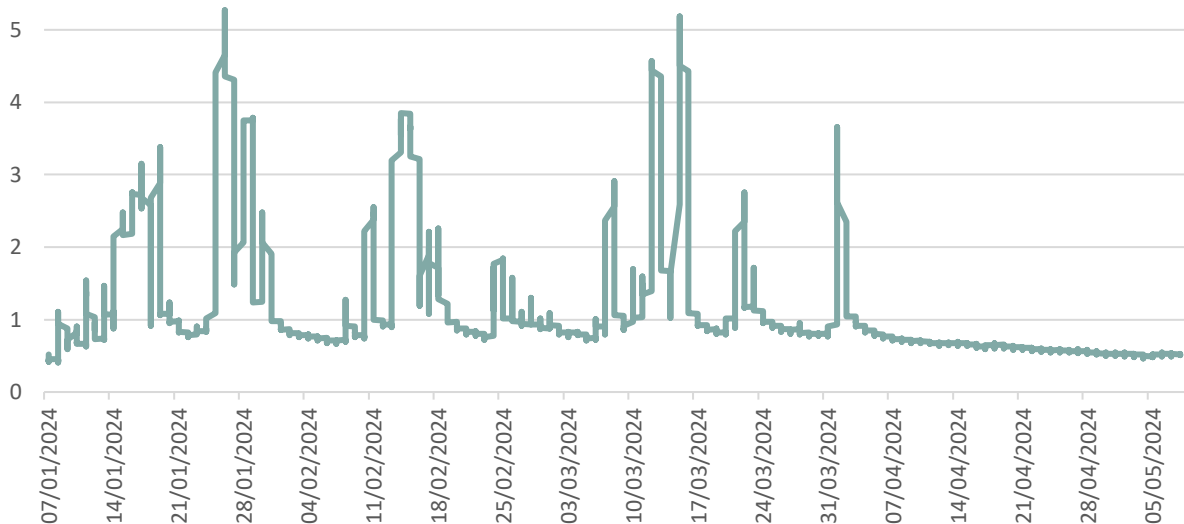
Figure 2 – Creek height at SWTG2 January - May 2024

The water height of Mount Bunday Creek at site SWTG2 is presented below in Figure 2. Spikes in creek height were short and sharp, suggesting episodic rainfall across the catchment. Peak flows were recorded in January and March, with sustained creek flow present throughout a three month period, tailing off to no flow by the end of May. It is acknowledged that the TGPA is located low in the Mount Bunday Creek catchment, and is subject to rainfall from a large catchment upstream and active discharge from Rustlers Roost Mine (RRPA). Flow remained steady at SWTG2 from April onwards, particularly for the month leading up to sampling in early May.

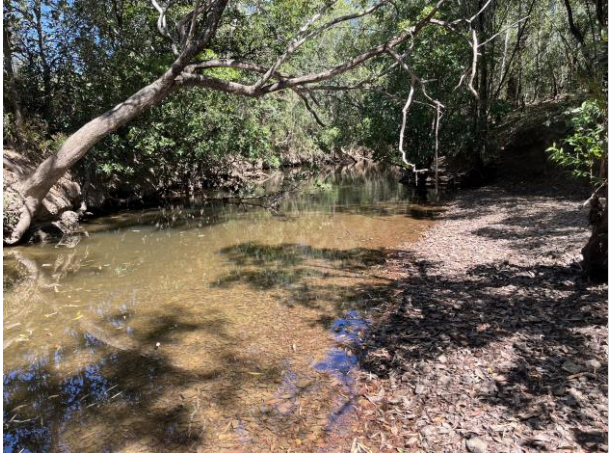
Site description	Site photo
<p><b>SWTG1A - Upstream</b></p> <p>The site was made up of two large pools connected by a shallow run. The creek was lined by a closed canopy of riparian vegetation and shading was high. The left bank was steep, and a mixture of consolidated clay and gravel with sections of bedrock, while the right bank was a gentle slope and consisted of cobbles and pebbles. Bed material was majority pebbles and sand.</p>

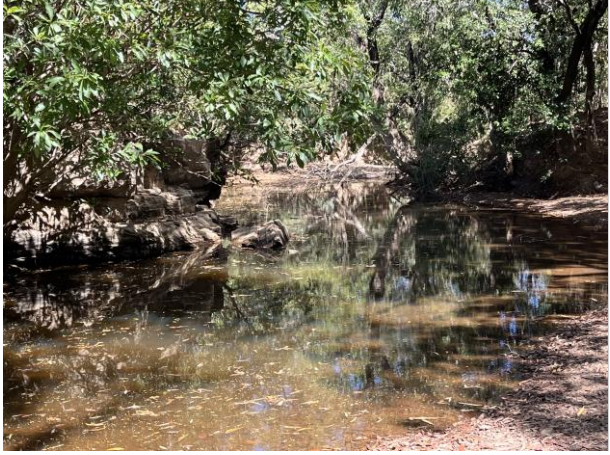
<p><b>SWTG1 – Upstream</b></p> <p>The site is made up of two large, deep pools, connected by a run. The substrate of both pools was made up of sand and gravel, and the connecting run has substrate made up of pebbles, cobbles and sand. Both banks of the pool are lined by continuous riparian vegetation providing shade and exposed roots. Undercut banks were prevalent, along with leaf packs and small log jams.</p>

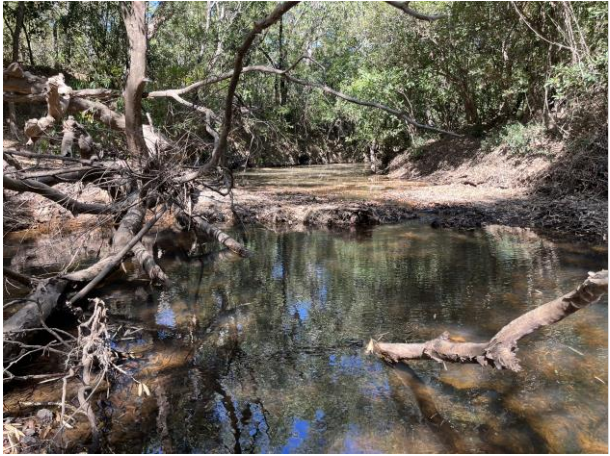
<p><b>MBC0 – Adjacent</b></p> <p>The site is located approximately 100m upstream of the confluence between a small, unnamed tributary that drains passive discharge from mining infrastructure. The site was well shaded due to a continuous riparian zone, and presence of trees along banks allowed for exposed roots, large woody debris and leaf packs to be common through the site. The majority of substrate at the site was made up of sand and pebbles. Long gliding pools were connected by shallow runs. And riffles</p>

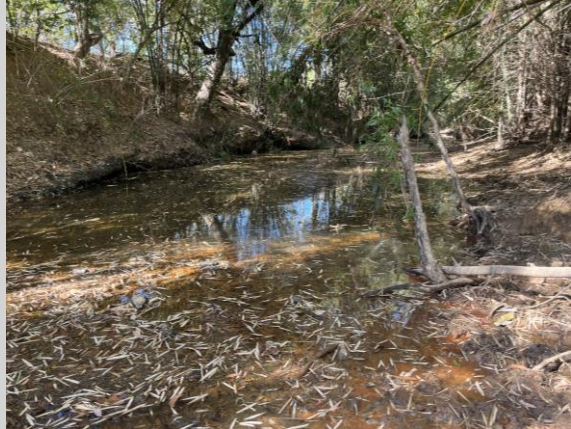
Site description	Site photo
<p><b>SWTG2 - Downstream</b></p> <p>The site is made up two gliding pools connected by runs, and is intersected by a stock crossing. The stock crossing has undergone significant upgrades, which have resulted in erosion and a change in flow through the site from previous years. Downstream of the crossing, the site was a wide, shallow pool. Substrate along the entire reach was a mixture of cobbles, pebbles and sand, with clay banks covered by a film of iron-producing bacteria.</p>

A photograph showing a shallow stream pool. The water is clear and reflects the surrounding trees. The substrate is a mix of cobbles, pebbles, and sand. The banks are covered with a film of iron-producing bacteria, appearing as a reddish-brown layer. The surrounding area is wooded with various trees and vegetation.

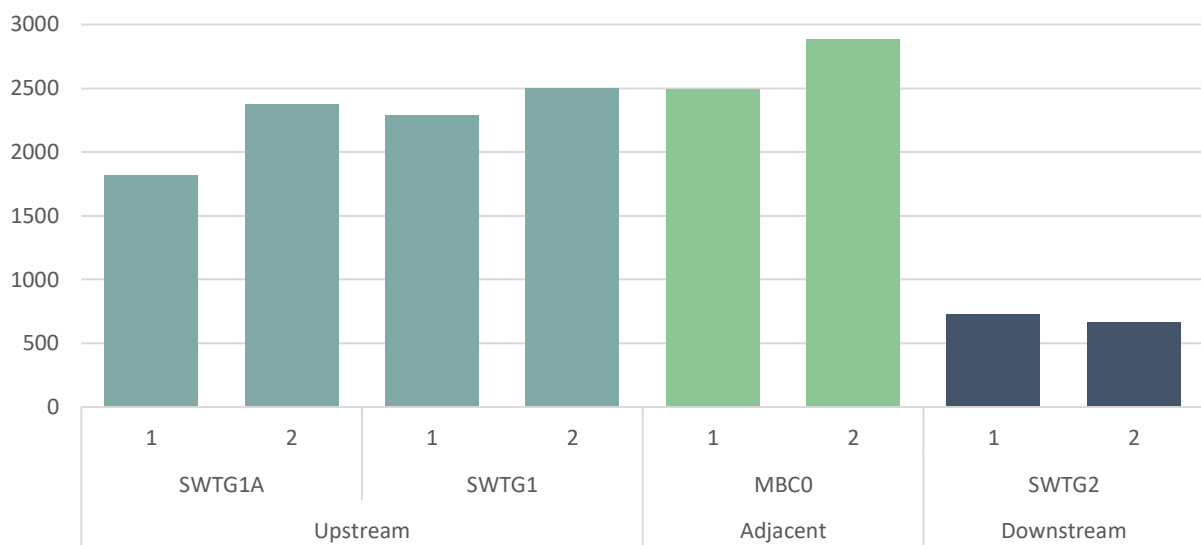
Figure 4 – Relative abundance at sites sampled in May 2024

Relative abundance results for all sites sampled in May 2024 are presented below in Figure 4. In general, numbers increased with distance downstream on Mount Bunday Creek, but dropped significantly downstream of mine influences. Control sites showed similar relative abundance at both sites, and downstream samples contained a slightly higher number of taxa.

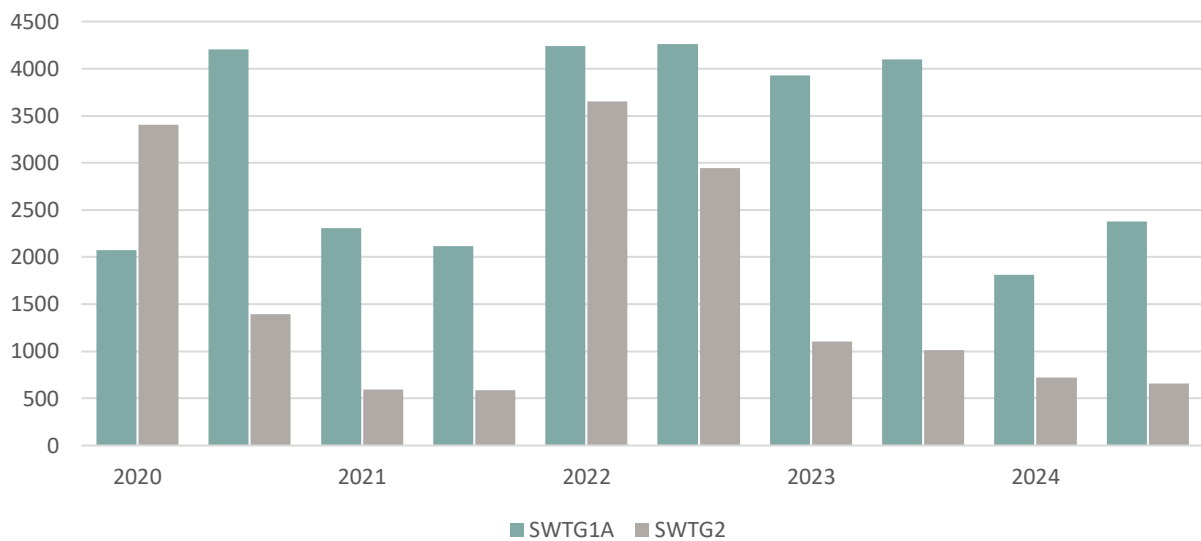
Figure 5 – Relative abundance of samples collected at SWTG1A (upstream) and SWTG2 (downstream) 2020 - 2024

When reviewing relative abundance data in a historical context (Figure 5) lower macroinvertebrate numbers observed in 2024 have been recorded downstream prior to any active discharge to Mount Bunday Creek. A similar trend of lower relative abundance was seen both upstream and downstream of TGPA in 2021.

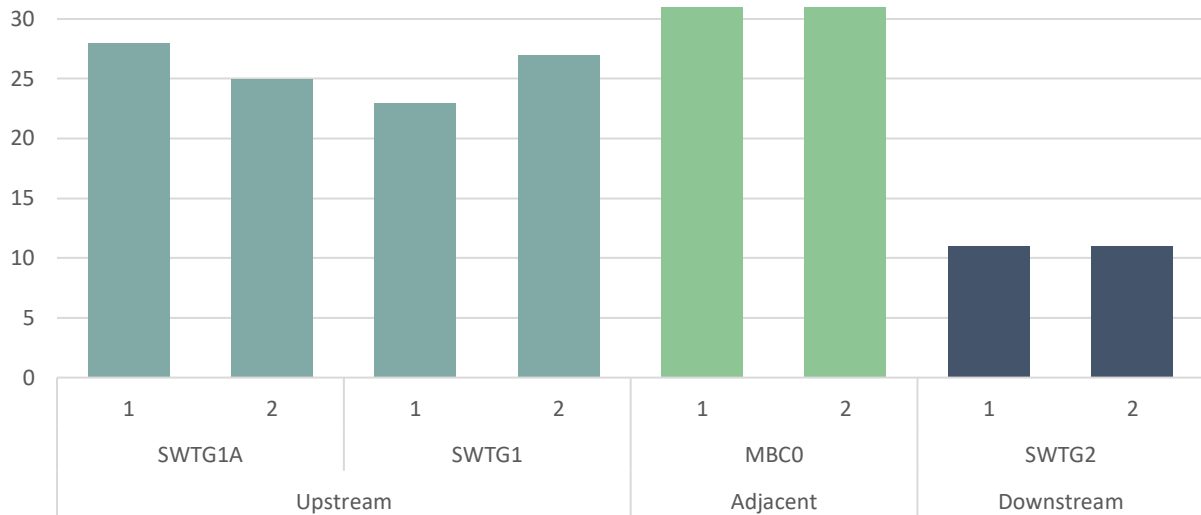
Figure 6 – Taxa richness results at sites sampled in May 2024

Taxa richness results from all sites sampled are presented in Figure 6. Family diversity was highest at MBC0, which matched relative abundance results, and the number of taxa was more than halved downstream at SWTG2. Taxa numbers were lower in 2024 compared to previous years of baseline sampling (Figure 7), but has had a variable relationship with the upstream site (SWTG1A) in previous years.

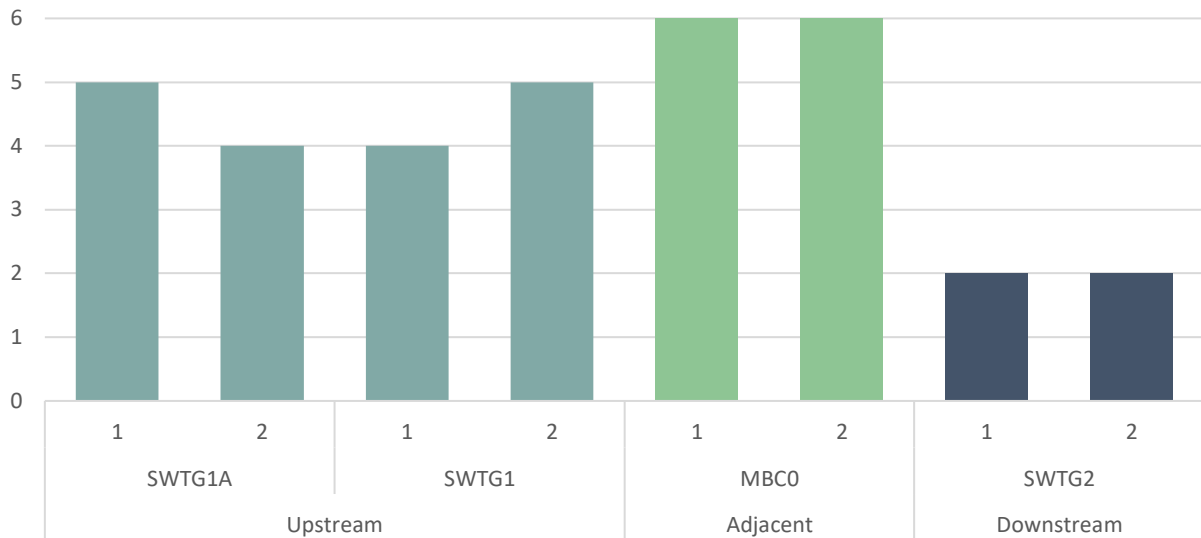
Figure 8 – PET richness at sites sampled in May 2024

The PET richness results for all sites sampled in May 2024 are presented below in Figure 8. PET richness was similar upstream, highest adjacent on Mount Bundey Creek, and lower downstream. Historically, PET richness has been lower or equal to numbers recorded at the upstream site, but 2024 showed a more notable difference between the two sites. The number of PET taxa has been trending downwards over the last three years.

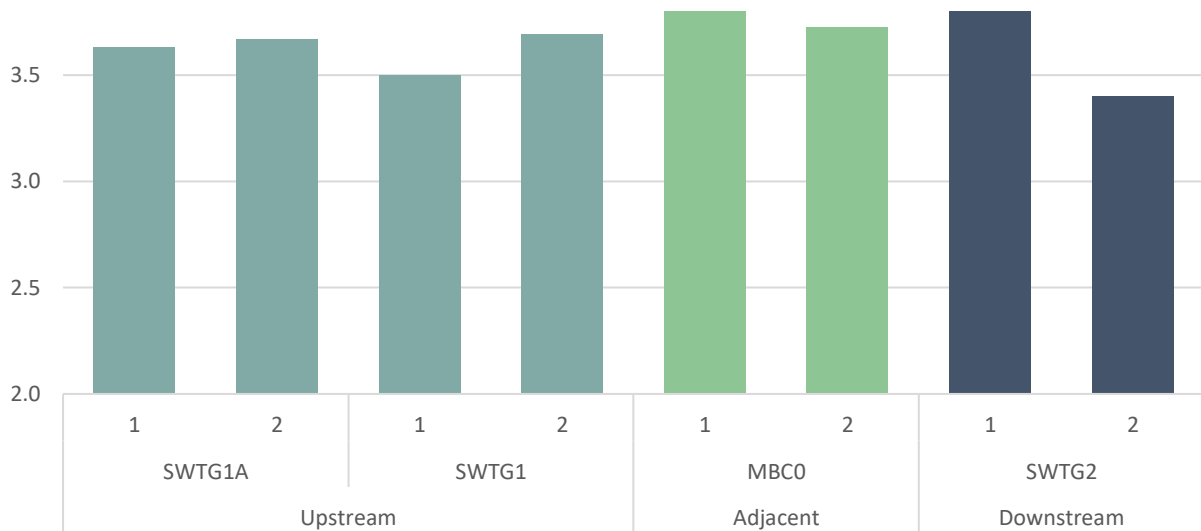
Figure 10 – SIGNAL-2 scores at all aquatic ecology sites visited in May 2024

SIGNAL-2 scores for all samples collected in May 2024 are presented in Figure 10. There was very little variation in SIGNAL-2 scores between site types on Mount Bunday Creek (3.4-3.83). The SIGNAL score range at the sites are well within the pollution tolerant end of the scale (Marshall *et al.* 2001). Results from the past five years showed a decrease in pollution sensitivity at both upstream and downstream sites in 2023 and 2024. The macroinvertebrate community surrounding Toms Gully Mine is made up of a community tolerant of intermittent flows and poorer water quality, which is in line with previous findings (AES 2023).

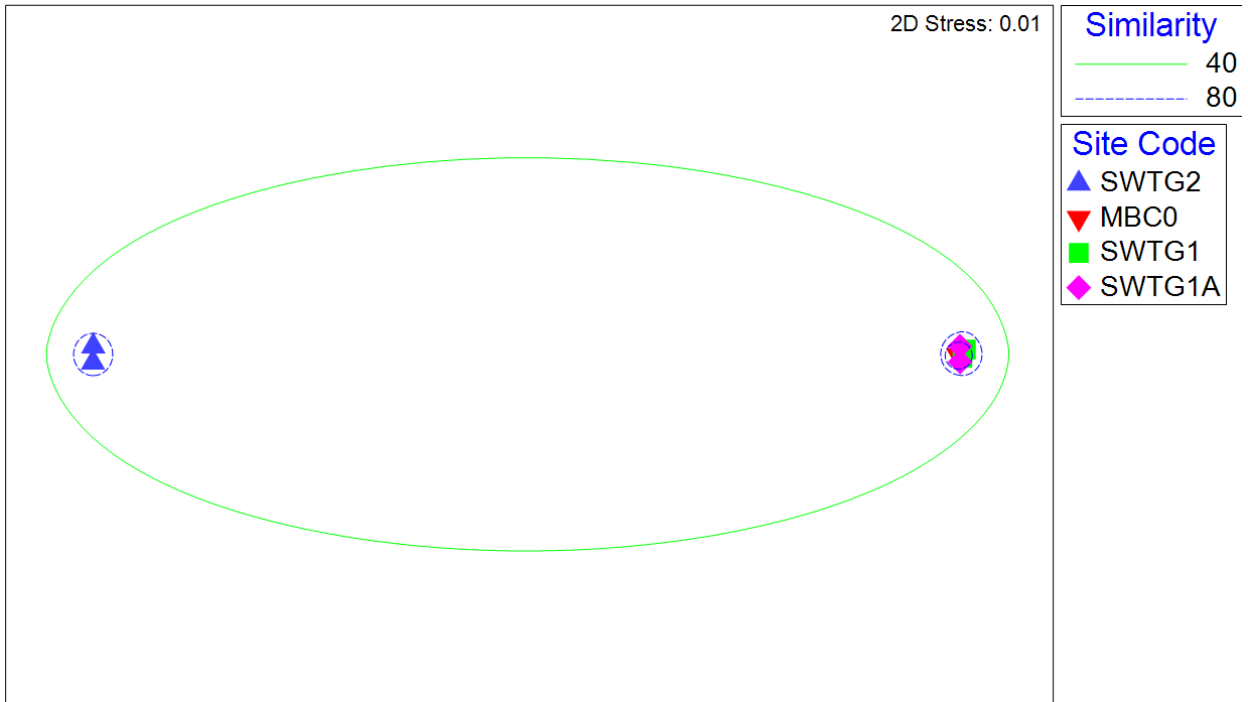
Figure 12 - NMDS demonstrating relative similarity of macroinvertebrate communities in samples collected on Mount Bunday Creek in May 2024

Similarities in habitat availability is noted in Section 4.1.2 is likely to be influencing the similarity in community composition across upstream and adjacent sites, whereas differences in water quality (Section 4.2.2) are likely to be separating samples at SWTG2. Lower abundances at SWTG2, along with several taxa present at upstream and adjacent sites that were not collected downstream have resulted in the difference between the site and others.

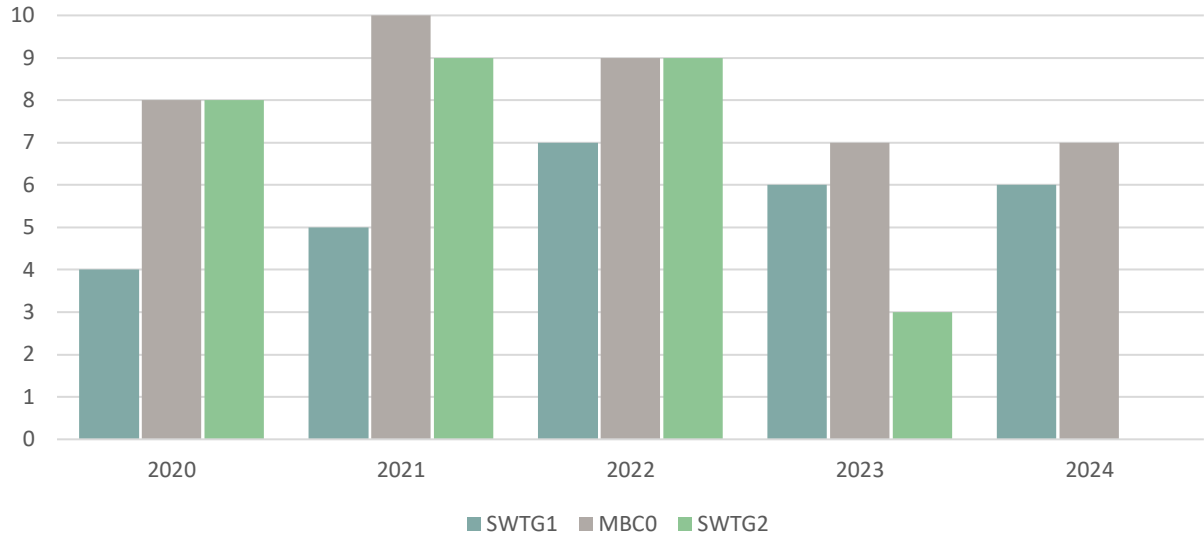
Figure 14 – Fish diversity results 2020 - 2024

Compared with the previous four years, there was a reduction in diversity at SWTG2 in 2023, before no fish were collected in 2024 (Figure 14). Fish diversity did also decrease at upstream sites in 2023 and 2024, but the trend was much less prominent.
