G-TEK AUSTRALIA PTY LIMITED WATERFRONT REDEVELOPMENT DARWIN, NORTHERN TERRITORY

INITIAL REPORT

POST ACTIVITY REPORT

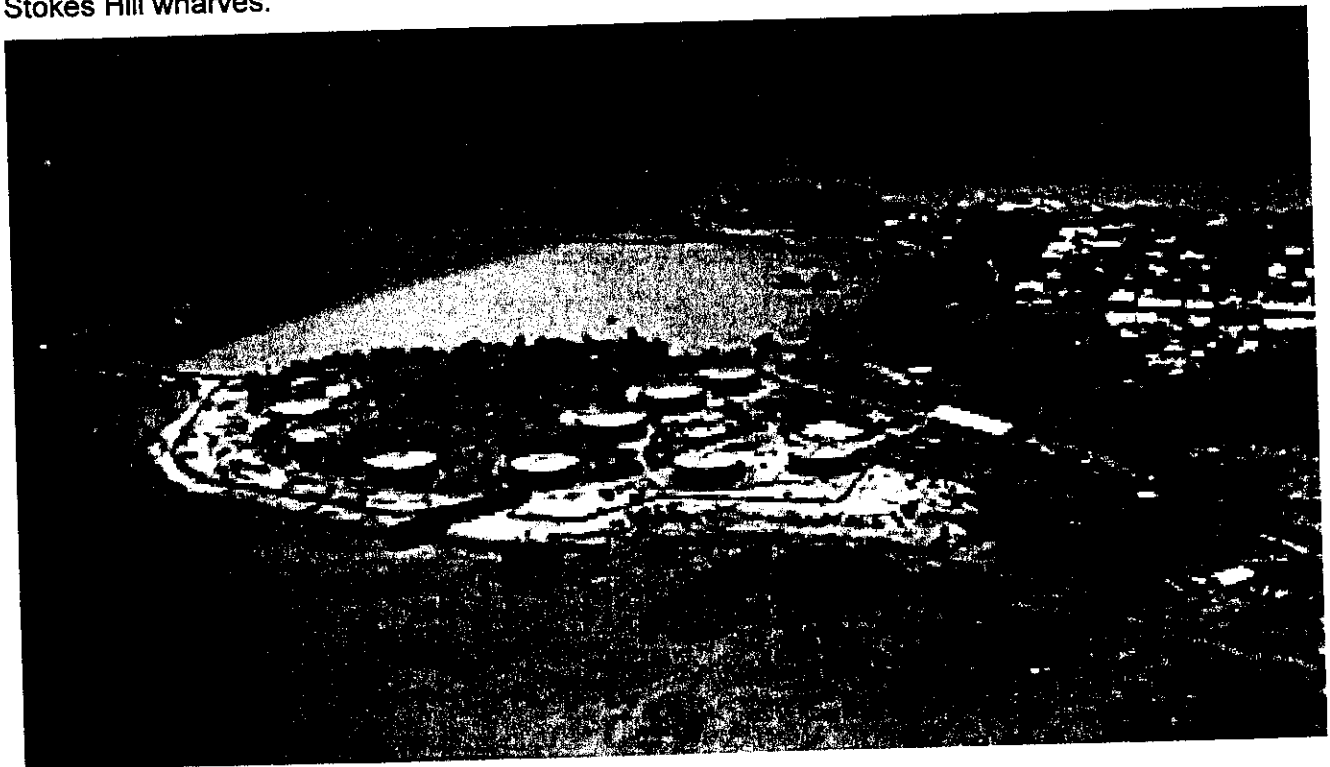
Darwin Wharf Area 1938 (32)

Based on a review of contemporaneous photographs and records and a review of current material and the site itself, it is obvious that a large portion of the area of interest has changed considerably since WW11. Those areas that appear to be basically unchanged include the area of the oil storage facilities and its surrounds at Stokes Hill, the escarpment area adjacent to Kitchener Drive, very early fill areas around the former Fort Hill and the current tidal areas out to the Fort Hill and Stokes Hill wharves.

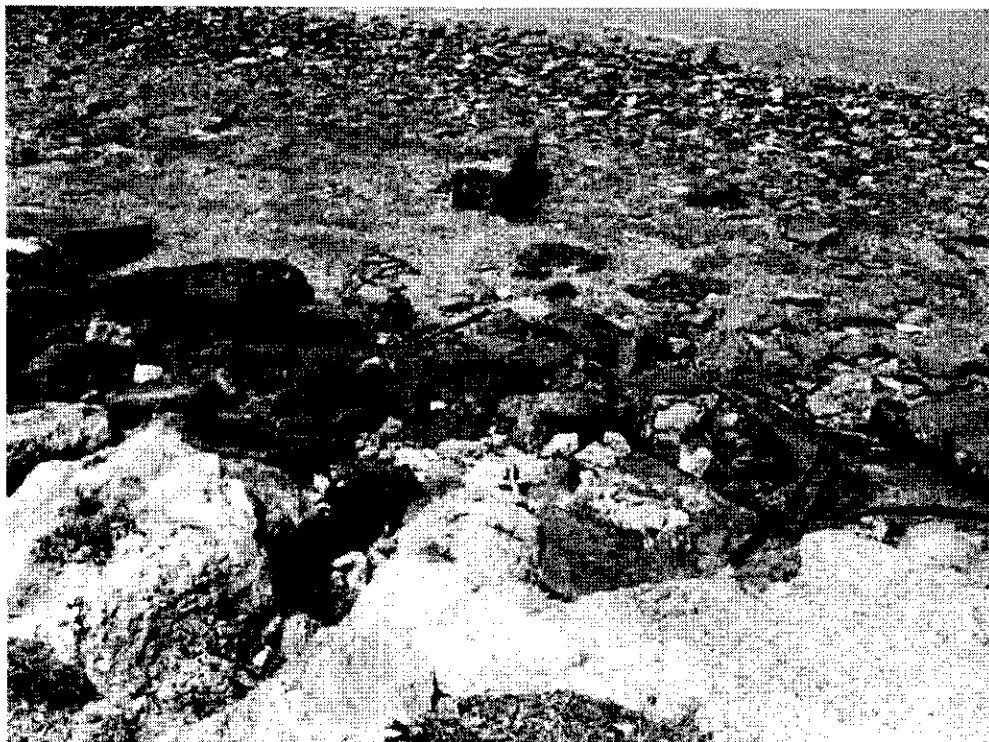
Photograph 3 – Surface Debris, Western Foreshore Area

Within many of the areas tested, large amounts of metallic debris were found to be located on or near the surface.

Metallic debris was generally found on or near the surface in many of the areas tested.
