# memorandum

**To:** File  
**From:** Francess Perrett  
**Subject:** Site inspection Frances Creek Mine

**Date:** 18/10/2006  
**Ref:** EPA2006/0119

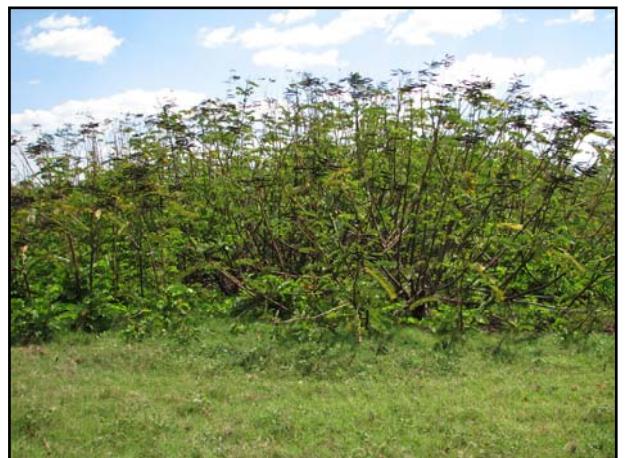
Low Ecological Services identified the TSF as a good quality wetland. While on site this wetland was observed to be degraded with weed species. In particular Candle Bush (*Senna alata*), which formed dense stands around the margins of the wetland (Photo 1). Although this wetland is providing habitat for fauna species, it is not considered to be of high regional value due to the prominent weed presence.

**Photo 1:** Candle Bush (*Senna alata*) around margins of TSF.

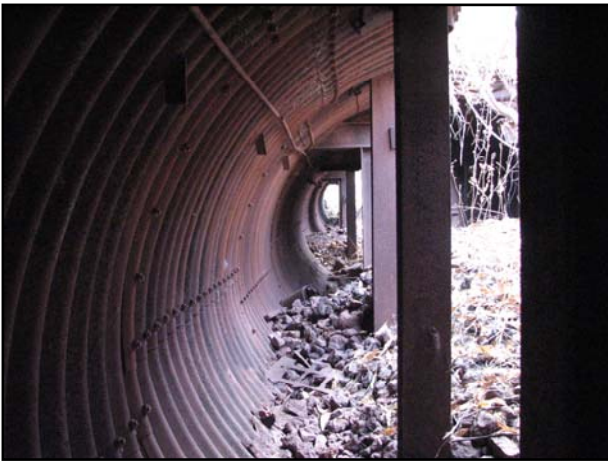
Ghost Bats (*Macroderma gigas*) and another species of micro bats were seen in the conveyor tunnel (Photo's 2 & 3). The tunnel has two openings. If the work proposed by Territory Iron only impacts on one end on the tunnel, the Ghost Bats could still roost in the tunnel. However mining activities such as noise, vibrations and dust may adversely affect the bat colony. A management strategy for this NT Near Threatened species needs to be provided. It should include opportunities for removal and relocation of the colony with consideration to the best time to carry out the work i.e. night time or day time and making sure that the bats are not interfered with during the breeding season. Expert advice should be sought when developing these management strategies.

**Photo 2:** Old conveyor tunnel.

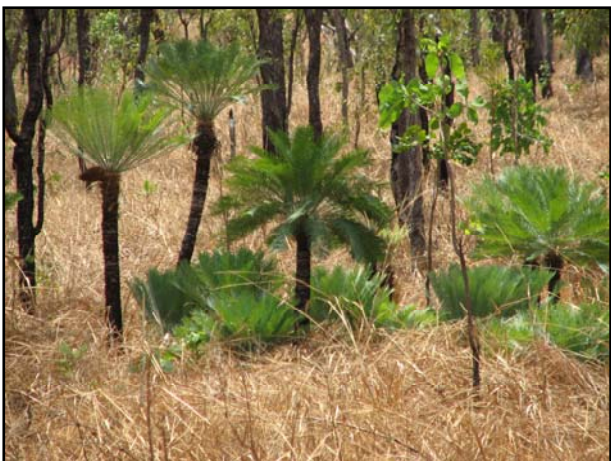
A small patch of *Cycas armstrongii* is located near the haul road to Ochre Hill (809 082E, 849 8323N GDA 94 Zone 52). Any widening of this route should only occur to the east as some plants are only 12m west from the existing road alignment (Photo's 4 & 5).

**Photo 4:** *Cycas armstrongii* adjacent to the haul road.

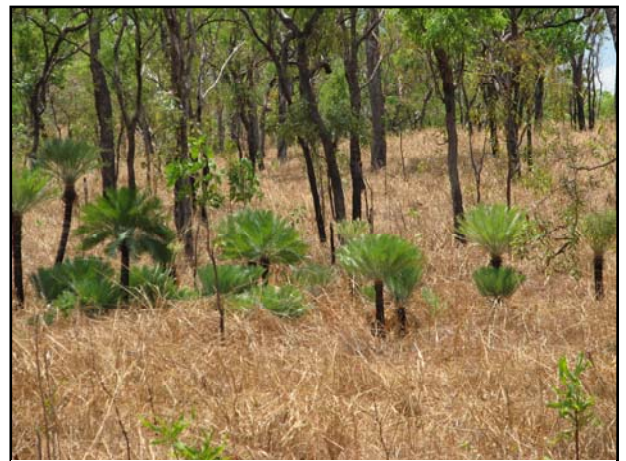
**Photo 5:** *Cycas armstrongii* adjacent to the haul road.

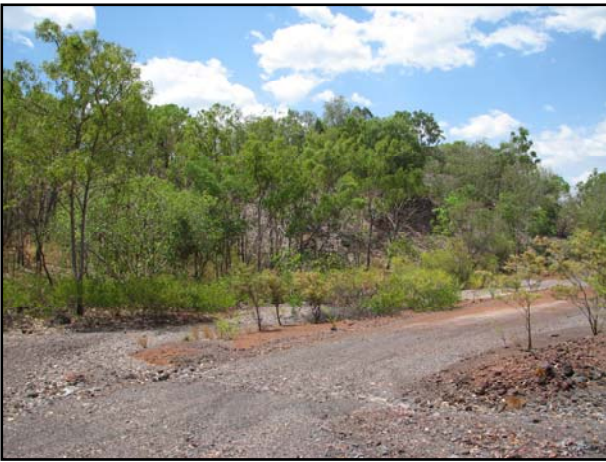
Several waste rock stockpiles from previous mining operations were visited. The vegetation cover over the stockpiles varied. Most stockpiles were reasonably vegetated (Photo 6), however the Thelma 2 stockpile had no vegetation cover due to the rocks being oxidised (Photo's 7 & 8).

**Photo 6:** Waste rock stockpile with vegetation cover.

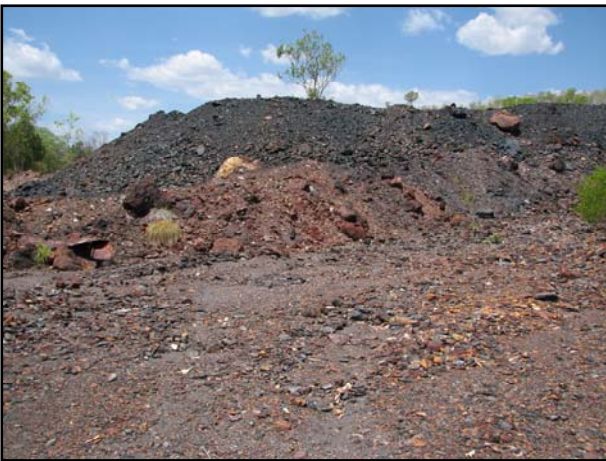
**Photo 7:** Thelma 2 waste rock stockpile with no vegetation cover.

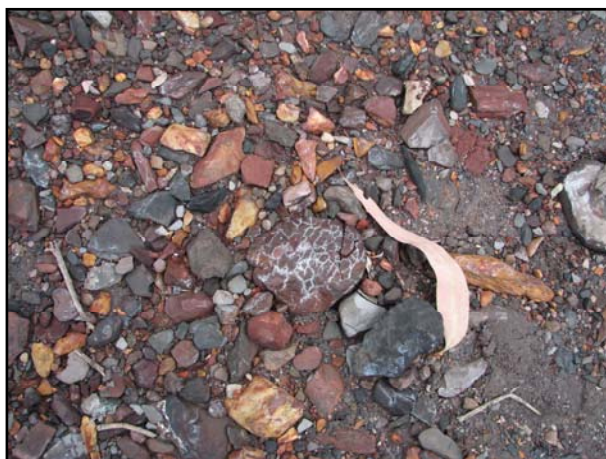
**Photo 8:** Thelma 2 waste rock showing acid leaching caused by sulphide oxidation.
