## 3. Existing Environment

### 3.1 Topography

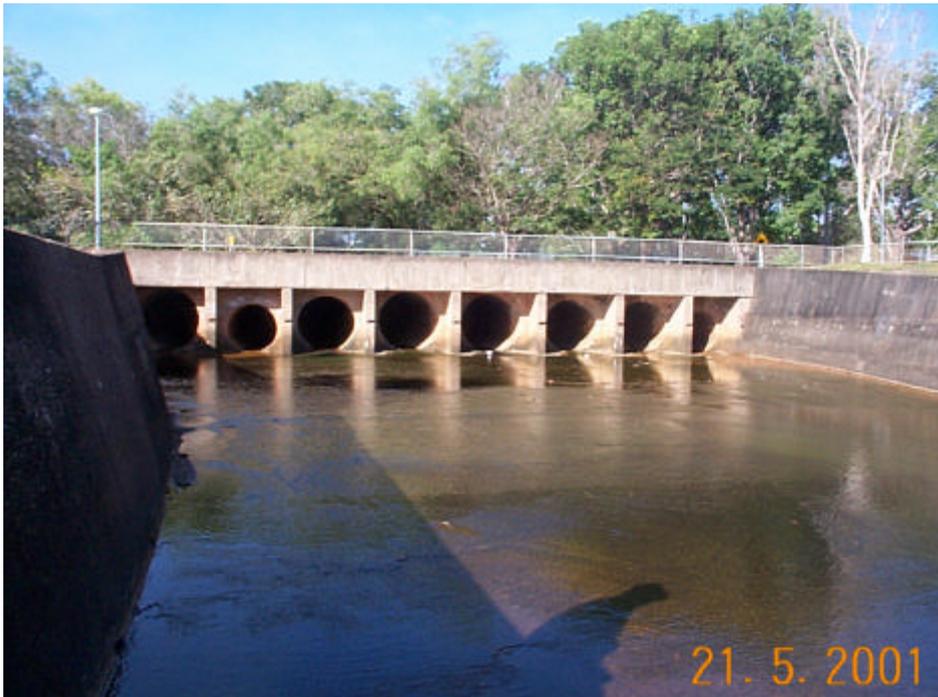
■ Figure 3.1: Upstream end of concrete lined drain showing culverts. Note low dry season flow.

The drain is also tidal with seawater moving in and out directly from Rapid Creek. The stormwater drainage system discharges urban freshwater runoff from northern suburbs. In the dry season flow from the stormwater pipes is minimal, (**Figure 3.1**) and this would mostly result from urban activities such as car washing. In the summer rainy season, heavy pulses of freshwater flows enter the drain during storm events.

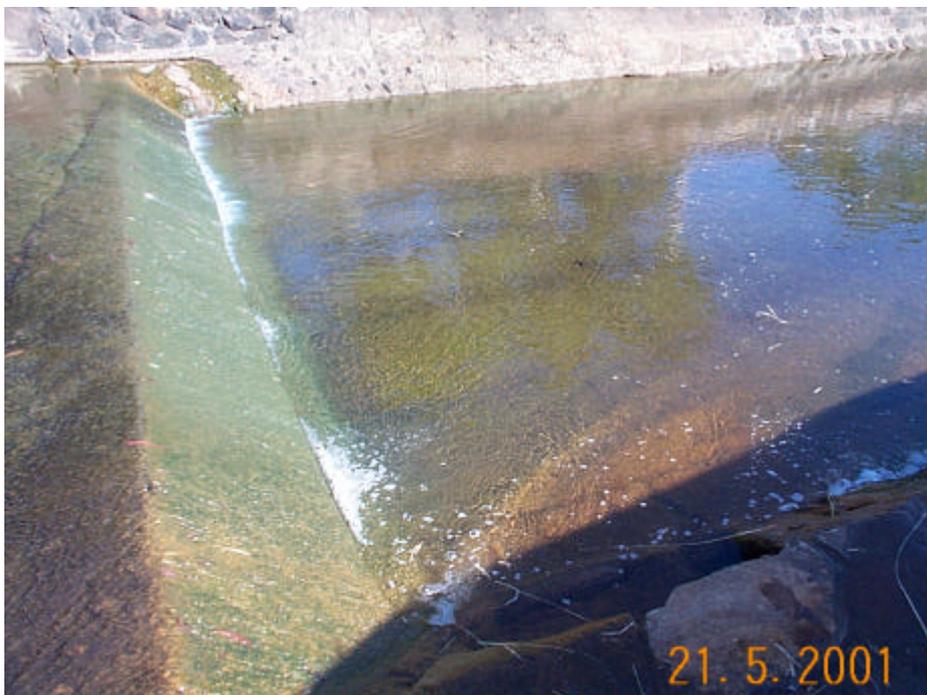
■ Figure 3.2: Step in drain downstream of culverts. Note presence of film of algae on substrate above and below step.

The drain empties directly into Rapid Creek and there is no obstruction to fish movement between the creek and drain, except for the step just downstream of the culverts at the upper end of the drain. At low tide and low flows this creates a barrier for the movement of fauna upstream and into the culverts.

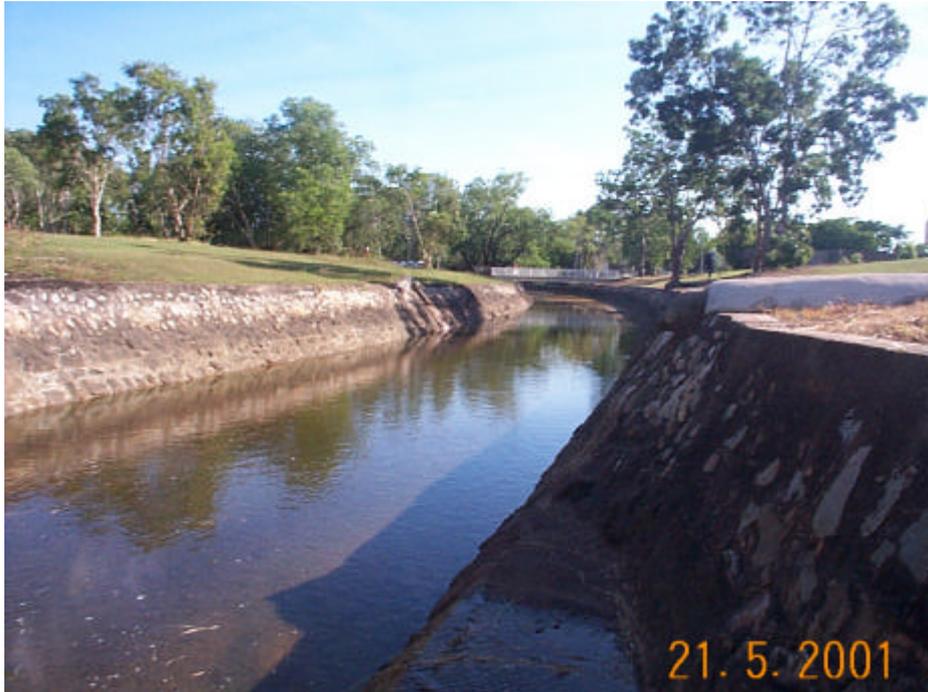
■ Figure 3.3: View looking downstream toward footbridge at low tide, dry season.

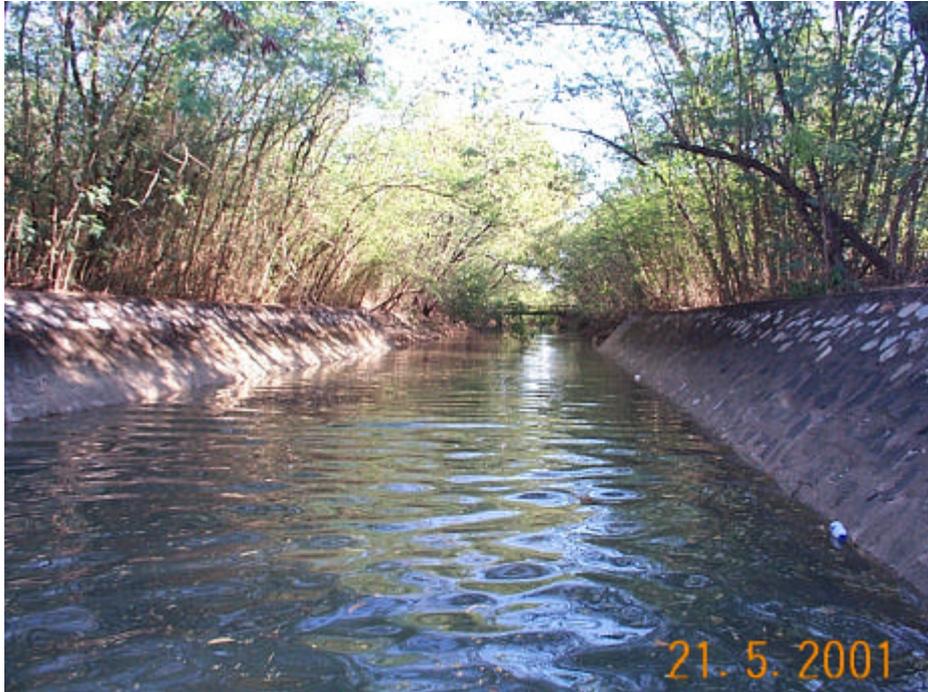
■ Figure 3.4: View of lower end of formed drain on rising tide, with lower footbridge in distance. Note thickets of coffee bush on both banks.

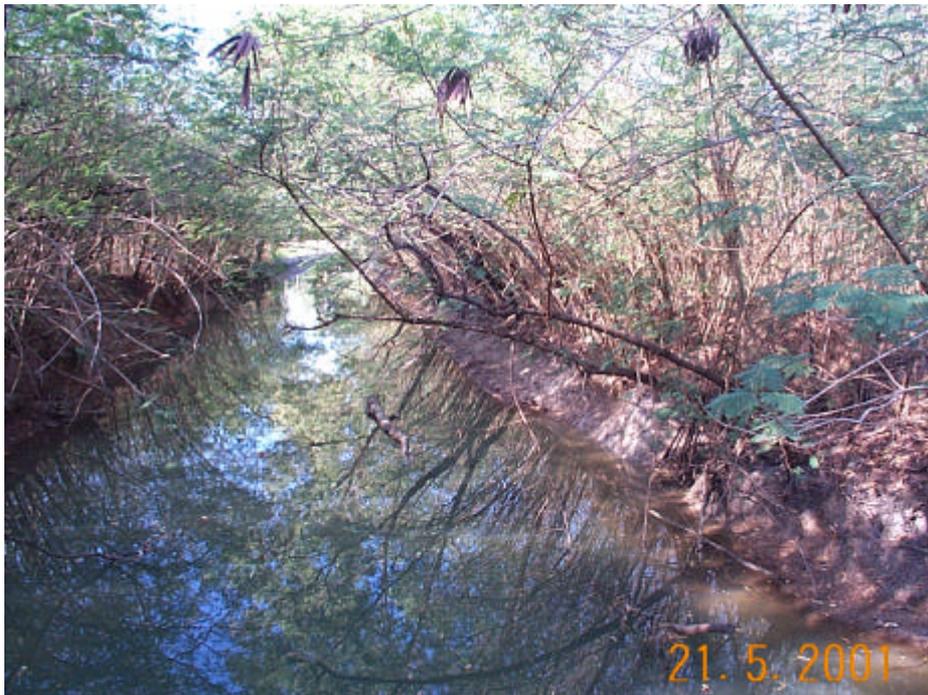
- **Figure 3.5: View looking upstream from lower footbridge. Here the substrate is a mixture of sand, gravel and rocks with some pieces of timber and rotting vegetation.**

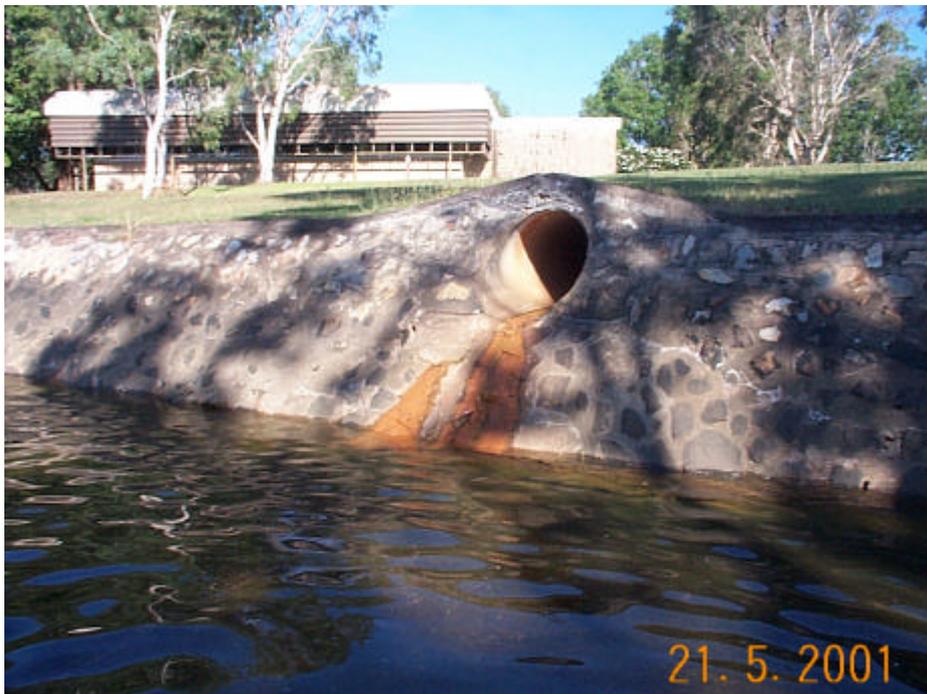
- Figure 3.6: The largest formed stormwater drain that discharges into the NTU drain. Note brown stain of algae growing in effluent stream.

Smaller open drains and stormwater pipes discharge runoff into Rapid Creek or the large open drain. **Figure 3.6** shows the end of a stormwater drain that discharges into the larger NTU drain in the area where the proposed lake will be sited.

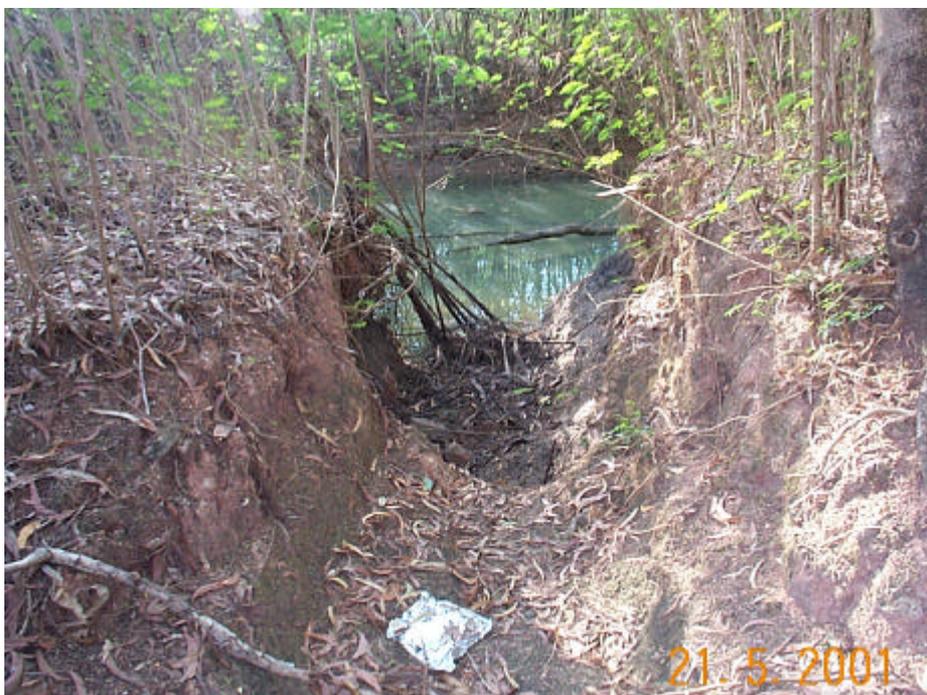
- Figure 3.7: Large drainage channel discharging into lower end of NTU drain just upstream of lower footbridge. Note evidence of erosion of banks and presence of rubbish.

**Figure 3.7** shows a unformed drainage channel with erosional features that drains a small patch of disturbed forest before entering the NTU drain just upstream of the lower footbridge.

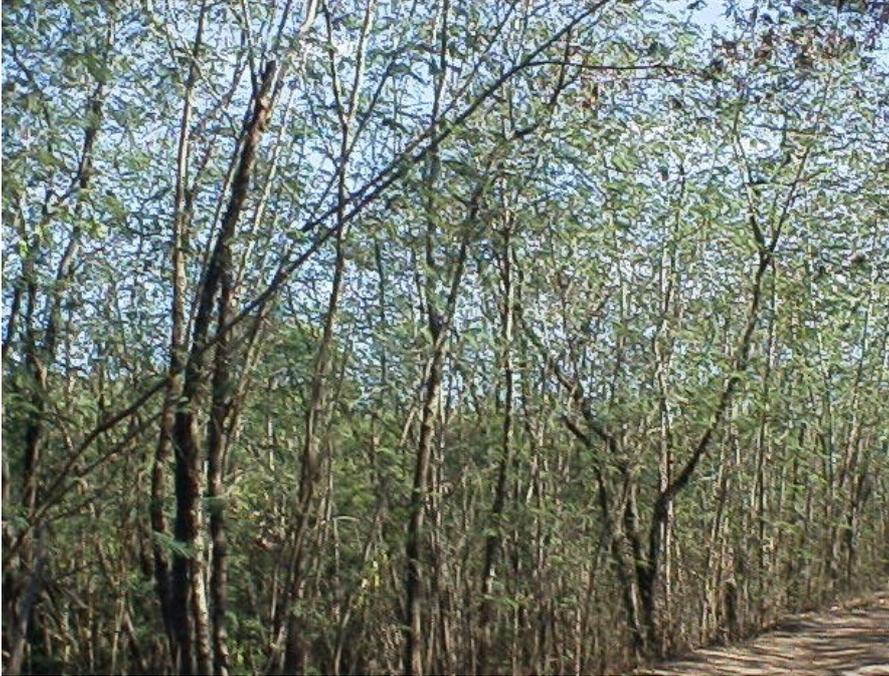
■ Figure 3.9: Coffee Bush (*Leucaena Leucocephala*) infestation.

Approximately 52% of the area to be cleared for the proposed lake comprises monospecific stands of *Leucaena leucocephala* (Coffee Bush). Construction of the weir and spillway will involve further clearing of dense Coffee Bush. This species tends to exclude native vegetation and forms thickets to 6m high that extend right to the edge of the intertidal zone and overhang the canal. (See **Figure 3.9**)

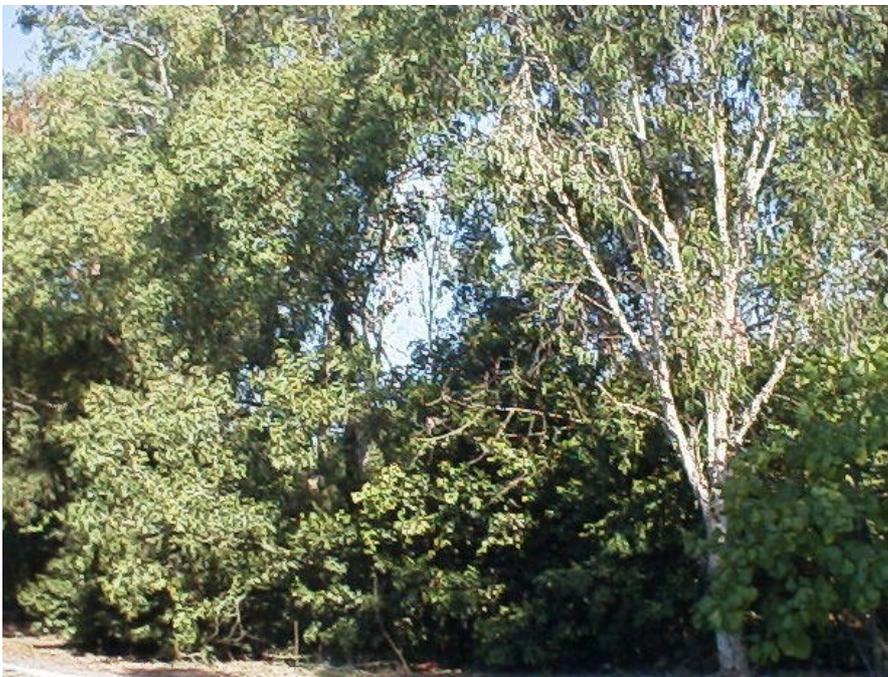
■ Figure 3.10: Remnant vegetation containing valuable specimen trees.

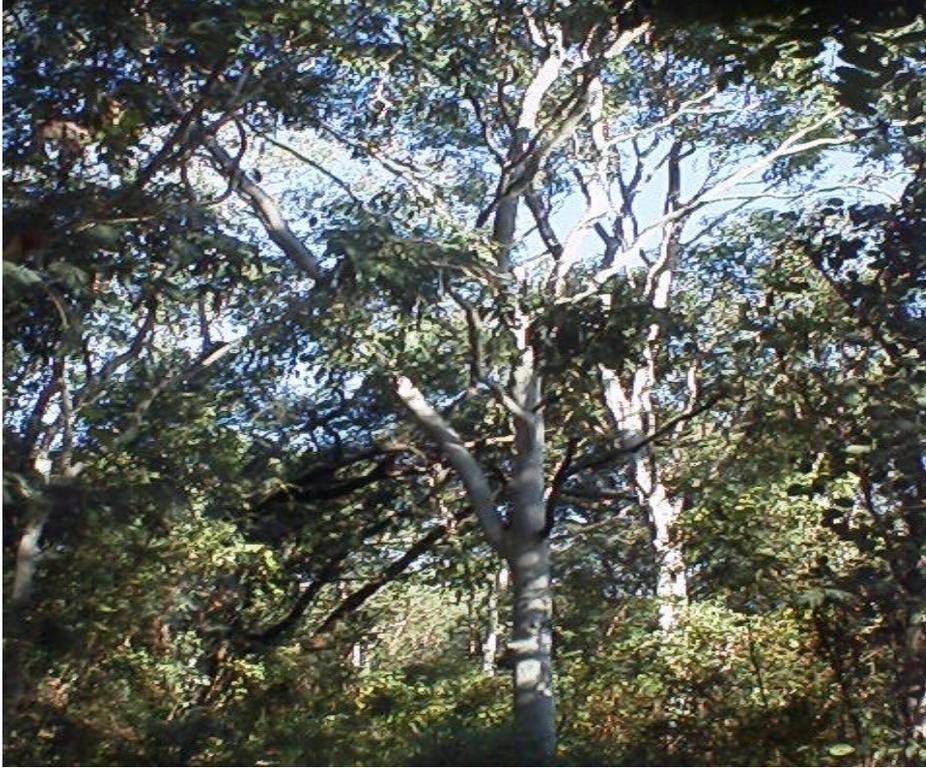
■ **Figure 3.11: Ghost Gums (*Eucalyptus papuana*) in the vicinity of the proposed carpark.**

Although occupying only a small area, the healthy stand of Ghost Gums occurs amongst Paperbarks (*Melaleuca leucadendra*) and tall *Acacia auriculiformis*, forming an attractive pocket of native vegetation. (See **Figure 3.11**) Beneath the canopy formed by the Eucalypts, saplings of *Carallia brachiata*, *Carpentaria acuminata*, *Terminalia microcarpa* and *Wrightia saligna* occur. This pocket of vegetation contains valuable specimen trees and should be retained as a landscape feature, providing shade to the carpark area.

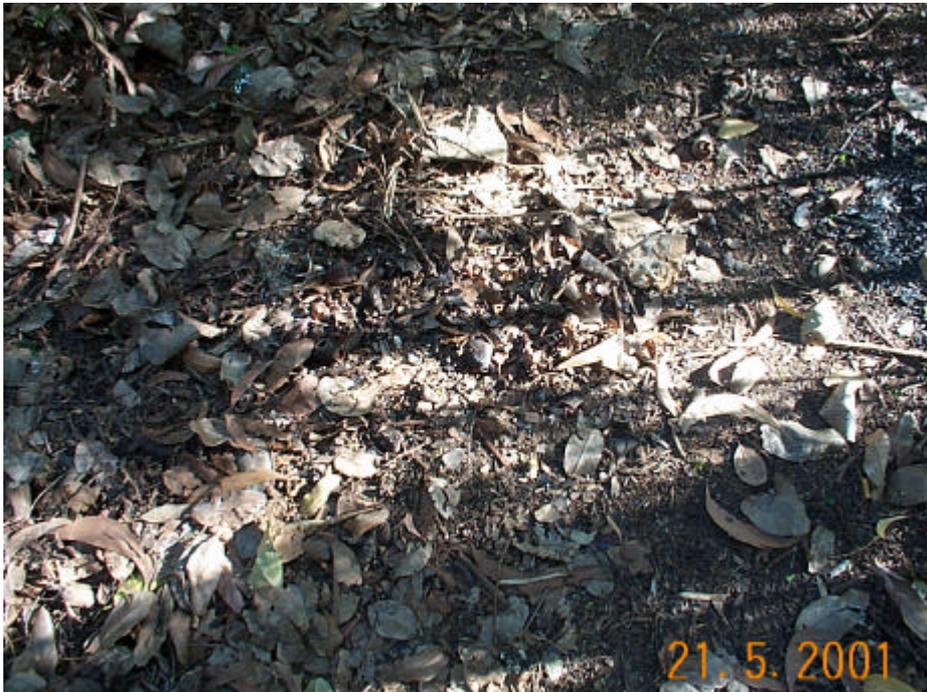
■ **Figure 3.12: Remains of the molluscs *Terebralia spp* and *Telescopium telescopium* in a coffee bush thicket along side the drain.**
