SECTION 14 INCIDENT REPORT (*Waste Management and Pollution Control Act*)

Date and Time of Notification:	Thursday 3 rd November 2022, 09:30hrs
Person / Company:	Power and Water Corporation (PWC)
Incident:	Discharge of fully treated effluent from Bulman wastewater stabilisation ponds.

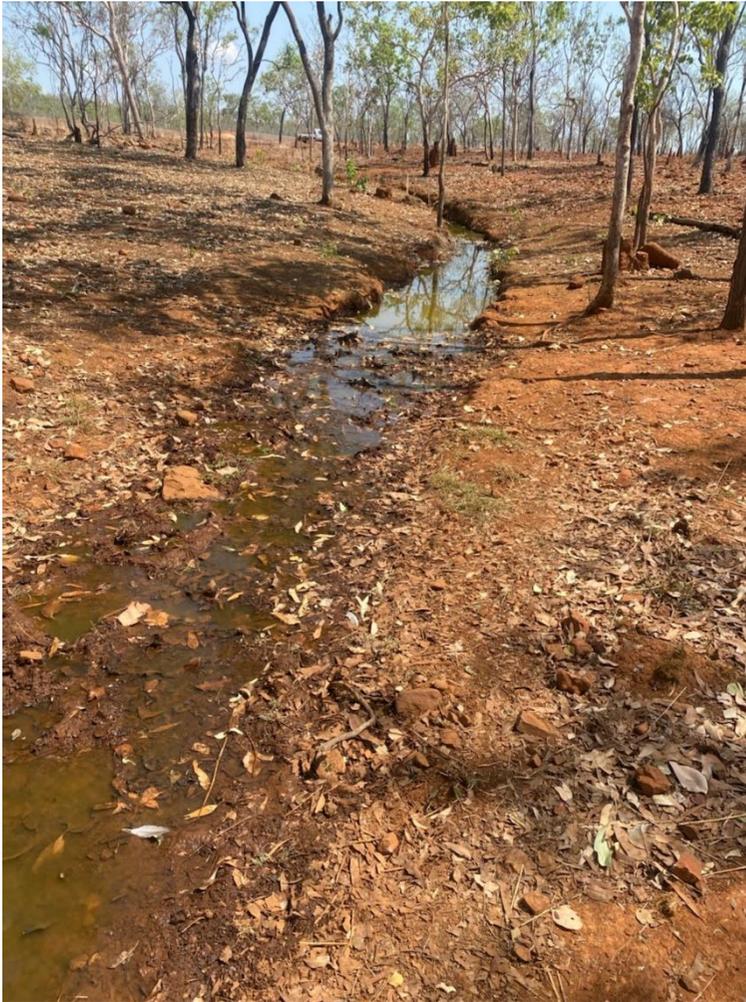
Location #2, final discharge location

Photographs taken 2nd November 2022, by the ESO

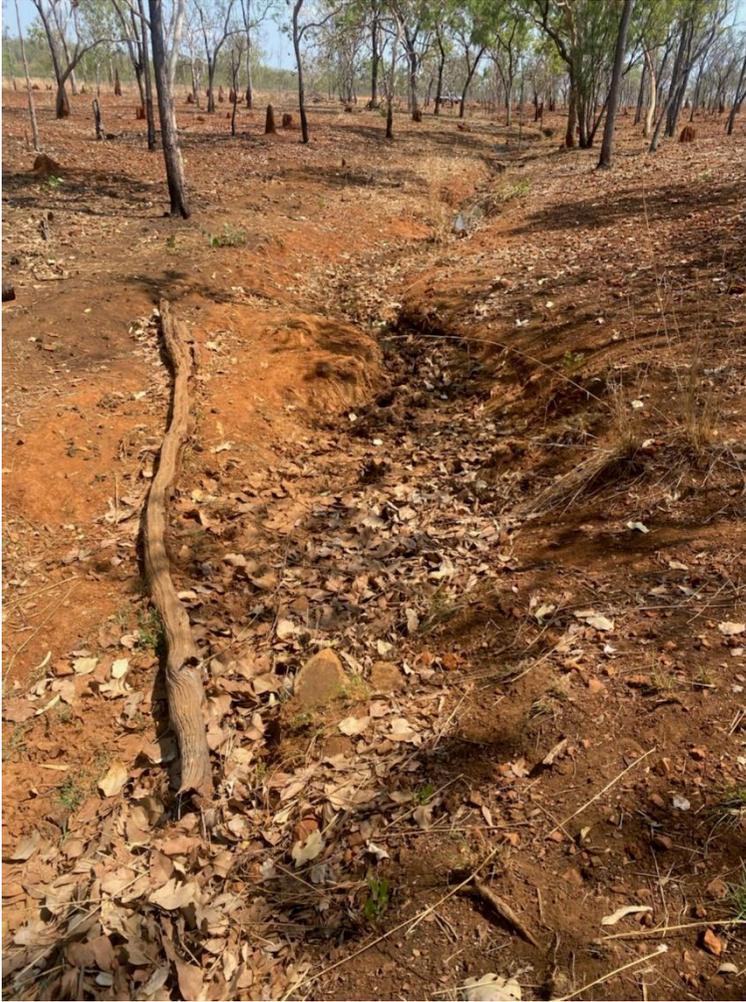
Approximately 45m further downstream from location #2
