SECTION 14 INCIDENT REPORT (*Waste Management and Pollution Control Act*)

Date and Time of Notification:	Tuesday 3/12/2024 10:30hrs
Person / Company:	Power and Water Corporation
Incident:	Discharge of sewage from sewerage network (overflow relief gully (ORG))

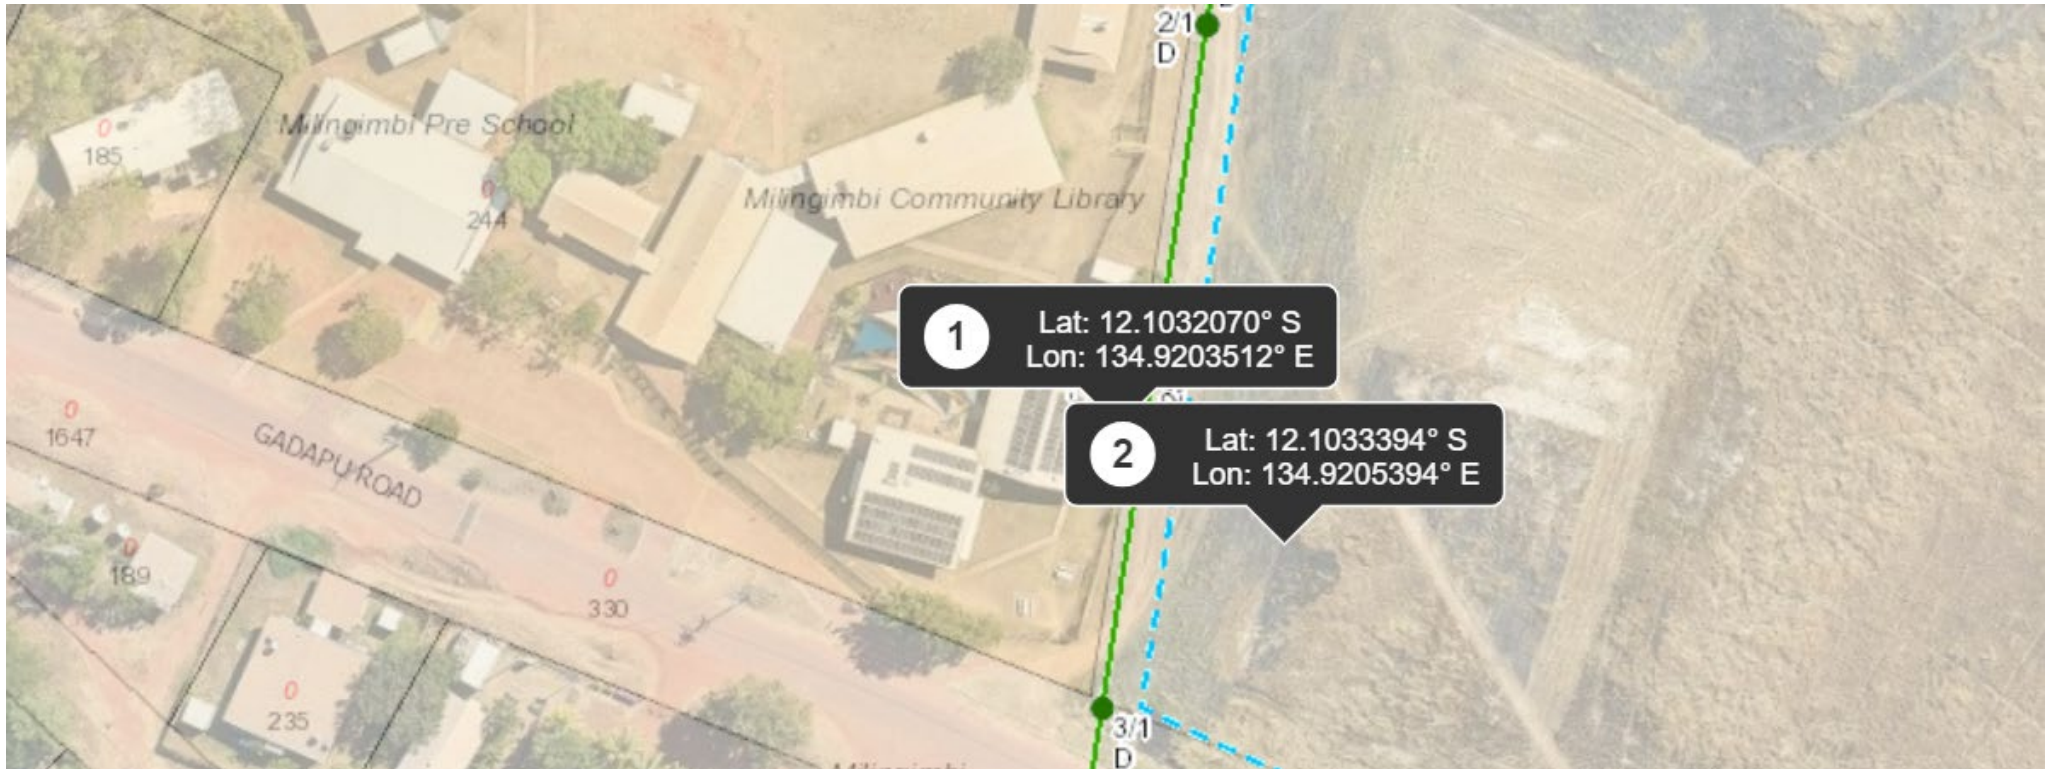
Overflow relief gully – Milingimbi School and adjacent lot

(d) how the pollution has occurred, is occurring or may occur	As per (c) iii & (c) iv.
(e) the attempts made to prevent, reduce, control, rectify or clean up the pollution or resultant environmental harm caused or threatening to be caused by the incident	<p><i>i. Confirmation signage and fencing has been erected, as appropriate.</i></p> <p>Flagging tape and signage has been erected around the area to alert the public and prevent access to the site.</p> <p><i>ii. Decontamination of the site as appropriate.</i></p> <p>The site has been inspected for gross pollutants and removed where identified. The site has been cordoned off and will be decontaminated</p>

<p>and have topsoil applied. The flagging and signage will remain in place until the end of the school term (13/12/24).</p> <p><i>iii. Attempts made to prevent, reduce or control the discharge.</i></p> <p>Blockage was cleared stopping the overflow.</p>
<p>(f) the identity of the person notifying the NT EPA</p>	<p>PWC Environmental Team on behalf of Water Services</p>
