## **BP Darwin Terminal Facility Lot B of Remediation Zone 1 Environmental Audit Report**

**Volume 1 of 2**

**BP Australia Pty Ltd**

51614-011-6000-R500

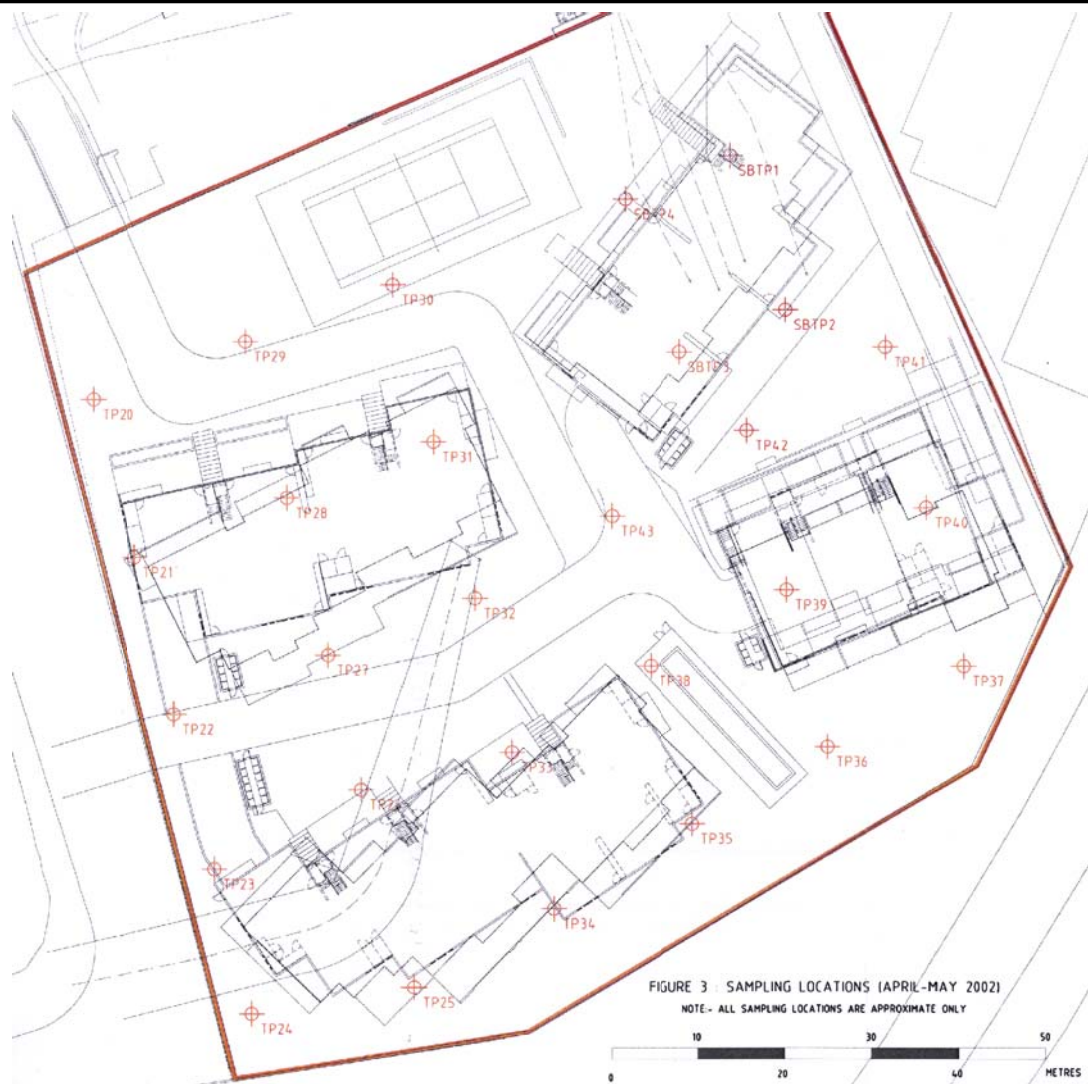
FIGURE 3 : SAMPLING LOCATIONS (APRIL-MAY 2002)

NOTE - ALL SAMPLING LOCATIONS ARE APPROXIMATE ONLY

Designed AH	Approved	Client <b>BP AUSTRALIA PTY LTD</b>	Project No: 51614-011	Date MAY 2004
Drawn KWB	Scales		CAD File No: 51614-011-002-02	Status FINAL
Checked	AS SHOWN		Title: LOT B SAMPLE LOCATIONS APRIL - MAY 2002

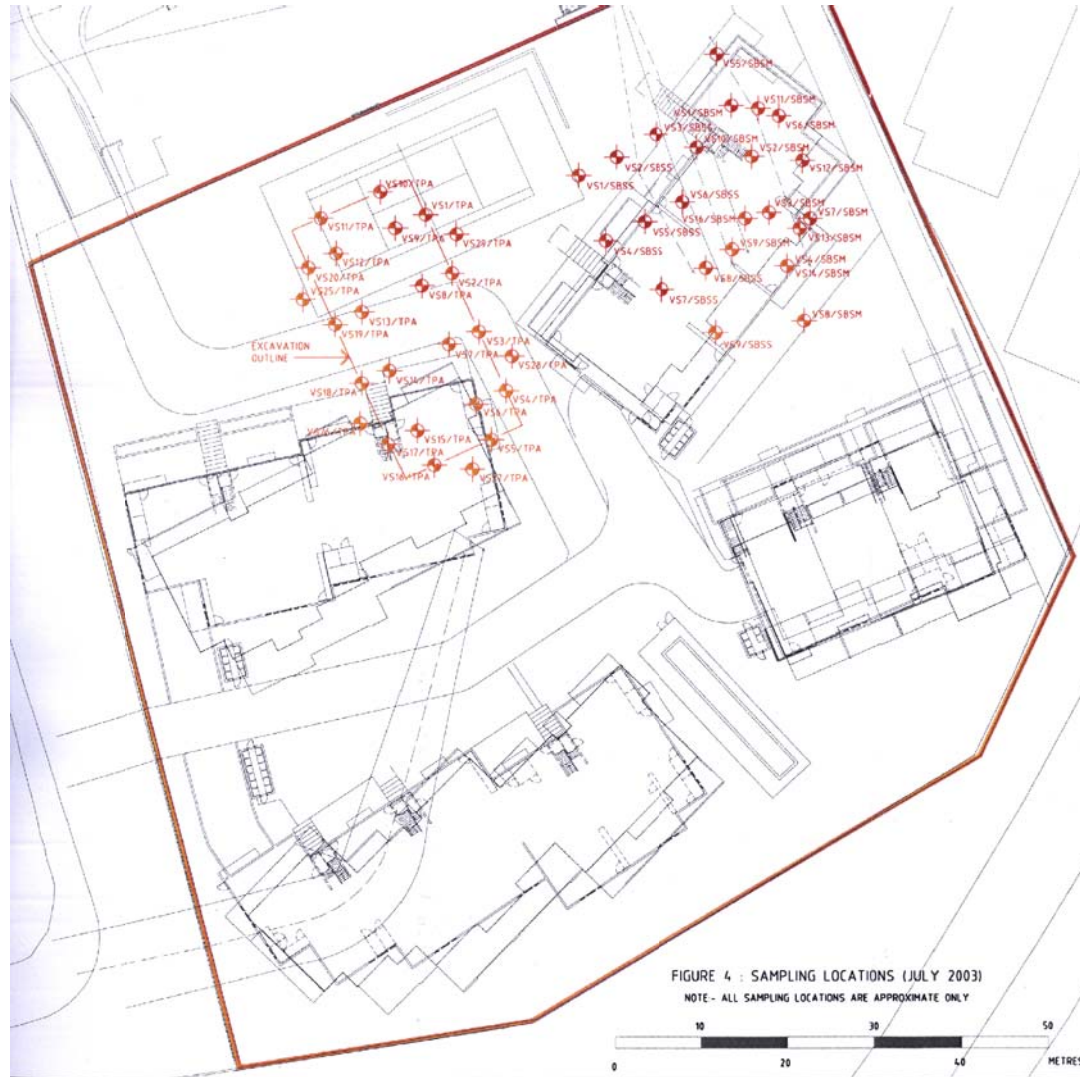
FIGURE 4 : SAMPLING LOCATIONS (JULY 2003)  
NOTE - ALL SAMPLING LOCATIONS ARE APPROXIMATE ONLY

Designed AH	Approved	Client <b>BP AUSTRALIA PTY LTD</b>	Project No: 51614-011	Date MAY 2004
Drawn KWB	Scales AS SHOWN		CAD File No: 51614-011-002-03	Status FINAL
Checked		Project DARWIN LOT B AUDIT	Title: LOT B SAMPLE LOCATIONS JULY 2003

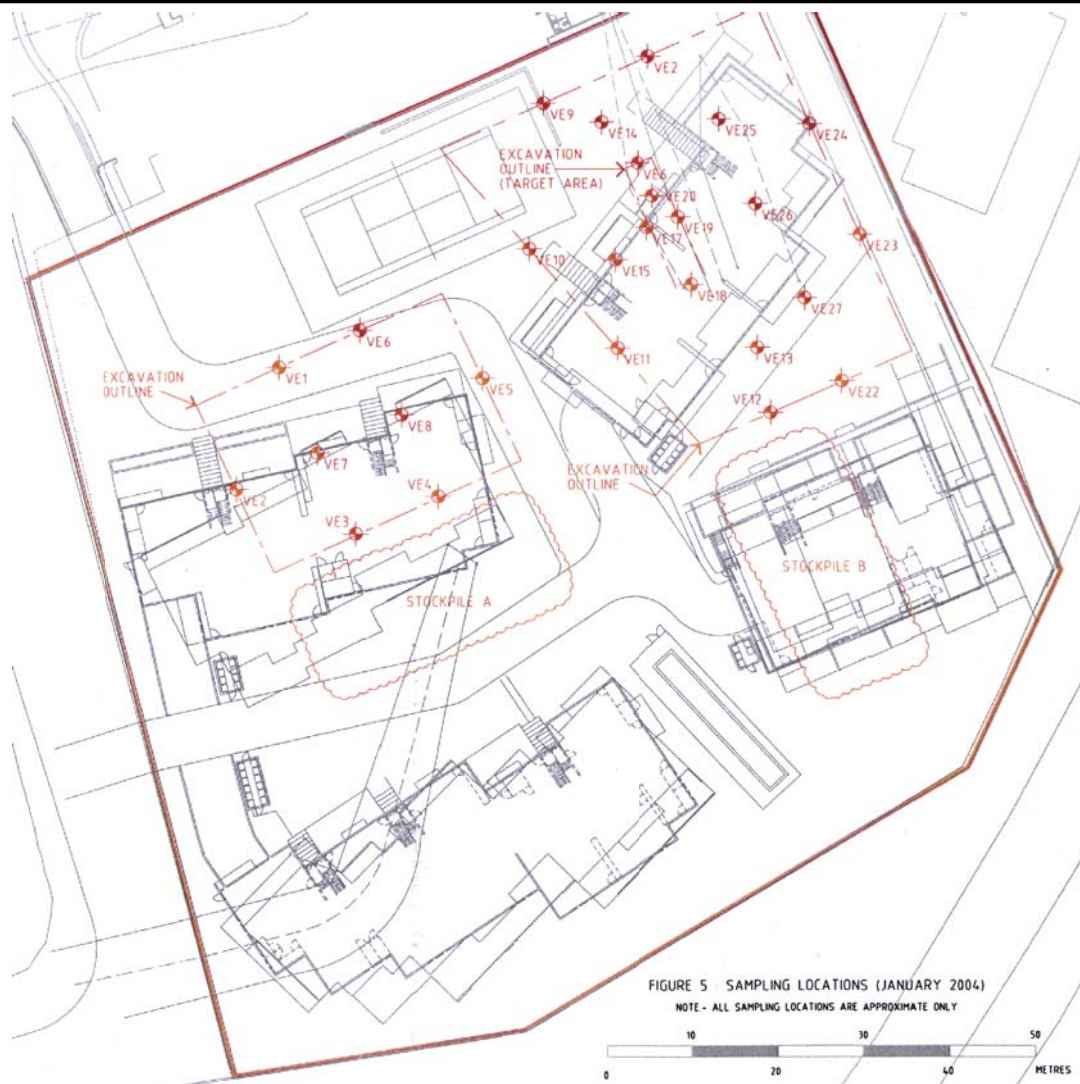
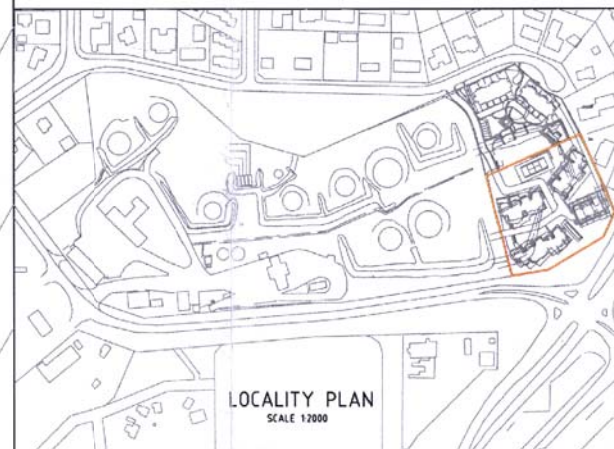
<p>URS Australia Pty Ltd 25 North Terrace Hackney SA 5069 AUSTRALIA Tel +61 8 8366 1000 Fax +61 8 8366 1001</p>		Project DARWIN LOT B AUDIT	Figure: <b>5</b>	Rev <b>A</b>

Designed AH	Approved	Client <b>BP AUSTRALIA PTY LTD</b>	Project No: 51614-011	Date MAY 2004
Drawn KWB	Scales		CAD File No: 51614-011-002-04	Status FINAL
Checked	AS SHOWN		Title: LOT B SAMPLE LOCATIONS OCTOBER 2003

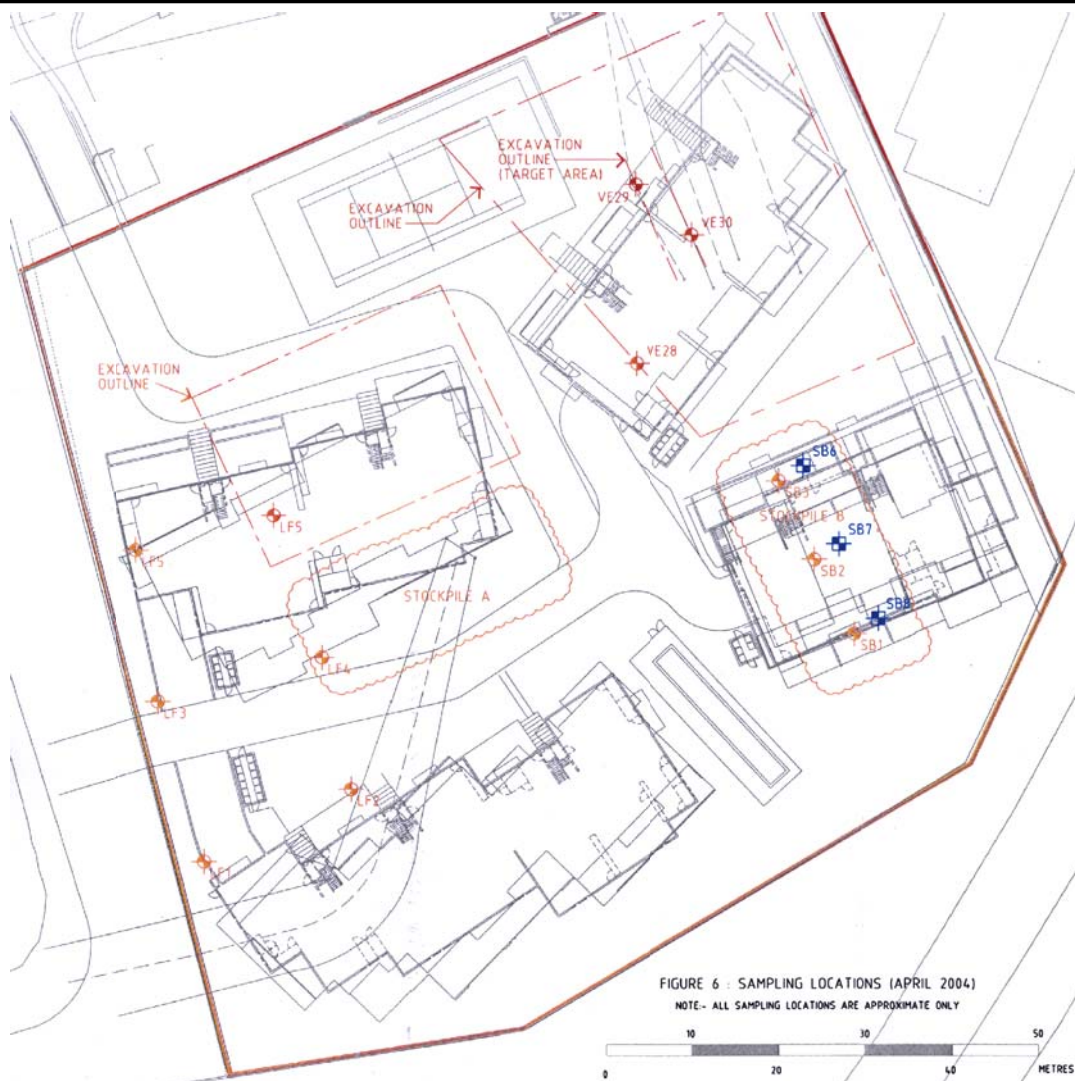
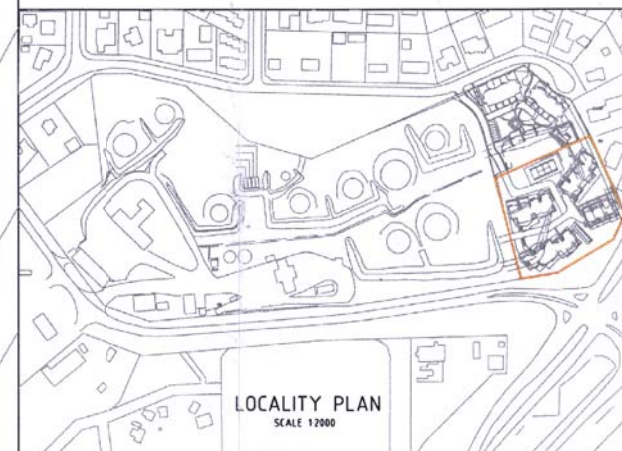
FIGURE 6 : SAMPLING LOCATIONS (APRIL 2004)

VE30 — SAMPLE LOCATIONS : 14 APRIL 2004

SB6 — SAMPLE LOCATIONS : 19 APRIL 2004

NOTE - ALL SAMPLING LOCATIONS ARE APPROXIMATE ONLY
