SECTION 14 INCIDENT REPORT (*Waste Management and Pollution Control Act*)

Date and Time of Notification:	25 th February 2020, 08:29hrs
Person / Company:	Power and Water Corporation (PWC)
Incident:	Discharge of raw sewage from sewerage network (no gross pollutants)

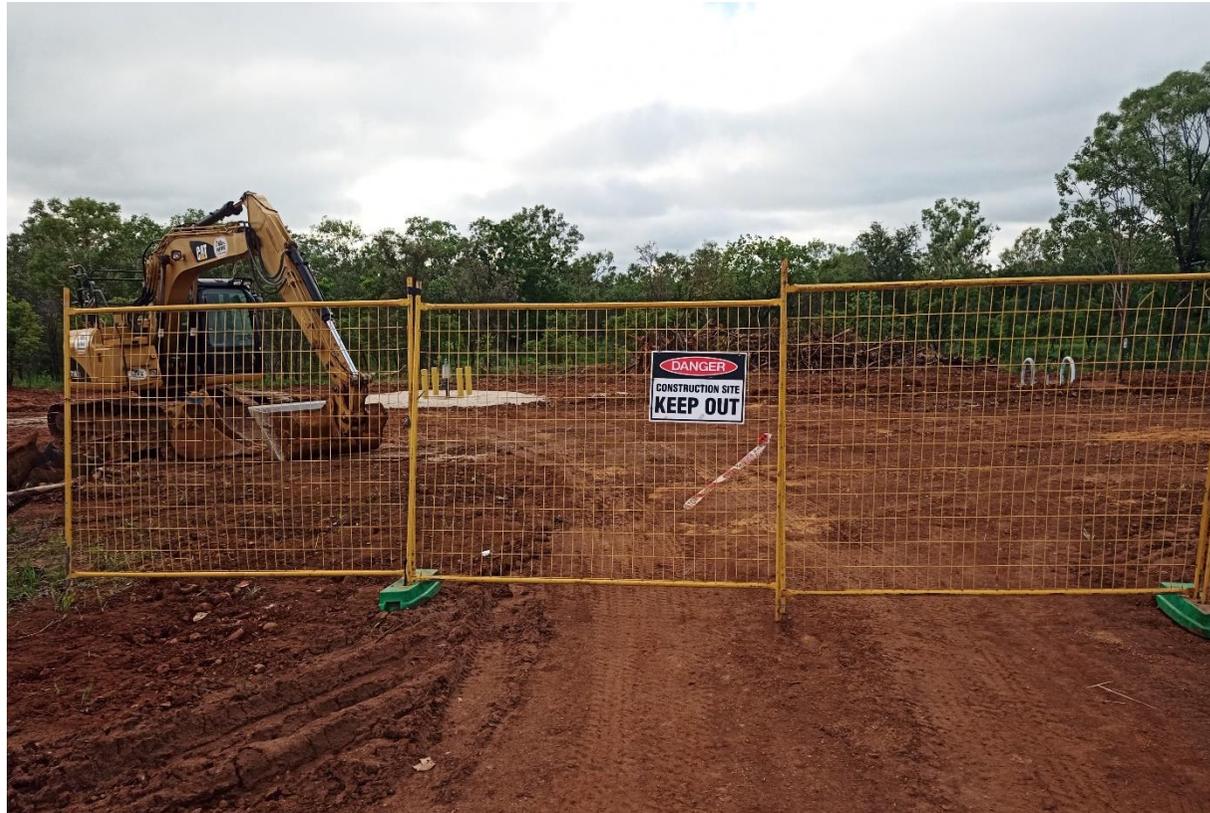
Appendix C – Photo showing fencing of the area in addition to five strand pastoral cattle fencing that surrounds the property. Spill location in background, following replacement of 120 meters of sewer pipeline.

<p>(d) how the pollution has occurred, is occurring or may occur</p>	<p>As per (c) iii & (c) iv.</p> <p>The receiving environment was open woodland, any pooling sewage was vacuumed up and take to Katherine ponds for screening and disposal. Post rectification of the main line, which involved excavation and replacement of 120 meters of pipework, the area had no signs of any spillage.</p>
<p>(e) the attempts made to prevent, reduce, control, rectify or clean up the pollution or resultant environmental harm caused or threatening to be caused by the incident</p>	<p><i>i. Confirmation signage and fencing has been erected, as appropriate.</i></p> <p>No fencing or signage was installed as this was on private, fenced scrubland, away from public access – of which the owner was aware of the overflow. Additional fencing and signage was erected at the time the 120 meters of pipeline was replaced.</p> <p><i>ii. Decontamination of the site as appropriate.</i></p> <p>Clean up consistent with Sewage Spills/Overflow Response Work Instruction as appropriate to the location, and to minimise risk to public health and the environment. Any waste product lying on the ground has been removed to Power and Water wastewater ponds via vacuum truck.</p>

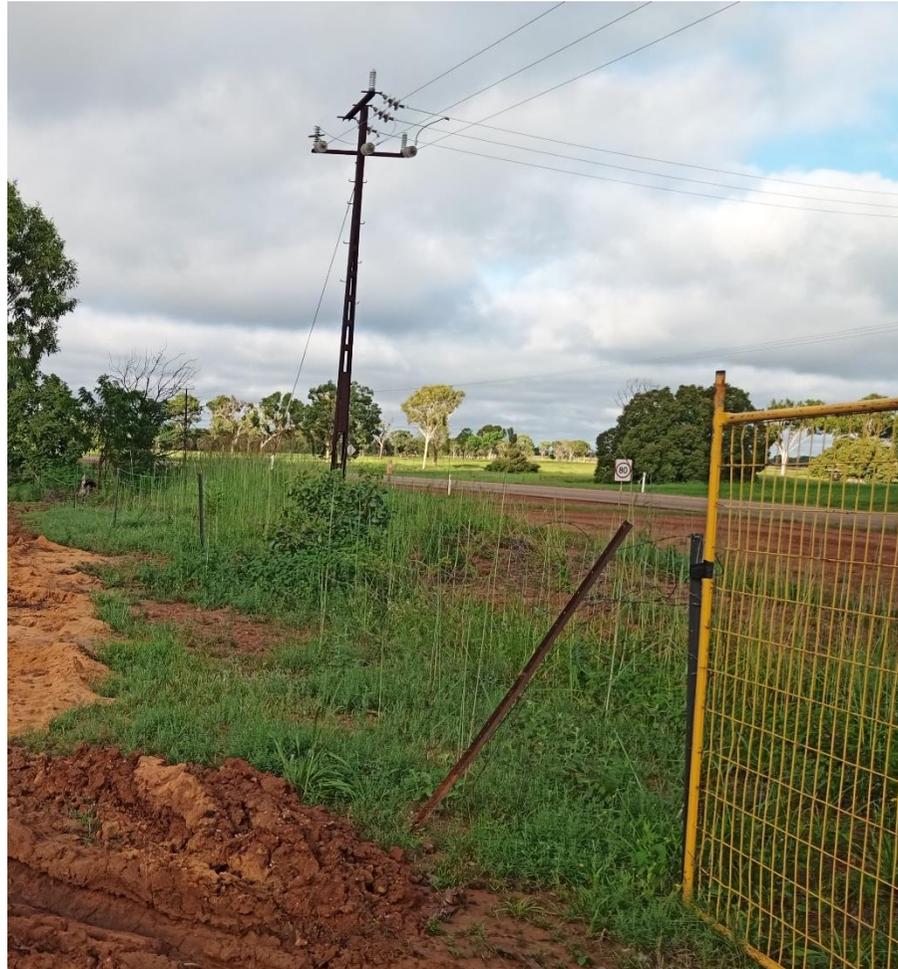
Appendix D – Photo of typical five strand stock fencing used on the private property, limiting access to the public.
