Annual Riparian Monitoring Report

BP₃₃
POST DRY SEASON
RIPARIAN VEGETATION
ANNUAL MONITORING

2025

Lithium Developments (Grants NT) Pty Ltd

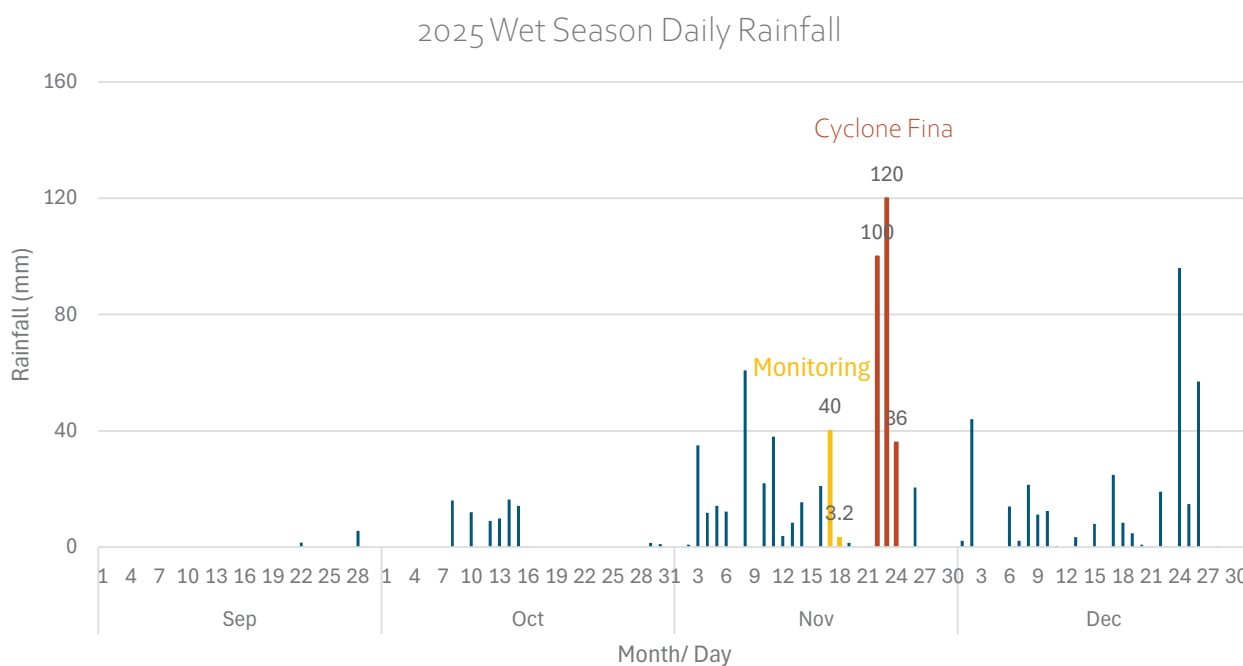
Figure 4-2 Wet Season Daily Rainfall (Station Number 14264; BoM, 2026a)

Rainfall was recorded at the BP33 prior to monitoring on the 17 and 18 November, which allowed for creek flow. In the field, higher levels of BP1 creek were observed at most sites with indication from organic debris caught on banks and on trunks of trees. Prior to the monitoring event, the nearby Territory Wildlife Park, located 12km east of the BP33 Project (Figure 4-2), recorded 330mm since September and prior to the 2025 monitoring event.

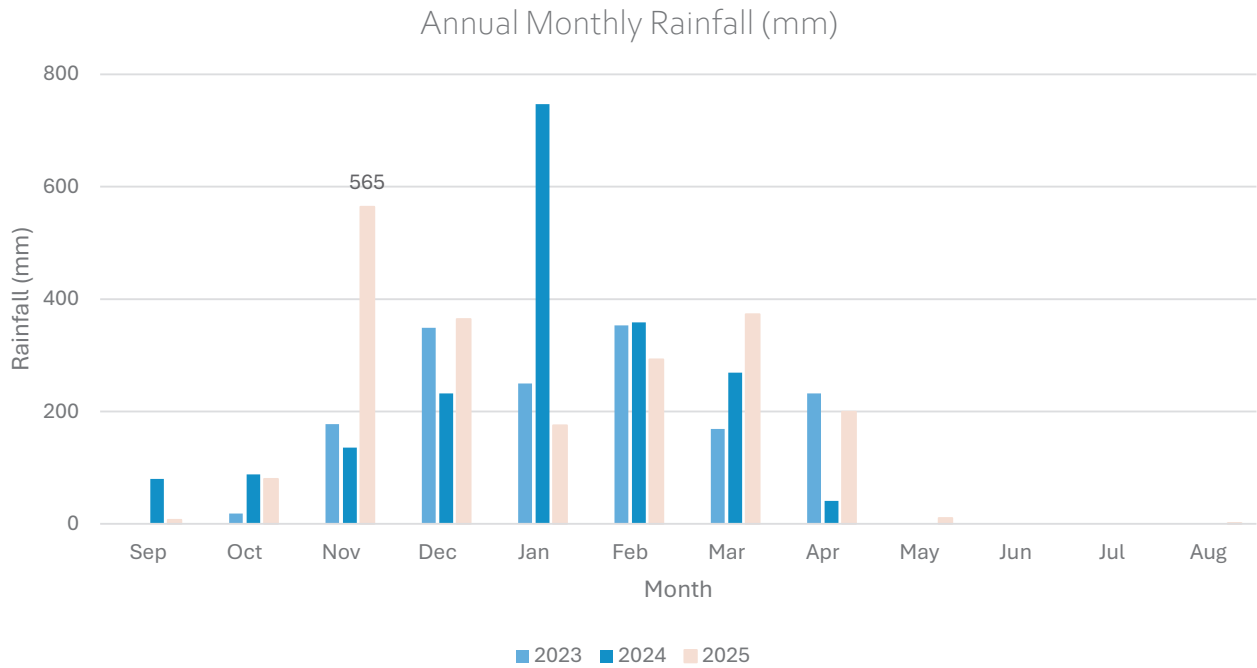
Figure 4-3 Annual Monthly Rainfall (Station Number 14264; BoM, 2026b)

Following the monitoring event, Cyclone Fina struck Darwin on the 22 November, some 4 days following the riparian monitoring, though rainfall was captured on the 21 November. This weather event and leading up to the Cyclone would have attributed to the increased rainfall in the region. Rainfall from Cyclone Fina was recorded over three days with a total of 256mm recorded at the weather station. This in turn increased November's total well above previous decades with a total of 565mm recorded for the month (Figure 4-3; BoM, 2026b).

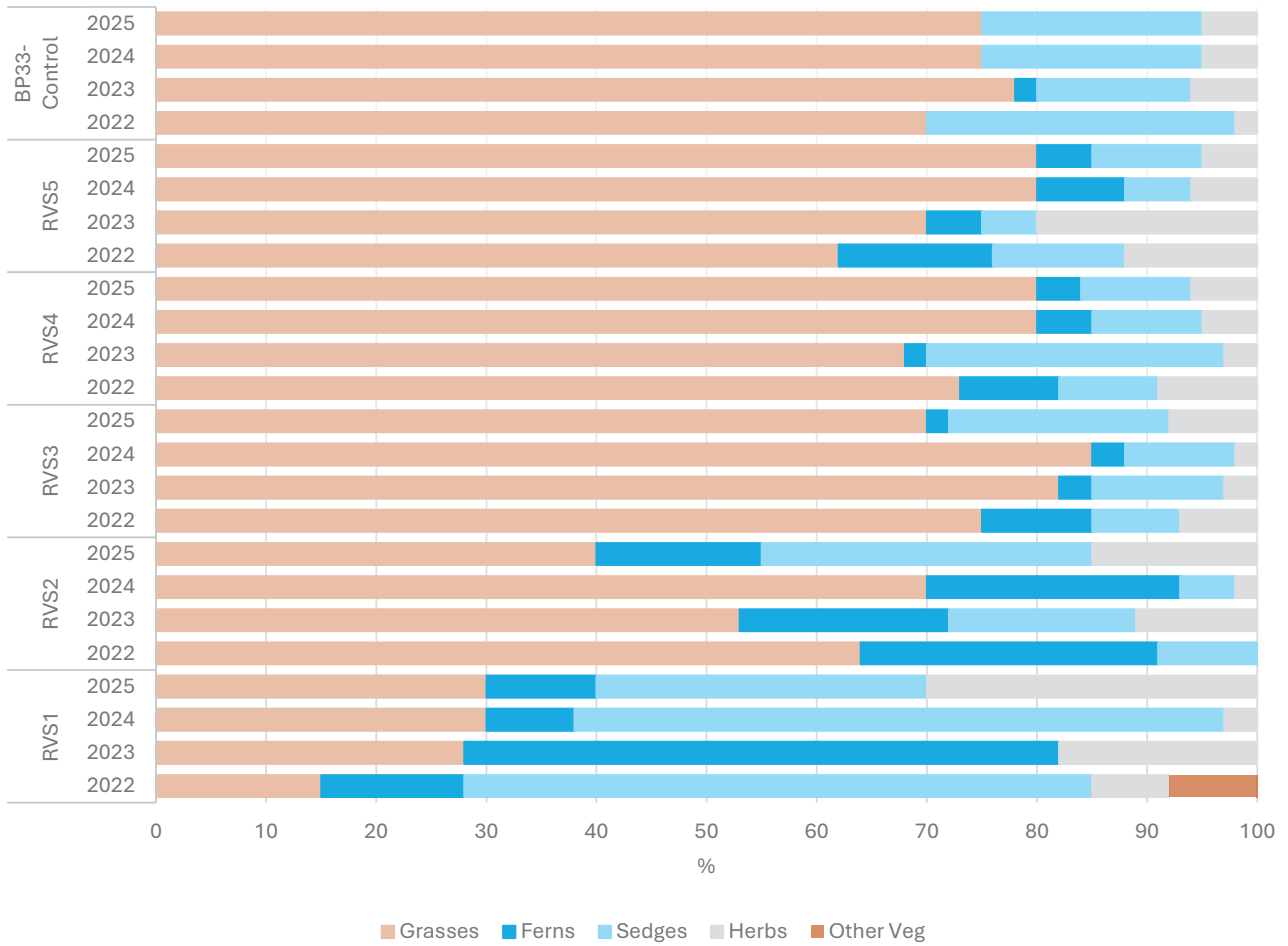
Figure 5-2 Vegetative Ground Cover for All Monitoring Sites (2022- 25)

Of the vegetative cover, grasses were the dominant ground cover at most monitoring sites. The grass cover shows consistency with the 2024 survey at sites RVS1, RVS4 and RVS5. The 2025 overall average grass cover for all sites was 63%, whilst the ferns recorded 7%, sedges recorded 20% and herbs recorded 12%.

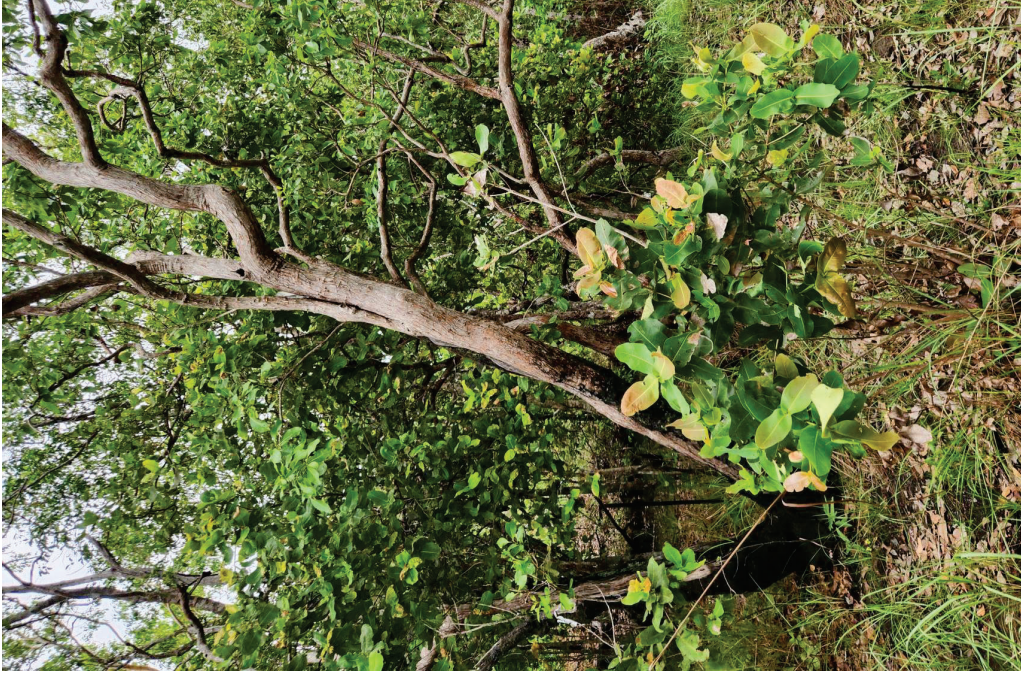
Image shows the start picket marker and the waters edge. Due to safety, the plot was altered which resulted in varying species composition.
