## SECTION 14 INCIDENT REPORT (*Waste Management and Pollution Control Act*)

| <b>Incident:</b> | Planned Discharge from the Papunya Wastewater Stabilisation Ponds |

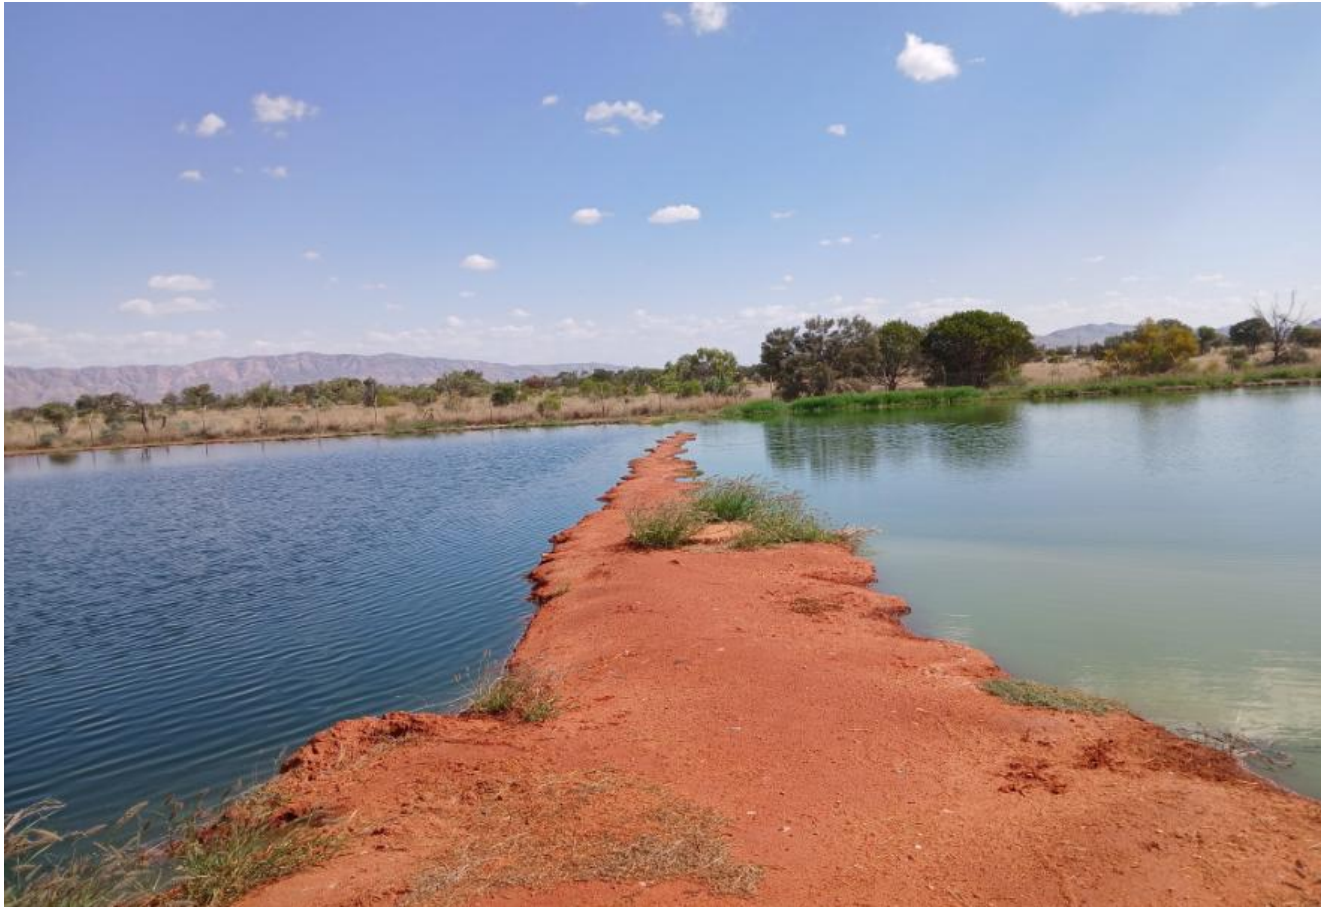
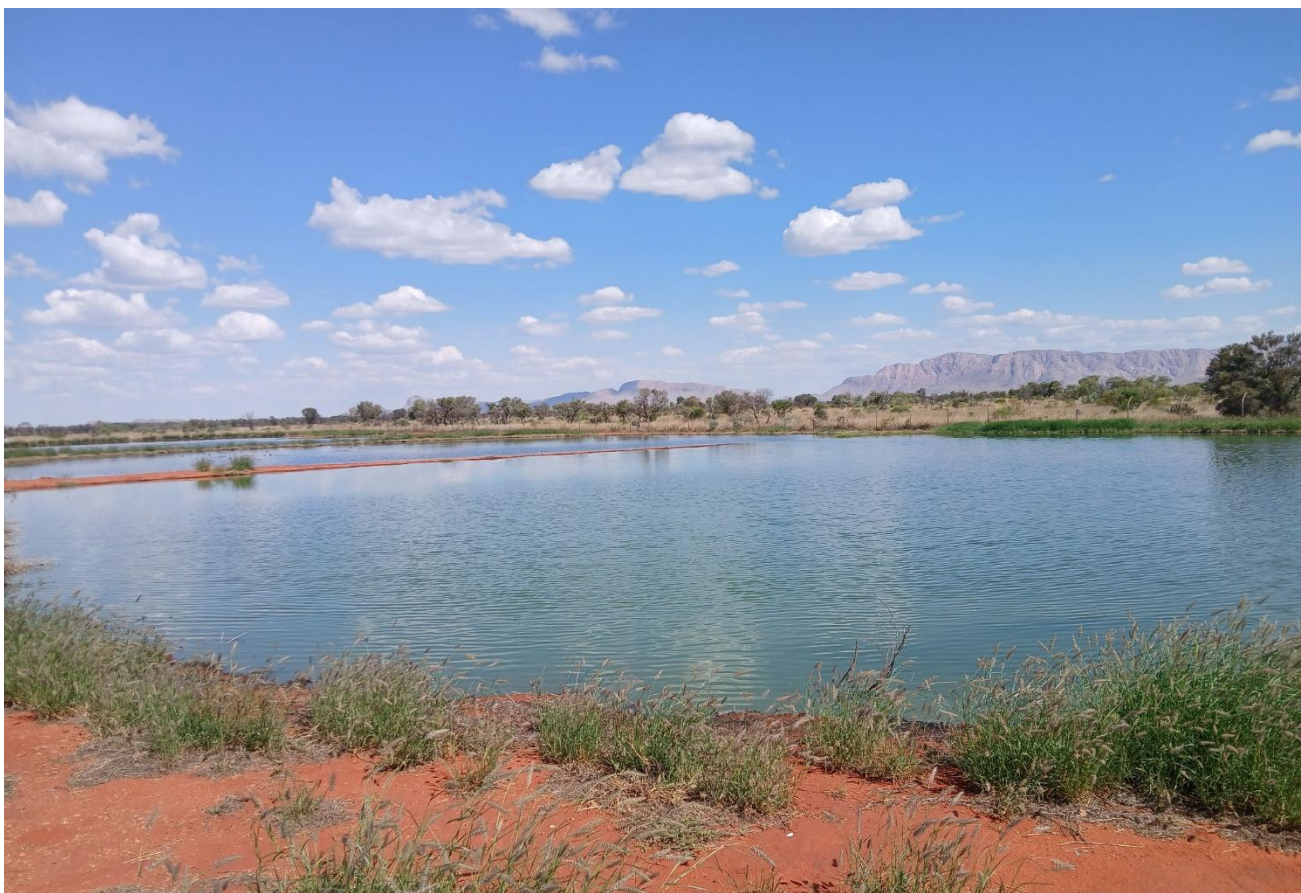
| <b>(c) the date and time of the incident</b> | <p><i>i. The time and date of commencement and cessation of the discharge.</i></p> <p>The date of discharge is currently unknown but will occur within a week from the date of this notification. The discharge will be stopped once the safety risk to our operational staff is mitigated.<br/>The southern region is entering a period of higher evaporation and this increased evaporation will also assist in lowering the water level.</p> <p><i>ii. How Power &amp; Water were notified or became aware of the potential discharge.</i></p> <p>A Power &amp; Water employee noticed the high pond levels during a planned assurance inspection.</p> <p><i>iii. The process by which the discharge will occurred.</i></p> <p>The effluent will be released in a controlled manner from a valve at pond number 5, the last pond in the treatment train.</p> <p><i>iv. The reason why the discharge will occur.</i></p> <p>The pond levels have reached the height of the pond walls due to higher than normal inflow rates, which would be expected from the number of residents in the community. Winter months have lower evaporation rates which have intensified the high water level.</p> |

Appendix B – Photographs of the ponds showing the overtopping of an internal pond wall.

| <b>(e) the attempts made to prevent, reduce, control, rectify or clean up the pollution or resultant environmental harm caused or threatening to be caused by the incident</b> | <p><i>i. Confirmation signage and fencing has been erected, as appropriate.</i></p> <p>A sign is being affixed to the gate at the ponds advising that there is no access permitted until the facility is safe. A road closed sign will also be erected at the ponds access road.</p> <p><i>ii. Decontamination of the site as appropriate.</i></p> <p>A clean-up will not required in this instance, as there will not be any gross pollutants and the water quality is high.</p> |
