SECTION 14 INCIDENT REPORT (*Waste Management and Pollution Control Act*)

Date and Time of Notification:	Friday 08/05/2020 13:00hrs
Person / Company:	Power and Water Corporation (PWC)
Incident:	Discharge of raw sewage from sewerage network (no gross pollutants)

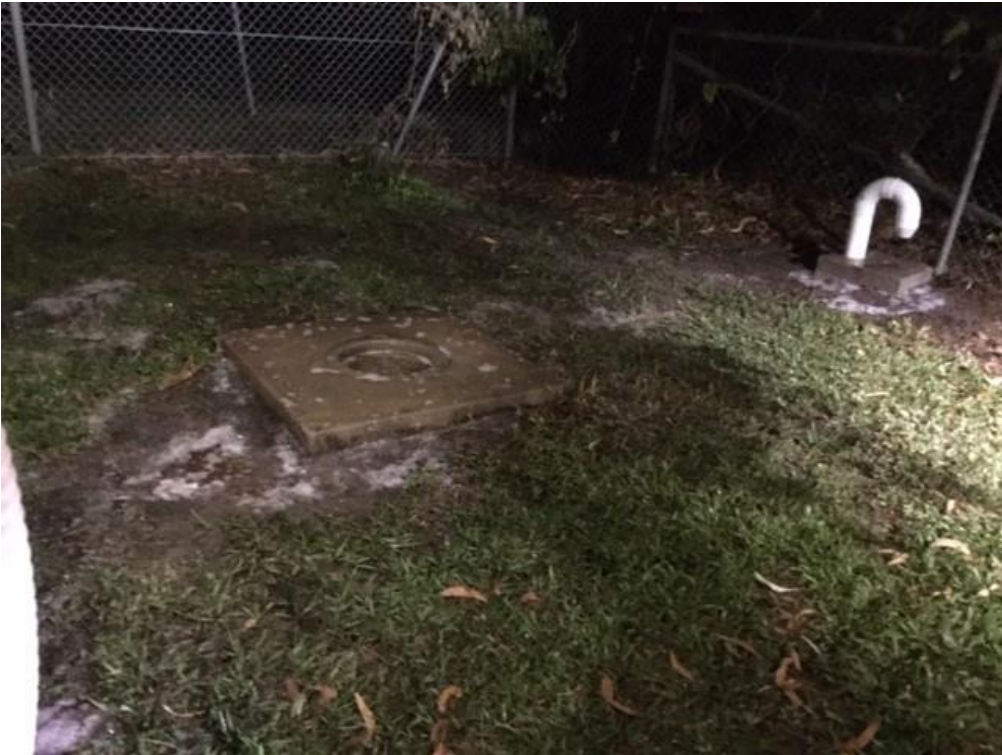
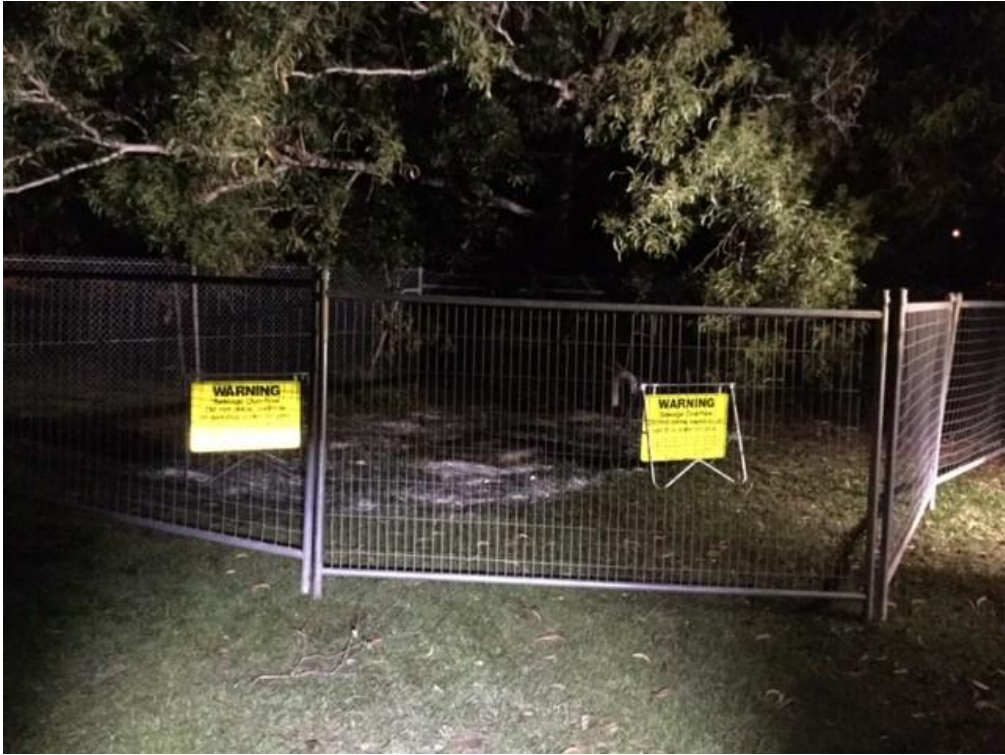
Appendix B – Photographs of spill location

(c) the date and time of the incident	<p><i>i. The time and date of commencement and cessation of the discharge.</i></p> <p>The commencement time of the overflow is unknown. The overflow was observed at approximately 18:30hrs by PWC staff on 07/05/2020 and the spill stopped by 19:00hrs 07/05/2020.</p> <p><i>ii. How PWC were notified, or became aware of the discharge.</i></p> <p>This overflow was reported by one of the nearby residents to the PWC call centre, who then relayed the information to the on-call PWC operations staff. PWC personnel attended the site at 18:30hrs (07/05/20) and undertook action to resolve the situation and make it safe.</p> <p><i>iii. The process by which the discharge occurred.</i></p> <p>The cause of the spill was due to a blockage in the main line, as a result of paper towels being incorrectly disposed of into the sewage system.</p> <p>Public education about what can be disposed in sewer/is flushable: https://www.powerwater.com.au/about/what-we-do/wastewater/sewer-blockages-and-overflows/think-before-you-put-it-down-the-sink In the aim of prevention this material is available on the PWC website and is used as an educational tool for customers. Additionally, PWC has recently been running an educational campaign on social media, print media and radio on the 3P's.</p> <p><i>iv. The reason why the discharge occurred.</i></p> <p>As per (c) iii. Sewerage network infrastructure has been designed to overflow with the best public health and environmental outcomes possible. Design focuses on not overflowing directly inside houses/businesses; rather discharge is designed to occur in a controlled manner at locations which can be accessed for infrastructure repair and clean up and with minimal public health or environmental impacts.</p>

(d) how the pollution has occurred, is occurring or may occur	<p>As per (c) iii & (c) iv.</p>
(e) the attempts made to prevent, reduce, control, rectify or clean up the pollution or resultant environmental harm caused or threatening to be caused by the incident	<p><i>i. Confirmation signage and fencing has been erected, as appropriate.</i></p> <p>Barricading and signage was erected, to alert the pupils and staff, as per Sewage Spills/Overflow Response Work Instruction.</p> <p><i>ii. Decontamination of the site as appropriate.</i></p> <p>Clean up consistent with Sewage Spills/Overflow Response Work Instruction – Unsealed land (beaches, parks, open land and gardens) and public footpaths, Bushland; Remove any gross contamination (including paper, rags, etc.) from impacted area, apply lime until surface ponding is eliminated and then apply 50mm imported topsoil. Installation</p>

of barrier fencing around any contaminated area and installation of advisory signage.
(f) the identity of the person notifying the NT EPA	PWC Environmental Team on behalf of Water Services
