**Leachate Storage Pond (LP03), Shoal Bay Waste
Management Facility, Darwin, Northern Territory**
Manufacturers Data Report

PS132636-028-R-RevA

July 2023

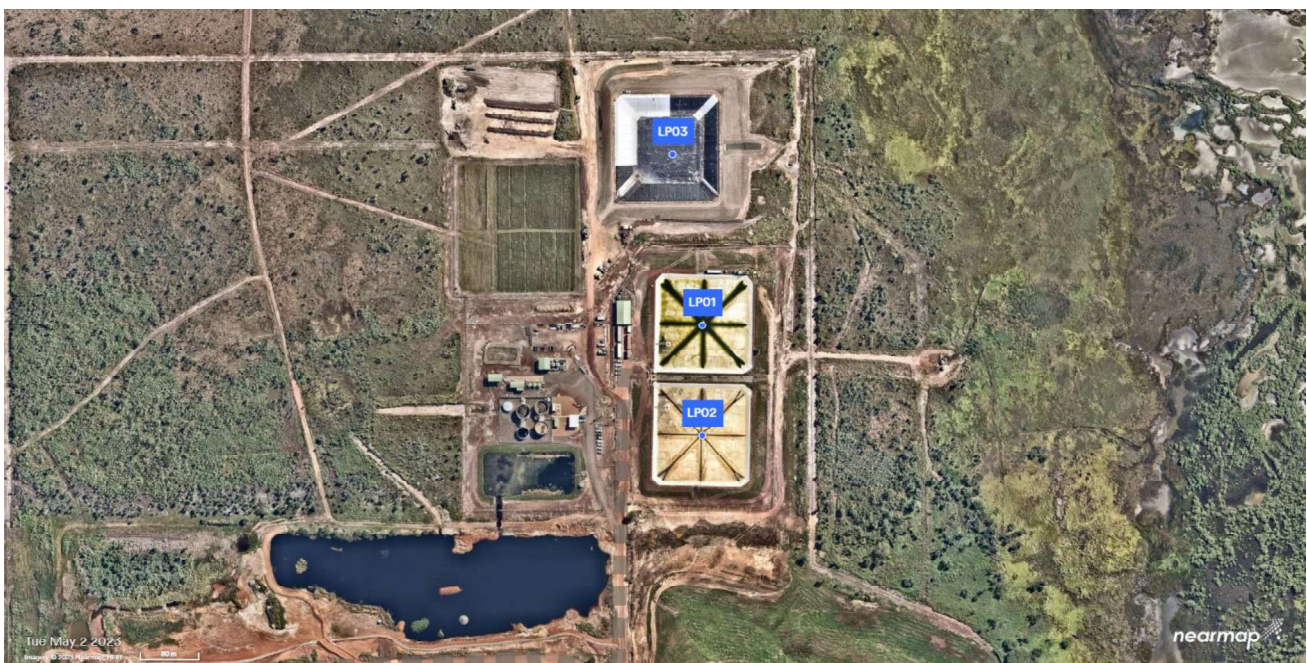
Figure 1: LP03 Located to the north of the existing ponds.

LP03 is located within the boundaries of the SBWMF and to the north of the existing leachate ponds (LP01 & LP02), please see Figure 1 below.
