AQUENAL

BASELINE ENVIRONMENTAL SURVEY

FOR THE MONITORING OF BIOLOGICAL IMPACT OF NUTRIENTS

SNAKE BAY, MELVILLE ISLAND

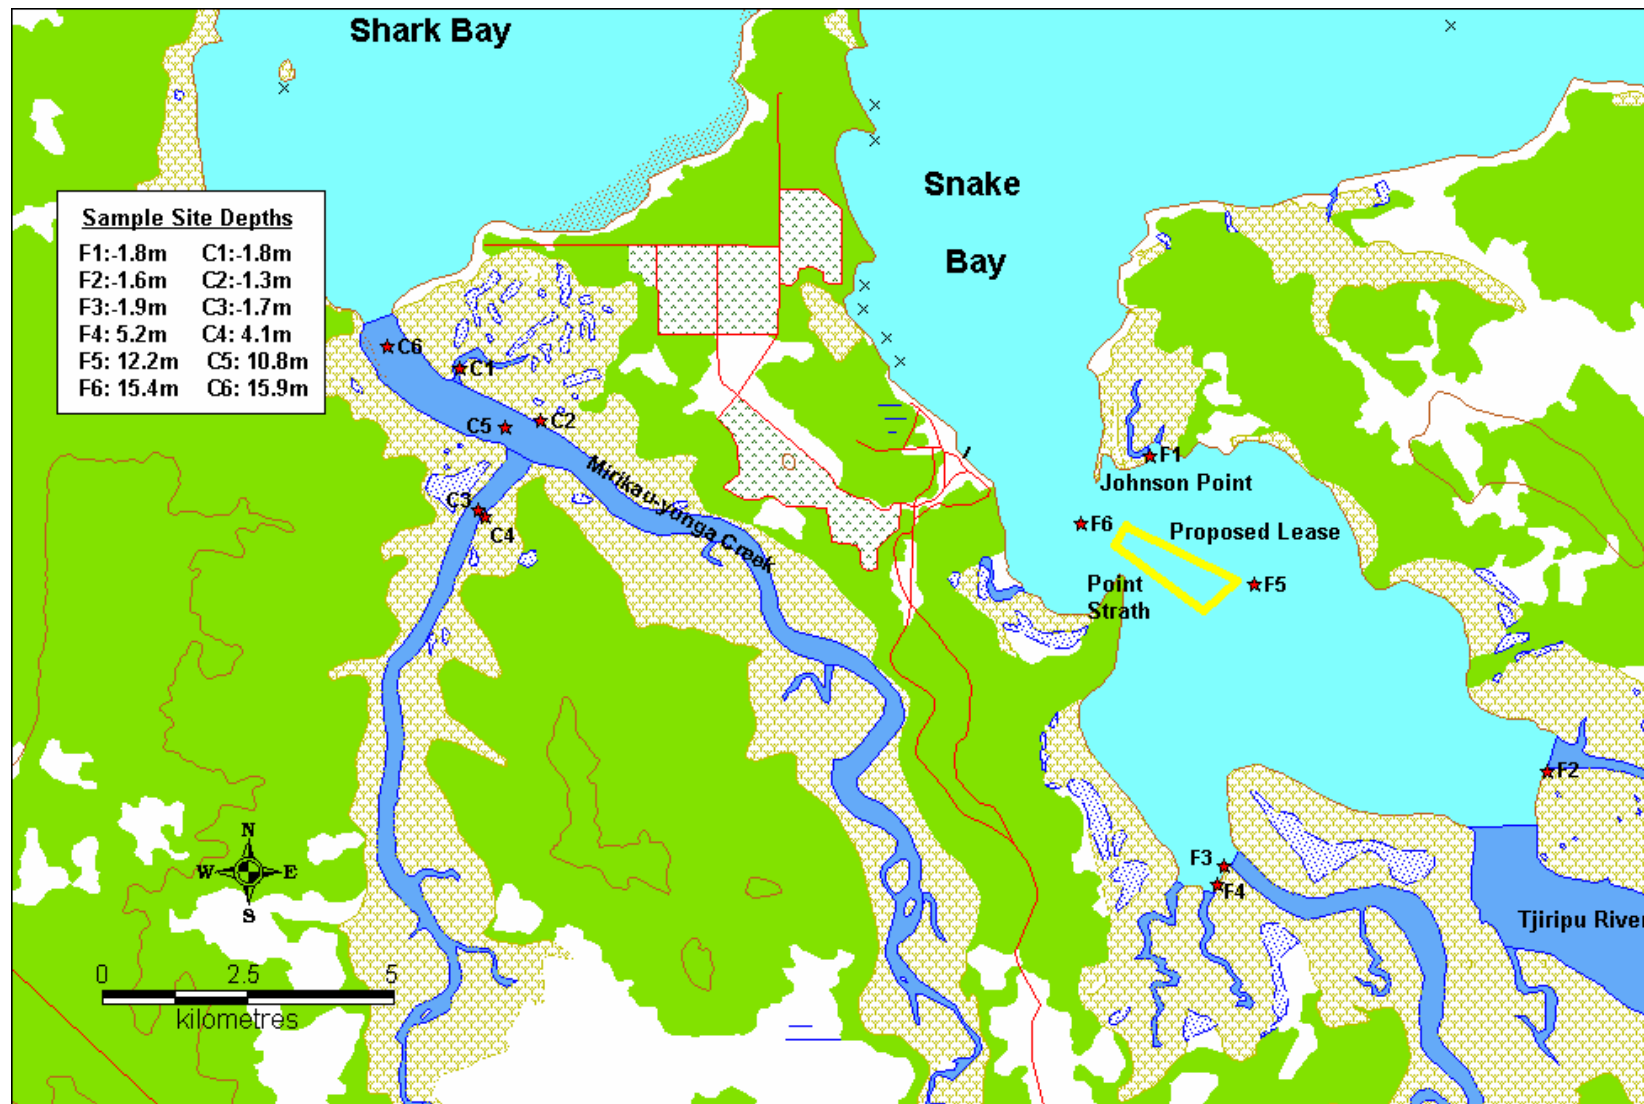
Figure 2-2 Survey map showing farm and control sample sites and the farm location.

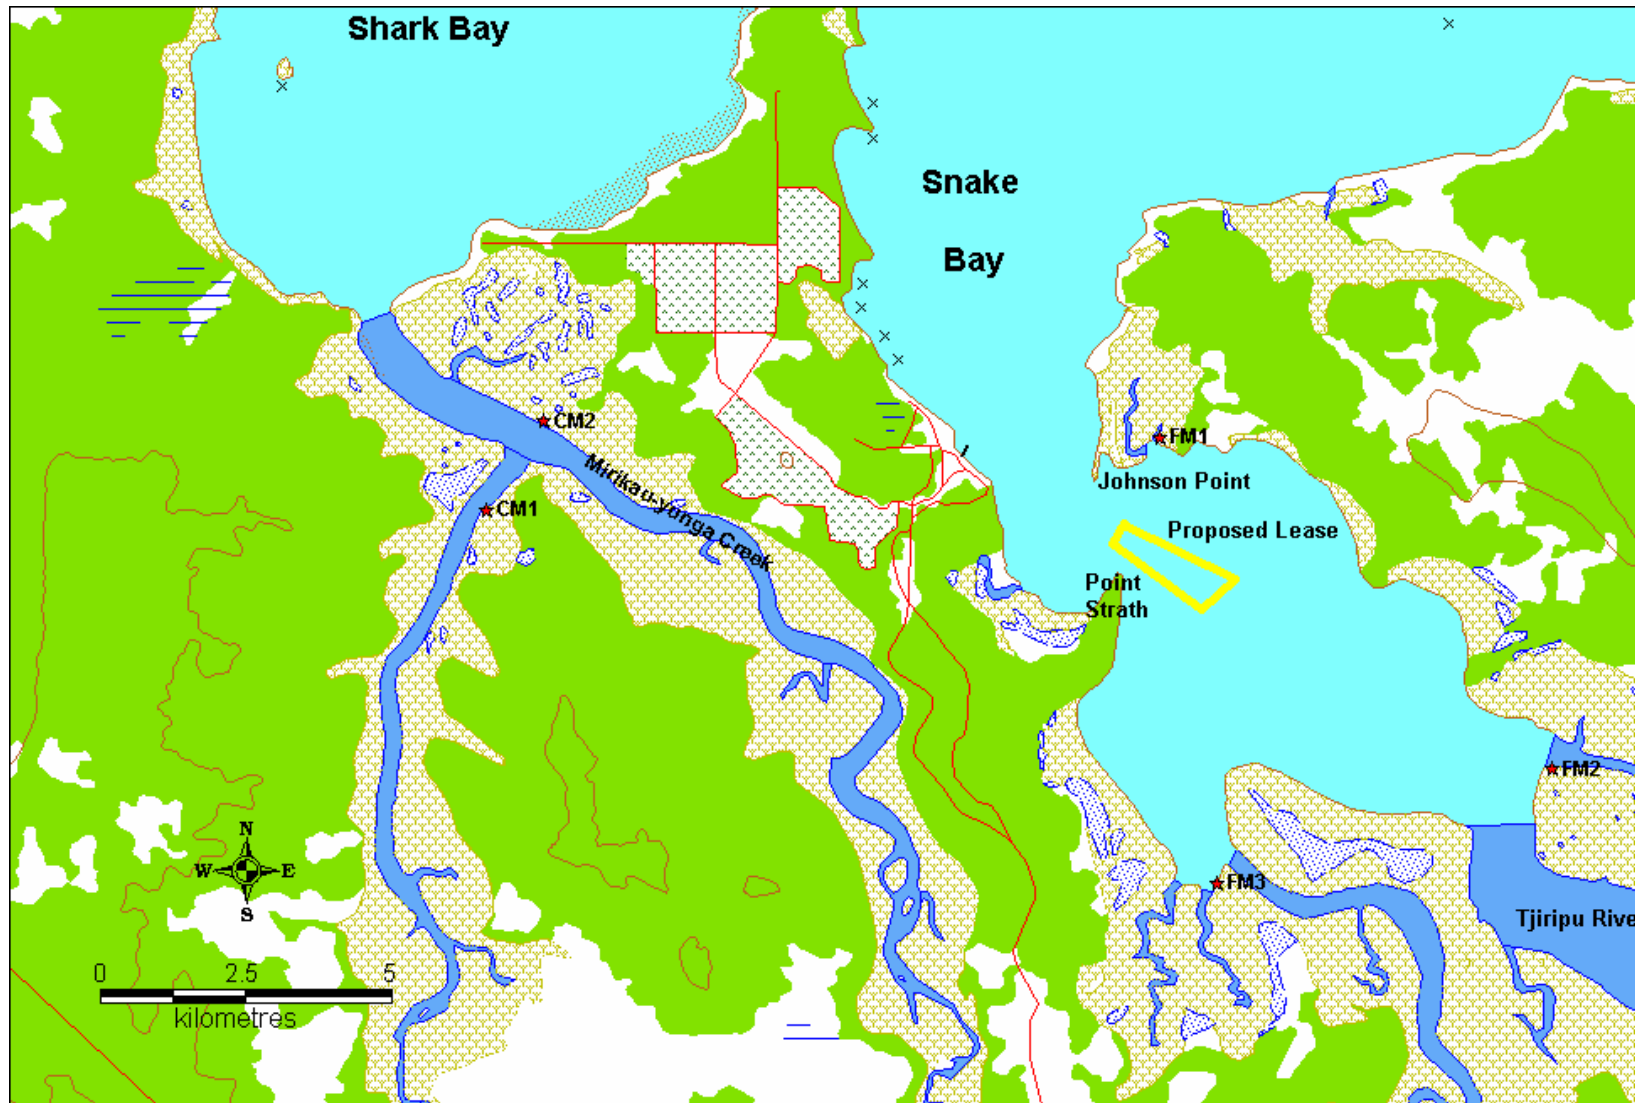
Figure 2-3 Survey map showing farm and control mangrove transect sites and the farm location.

Mangrove transects were surveyed near the shallow water sites to enable any changes noted to be correlated to nutrient and benthic data. However to gain access to the shore without crossing extensive mud banks they were located near a relatively steep bank nearby the shallow water site. The mangrove sites are labelled FM1, FM2 and FM3 for the farm transects in the Snake Bay estuary and CM1 and CM2 for the control transects in the Shark Bay estuary.

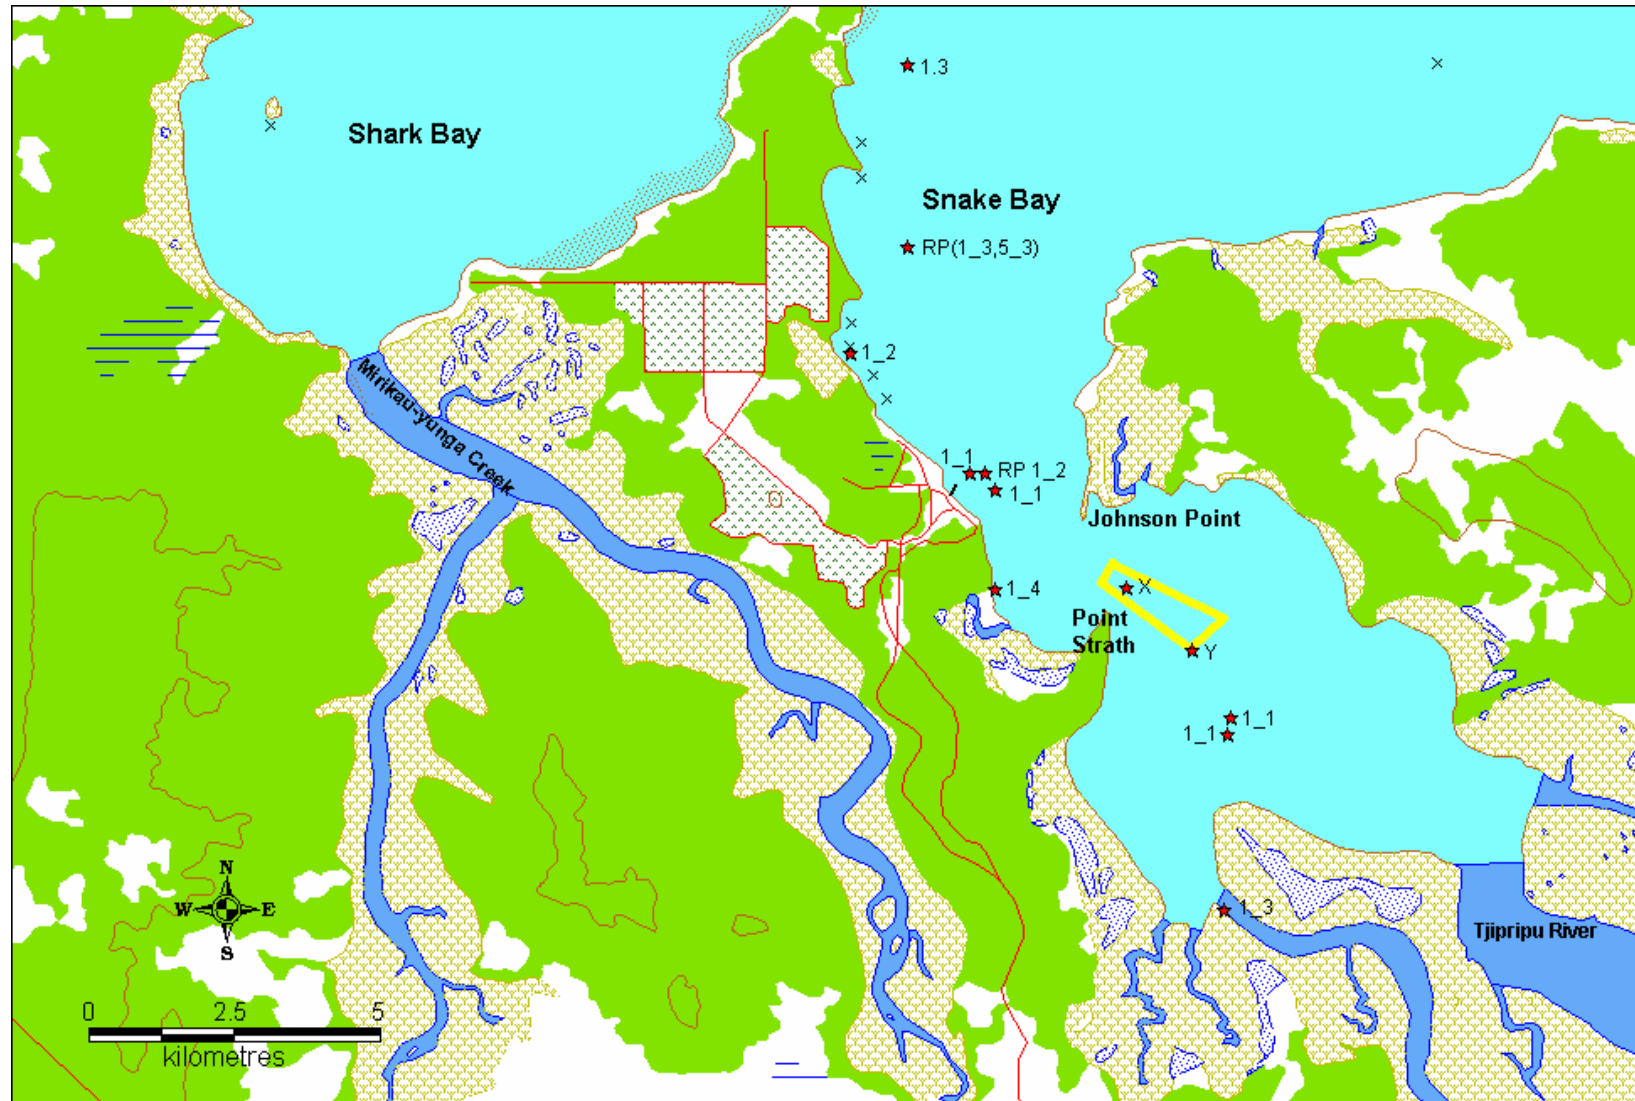
Figure 3-1 Shallow water (1m) drogue survey showing positions of drogues during one spring tide cycle. Drogues to seaward of the farm site were released during the ebb tide at position X or the relevant RP site; those inland were released during the flood tide from point Y.

Movements of drogues gives a simplistic but reliable indication of the immediate fate of nutrient output from a point source without resorting to costly computer modelling of estuarine flows. In this case the drogues showed that much of the water passing the farm on the ebb will remain within the confines of the outer embayment of Snake Bay and be drawn back into the estuary with the incoming tide. They also indicated that waters passing through the proposed farm site on an incoming tide will be carried to all parts of the lower estuary within 10 km on a single tide cycle and their primary direction can be greatly influenced by strong winds.

Shallow waters carrying floating and dissolved nutrients as represented by the 1 m drogues were more subject to wind influences and the dispersion of water into intertidal beaches and mudflats. Deep waters as represented by the 5m drogues tended to follow the deeper channels until they shoaled up then moved with the shallow water.

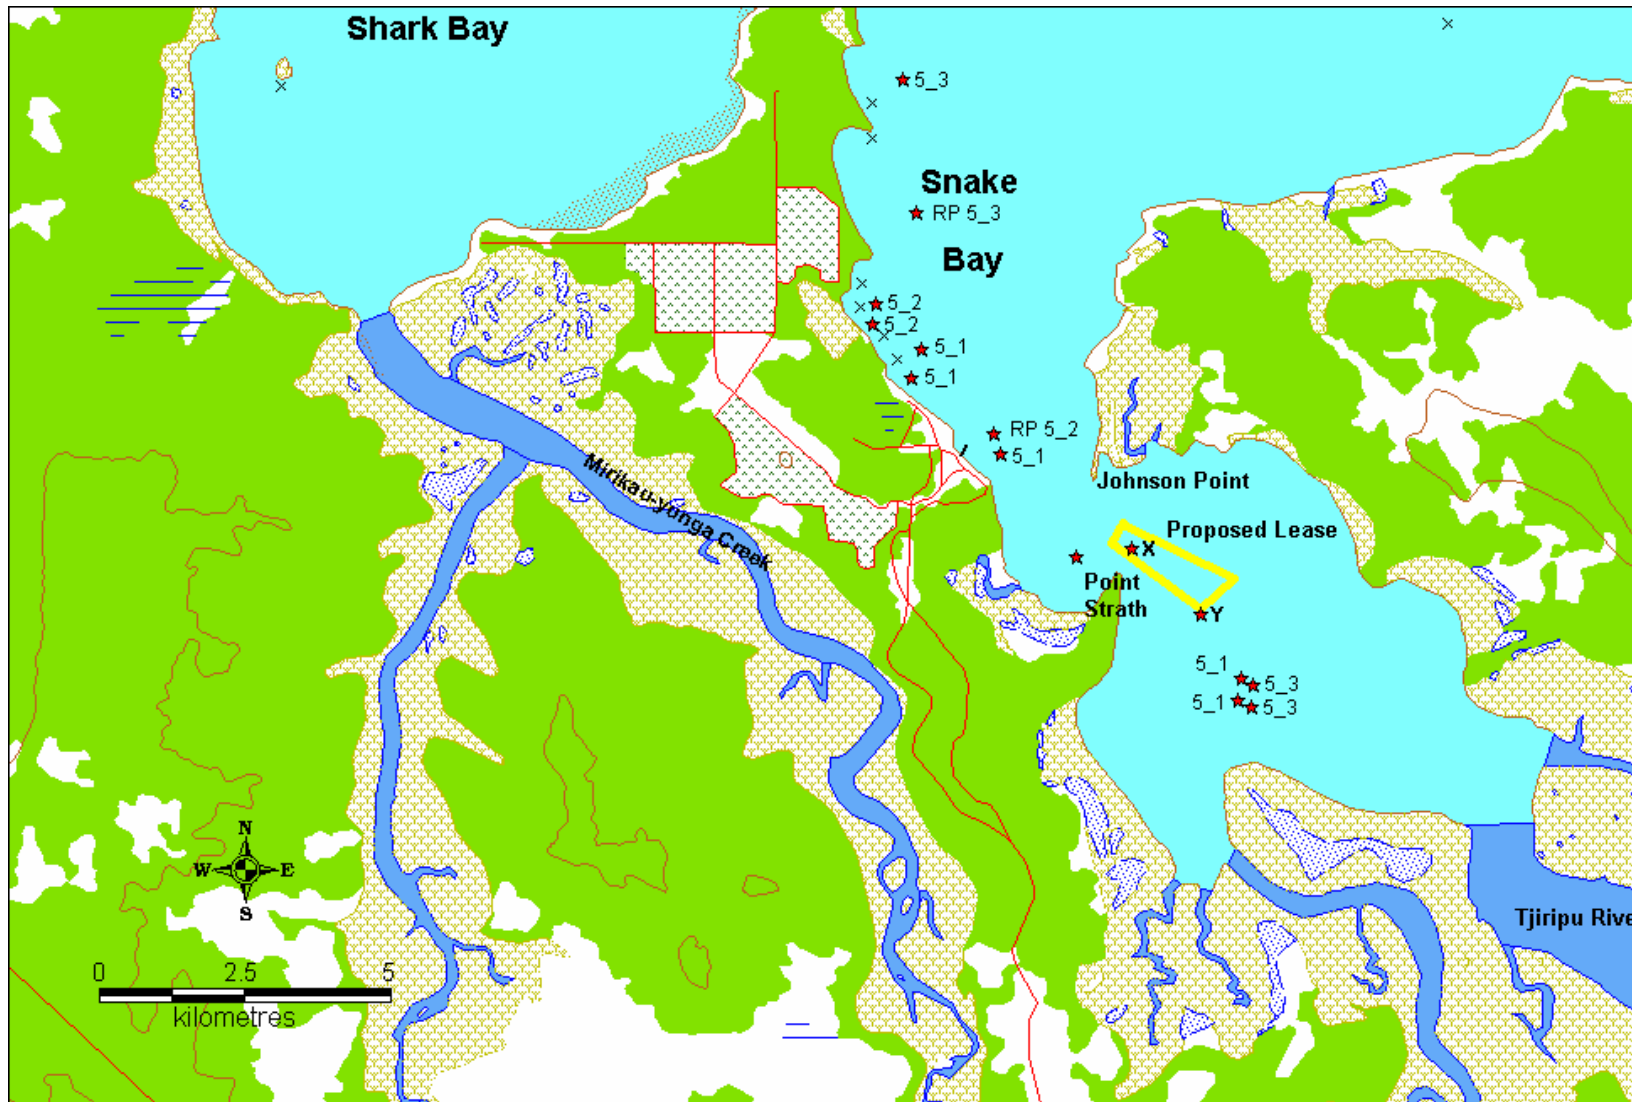
Figure 3-2 Deep water (5m) drogue survey showing positions of drogues during one spring tide cycle. Drogues to seaward of the farm site were released during the ebb tide at position X or the relevant RP site; those inland were released during the flood tide from point Y.

Drogues released on the outgoing tide followed the deep channel through the narrows and out to sea with those released at 4 hours after high tide travelling 2.4 km in their first hour. Once the drogues entered the open waters of Snake Bay they became difficult to track due to the wind generated waves and white water. Several were lost until they returned with the incoming tide or were found grounded on the west side of the bay. Drogues 1-1 and 5-1 were released 4 hours after high tide and tracked from the farm site to 4.6 km seaward then pulled from the water an hour after the turn of the tide as they moved back up the channel. 1-2 and 5-2 were released in the channel 2.8 km to seaward of the farm and 1-3 and 5-3 were released in the channel 6.8 km to seaward. 1-2 was

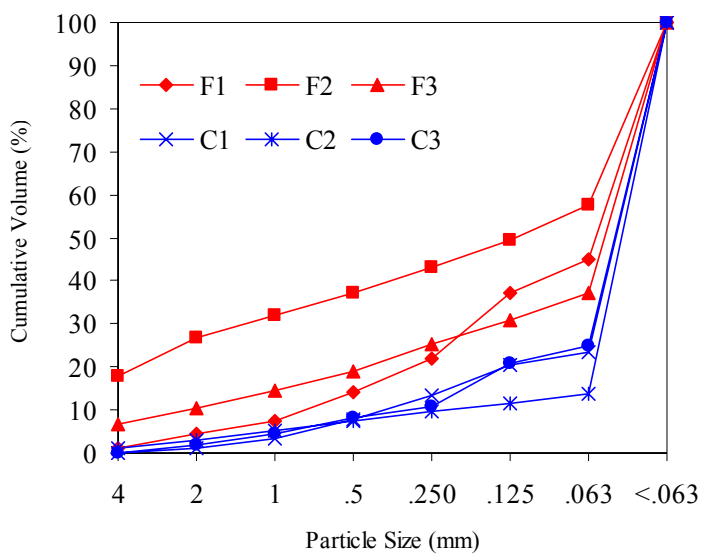
Figure 4-3 Particle size analysis of the top 100 mm of sediment cores from the intertidal farm and control sites.

The noted difference between farm and control sites reflects the difference between the more open water environment of the Snake Bay estuary compared to the narrower, more sheltered waters of the Shark Bay estuary. There would be more wave action particularly at the shallow water farm site of F2 than at the remaining sites. Fine sediments at F5 indicate it is a depositional environment and will be a good site for assessing the impact of farm fallout. Coarse sediments found at F6 reflect its location in the rapid flowing section of the channel seaward of the proposed farm site. However it was judged to be the best site available for assessing nutrient build-up and impact from out-flowing waters. The coarse material at F4 consisted mainly of shells and wood material hence they do not reflect on the energy levels in the water.

The normal trend to coarser sediments with greater water movement is masked at most sites by the occurrence of decayed plant material in the sediments. In sites remote from mangroves, sediments are transported either in from the ocean or down rivers and deposited. In these cases the size of the particles reflects the energy of normal ambient water movement with fine sediments indicating low energy movement and coarse indicating high. The more mixed the particle size distribution the greater the range of water movement from calm to rough. The preponderance of fines at shallow water sites reflects this trend with shells and plant material at F2 being the only exception. The occurrence of coarse sand and pebbles in sediments from channel sites also reflects this trend however there is no clear division between intertidal sheltered sites and deep water mid-channel sites on particle size analysis alone. The main use of these results will be in characterising the environment of the benthic infauna to assist in explaining similarities and differences between sites.

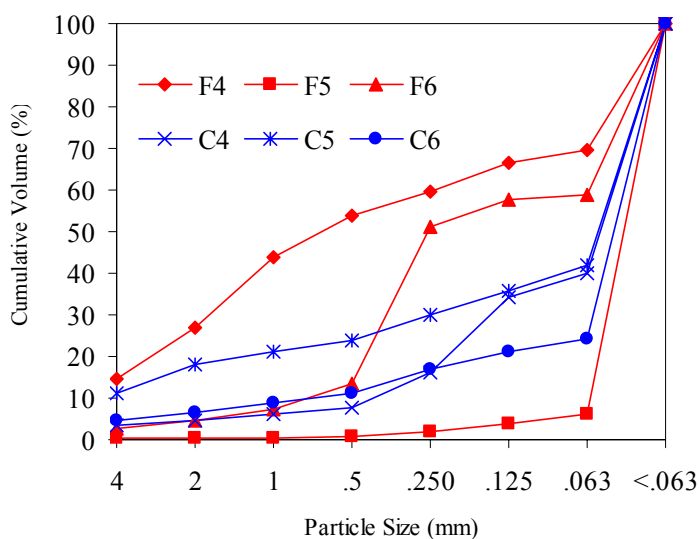
Figure 4-4 Particle size analysis of the top 100 mm of sediment cores from the subtidal farm and control sites.

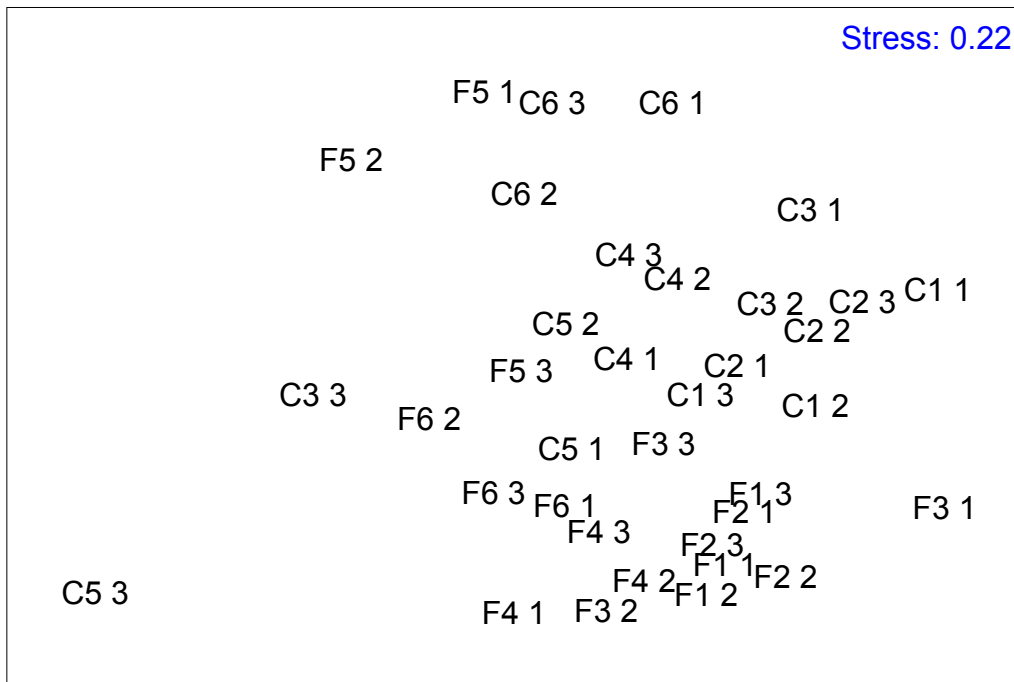
Figure 6-1 Results of MDS analysis using macrobenthic data from triplicate samples at each site.

Patterns of similarity amongst macrobenthic samples therefore reflect both habitat/depth variation and geographical separation of the two estuary systems surveyed. The taxa that account most for differences in assemblages on the basis of habitat and estuary are tanaid crustaceans belonging to the genus *Apseudes* and a polychaete worm belonging to the genus *Eunice*. One species of *Apseudes* was present at intertidal and shallow subtidal sites but was not found at deeper subtidal sites, a finding that contributed significantly to the separation of sites on the basis of habitat in the MDS plots. Site C6 displayed the lowest similarity with other sites due not only to the absence of the above *Apseudes* species, but the virtual absence (1 individual was identified) of a second *Apseudes* species that was relatively common at other deep subtidal sites. *Eunice* sp. was common at the farm intertidal sites in Snake Bay and was also identified at F4, but was absent from intertidal and shallow subtidal control samples in the adjacent Shark Bay Estuary. The latter finding

significantly contributed to the separation of intertidal and shallow subtidal samples on the basis of estuary, although other taxa also contributed to the MDS groupings observed.

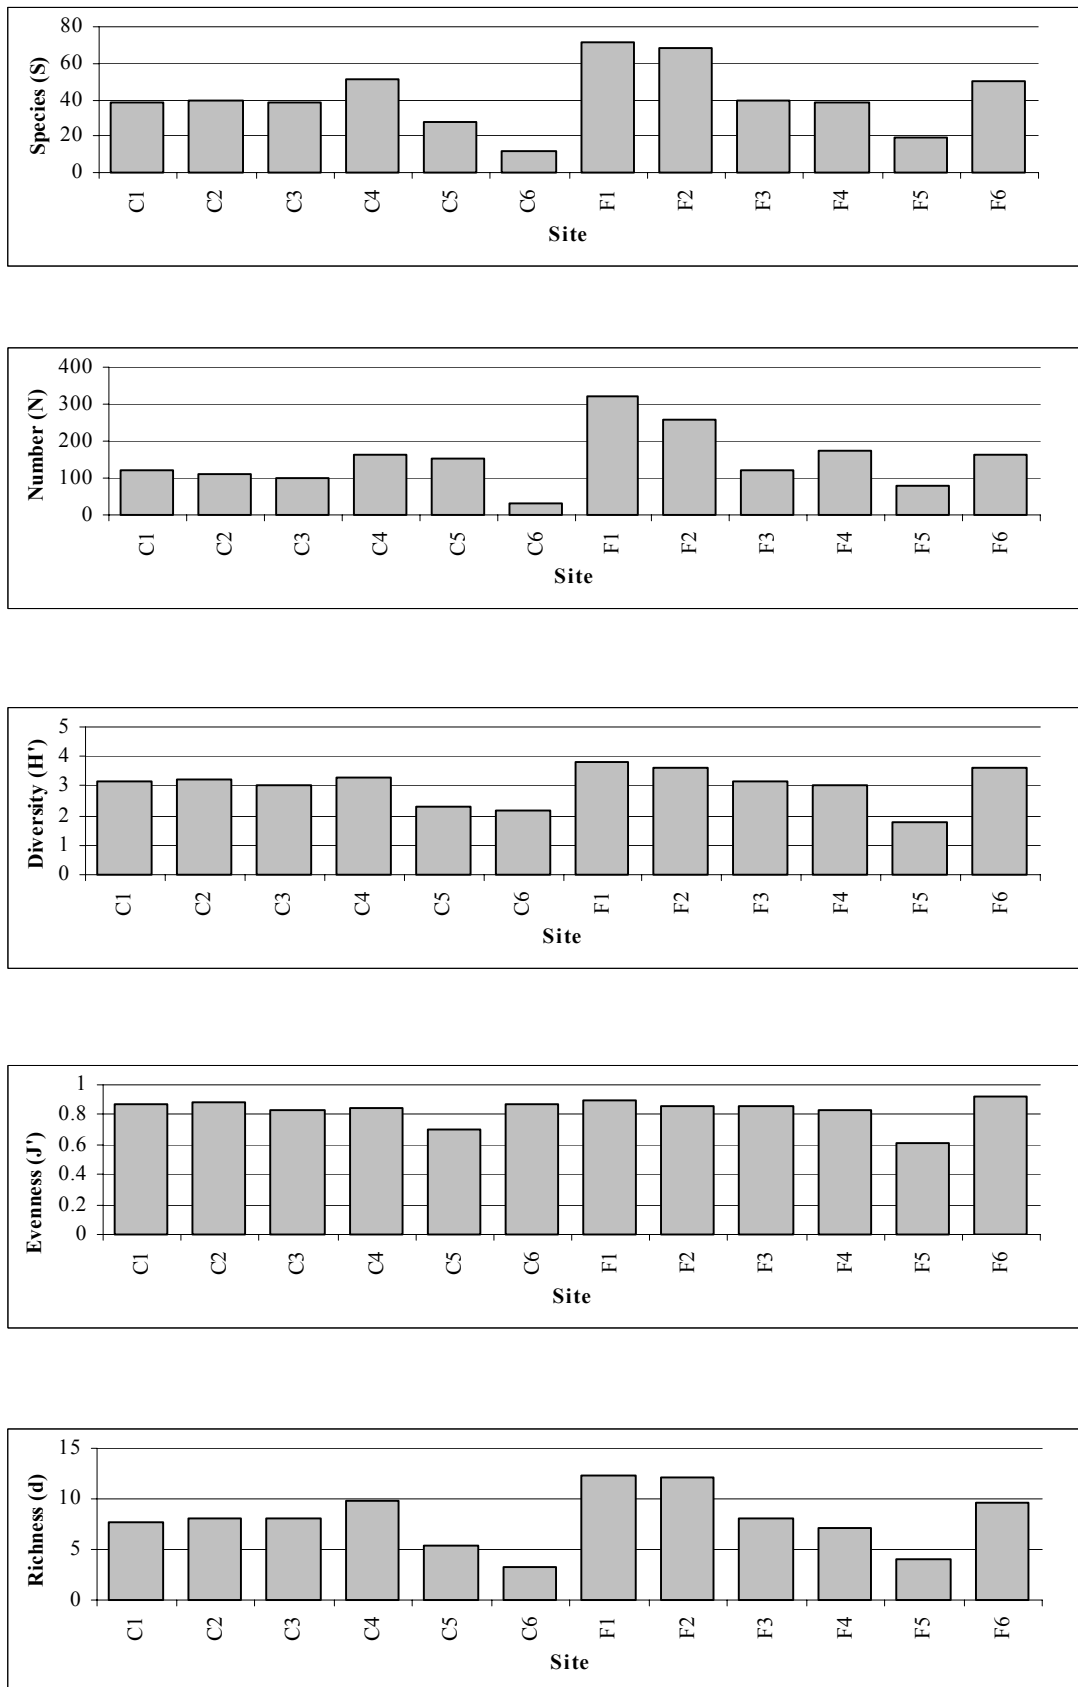
Figure 6-3 Macrobenthic diversity indices for farm and control sites; S = number of species, N = number of individuals, H' = Shannon-Wiener diversity index, J' = Pielou's evenness index, d = Margalef's richness index.

The results of diversity indices calculations are provided in Figure 6-3 and provide baseline data that can be readily compared with future data to assess temporal variation in biodiversity. Species and individual numbers peaked at sites F1 and F2, and were consistently low at C6 and F5. Species number and abundance exhibited no clear relationship to depth, although it is notable that highly consistent values of these parameters were recorded across the three intertidal control sites. Similar patterns were observed for the Shannon–Wiener diversity index (H') and Margalef's richness index (d), with highest values at F1 and F2, lowest values at C6 and F5 and comparable values for the intertidal control sites. Sites C4 and F6 also recorded elevated values for these indices due to the high numbers of species observed relative to the numbers of individuals collected. Pielou's evenness index (J'), which reflects how evenly the numbers of individuals are distributed amongst species, recorded similar values at all sites, with the exception of reduced evenness at sites C5 and F5. Overall, there was no consistent trend for elevated diversity in one estuary compared with another, or in one particular habitat compared with another. It is notable however that the lowest diversity and abundance values were recorded in several of the deeper subtidal sites, a finding that may reflect reduced light penetration and primary production in some of the deeper sections of the estuaries.

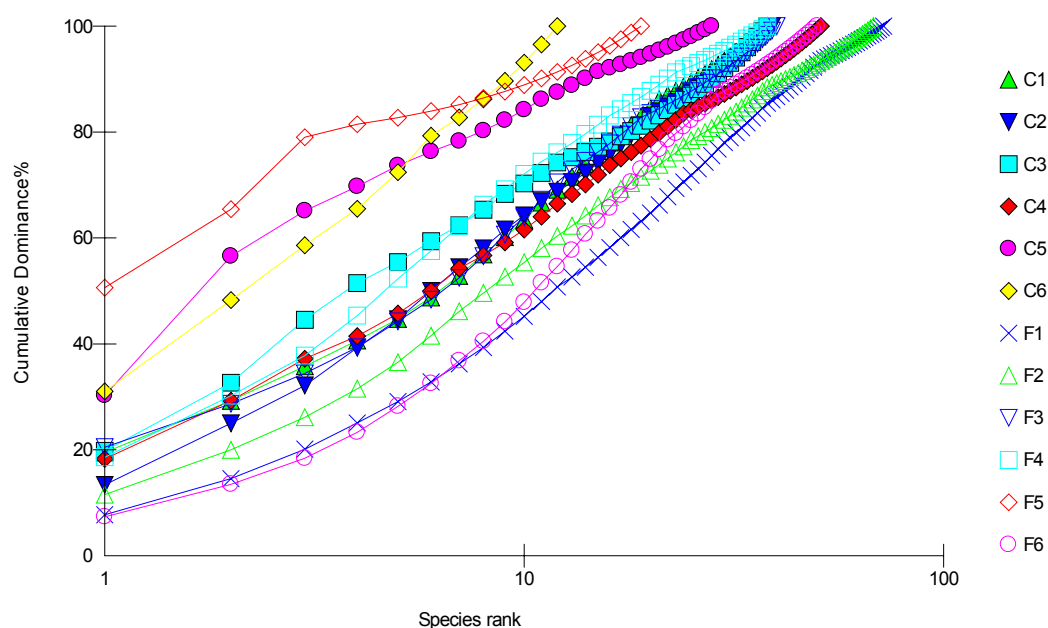
Figure 6-4 K-dominance curves for pooled replicate macrobenthic samples at each site.

K-dominance curves for pooled replicate samples at each site are presented in Figure 6-4. At most sites the curves reflected low levels of faunal dominance with the most dominant species comprising 20% or less of animal numbers. Where this was the case, remaining components of the assemblages consisted of a large number of low abundance species, again reflecting low levels of dominance. Consistent with reduced diversity values depicted in Figure 6-3, sites C5, C6 and F5 were exceptions to the above, since the most common species at each of these sites comprised 30 to 50 % of the total animal numbers. These sites were also characterised by lower species numbers overall than other sites, again reflecting higher faunal dominance on the basis of cumulative calculations. The higher dominance at these deeper subtidal sites may reflect reduced habitat suitability for many species due to poor light conditions and associated primary production, as described above in diversity indices results. None of the K-dominance curves depicted in Figure 6-4 are indicative of high levels of pollution or other forms of environmental degradation.
