SECTION 14 INCIDENT REPORT (*Waste Management and Pollution Control Act*)

Date and Time of Notification:	Tuesday 30 th April 2019, 3:56pm
Person / Company:	Power and Water Corporation (PWC)
Incident:	Discharge of raw sewage from sewerage network (access chamber)

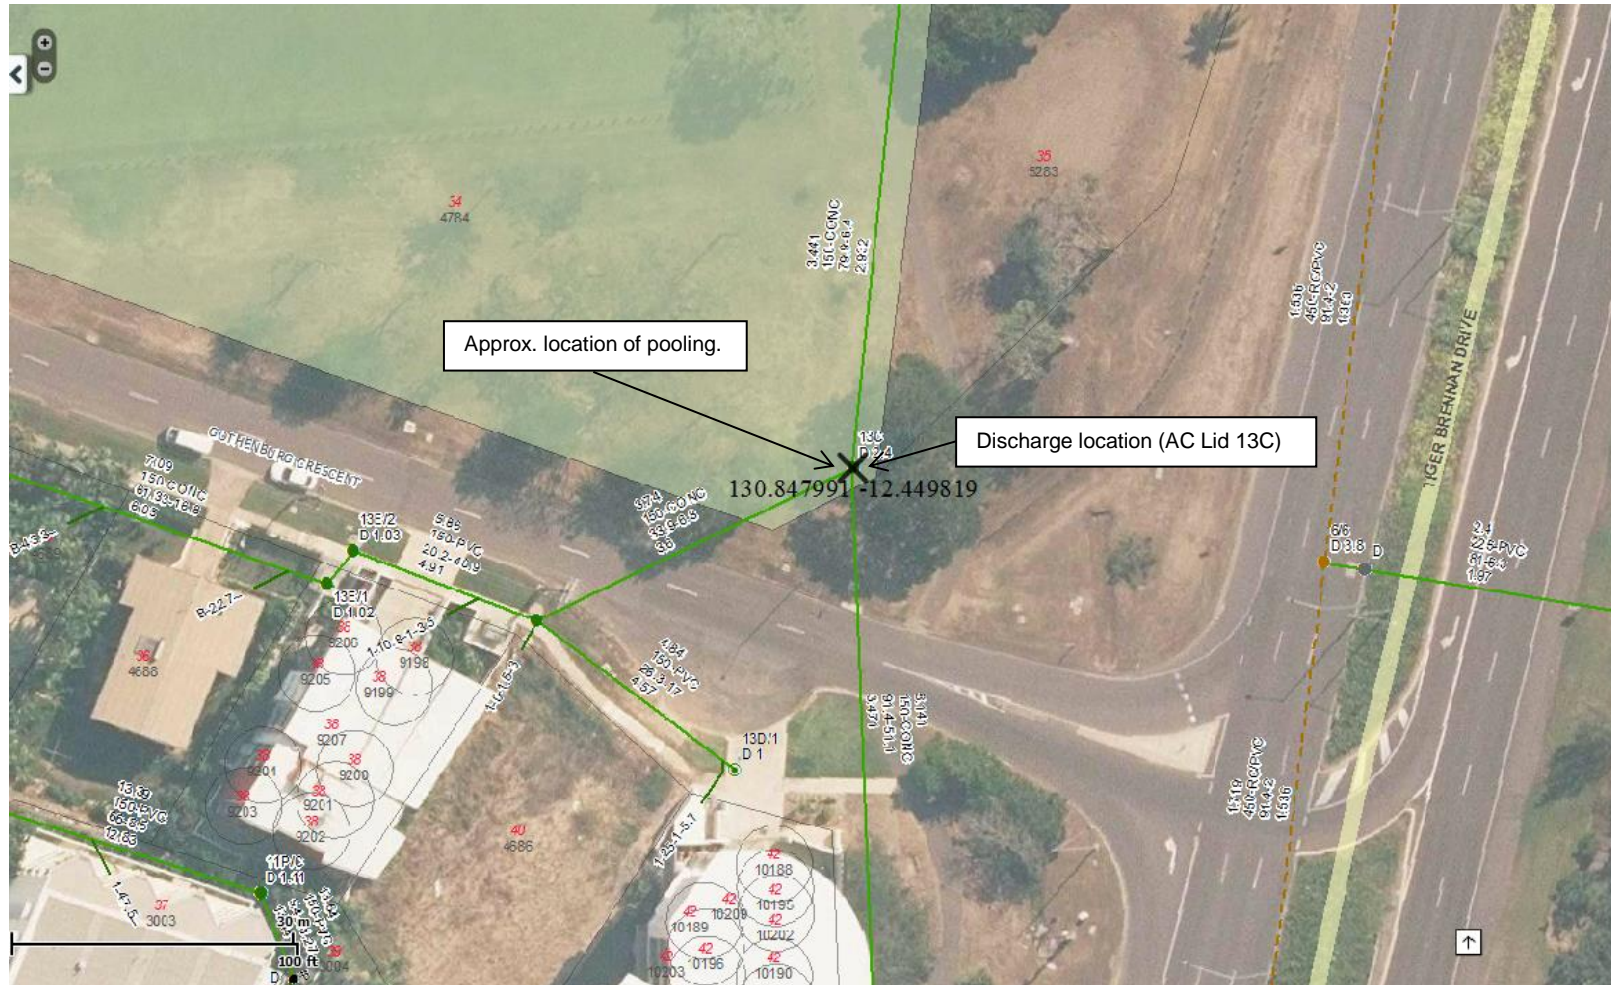
<p>incident occurred</p>	<p>– AC Lid 13C</p> <p><i>i. Description of the PWC asset from which the discharge occurred.</i></p> <p>Access Chamber Lid 13C – as per map below.</p> <p><i>ii. GPS coordinates of the discharge point from the PWC asset, and the final coordinates of the final discharge point.</i></p> <p>As per map below.</p> <p><i>iii. Indicate any locations nearby to the discharge point where public can gain ready-access, such as public open spaces through which the discharge moves.</i></p> <p>Public access is available throughout the area due to public parks and bike paths present. The area impacted by the discharge was fenced off during the clean up to prevent access by the public as per Sewage Spills/Overflow Response Work Instruction.</p>
<p>(c) the date and time of the incident</p>	<p><i>i. The time and date of commencement and cessation of the discharge.</i></p> <p>The commencement time of the overflow is unknown. The overflow was observed at approximately 6:00pm on 29/04/19 and was stopped at approximately 6:10pm (29/04/19).</p> <p><i>ii. How PWC were notified, or became aware of the discharge.</i></p> <p>PWC were notified by a member of the public through the call centre. From this PWC immediately attended the area and resolved the overflow and cleaned the area.</p> <p><i>iii. The process by which the discharge occurred.</i></p> <p>Fat and other substances have been incorrectly disposed of into the sewer network by customers, resulting in the blockage and the overflow.</p> <p>The fats, oils, meat juices, food scraps and other non-degradable objects that are put down the sink or toilet have collected and built up in the pipe work.</p> <p>When fats, oils and meat juices are put down the sink it is usually as a liquid, but as it cools it can become more solid and cause build-up, bad odours and blockages in the sewerage system. This can lead to the sewage overflows into the environment, households and businesses.</p> <p><i>iv. The reason why the discharge occurred.</i></p> <p>Sewerage network infrastructure has been designed to overflow with the best public health and environmental outcomes possible. Design focuses on not overflowing directly inside houses; rather discharge is designed to occur in a controlled manner at locations which can be accessed for infrastructure repair and clean up and with minimal public health or environmental impacts.</p>
