Australian Government
**Australian Radiation Protection
and Nuclear Safety Agency**

ARPANSA Licence S0340

Koongarra, Northern Territory site survey

Field Trip report

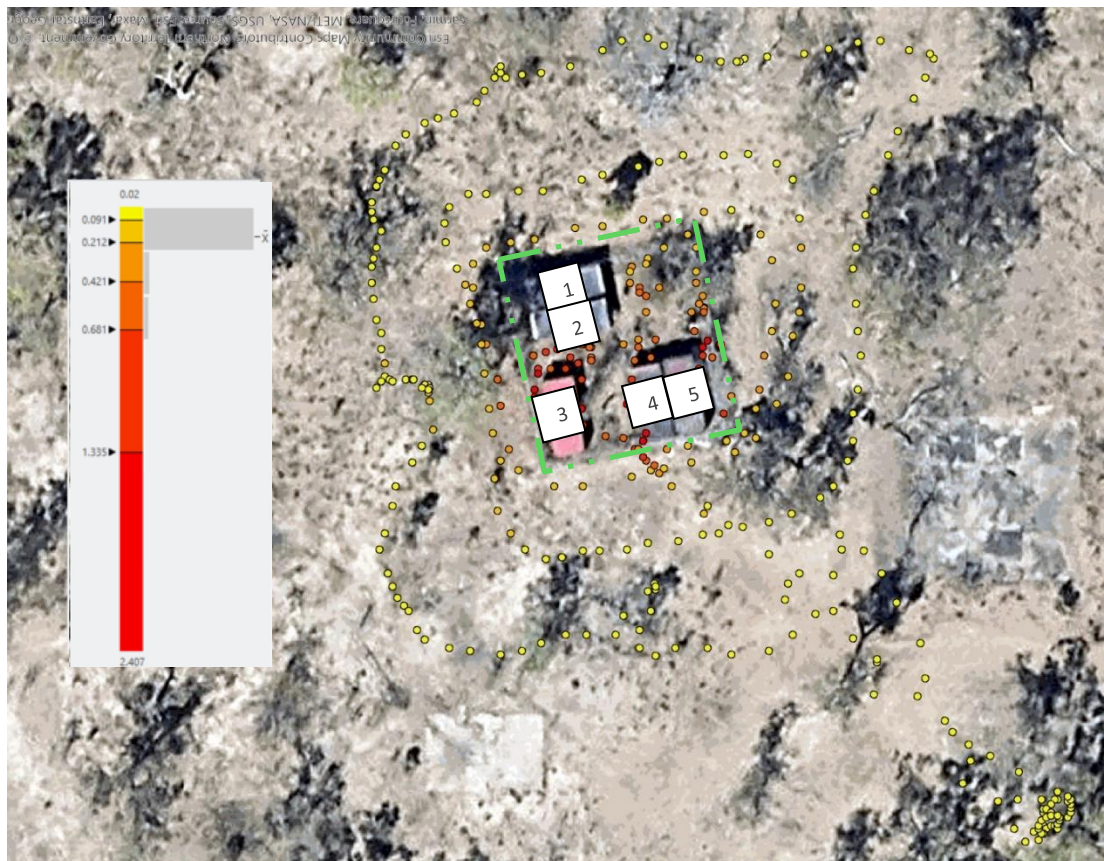
Results for site dose rate measurements are presented in figure 4. Measured dose rates of up to $2.4 \mu\text{Sv/h}$ were measured using the backpack system. Ad hoc measurements made using a AccuRad are presented in figure 5 and show good agreement with the AGMS dose rate mapping system.

Figure 4. AGMS dose rate map of the Koongarra source site. The secure fence boundary is indicated by the green dashed line and shipping containers are labelled

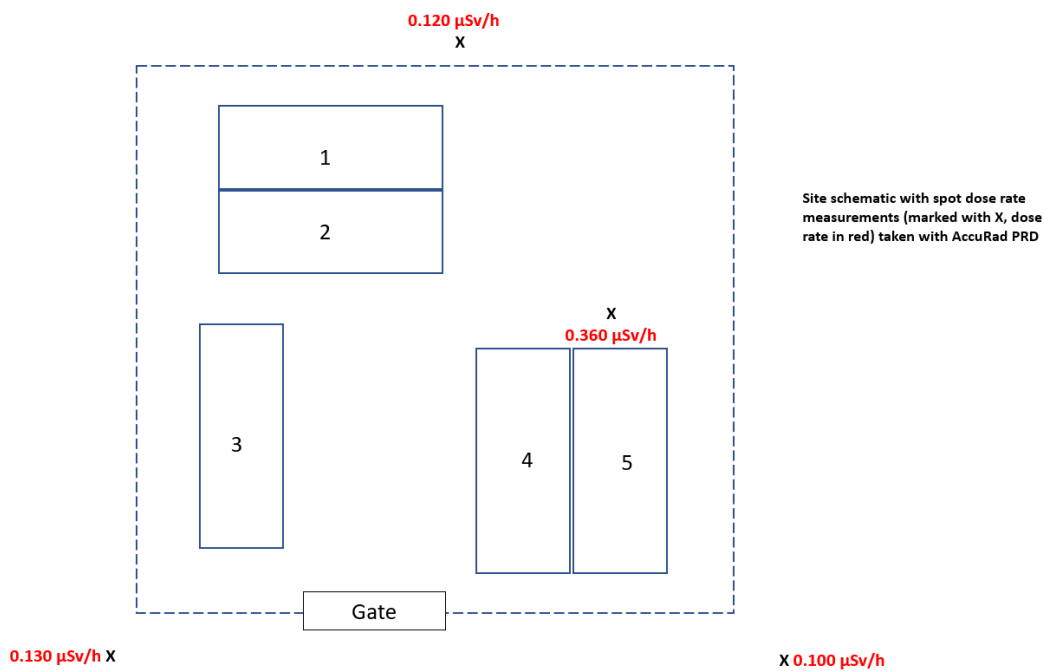
Figure 5. Ad hoc dose rate readings made using a AccuRad PRD in $\mu\text{Sv/h}$

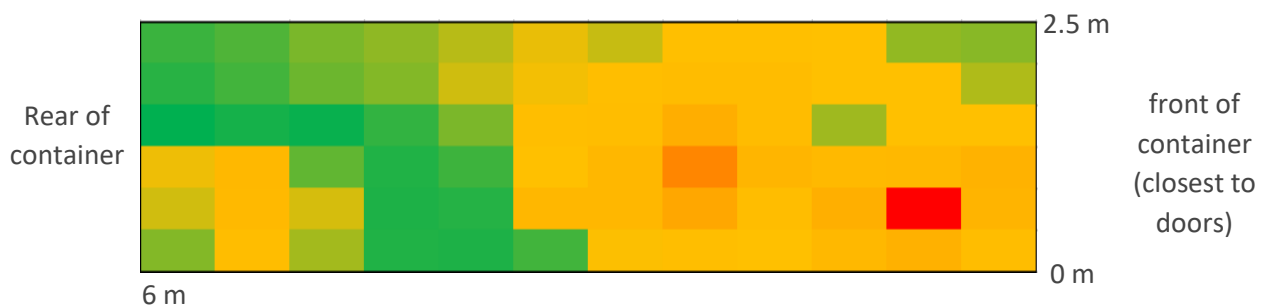
Dose rate mapping using the AccuRad PRDs was performed on the sides of shipping containers 4 and 5 by holding the AccuRad PRD against the side of the container at set interval points of either 1m or 0.5m (as indicated in the descriptions of figure 6 and 7). As can be seen in figures 6 and 7, measured hot spots of activity up to $23 \mu\text{Sv/h}$ were found along the length of container 5 and $5.62 \mu\text{Sv/h}$ along the length of container 4.

Figure 6. dose rate heat map of the long length of container 5, side closest to fence. Measurement intervals were every 0.5 m along the length and height of the container. Highest dose rate measured indicated by the red colour was $23 \mu\text{Sv/h}$.

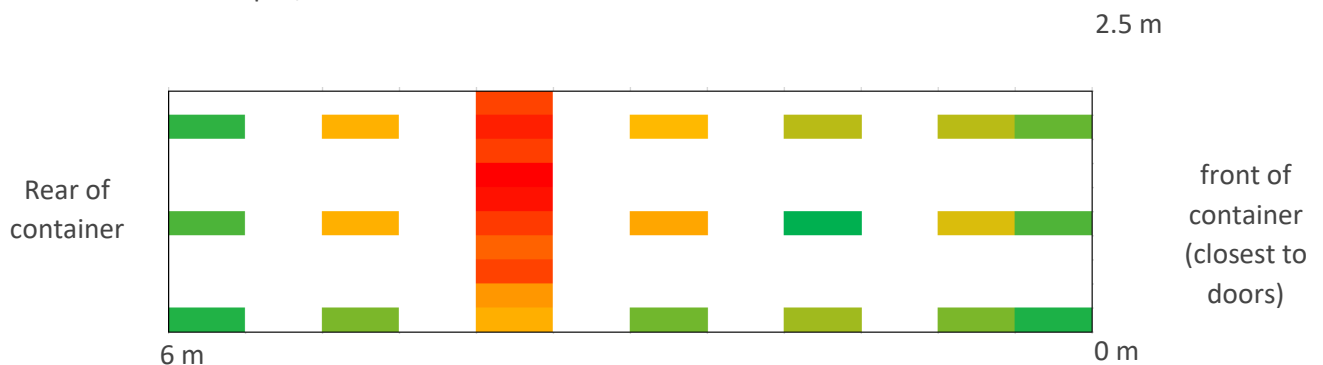
Figure 7. dose rate heat map of the long length of container 4. Measurement intervals were every 1 m along the length and 0.5m or 0.25 m along the height of the container Highest dose rate measured indicated by the red colour was 5.62 $\mu\text{Sv/h}$.

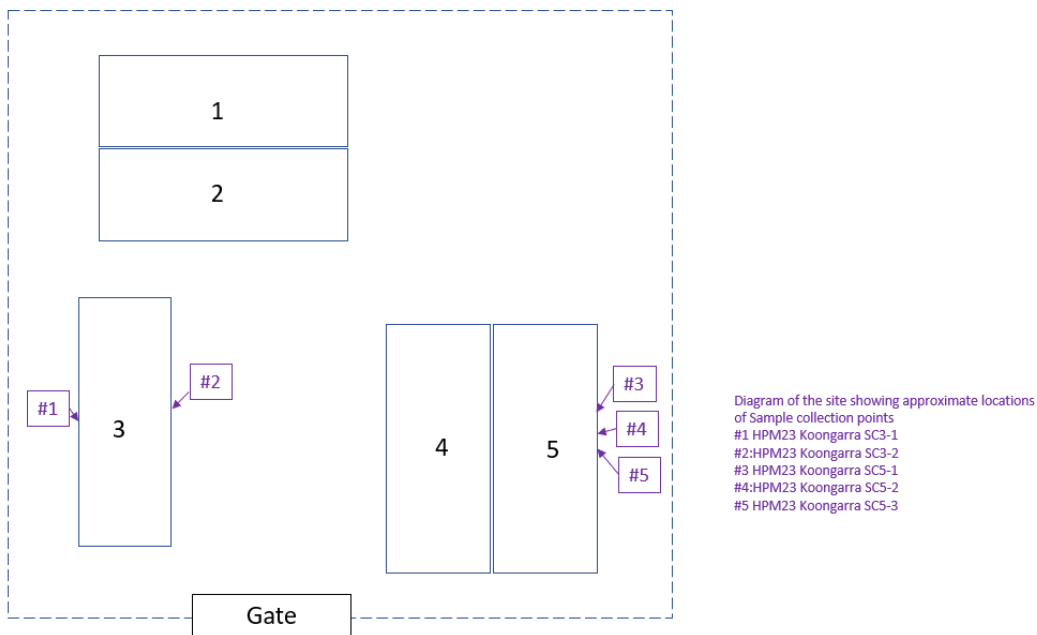
Some of the shipping containers showed physical degradation at stress points around the bottom edges and on the top of the containers due to harsh environmental conditions and age, leading to contents from the containers leaking out and subject to potential dispersion. With permission from the source licence holder, Parks Australia, ground samples were taken from areas around shipping containers 3 and 5 for further laboratory analysis. Sample results, details and locations are detailed in Table 2, 3 and figure 8.

Figure 8. Site schematic showing 'soil' sample collection points.

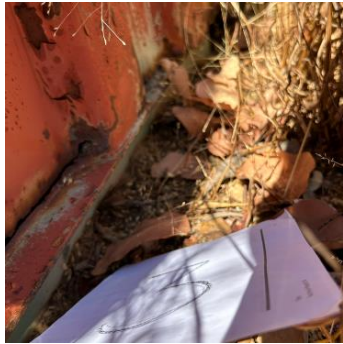
Sample RAS Lab #	Sample name	Observations/comments	Photos
EA23-023-0227	HPM23 NTK SC3-1	Shipping container #3, on fence side along bottom of shipping container where integrity has been breached.

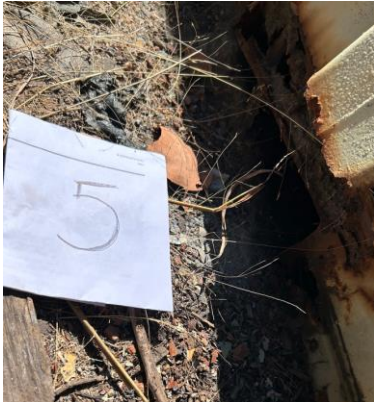
EA23-023-0228	HPM23 NTK SC3-2	Shipping container #3, on inside side along bottom of shipping container where integrity has been breached.	
EA23-023-0229	HPM23 NTK SC5-1	Shipping container #5, on fence side along bottom of shipping container where integrity has been breached. Sample is visually a chunk of red dirt. There is a geological sample tag which was also collected with the sample

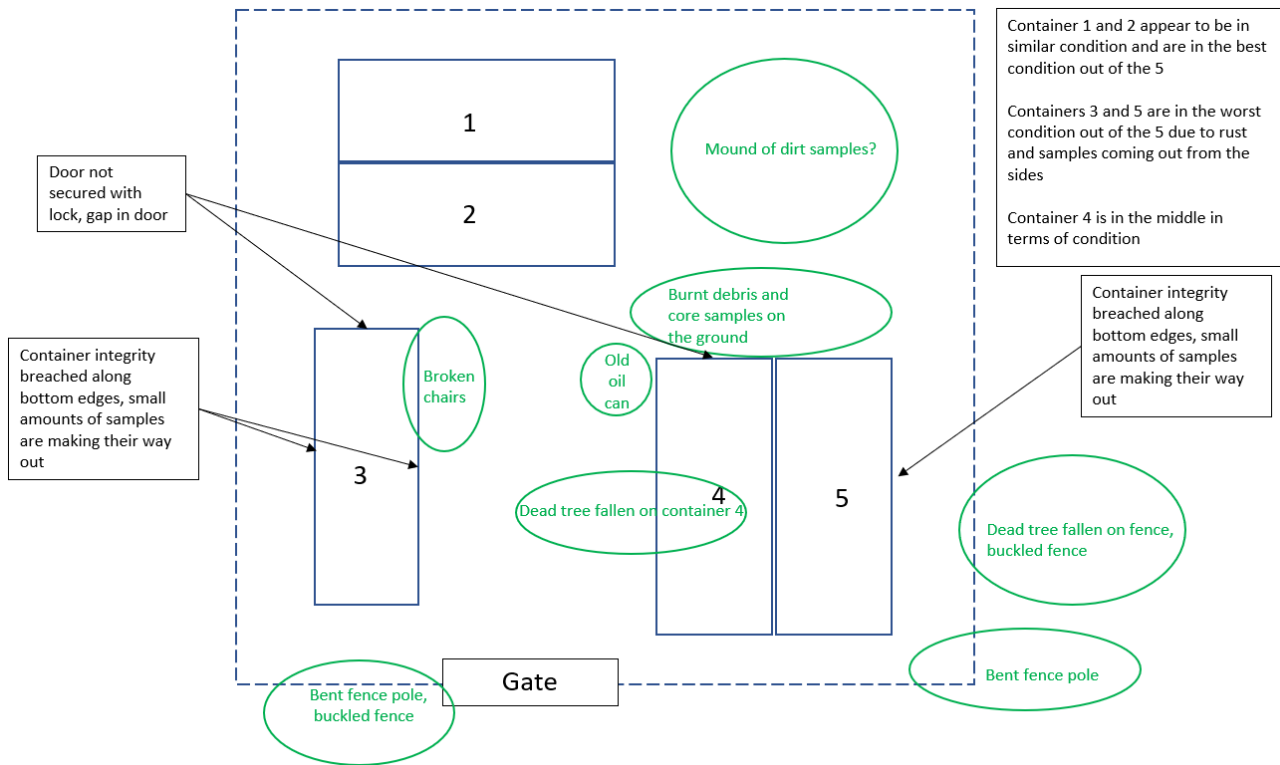
Photos for the site and shipping containers are presented in Appendices 15 to 24. Table 4 summarises the conditions of the site and the shipping containers. Figure 9 shows site schematic with some points of note. Refer to Table 4 for description of the site features and appendixes 15 to 21 for photographic details.

Figure 9. Site schematic showing some points of note highlighted in green

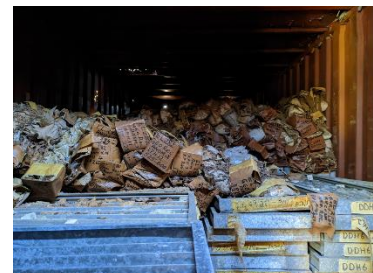
Figure 10. Pictorial examples of internet searchable products that are representative of what is likely to be present in the shipping containers. a) picture of steel core tray racking system and core trays (West Australian Steel Sales, 2023), b) example of a calico sample bag, popular with geologist (Dynamics G-Ex, 2023) c) inside contents of container #5 showing boxes and core tray present, estimated fill height is 2 m and cardboard content in the material and bag material has not been included in any calculations.

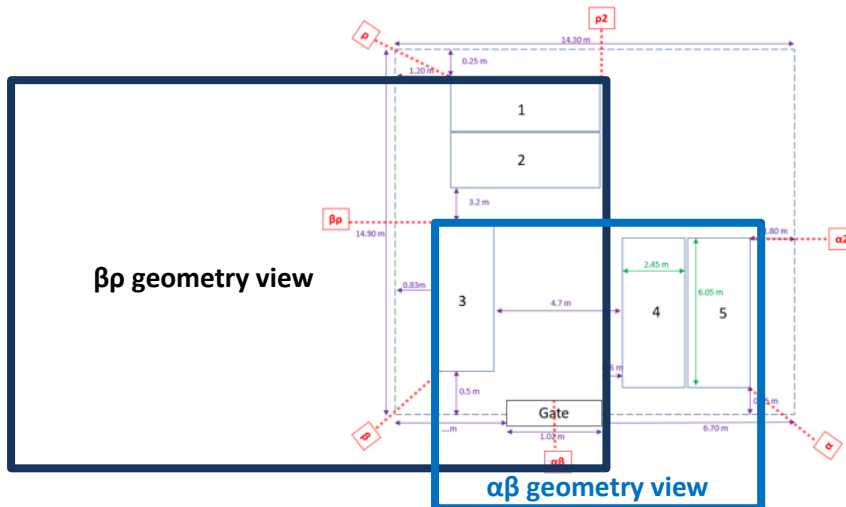
For the side view spectrums $\alpha\beta$ and $\beta\beta$ in with well-constructed ISOCS geometries with a 3-shipping container view (figure 14), the activity for the Uranium decay series is in good agreement and within uncertainty (3.30 ± 0.42 and 3.46 ± 0.44 Bq/g).

Figure 14. diagram showing the shipping containers were captured in the $\alpha\beta$ and $\beta\beta$ detector side geometry views

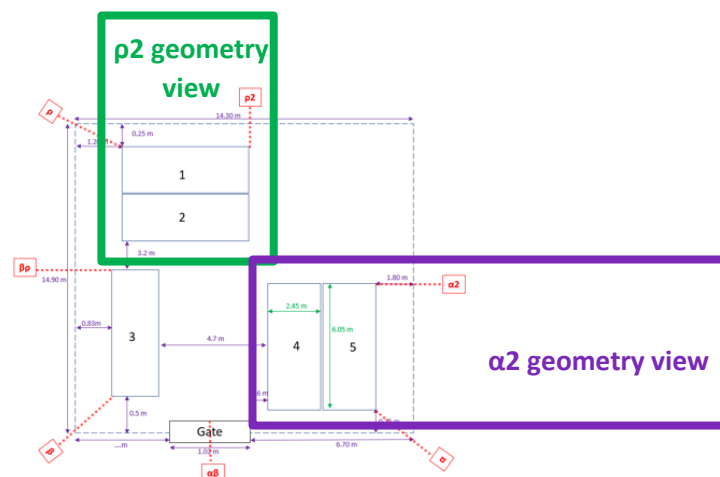
For the side view spectrum of α_2 , which has shipping containers 4 and 5 modelled, the activity for the uranium series is higher (6.75 ± 0.87 Bq/g) compared to the other results for the other modelled geometries (which with the exception of the ρ view with a result of 1.25 ± 0.16 , range from 2.82 ± 0.19 to 3.46 ± 0.44 Bq/g). This could be due to a hot spot which was found when performing a dose map on the side of the container 5 (refer to figure 5) which just happened to be very close to the detector line of site for the α_2 geometry. This is consistent with the ambient dose rate map (refer to figure 4) which was performed around the site and showed higher dose rate readings around containers 4 and 5.

The side view spectrum for ρ_2 , which contains containers 1 and 2 modelled (refer to figure 15, and third line of results in Table 7) has the lowest activity for the uranium decay series for the whole side views.

Figure 15. diagram showing the shipping containers were captured in the α_2 and ρ_2 detector side geometry views

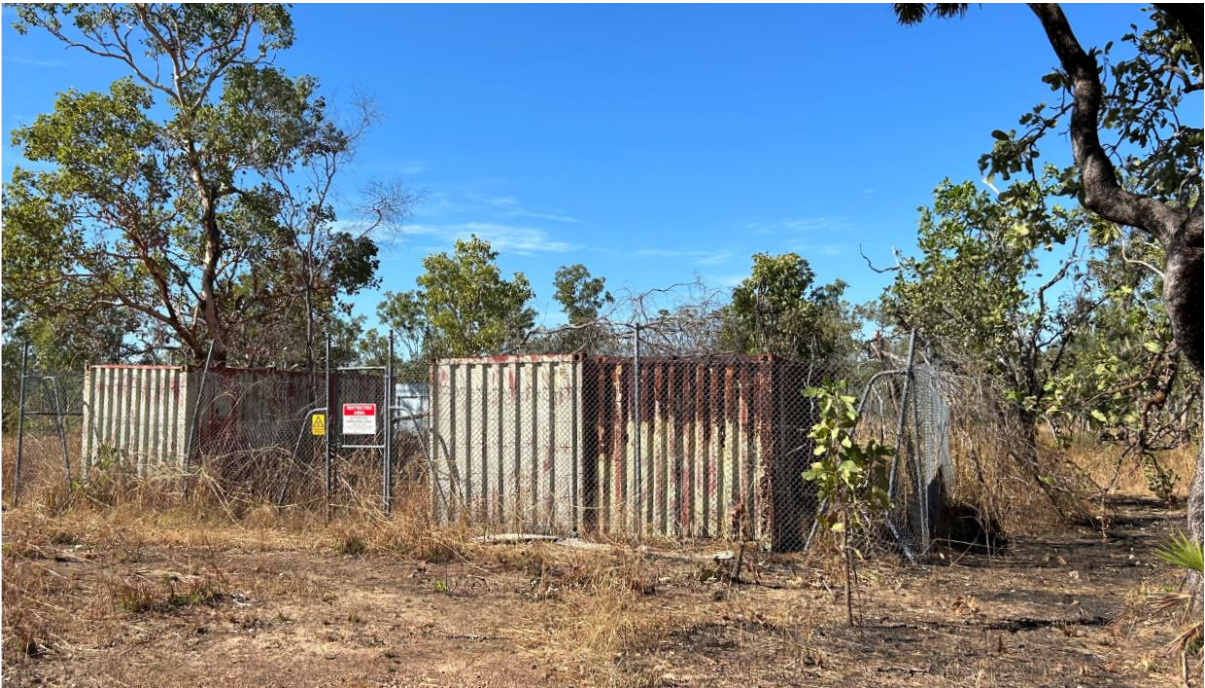
Figure 17. Photo of the secured fenced source enclosure as first sighted. Points of note include the right corner fence damage (bent corner pole) and the tree branches on the right side of the fence.

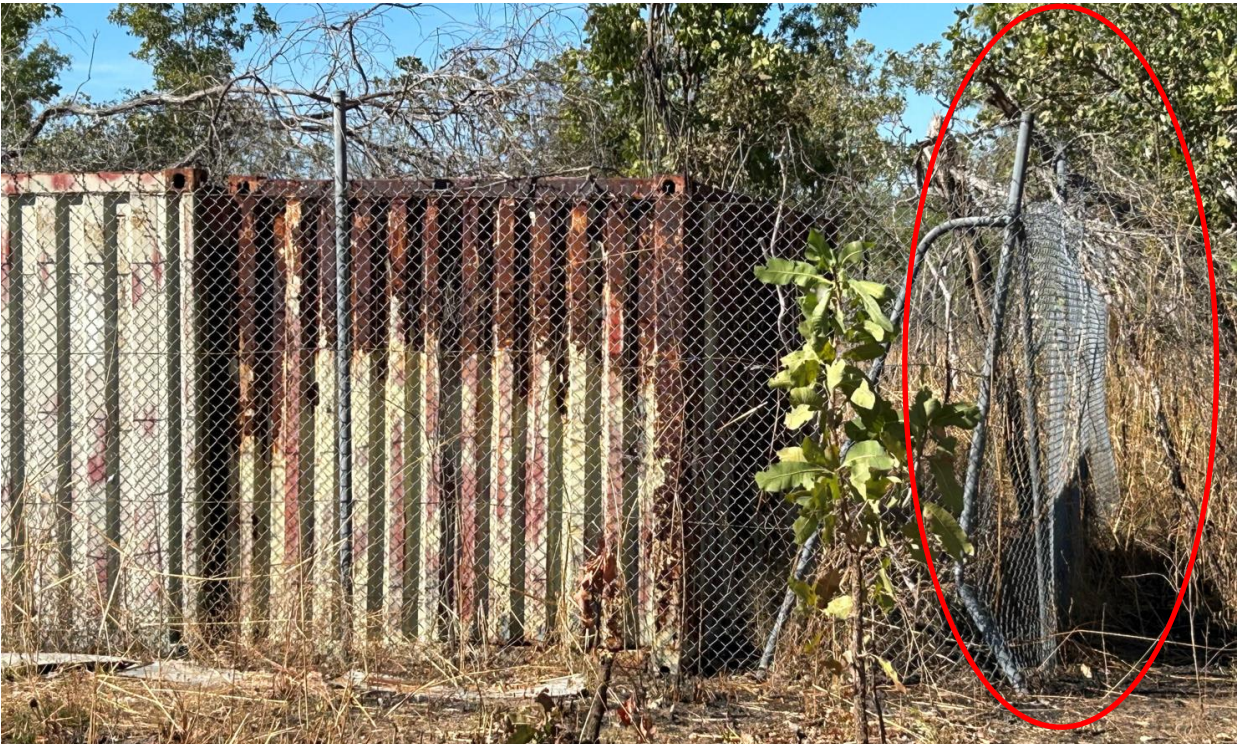
Figure 18a. Close of the damage to corner pole and tree branches on right side of fence. Fallen tree branches can also be seen on top of the shipping containers #4 and #5

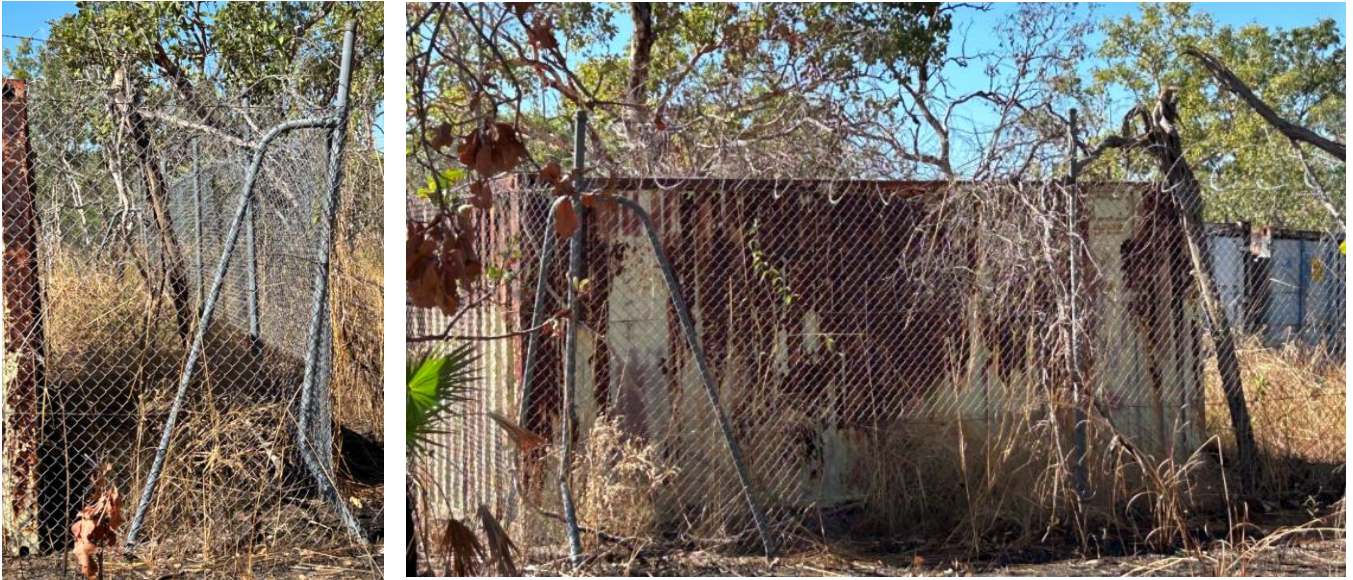
Figure 18b. Close of the corner pole damage and tree branches on the right side of fence, side view of the right side of the fenced enclosure. The fallen branches on the fence could be attributed to the broken tree on the inside the enclosure

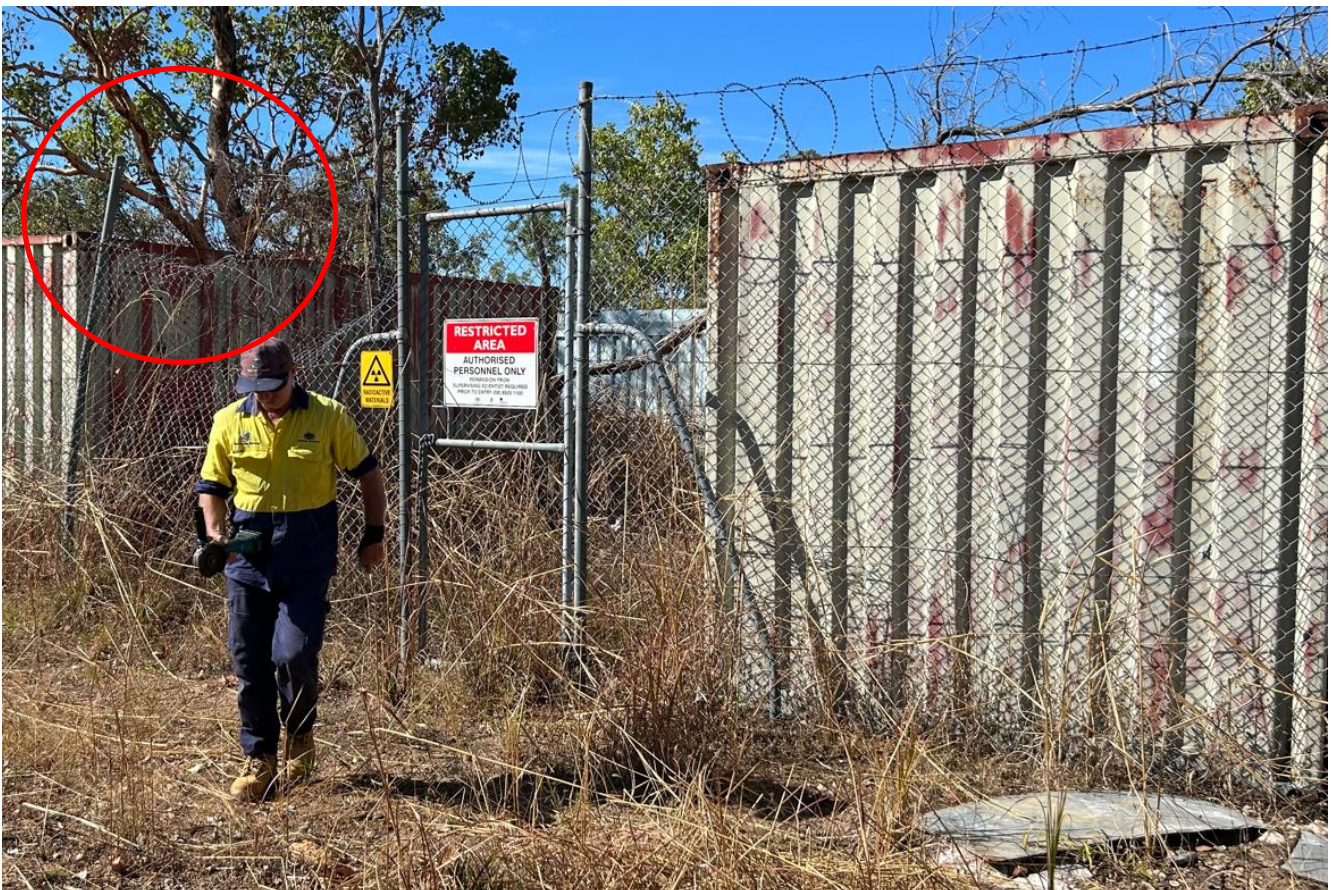
Figure 19. Photo showing gate secured with chain and padlock, restricted area and radiation warning signage. Note damage to the fence to the left of the gate with a buckled pole and fencing leaning inwards (circled in red).

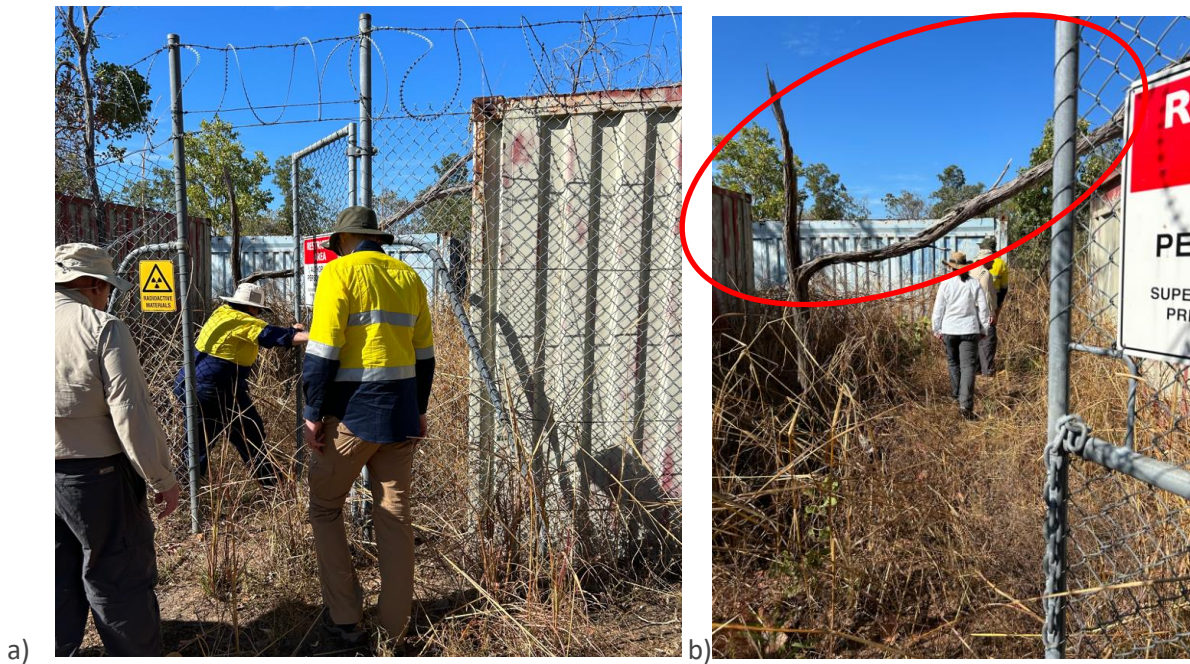
Figure 20a. Grass growth inside the fenced enclosure being pushed out of the way when the gate was opened. A fallen tree growing inside the enclosure can be seen in the background. **b)** close up of the central fallen tree which has a branch fallen on container #4. Movement through the enclosure does a great job of quickly flattening the overgrown grass.

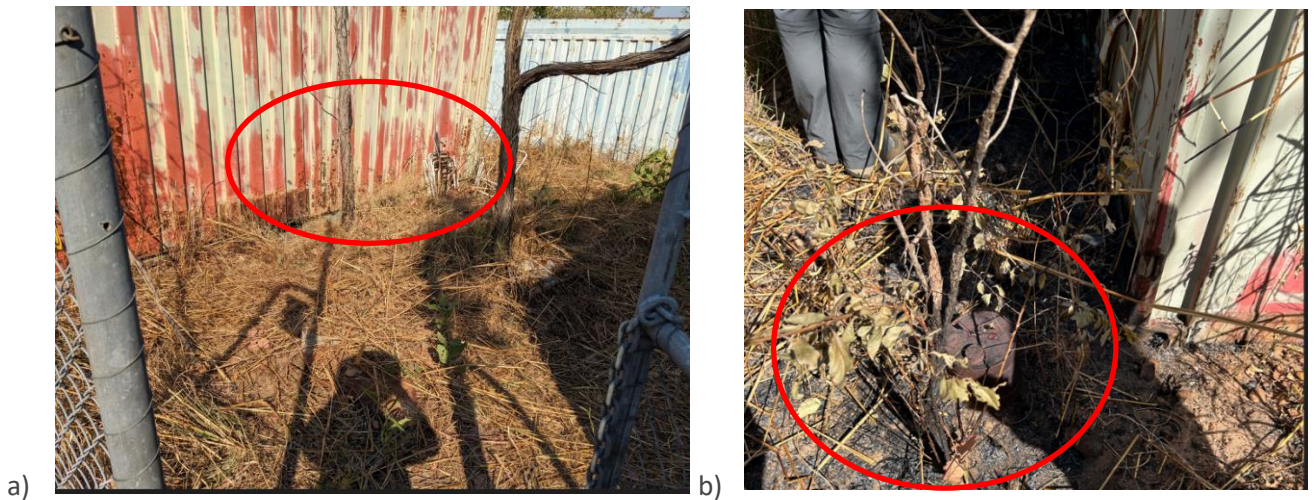
Figure 21a. Debris inside the enclosure - old broken chairs inside the enclosure near shipping container #3 and old oil can near door of container #4. **b)** The ground in front of shipping container #4 and #5 appears to have burnt debris in front of it – refer to pictures for shipping container 4 and 5 for close up details

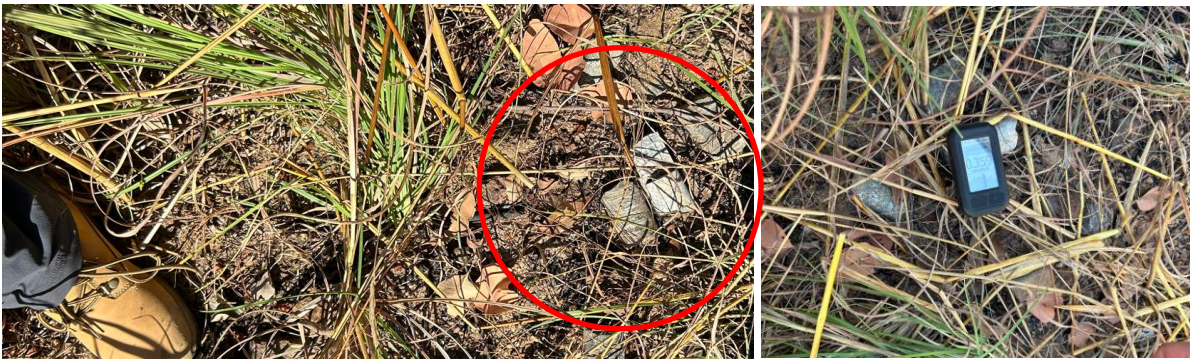
Figure 22. Photo showing what appears to be mining core samples, boot included for size comparison. Found outside shipping container 4 and 5 door. The ground is elevated in a slight mound outside the door of shipping container #5 with what appears to be discarded sample debris. Dose rate measurements on AccuRad PRD read 0.360 μ Sv.

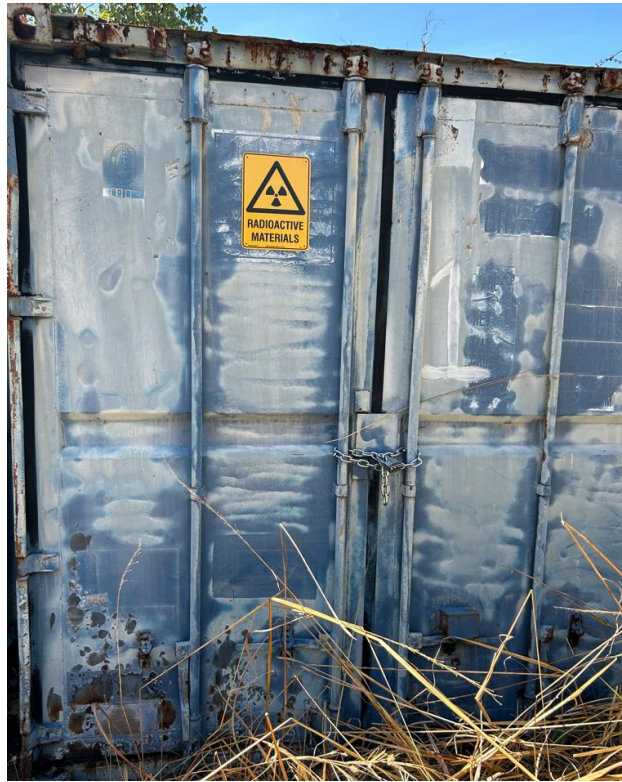
Figure 23. Photo showing chain and lock on the middle of shipping container #1 door and radioactive material warning label.

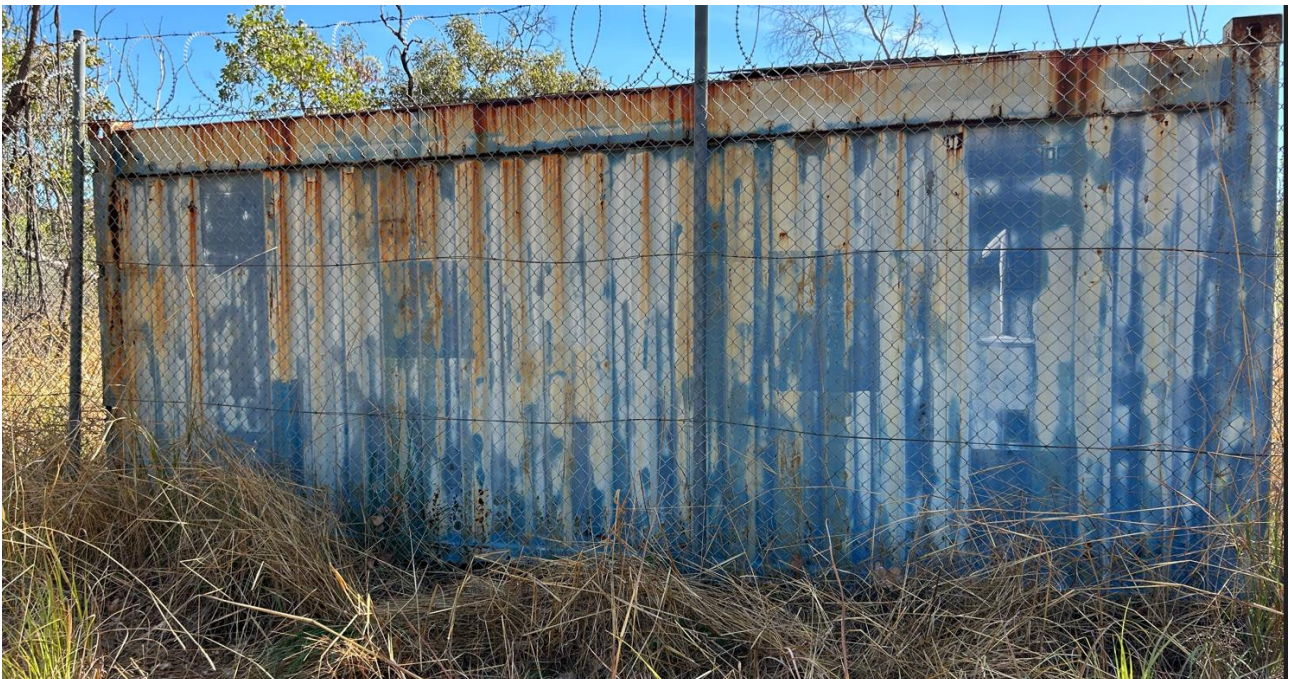
Figure 24. Photo showing condition of fence side view of shipping container #1, The other long side of shipping container #1 abuts onto shipping container #2 so photos are unavailable of the other long side

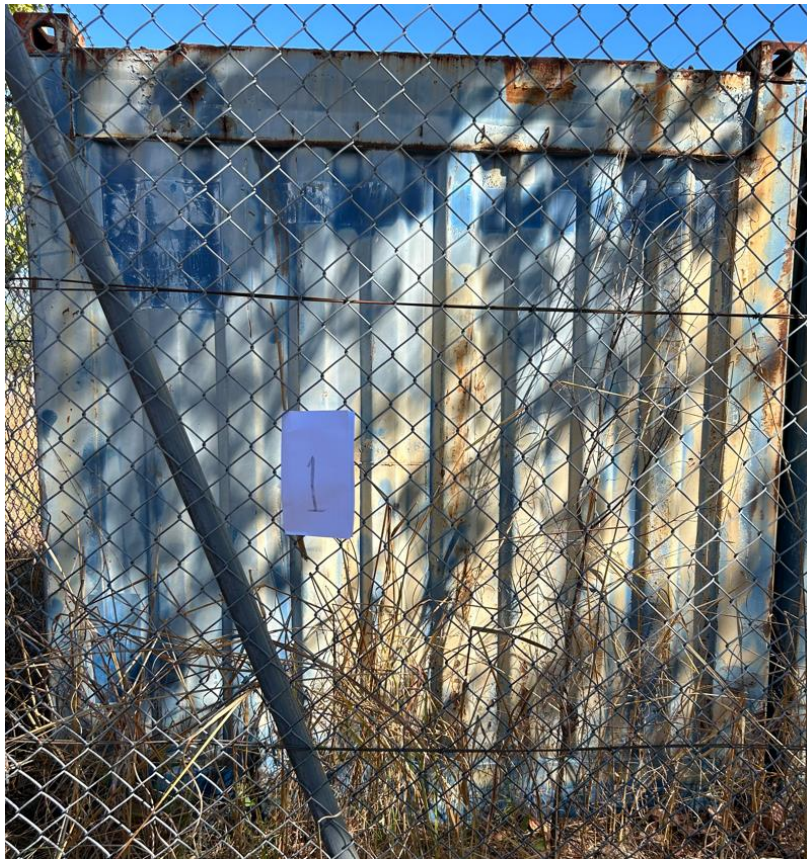
Figure 25. Photo showing condition of end view of shipping container #1

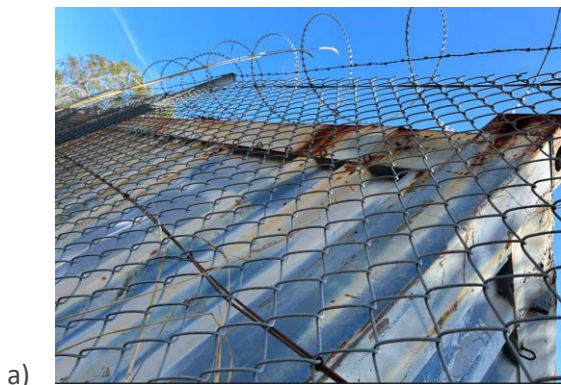
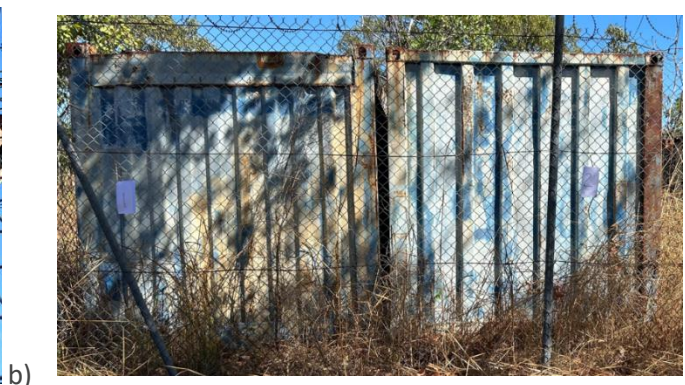
Figure 26b. Photo attempting to show the slight lean of shipping container #1, at the top of the fence line the shipping container is much closer to it than it was at the bottom. **b)** Photo showing positioning of shipping containers #1 and #2 next to each other.

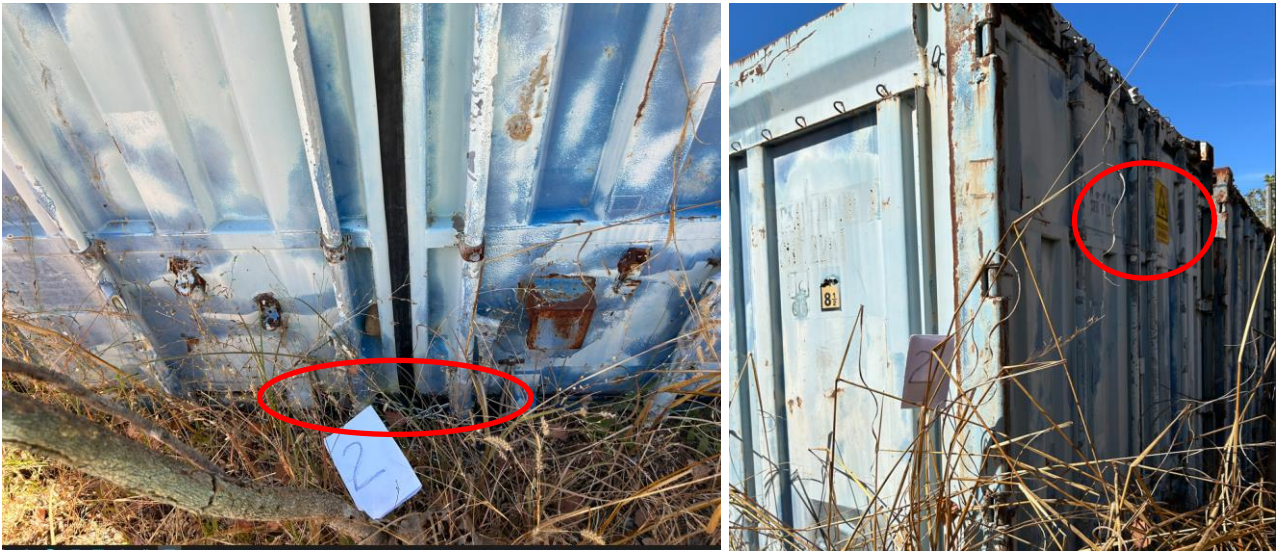
Figure 27. Photo showing chain and lock on shipping container #2 and radioactive material label.

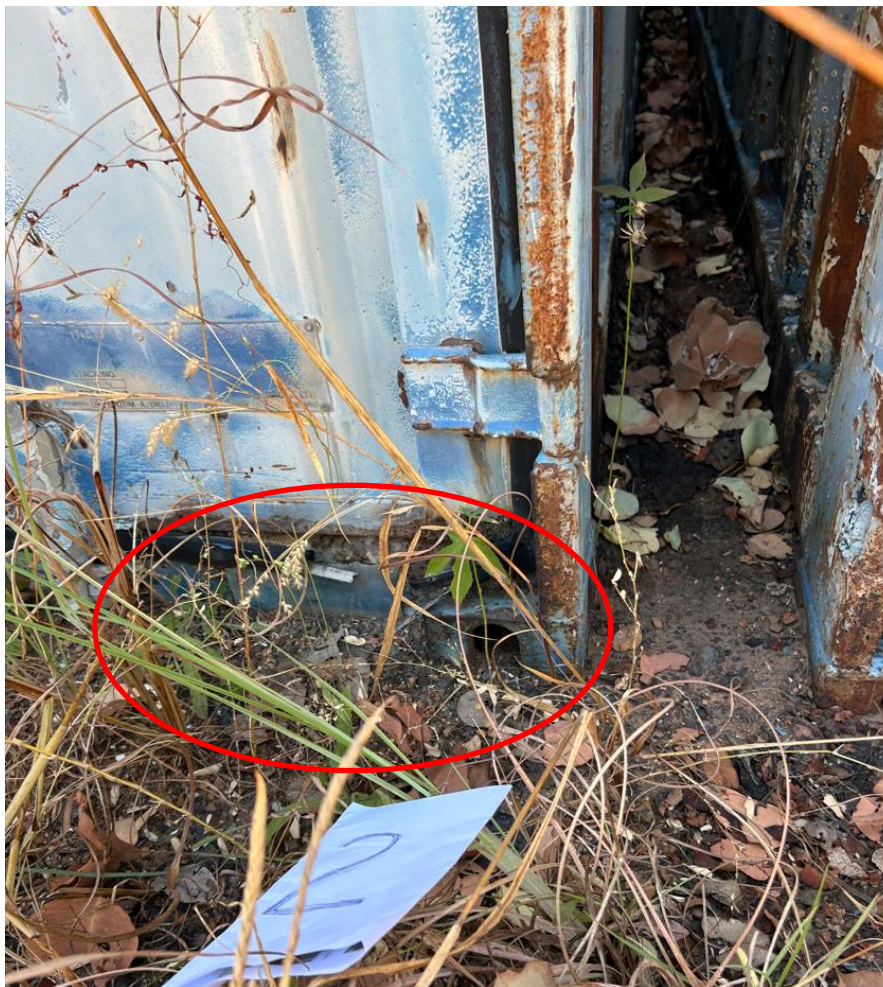
<p>Shipping container #2 Refer to Appendix 17</p>	<ul style="list-style-type: none"> • Rust was observed around edges of container, there could be a small amount of sample spill out near the lower hinge of the door (refer to figure 28). • This is one of the containers in better condition out of the 5 • Container #2 abuts container #1 so photos are only available of the long edge that does not abut container #1 • Container #2 is secured with padlock and chain at the bottom of the container door and displays radiation warning signage
<p>Shipping container #3 Refer to Appendix 18</p>	<ul style="list-style-type: none"> • Rust was observed around edges of container, especially the bottom of the door and both long sides where small amounts of sample appear to have worked its way out of the container and onto the ground, refer to Table 3. • Two of the containers were judged to be in poorer condition than the others due to the rust, the door not shutting properly, and samples coming out along the bottom sides. This is one of those two. • The Door of the container cannot be secured with a chain and lock due to door seizing up or misalignment. A radioactive materials label is affixed to the door

Figure 28. Photo showing some degradation round the bottom door of container #2 and potential sample spill out

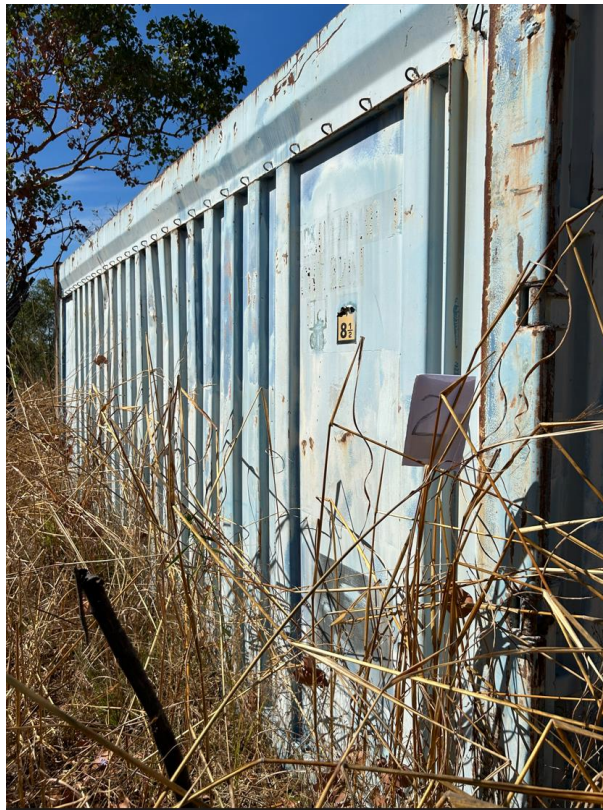
Figure 29. Photo showing condition of long side shipping container #2, looking towards the end of the container. The other long side of shipping container #2 abuts onto shipping container #1 so photos are unavailable of the other long side

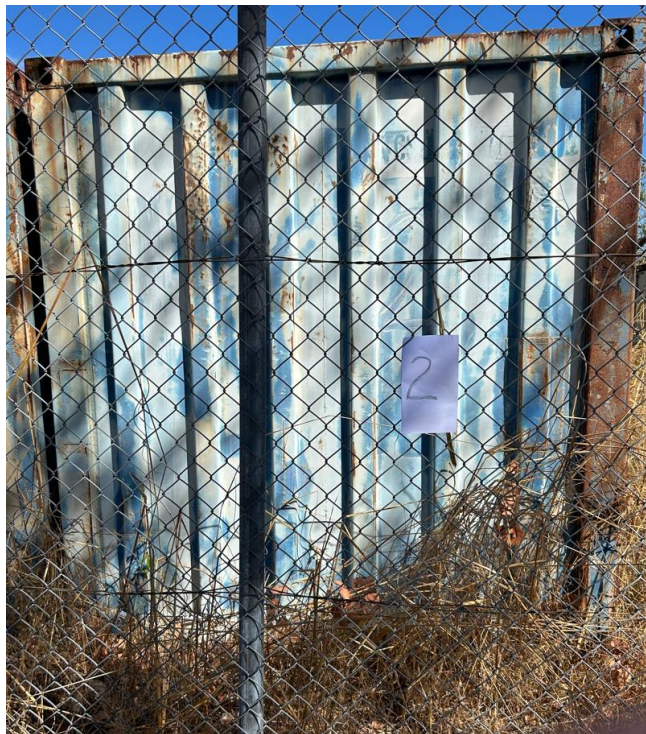
Figure 30. Photo showing condition of end view of shipping container #2

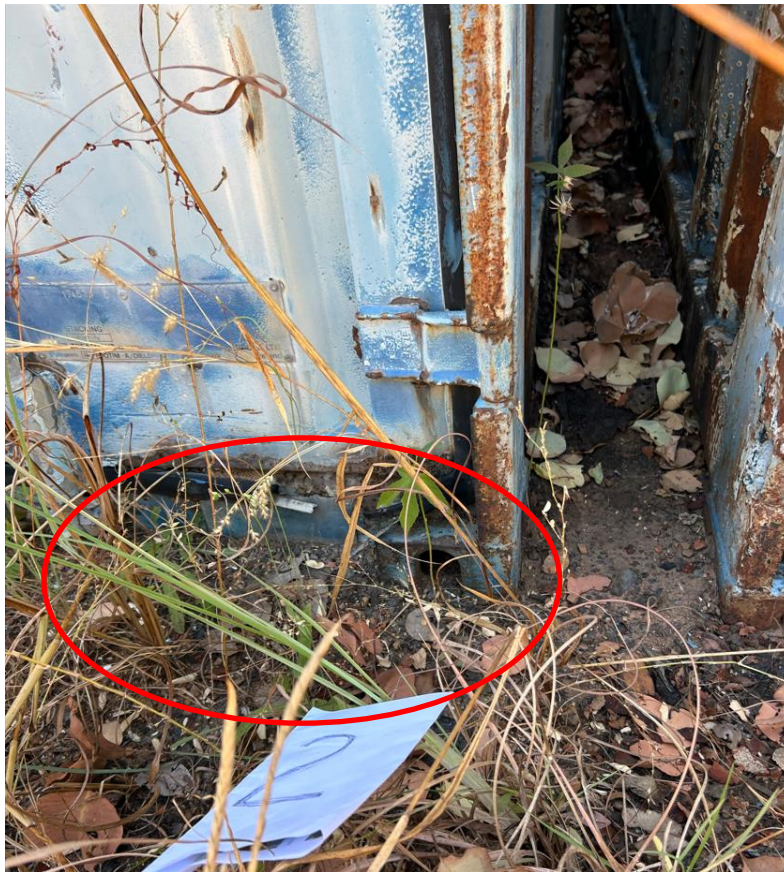
Figure 31. Photo showing some degradation round the bottom door of container 2 and potential sample spill out

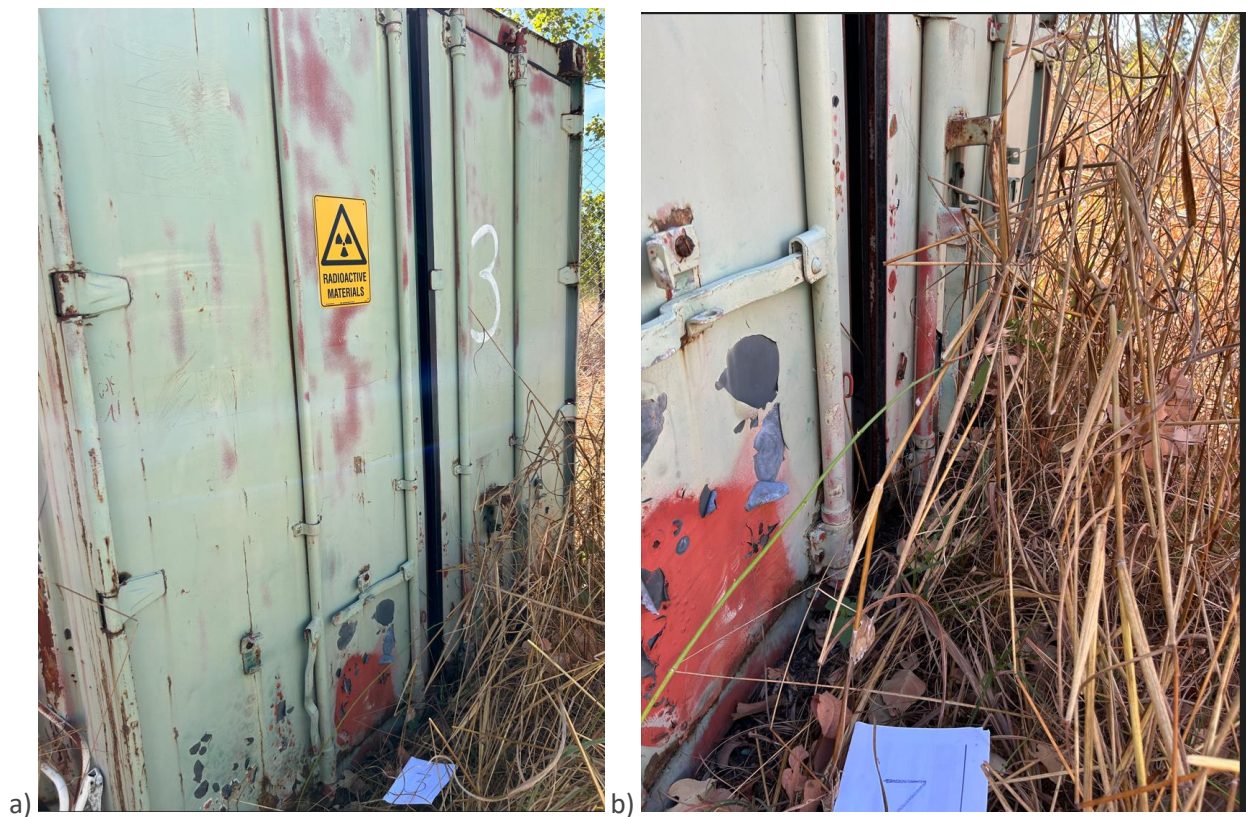
Figure 32a. Photo showing shipping container #3 door. The radioactive materials labels can be seen affixed to the door. The door has not been chained or locked due to difficulties doing this (likely due to door mechanisms seizing due to rust and environmental conditions). **b)** There is a gap where the 2 doors meet of about 5cm or less.

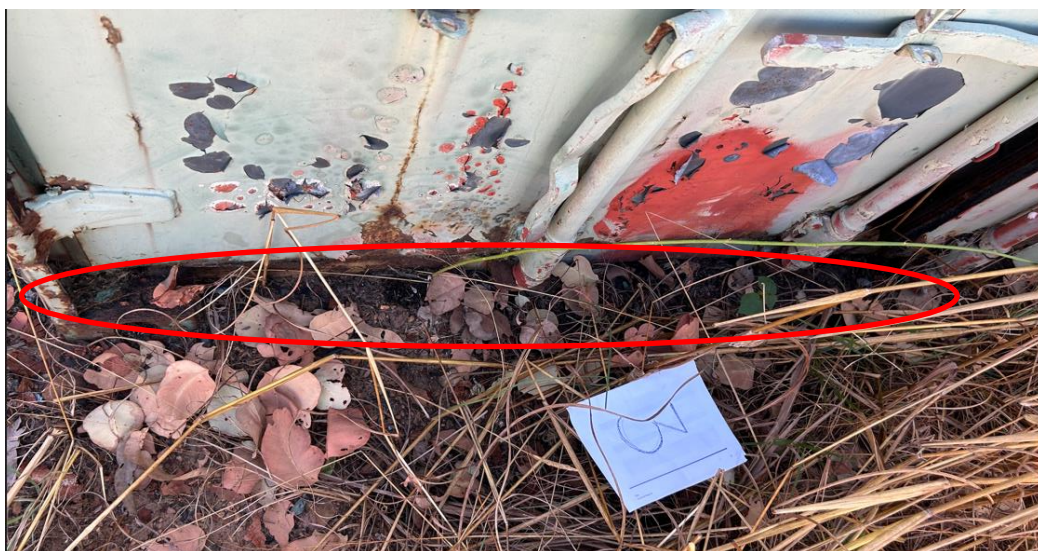
Figure 33. Photo showing closeup of some rust degradation of shipping container door #3.

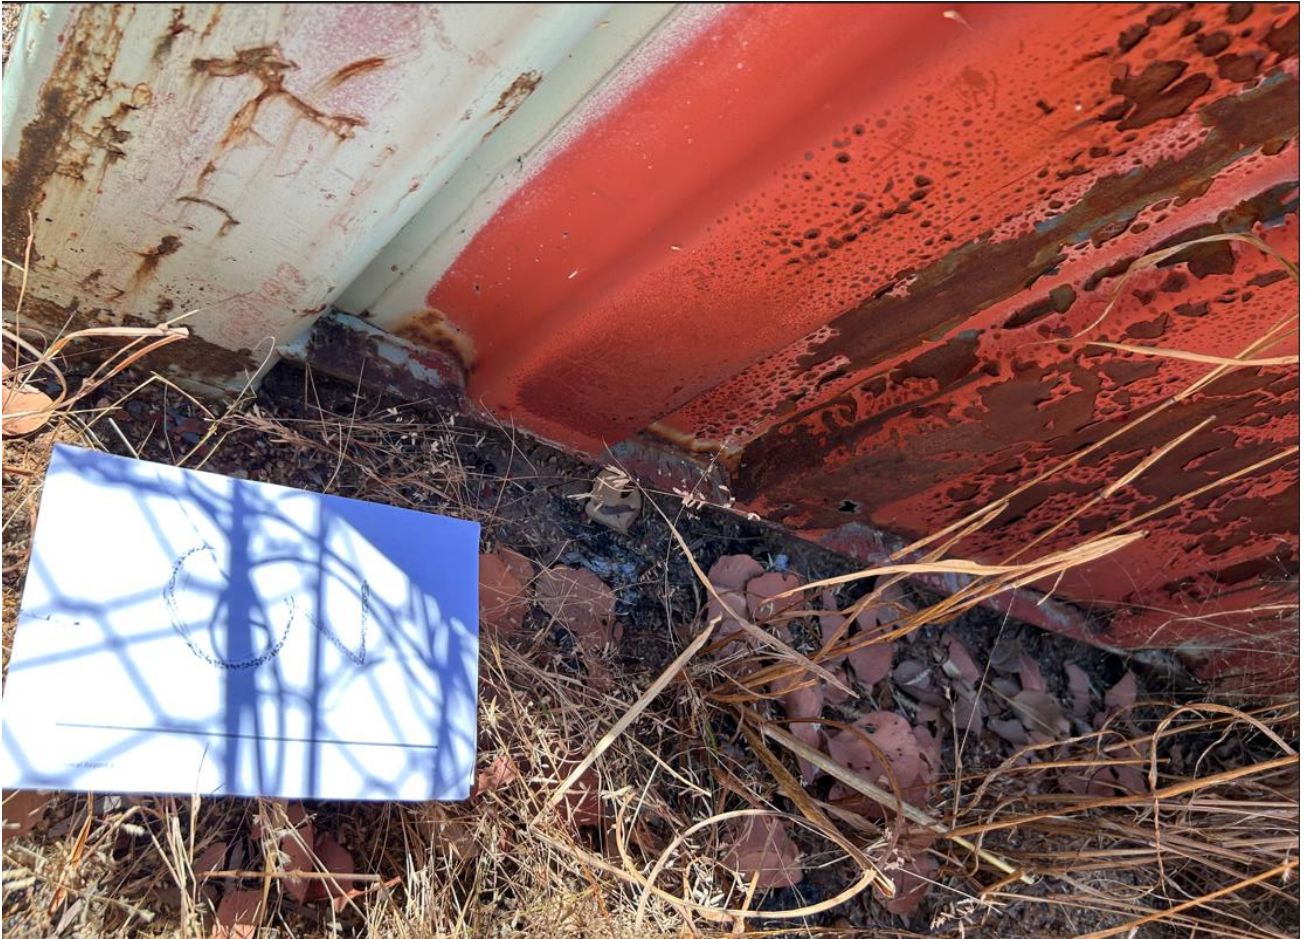
Figure 34. Close up of degradation along inside long side of container #3, where samples are potentially spilling out
