Australian Government
**Australian Radiation Protection
and Nuclear Safety Agency**

ARPANSA Licence S0340

Koongarra, Northern Territory site survey

Field Trip report

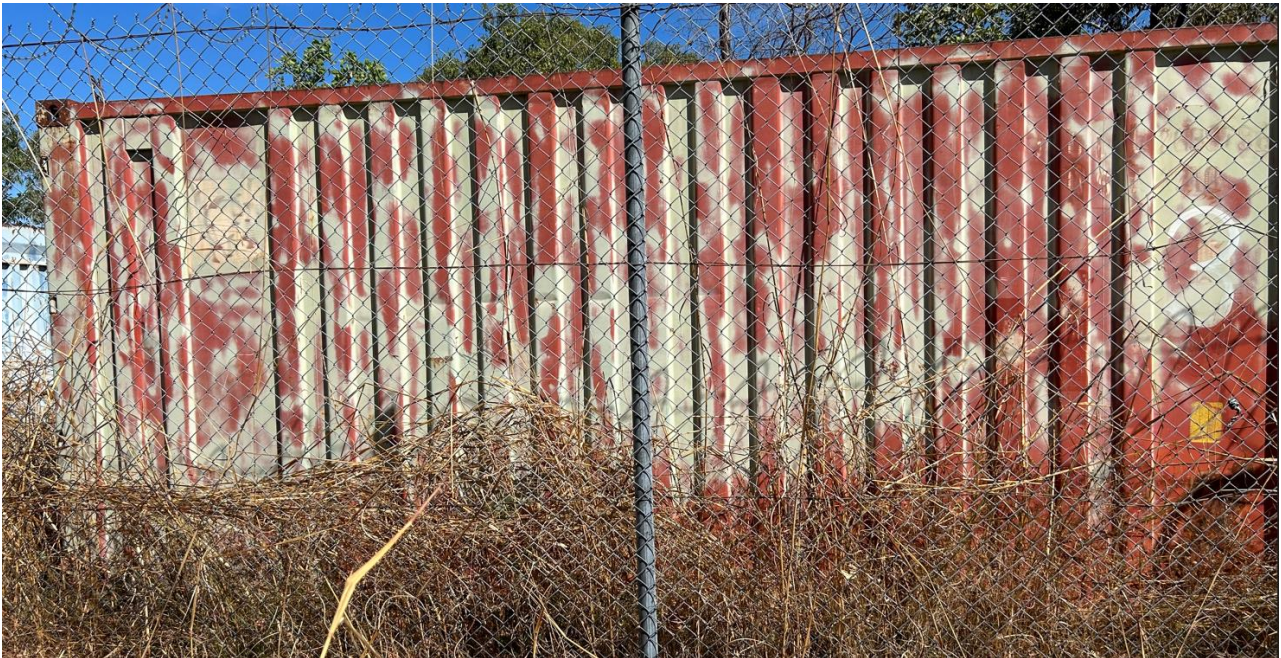
Figure 35. Photo showing condition of fence side view of shipping container #3

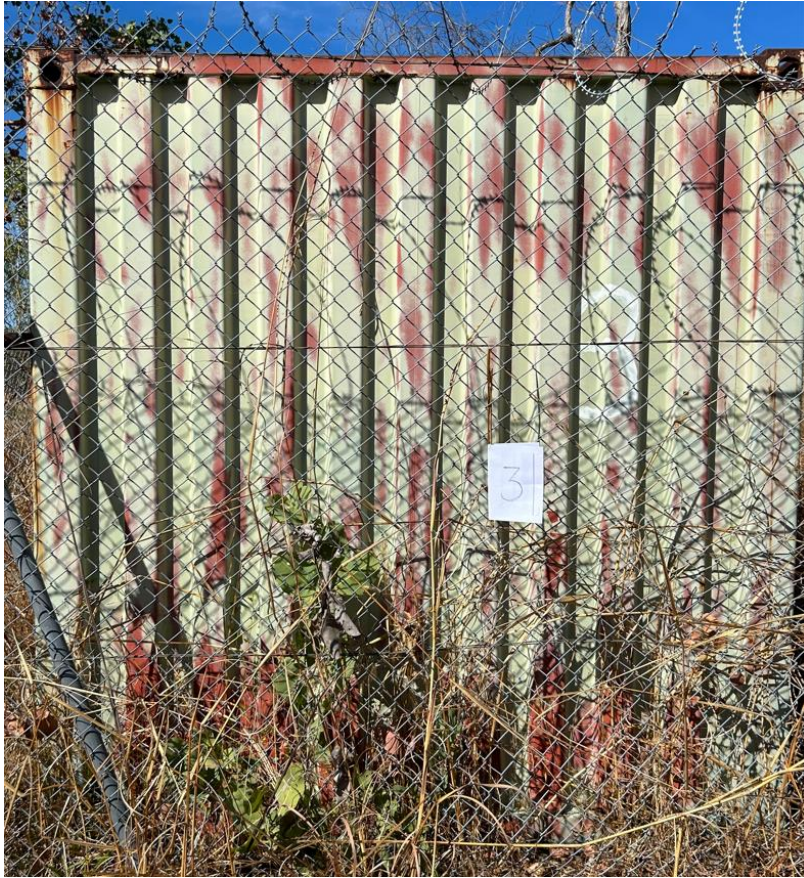
Figure 36. Photo showing condition of end view of shipping container #3

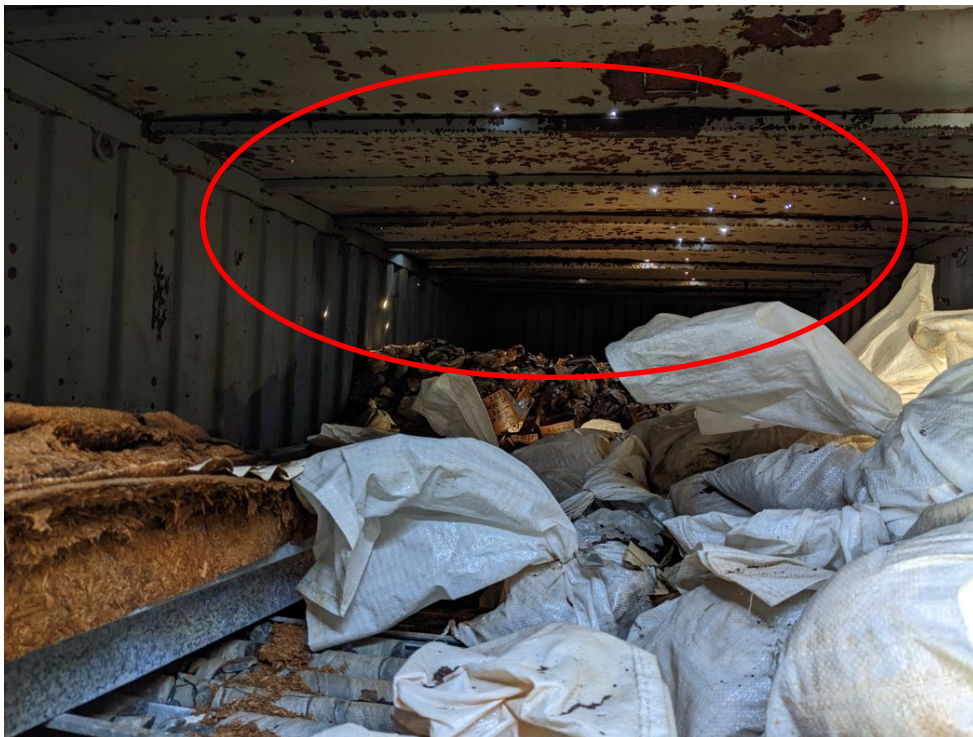
Figure 37. A person can fit their hand in the door gap in container #3 and take a photo of the inside of the container. There appears to be small holes in the roof of the container letting light in

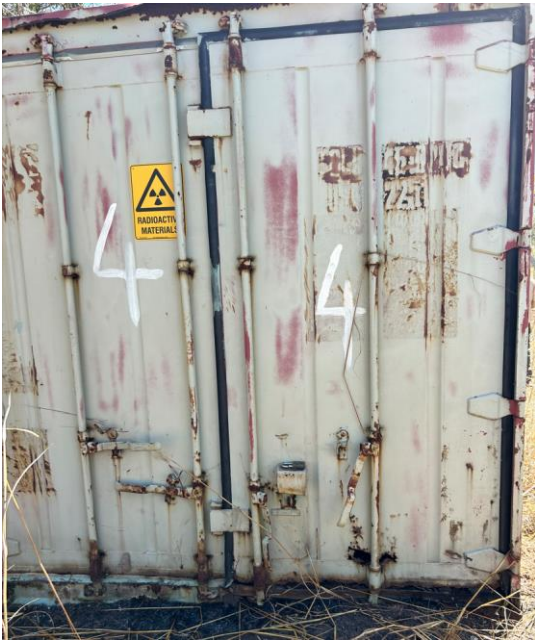
Figure 38. Photo showing shipping container 4 door and radioactive material warning label. The door has not been chained or locked due to difficulties doing this (likely due to door mechanisms seizing due to rust and environmental conditions). Rust degradation can be seen along the top and bottom edges of the door

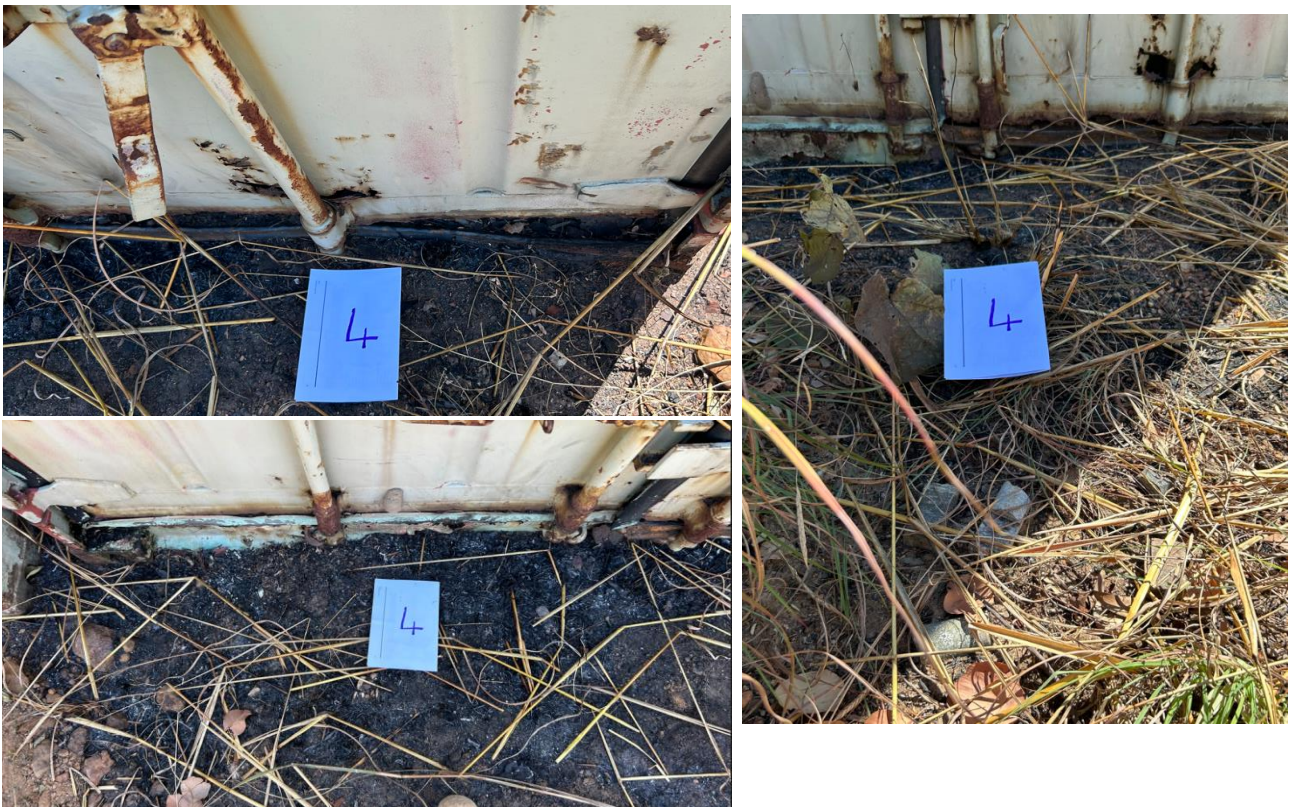
Figure 39. Close up photo showing degradation along bottom of container 4 door. Burnt looking debris is present and a old, rusted oil can is nearby. Broken core samples can be seen in the foreground.

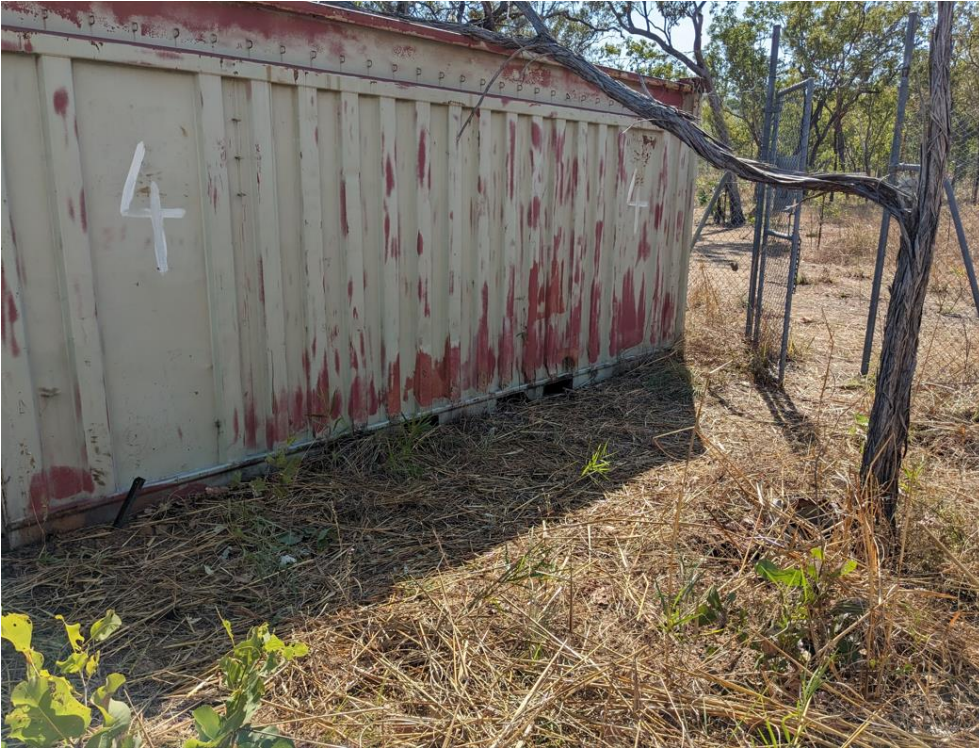
Figure 40. Photo of long side of shipping container 4. A fallen dead tree branch can be seen resting on the top of the container

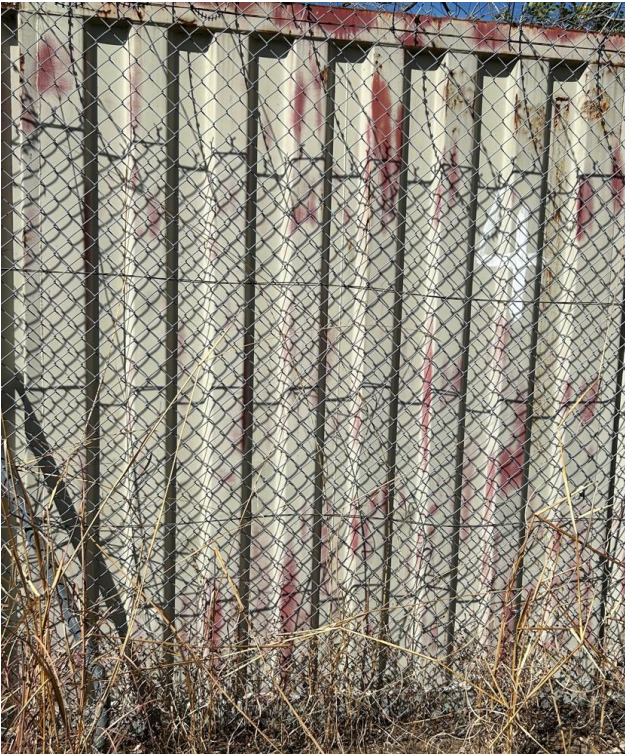
Figure 41. Photo showing condition of end view of shipping container #4

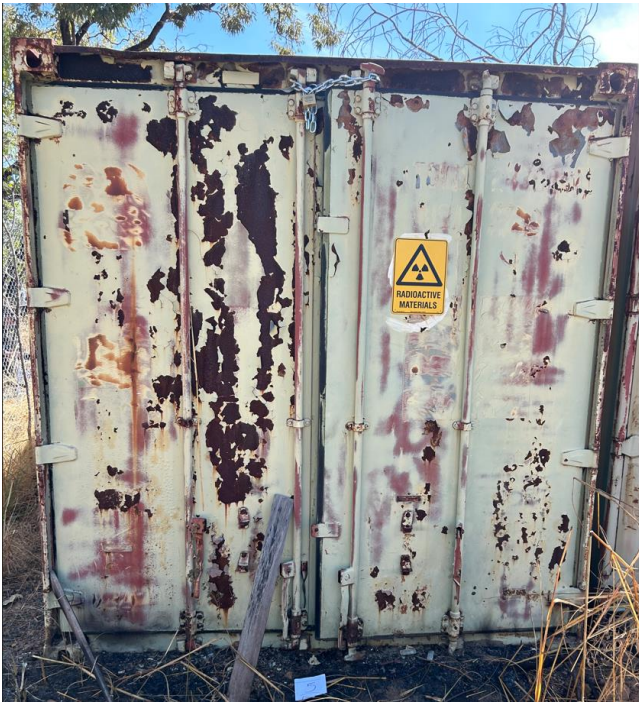
Figure 42. Photo showing radioactive material label and chain and lock on the top of shipping container 5 door. The door of shipping container 5 can't close properly and there is a gap of about 5-10cm where the doors close. Burnt material can be seen in front of the door of shipping container on the ground.

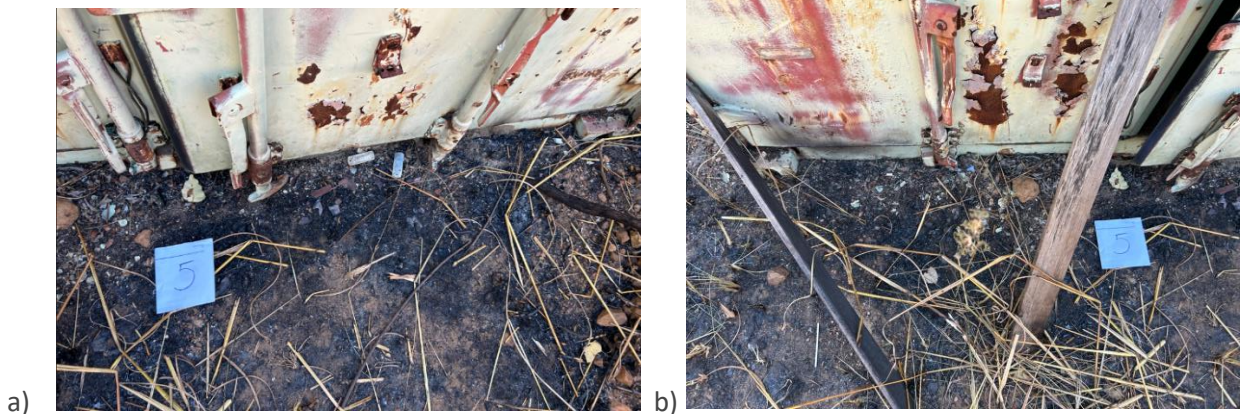
Figure 43a. Close up of the ground in front of shipping container 5. Two core samples can be clearly seen on the ground and the gap of 5-10cm can be seen in the second photo, along with considerable rust. **b)** The two wooden bits of wood are not doing much to hold the door in position, but their positioning suggests the wooden bits of wood may be have put there to do that.

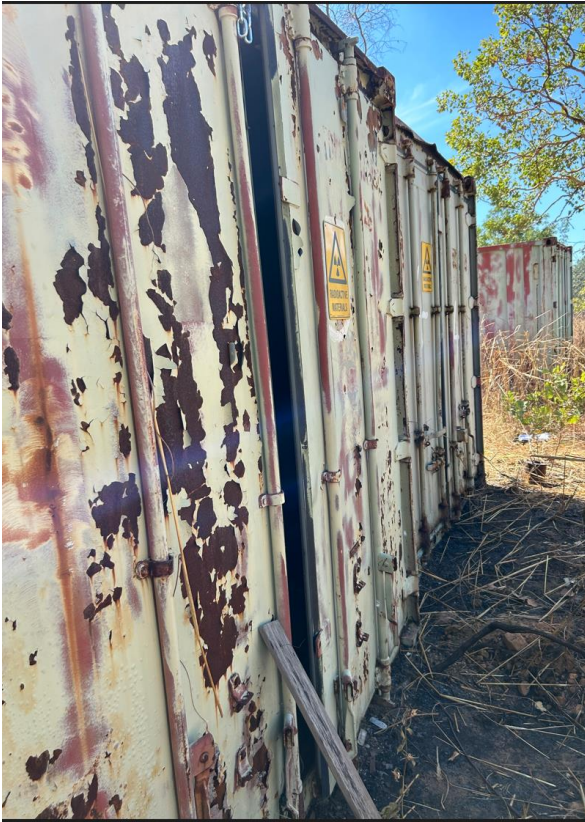
Figure 44. Close up of the door gap on container 5

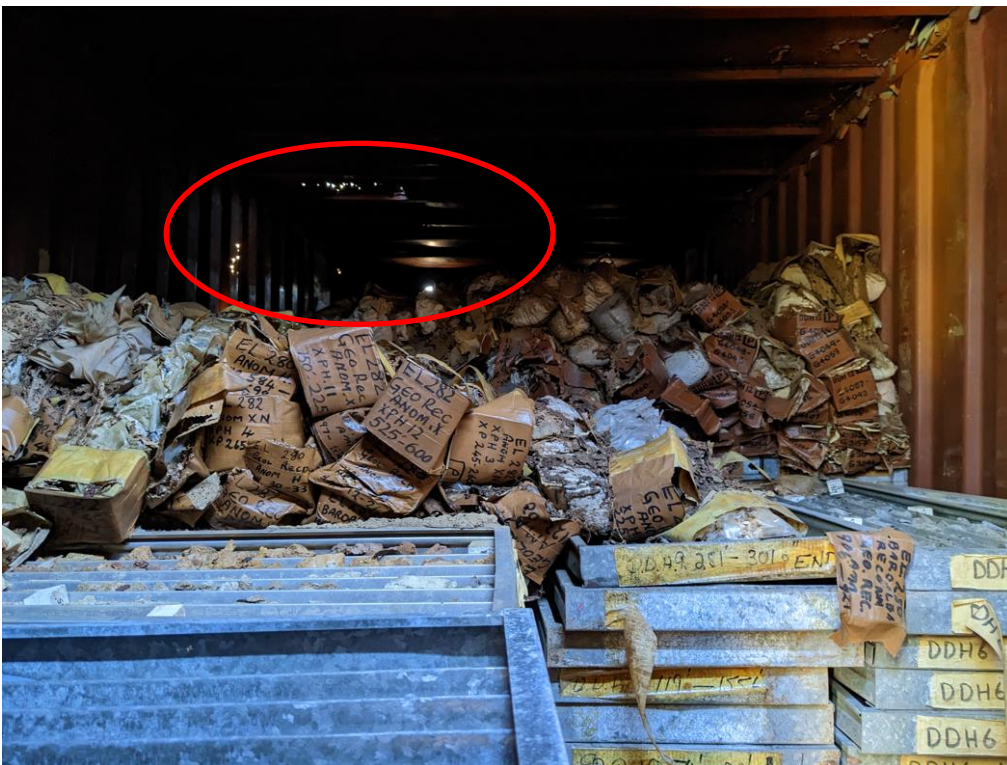
Figure 45. A person can fit their hand in the door gap in container #5 and take a photo of the inside of the container. There appears to be holes in the roof of the container letting light in

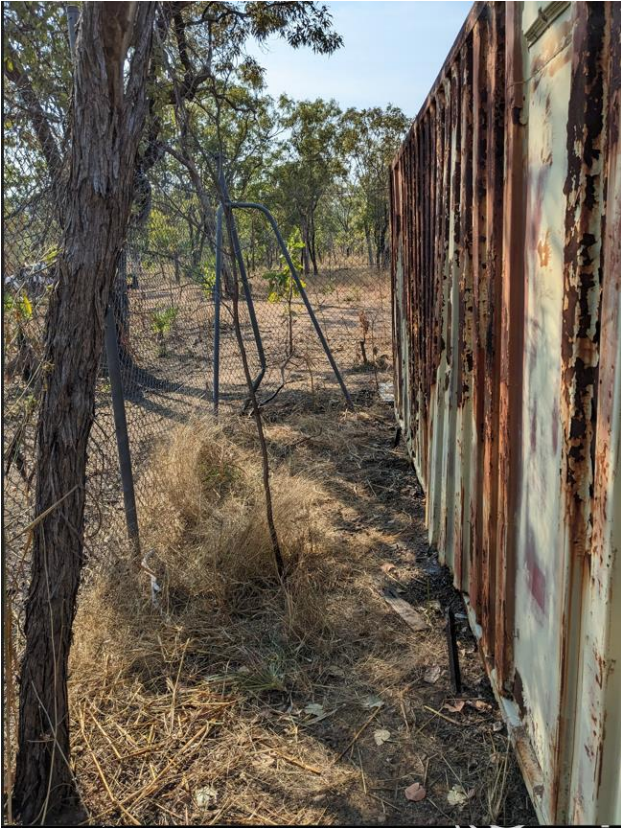
Figure 46. Photo of long side of shipping container #5.

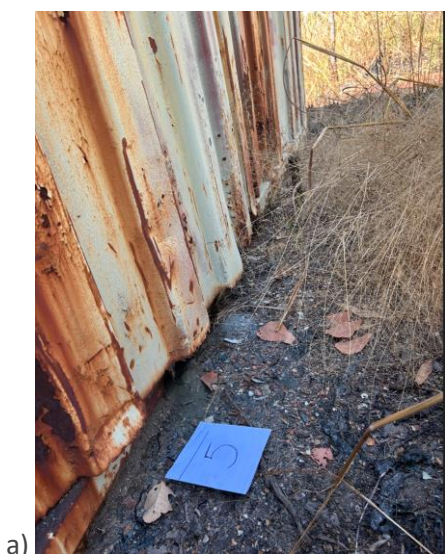
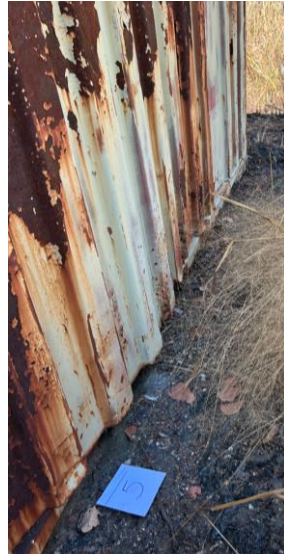
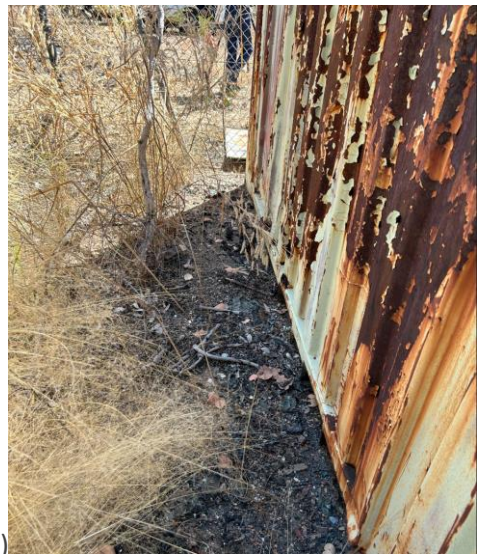
Figure 47a. Buckling of the side wall on container 5, integrity of the container has been breached along the bottom. **b)** and side **c)** Close up of rust along the wall looking towards the end of the container.

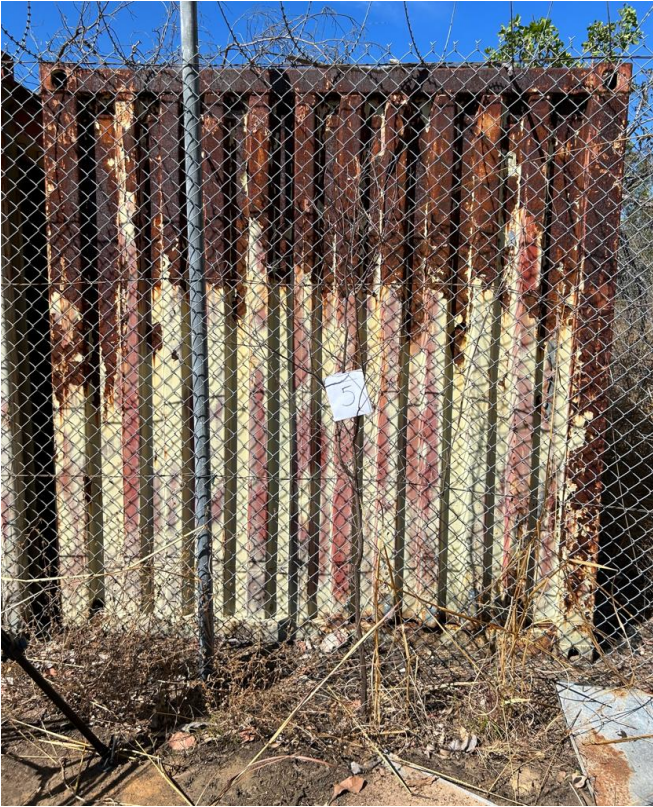
Figure 48. Photo showing condition of end view of shipping container #5. Rust is clearly visible.

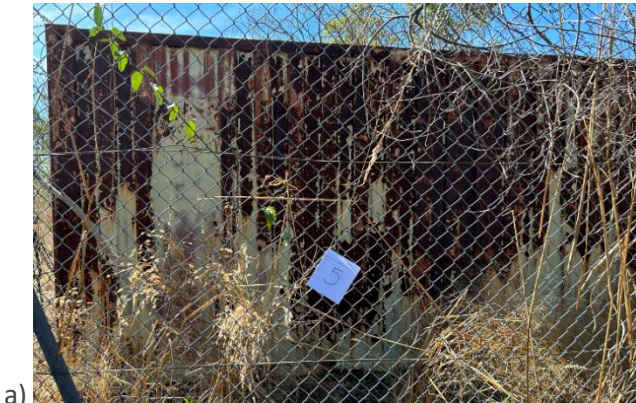
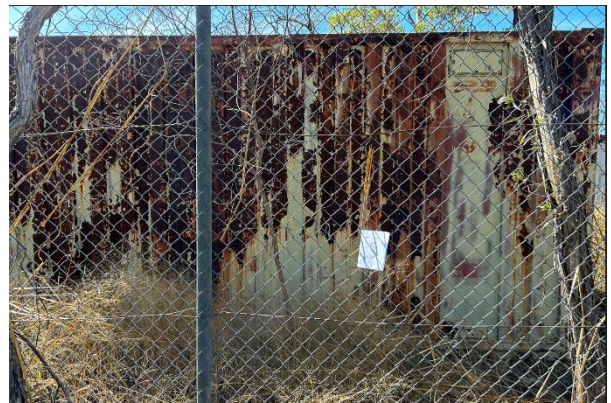
Figure 49a. and b) Photo showing condition of side view of shipping container #5 on the fence side. Rust is clearly visible. The other side of container #5 abuts onto shipping container 4 so no photos of the other long side are possible.

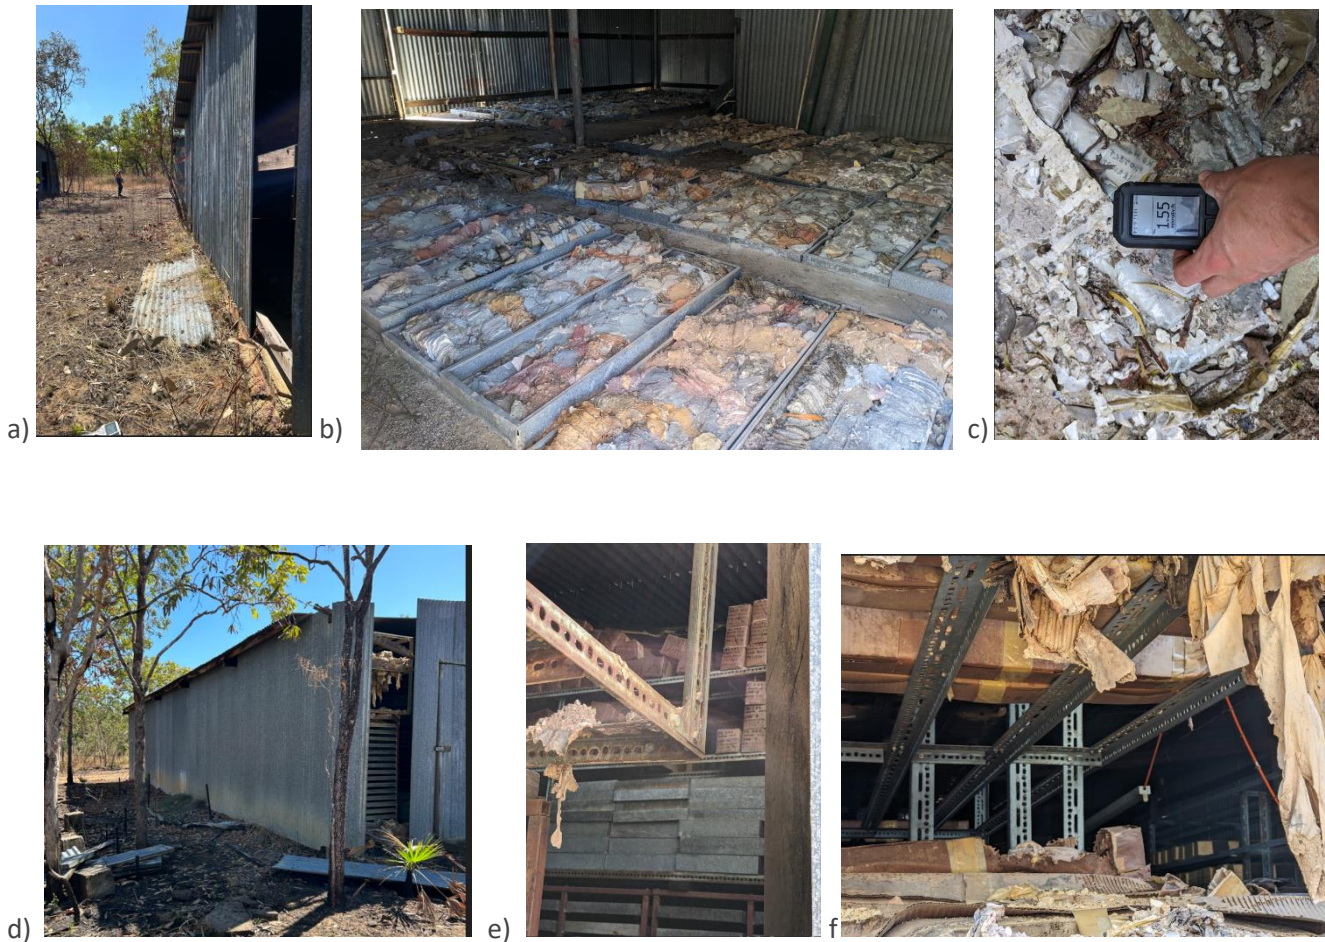
<p>Shed photos Refer to appendix 21</p>	<ul style="list-style-type: none"> • Sheds are degrading, with metal sheeting coming off the structures leaving large gaps that can be walked through. • Shed contain both empty sample core trays and trays containing degraded samples (i.e., in plastic bags that are falling apart or mixing with other samples due to weathering. • Dose rates measured with an AccuRad inside the sheds ranged from 1.55 $\mu\text{Sv/h}$ to background levels (0.040 $\mu\text{Sv/h}$) to refer to figure 51c and 52b
<p>Photos taken by:</p>	<p>HPM field members</p>

Figure 51a. The sheds are readily accessible due to missing wall and roof panels and are not secured in anyway. **b)** Photo of inside of shed one showing trays of what appears to be mining cores or samples laid out on the ground. **c)** Dose rate measurements using a Accurad PRD inside the shed showed reading of $1.55 \mu\text{Sv/h}$. **d)** to **f)** Shed stacked of sample trays can be seen in shed 2 with trays also seen on the ground in the left of the photo.
