SECTION 14 INCIDENT REPORT (*Waste Management and Pollution Control Act*)

Date and Time of Notification:	Friday 12 th July 2019, 8:08am
Person / Company:	Power and Water Corporation (PWC)
Incident:	Discharge of raw sewage from sewerage network (Manhole)

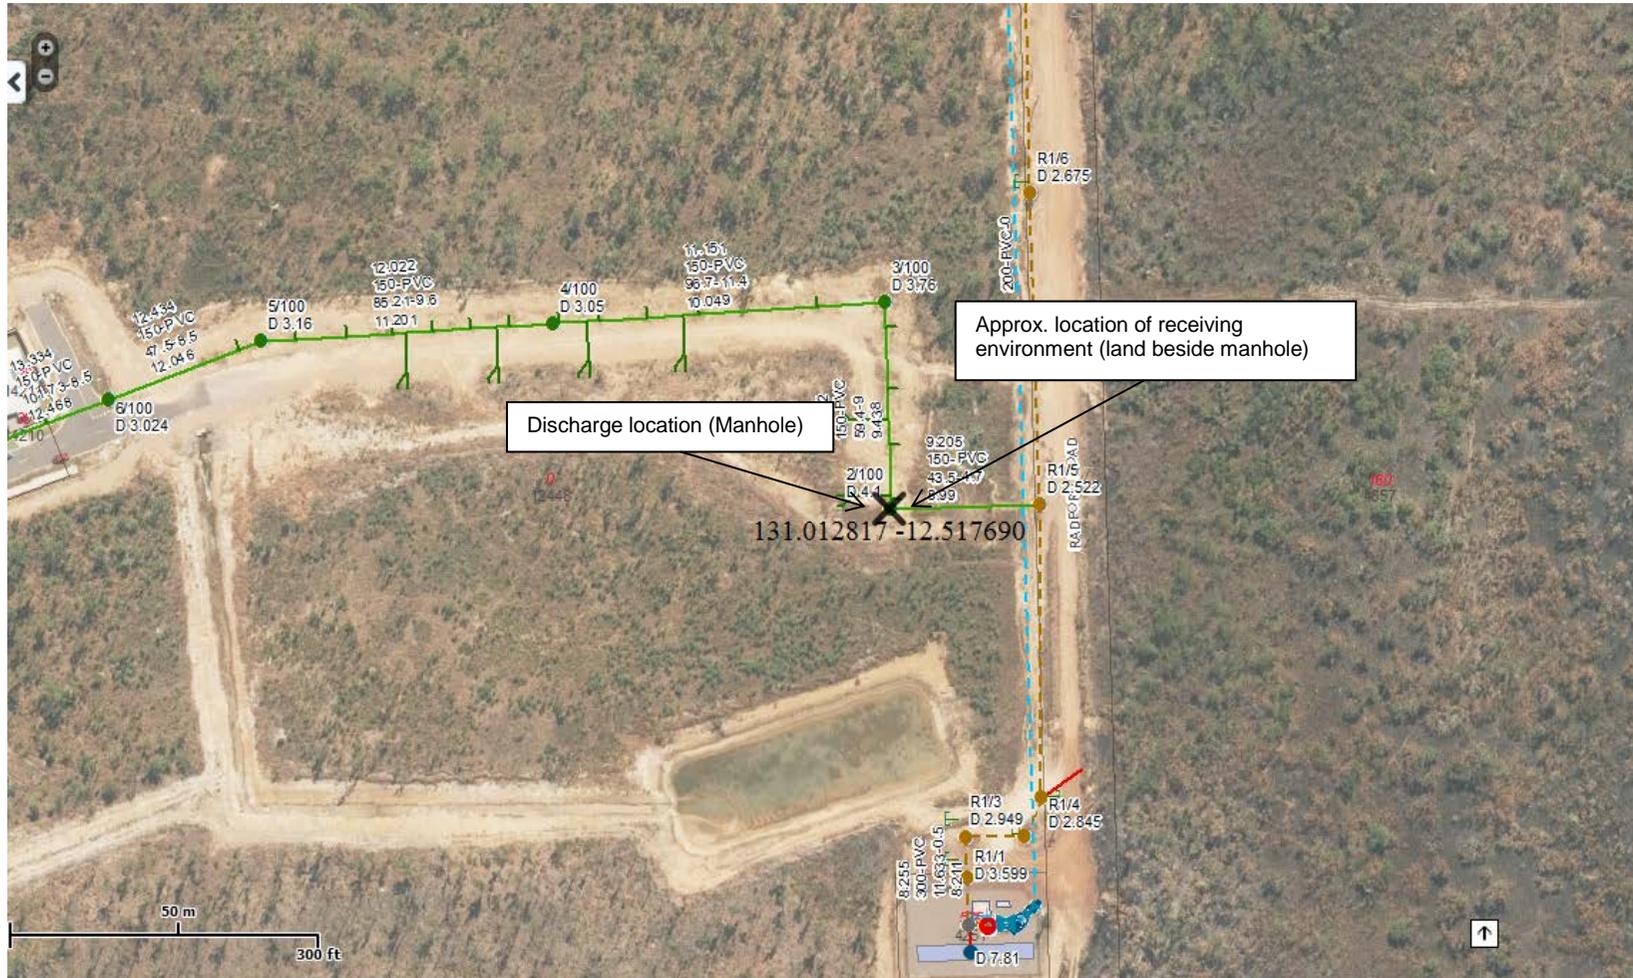
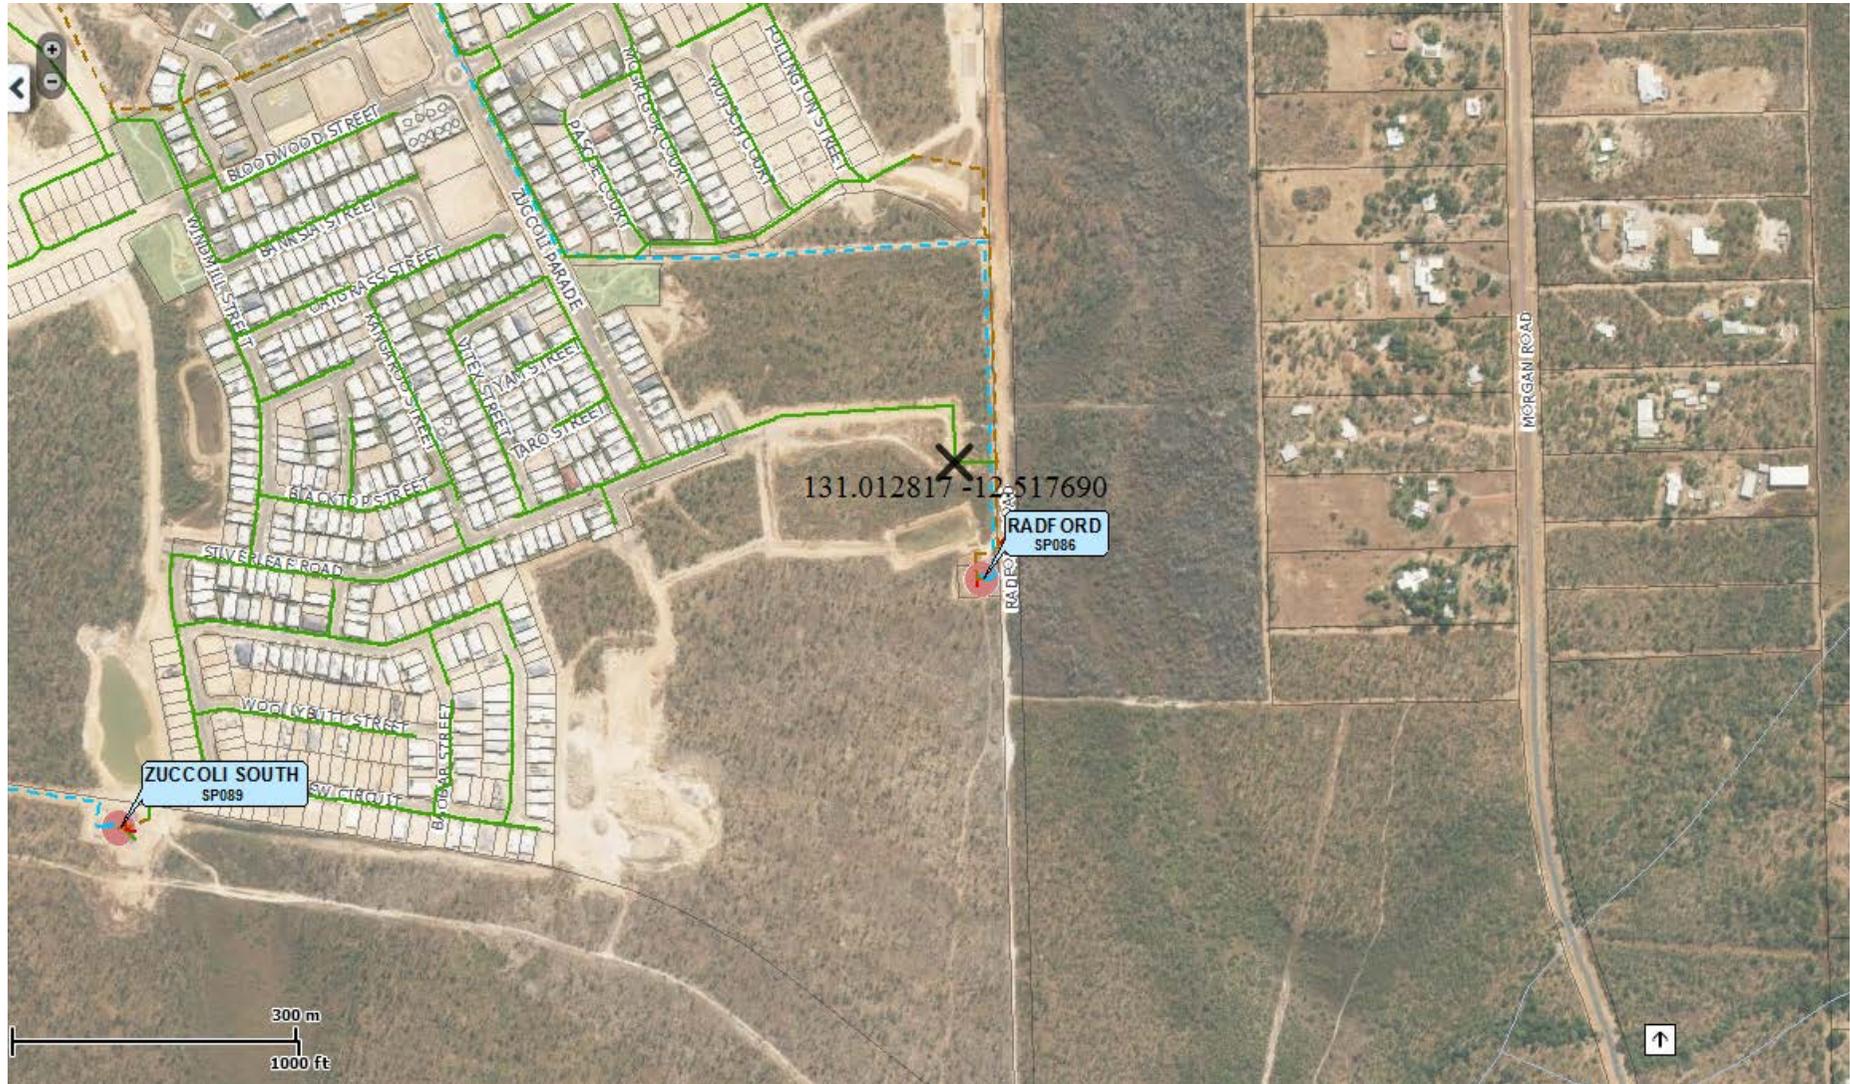
<p>Manhole located at the end of Radford Road (currently under development), Zuccoli – as per map below.</p> <p><i>ii. GPS coordinates of the discharge point from the PWC asset, and the final coordinates of the final discharge point.</i></p> <p>Discharge Point: 131.012817, -12.517690 Final Discharge Point: 131.012817, -12.517690</p> <p><i>iii. Indicate any locations nearby to the discharge point where public can gain ready-access, such as public open spaces through which the discharge moves.</i></p> <p>Access by the public is restricted due to temporary fencing around the site as this area of Zuccoli is currently under development. The area was checked for gross pollutants of which none were visible, due to the manhole lid trapping them within the sewer system. Clean up was undertaken as per Sewage Spills/Overflow Response Work Instruction.</p>
<p>(c) the date and time of the incident</p>	<p><i>i. The time and date of commencement and cessation of the discharge.</i></p> <p>The commencement time of the overflow is unknown. The overflow was observed at approximately 14:30pm on 11/07/19 and was stopped at approximately 15:00pm (11/07/19).</p> <p><i>ii. How PWC were notified, or became aware of the discharge.</i></p> <p>This overflow was discovered by PWC personnel at approximately 14:30pm 11/07/19 and action to resolve the situation was undertaken shortly after. From this PWC staff resolved the overflow and cleaned the area.</p> <p><i>iii. The process by which the discharge occurred.</i></p> <p>An investigation of the overflow was undertaken and discovered that the blockage was caused due to a combination of factors. A plumbers bung, rocks and rags were found within the sewer main resulting in the blockage. The plumbers bung was most likely left in the system by a contractor performing works at a private residence within Zuccoli. The rocks were most likely a result of abuse to the system by nearby residents.</p> <p>The plumbers bung and rocks have collected and built up, along with rags and other foreign bodies blocking the sewer main.</p> <p><i>iv. The reason why the discharge occurred.</i></p> <p>As per (c) iii. Sewerage network infrastructure has been designed to overflow with the best public health and environmental outcomes possible. Design focuses on not overflowing directly inside houses; rather discharge is designed to occur in a controlled manner at locations which can be accessed for infrastructure repair and clean up and with minimal public health or environmental impacts.</p>

<p>(e) the attempts made to prevent, reduce, control, rectify or clean up the pollution or resultant environmental harm caused or threatening to be caused by the incident</p>	<p>The blockage was cleared and the overflow was stopped. Clean up undertaken as per Sewage Spills/Overflow Response Work Instruction.</p> <p><i>i. Confirmation signage and fencing has been erected, as appropriate.</i></p> <p>The overflow location is currently a restricted site and is fenced off to the public as the area is currently under development. Signage was <u>not</u> installed as the area is a restricted site.</p> <p><i>ii. Decontamination of the site as appropriate.</i></p> <p>Clean up consistent with Sewage Spills/Overflow Response Work Instruction as appropriate to the location, and to minimise risk to the environment. Vacuum truck was used to remove the wastewater from the manhole, followed by cleaning of the surrounding surface.</p>
