WATER MONITORING REPORT

September 2021 – September 2022

This report contains the results of water quality monitoring conducted by Tasmanian Seafoods in accordance with EPL 276 in relation to a proposed sea cucumber aquaculture operation located at Berry Springs, NT, Australia.

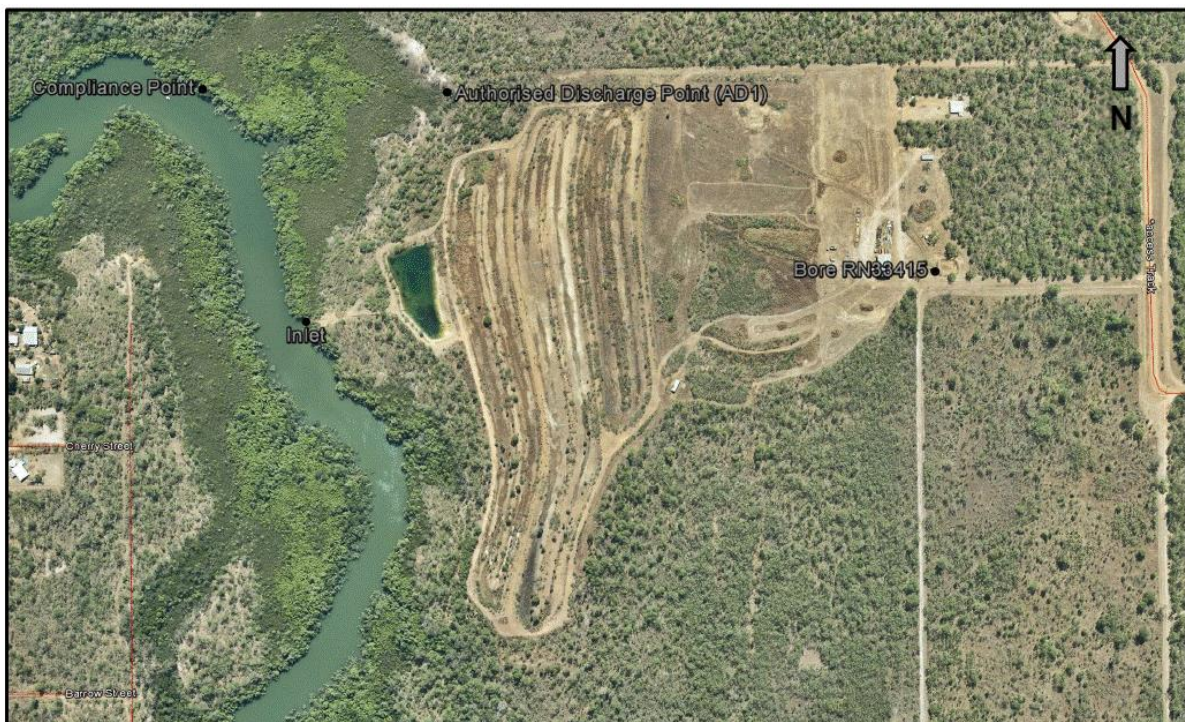
The monitoring plan is attached in appendix 1. The plan includes 4 sampling locations (Figure 1):

Bore: Ground water extraction point RN33415

AD1: authorised discharge point 1

CP1: Compliance point 1- 100m downstream of where the farm discharge meets the Darwin River receiving environment.

Intake1: The farm intake located on Darwin River.

Figure 1: Water quality monitoring plan sampling locations.
