**CONTAMINATED LAND AUDIT OF
ASBESTOS IN SOIL –
RICHARDSON PARK, LUDMILLA,
NORTHERN TERRITORY
NORTHERN TERRITORY GOVERNMENT:
DEPARTMENT OF INFRASTRUCTURE,
PLANNING AND LOGISTICS**

17 MAY 2022
721048
VERSION 1

Richardson Park, Ludmilla – Contaminated Land Audit for on-site containment of asbestos in soil

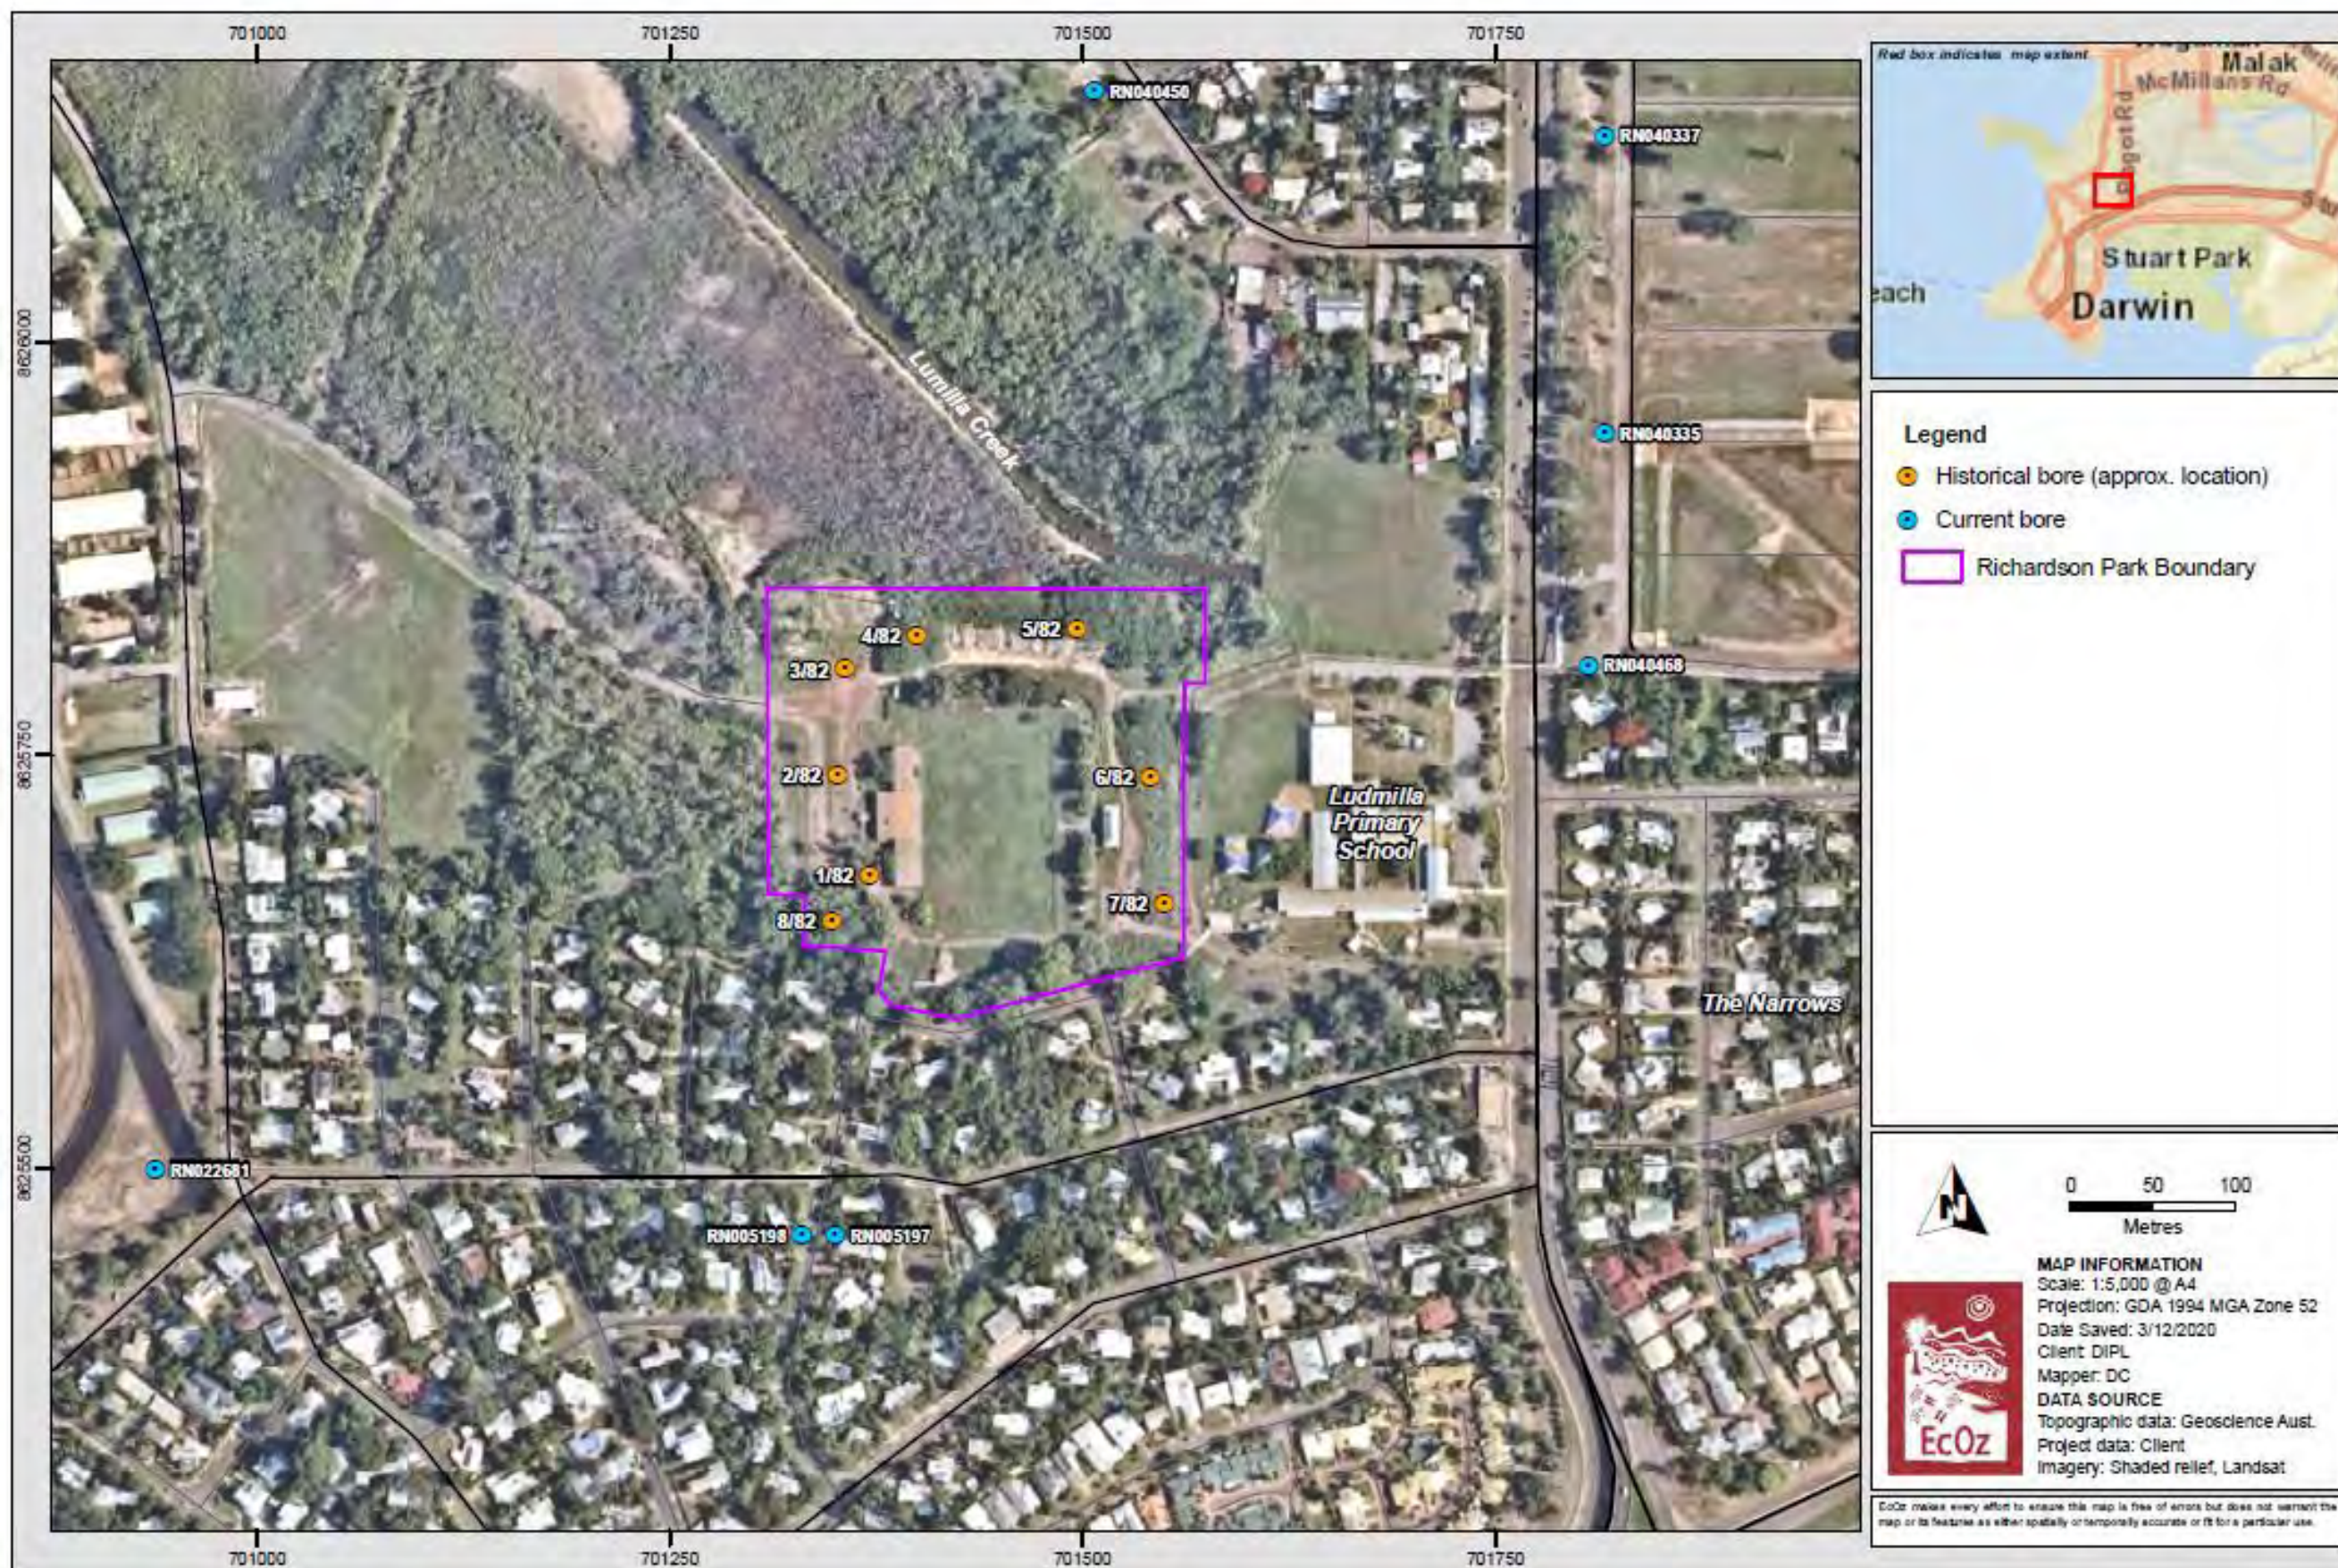
Figure 5: Historic and current bore locations (EcOz, 2021a)

Notes: RN026893 and RN040451 (refer **Table 9**) are not shown due to scale of Figure.

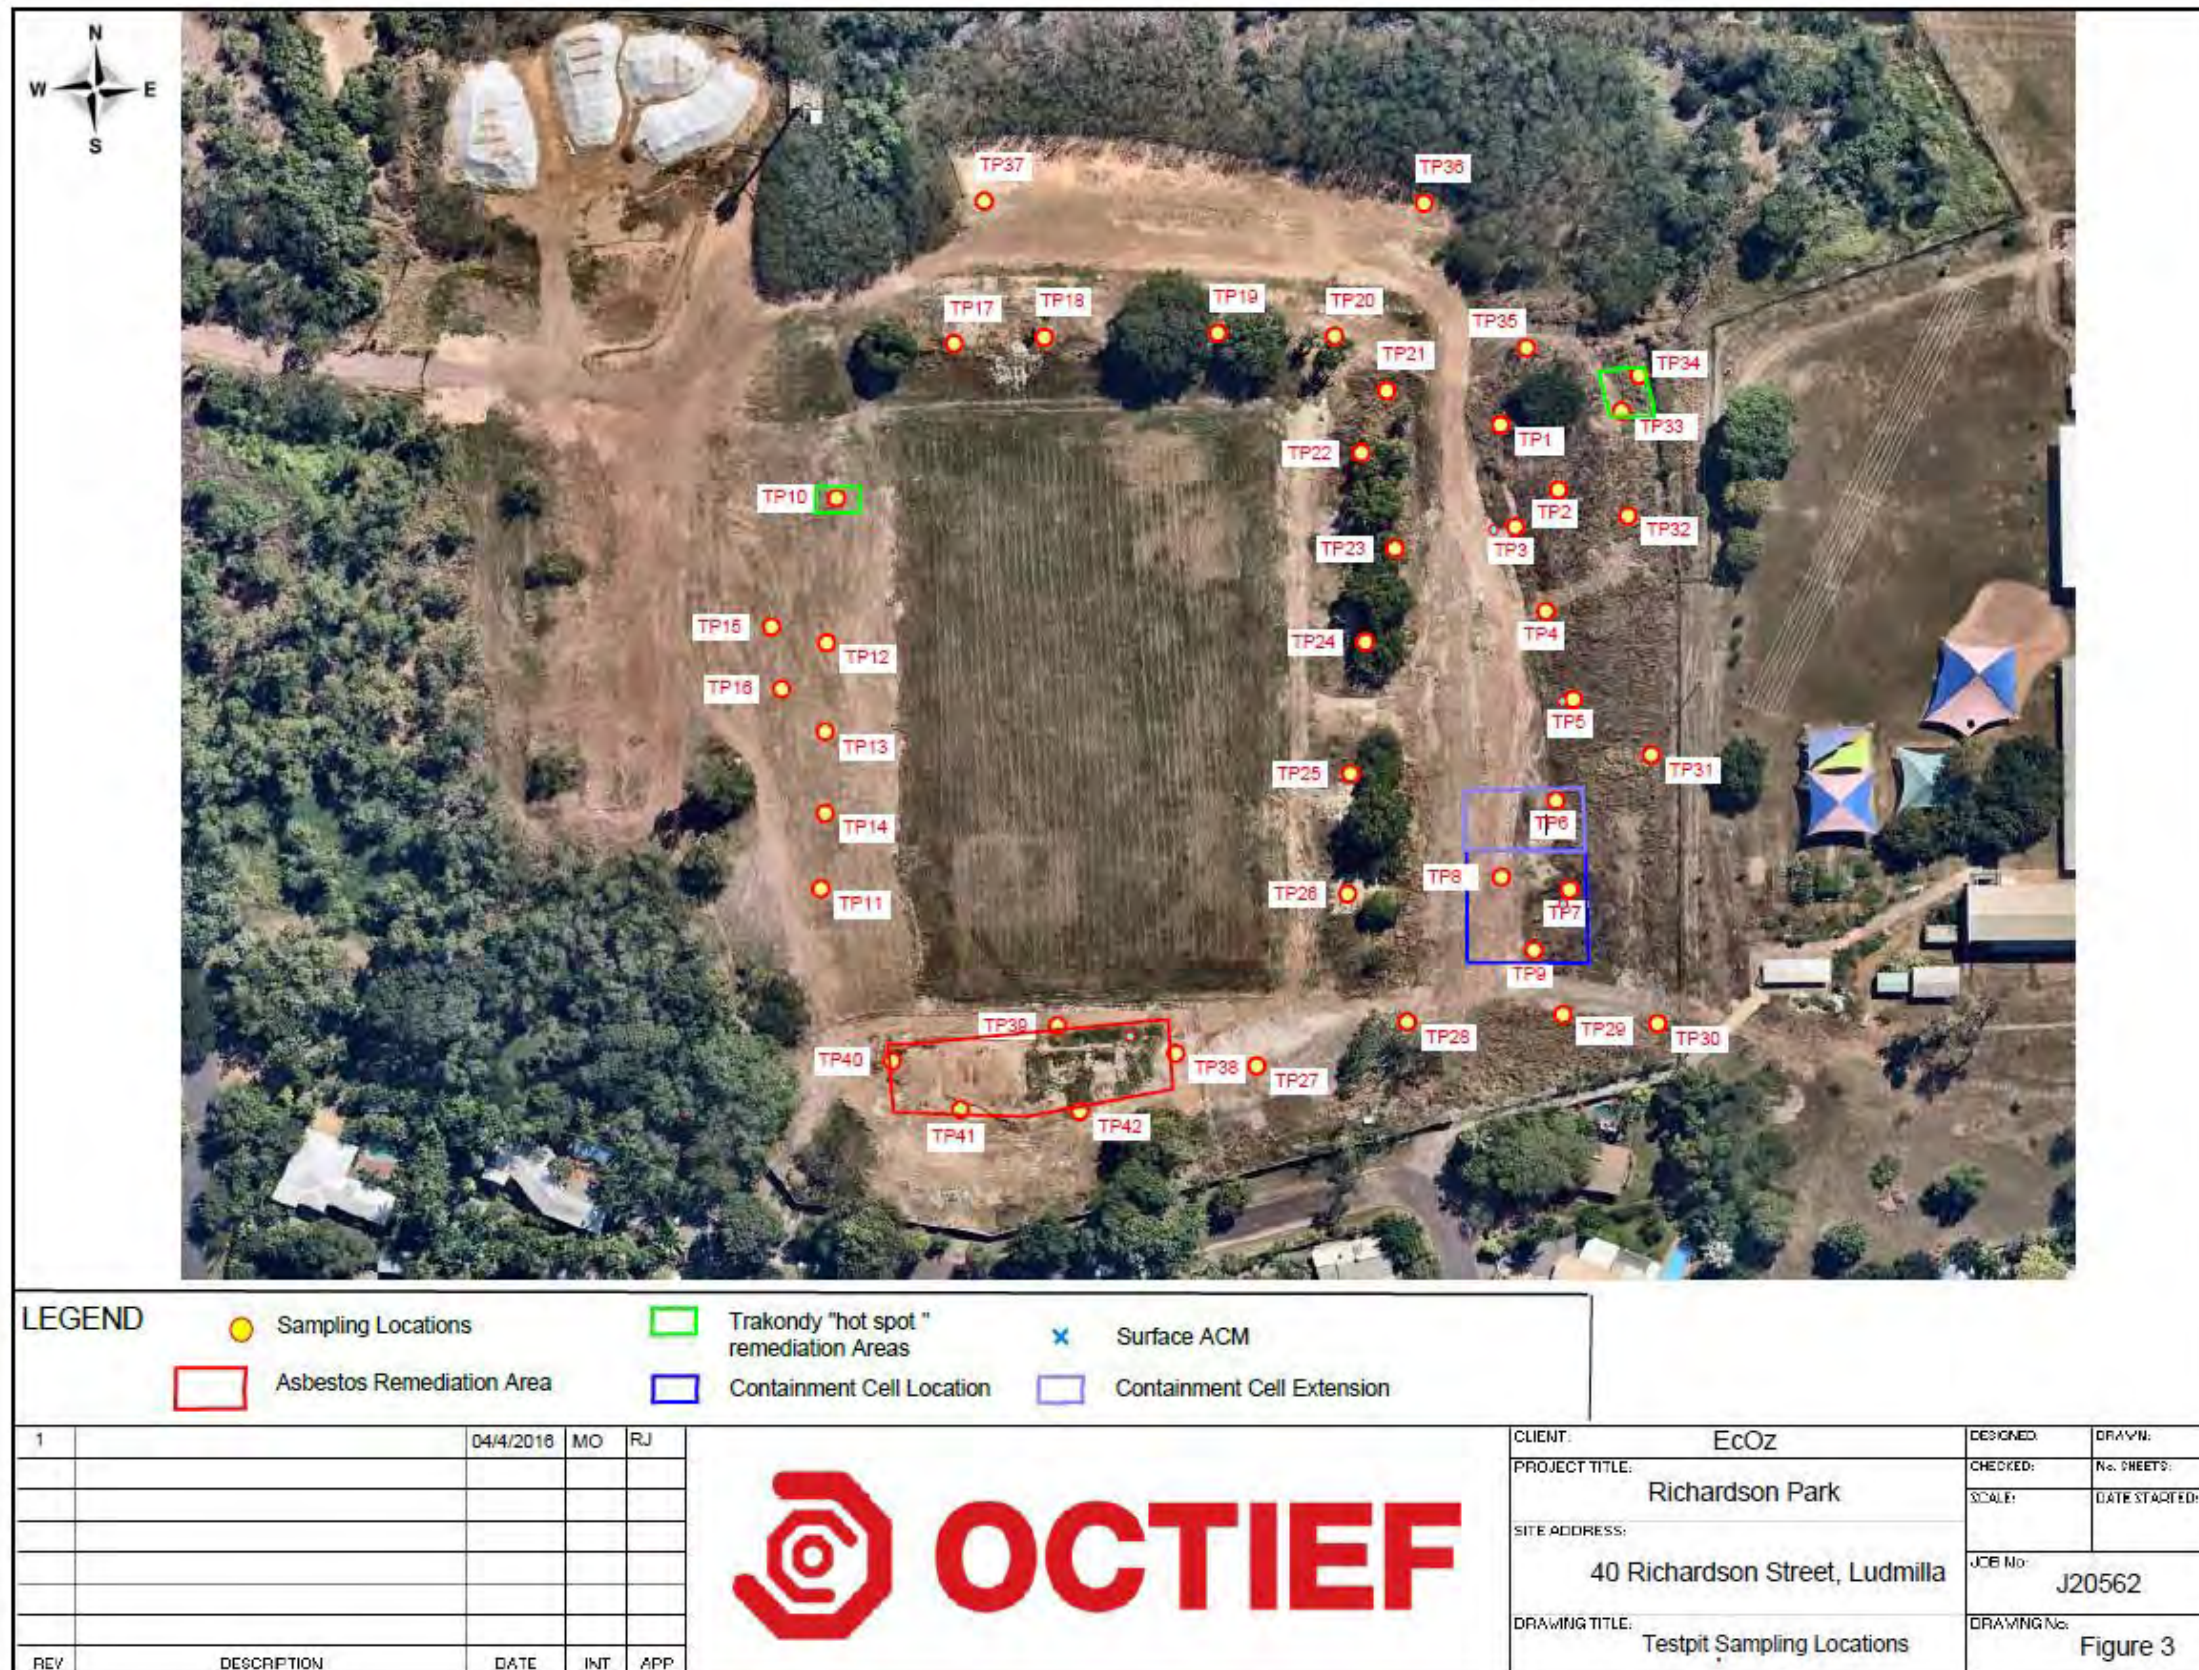
Figure 7: Supplementary investigation (test pit locations), Octief (2022)

As referenced in **Section 8.2.2**, Octief was engaged in late 2021 to complete a supplementary assessment at the site to address data gaps. Aside from the requirement to further delineate asbestos impacts (**Section 8.2.2**), the investigation was required to assess site condition, within the known southern asbestos impacted area, proposed encapsulation cell disturbance footprint and other areas of disturbance to confirm site condition with respect to “non asbestos CoPCs”; particularly PFAS.

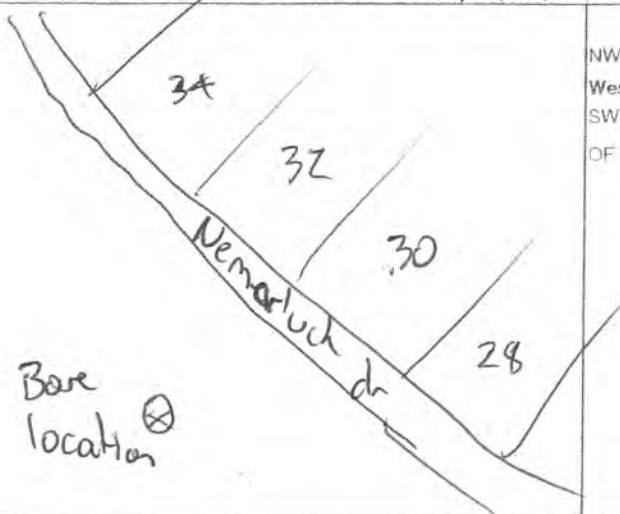
LOCATION SKETCH OF BORE RN: 040451

20 @/km
 NW North NE
 West East
 SW South SE
 OF Nemerluck dr

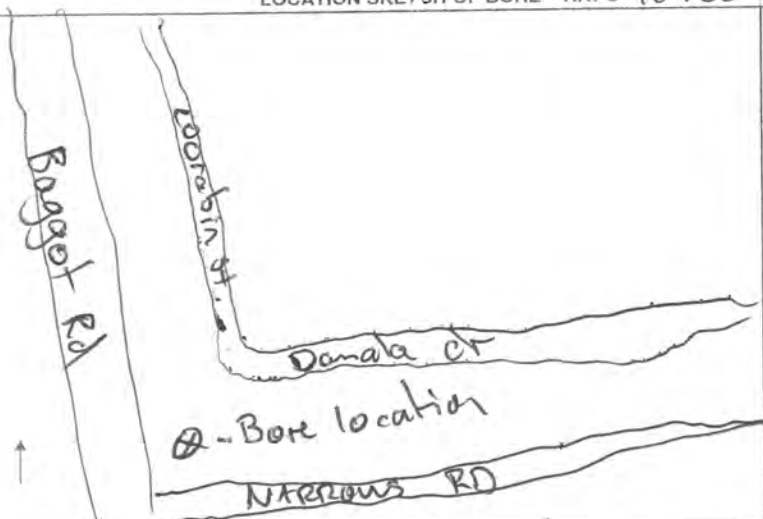
LOCATION SKETCH OF BORE RN: 040468

40 @km
 NW North NE
 West East
 SW South SE
 OF: Intersection of Coorabin st & Damala cr.
