**CONTAMINATED LAND AUDIT OF
ASBESTOS IN SOIL – 77
LAKESIDE DRIVE, ALAWA,
NORTHERN TERRITORY
RAY LAURENCE CONSTRUCTIONS PTY LTD**

**77 Lakeside Drive, Alawa – Contaminated Land Audit for the remediation of asbestos
in soil (excavation and disposal)**

77 Lakeside Drive, Alawa, NT; Victoria 53X Environmental Audit

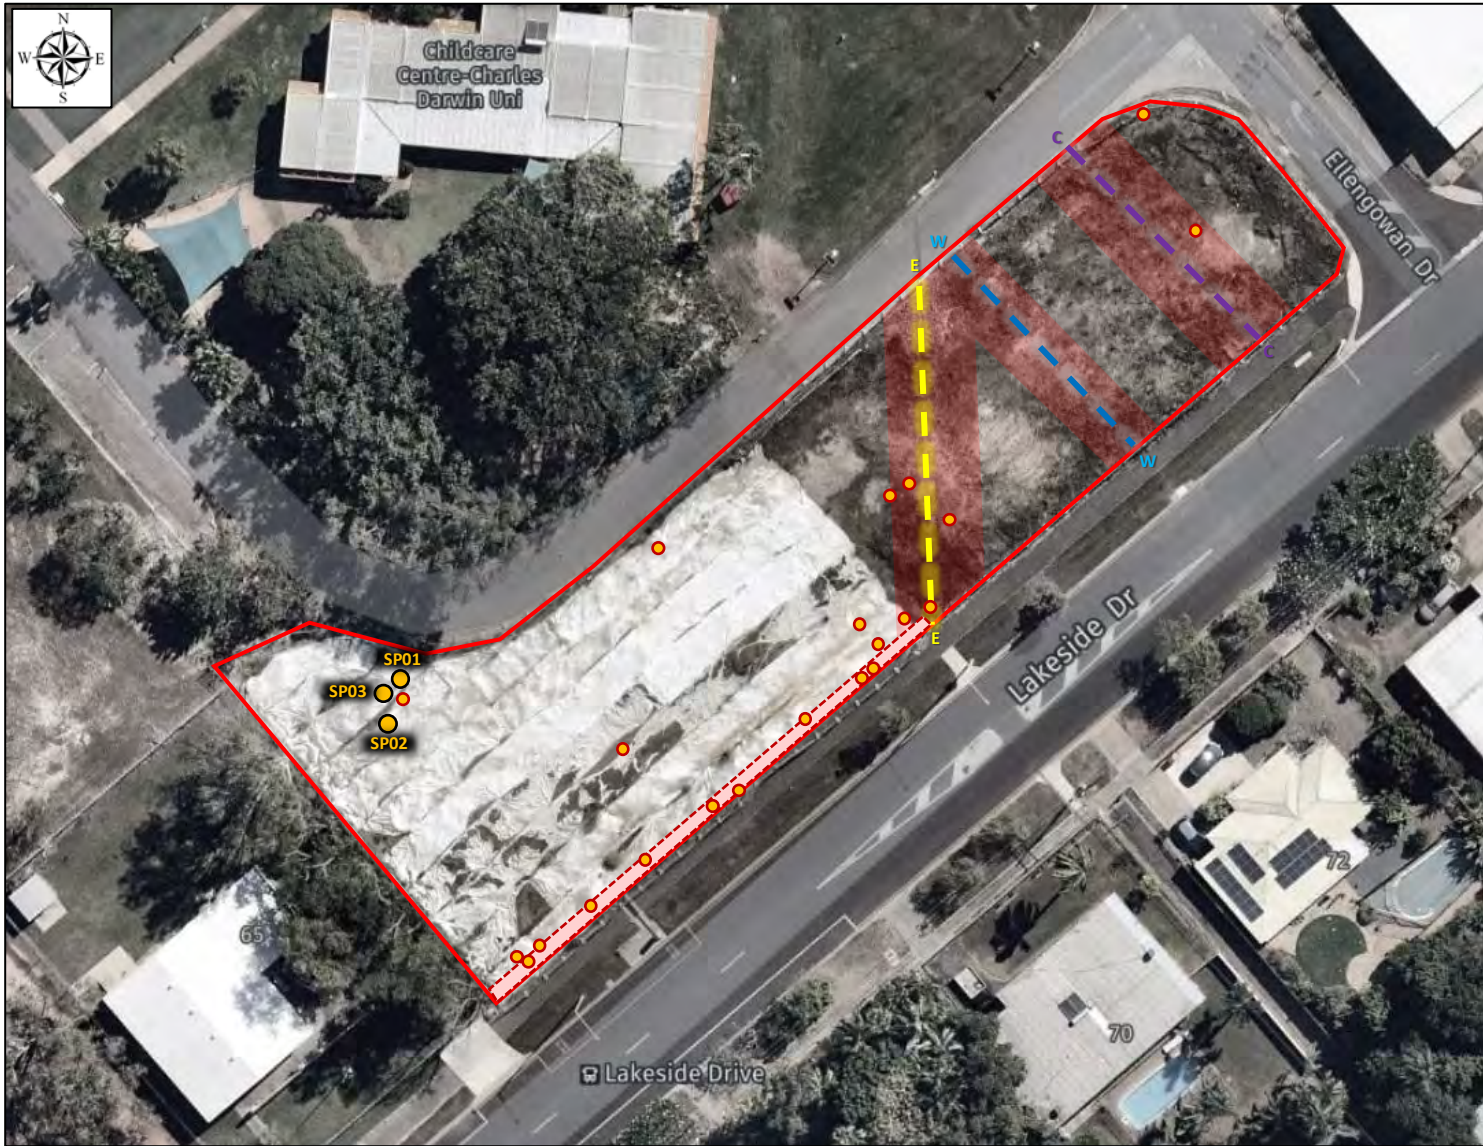
SLR completed a site inspection on 11 December 2020 to investigate the extent of asbestos contamination at the site. It was noted at this time that broken fragments of ACM were present at site surface, in the south-eastern portion of the site, apparently originating from a corrugated asbestos sheet fence located along the south-eastern boundary (having been distributed across site surface, due to earthworks) (refer **Figure 4**)

Based on the outcomes of the assessment, SLR concluded that the asbestos impacts at the site were primarily limited to fragments of ACM across the site surface and in the vicinity of the corrugated fence extending to a maximum depth of 0.1 to 0.2 m bgs (refer Figure 4). However, minor asbestos impacts were also noted (refer **Figure 6**):

On SLRs recommendation, to minimise any potential exposure to site workers and adjacent land users via release of respirable fibres while further investigation was undertaken and appropriate remediation planned, a geofabric layer was placed across the area of visible asbestos impact.

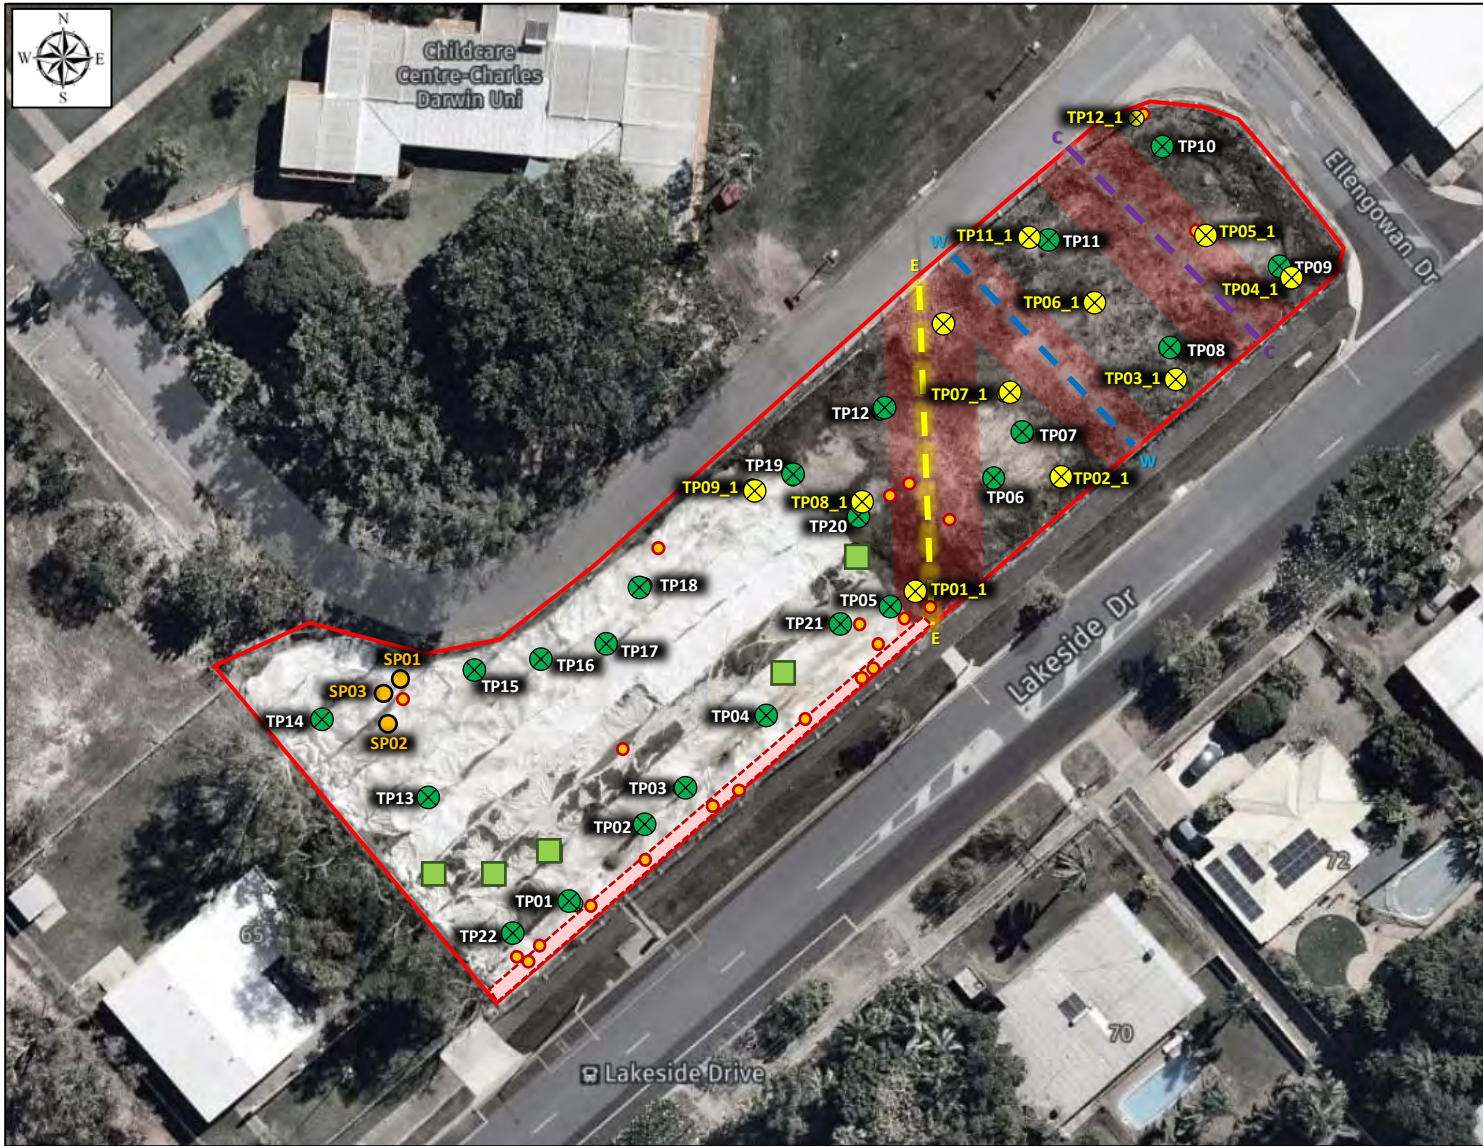
LEGEND

- Visible ACM – site surface (SLR, 2020)
- ⊗ Testpit locations (SLR, 2020)
- “Investigation” Testpits (SLR, 2020) – visual assessment only
- Stockpile locations (SLR, 2020)
- ⊗ Testpit locations (SLR 2021) Supplementary sampling program
- Corrugated asbestos fence (identified during initial site clearance)

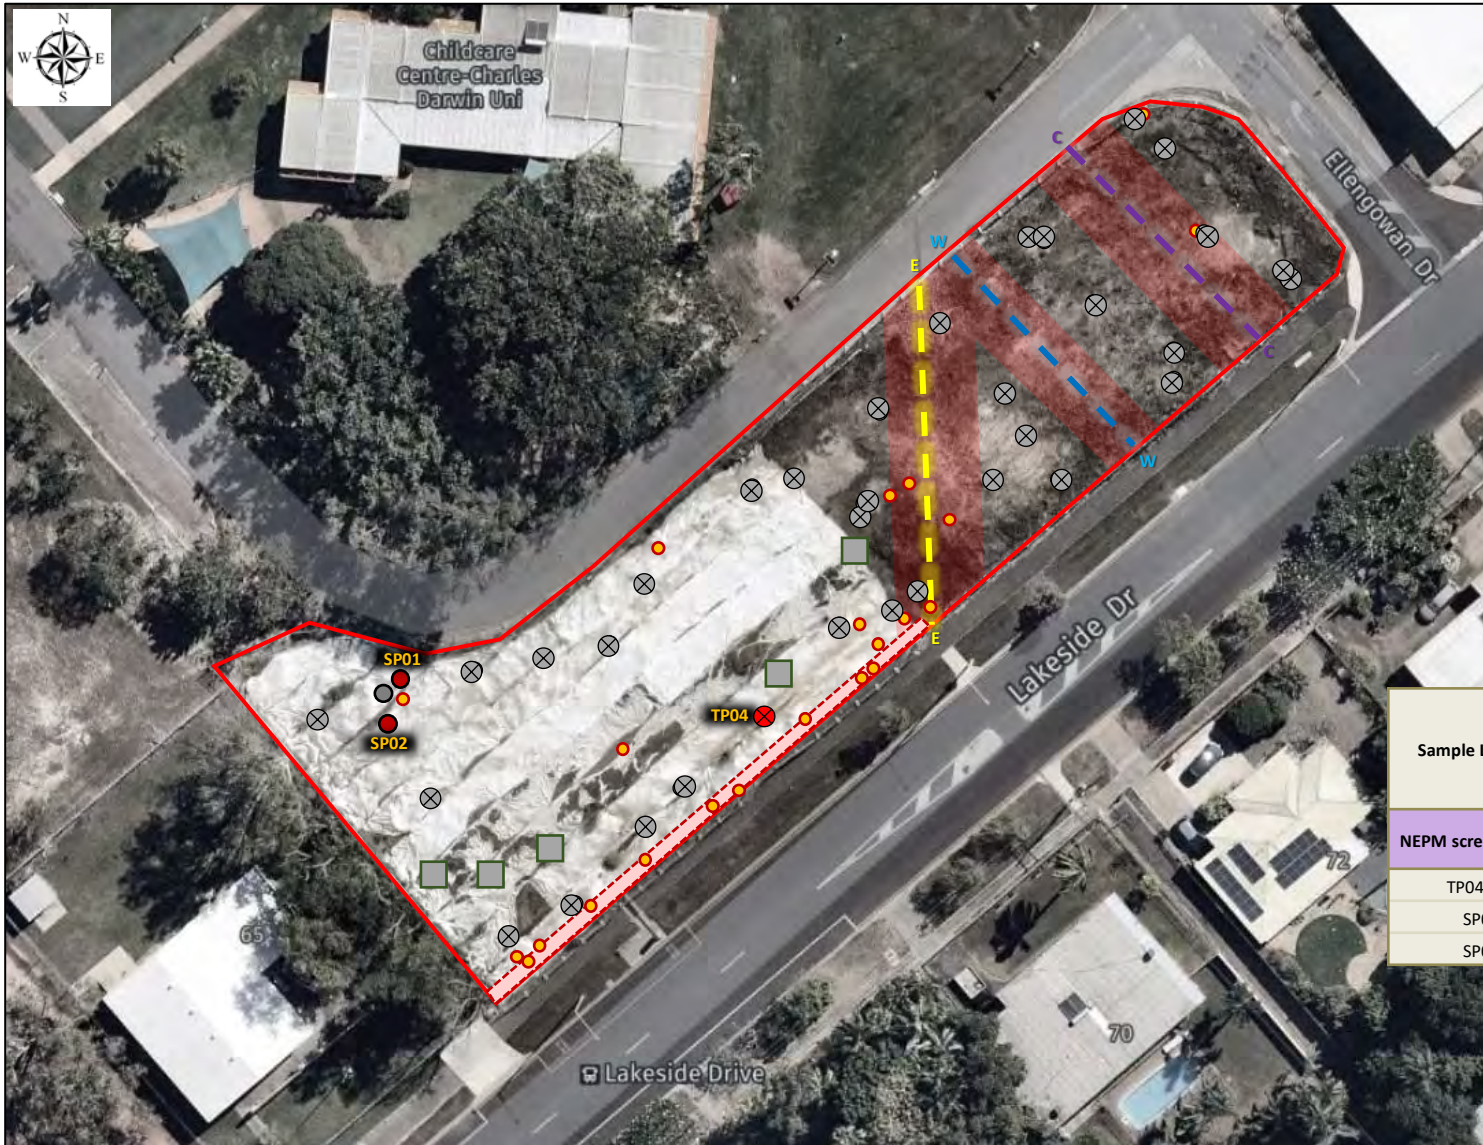
LEGEND

- Visible ACM – site surface (SLR, 2020)
- “Investigation” Testpits (SLR, 2020)
– visual assessment only – no ACM identified
- ⊗ Testpit locations (SLR 2020/2021) – no ACM, AF or FA detected
- ⊗ Testpit locations (SLR 2020/2021) – asbestos detected (refer Table below)
- Stockpile locations (SLR 2020/2021) – asbestos detected (refer Table below)
- Corrugated asbestos fence (identified during site clearance)

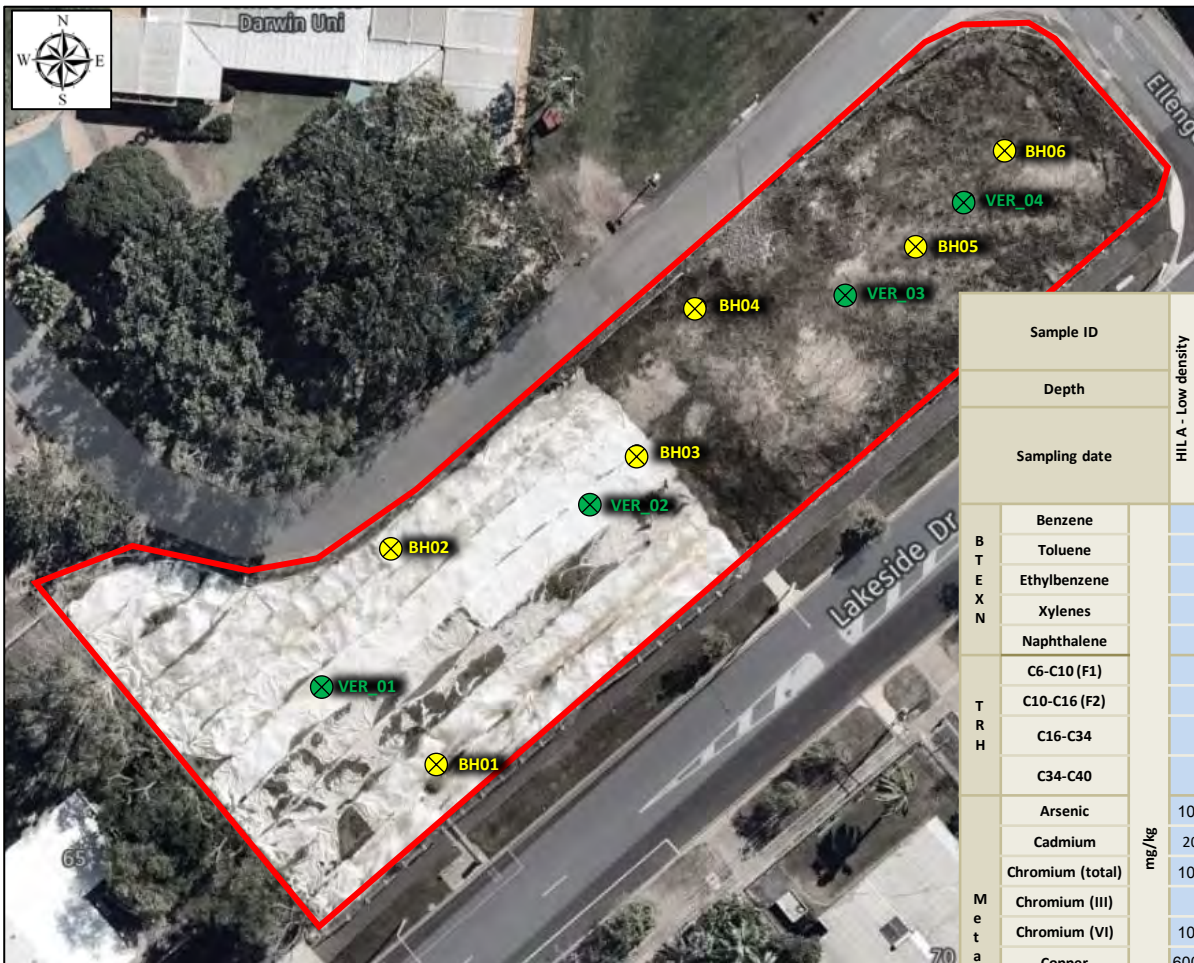
LEGEND

- Soil sampling locations "other CoPCs". (Prensa, 2019)
- Supplementary soil verification sampling locations "other CoPCs". (Prensa, 2021)

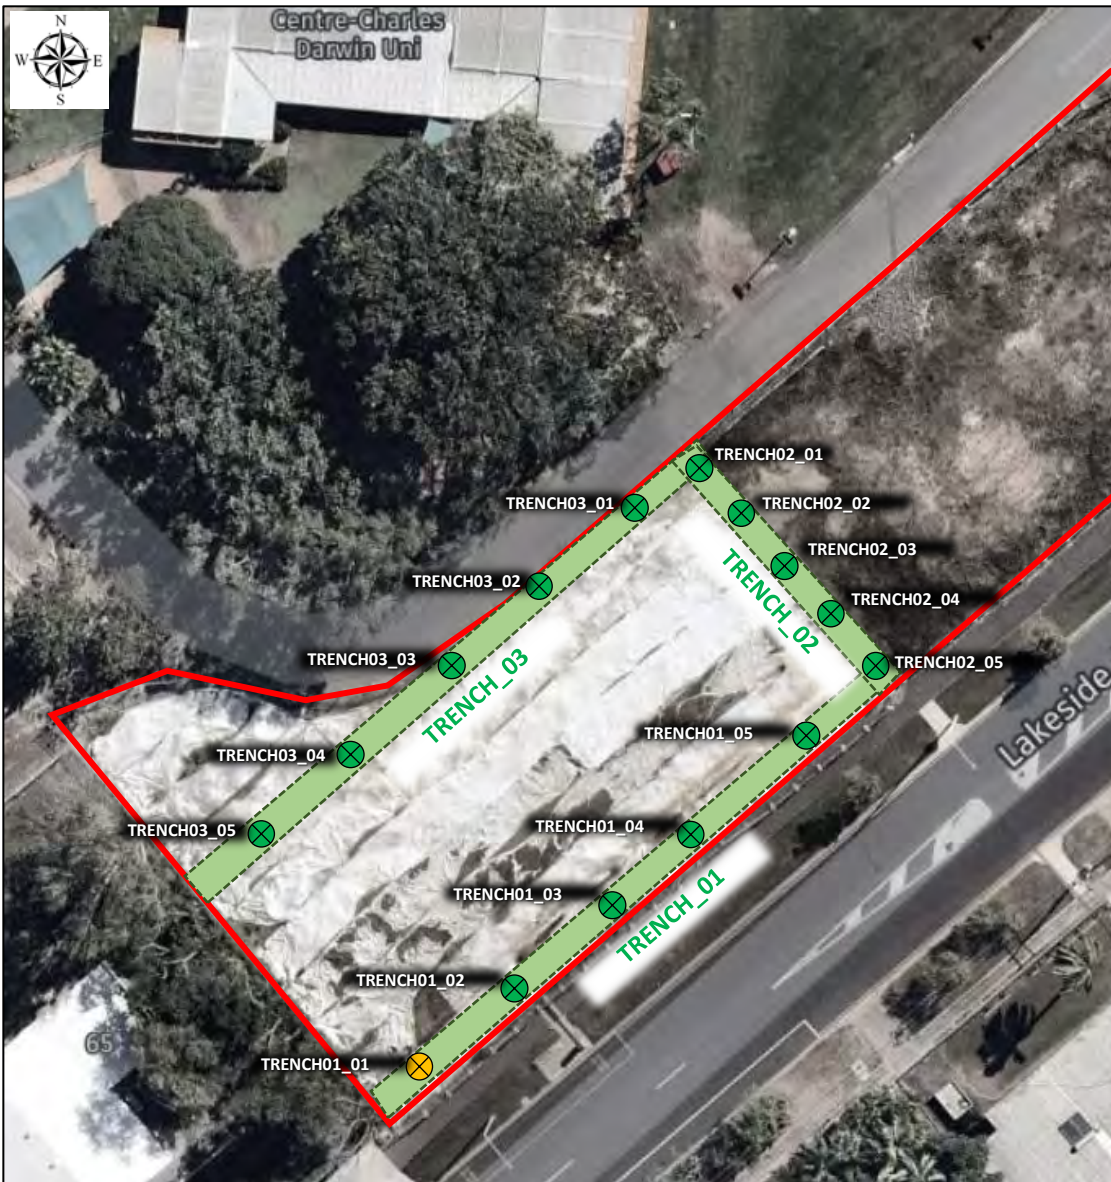
Sample ID	Location description	Depth	Type	Asbestos	
				Detection	W/W% (<7mm)
NEPM screening level (HIL A)				Y	0.001
TRENCH_01_01A	Base	1.2	Val	Y	0.022
TRENCH_01_01B	Base	1.2	Val	N	<0.001
TRENCH_01_01C	Base	1.2	Reval (01A, 01B)	Y¹	0.002
TRENCH_01_02	South wall	0.1-1.2	Val	N	<0.001
TRENCH_01_03	Base	1.2	Val	N	<0.001
TRENCH01_04A	South wall	0.1-1.2	Val	N	0.003
TRENCH01_04B	South wall	0.1-1.2	Val	N	<0.001
TRENCH01_04C	South wall	0.1-1.2	Reval (04A, 04B)	N	<0.001
TRENCH01_05A	Base	1.2	Val	N	0.004
TRENCH01_05B	Base	1.2	Val	N	<0.001
TRENCH01_05C	Base	1.2	Reval (05A, 05B)	N	<0.001
TRENCH02_01	Base	1.2	Val	N	<0.001
TRENCH02_02	Western wall	0.1-1.2	Val	N	<0.001
TRENCH02_03	Base	1.2	Val	N	<0.001
TRENCH02_04	Western wall	0.1-1.2	Val	Y²	<0.001
TRENCH02_05	Base	1.2	Val	N	<0.001
TRENCH03_01	Base	1	Val	N	<0.001
TRENCH03_02	Northern wall	0.1-1.2	Val	N	<0.001
TRENCH03_03	Base	1.2	Val	N	<0.001
TRENCH03_04	Northern wall	0.1-1.2	Val	N	<0.001

TRENCH03_05	Base	1.2	Val	N	<0.001

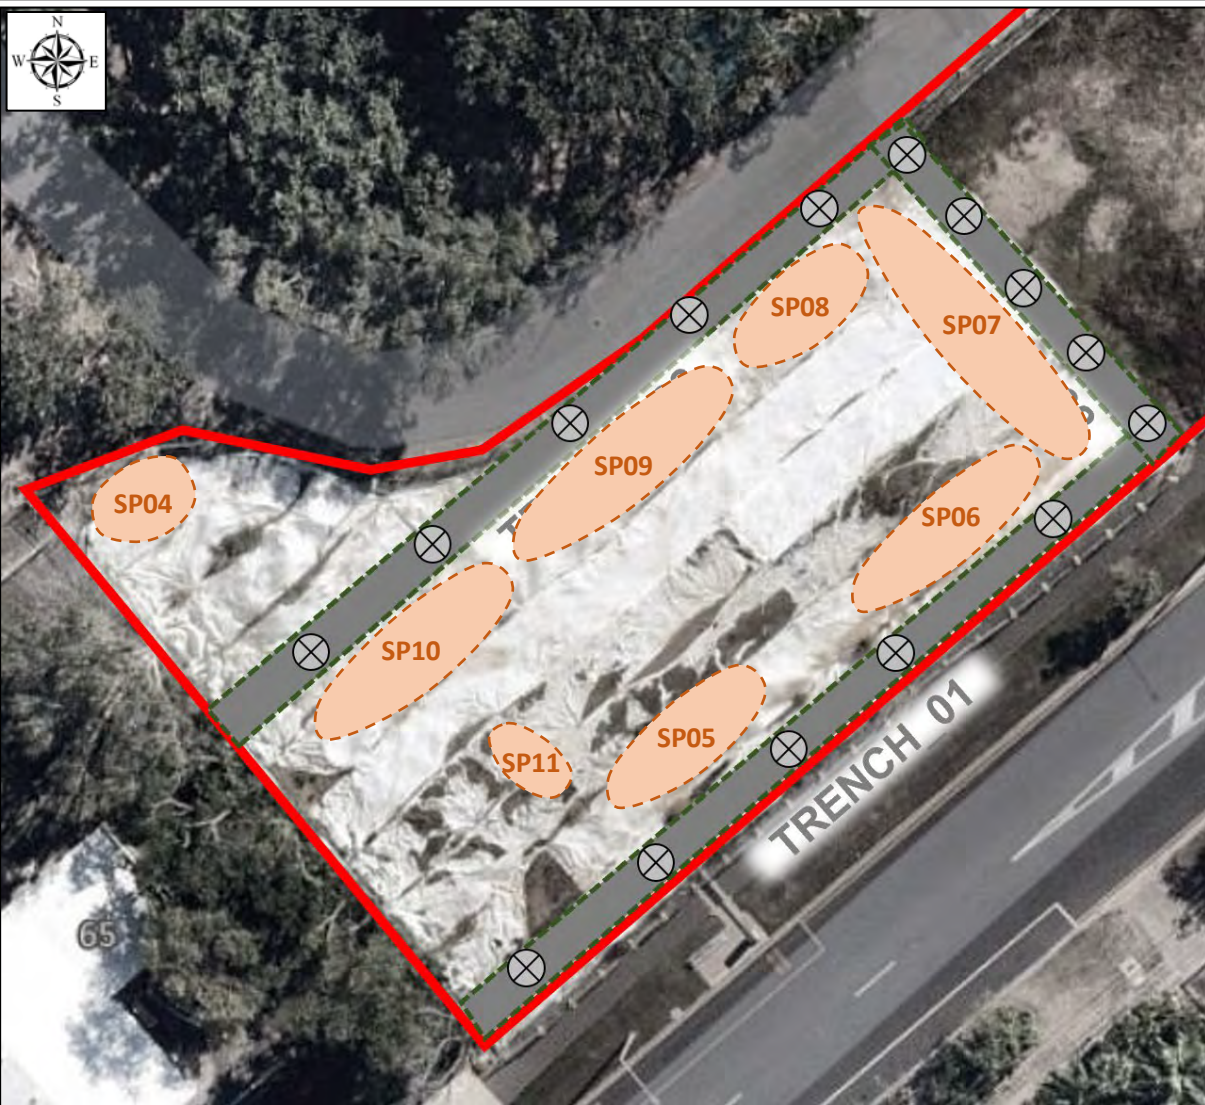
Stockpile ID	Volume (m ³)	Sample ID	Stockpile origin	Asbestos	
				Detection (ACM)	W/W% (AF/FA <7mm)
NEPM screening level (HIL A)				Y	0.001
SP01	11	-	Pre-existing – combined into SP04	-	-
SP03	11	-		-	-
SP04	22.5	SP04_01	Abatement SP01 and SP03	N	<0.001
		SP04_02			<0.001
		SP04_04			<0.001
SP05	27	SP05_1	Trench 1 (centre)	N	<0.001
		SP05_2			<0.001
		SP05_3			<0.001
SP06	13.5	SP06_01	Trench 1 (north-east portion)	N	<0.001
		SP06_02			<0.001
		SP06_03			<0.001
SP07	15	SP07_01	Trench 2	N	<0.001
		SP07_02			<0.001
		SP07_03			<0.001
SP08	16	SP08_1	Trench 3 (north-east portion)	N	<0.001
		SP08_2			<0.001
SP09	36	SP09_01	Trench 3 (central)	N	<0.001
		SP09_02			<0.001
SP10	22	SP10_1	Trench 3 (south-west portion)	N	<0.001
		SP10_2			<0.001
SP11	15	SP11_01	Trench 3 (central)	N	<0.001
		SP11_02			<0.001
		SP11_03			<0.001

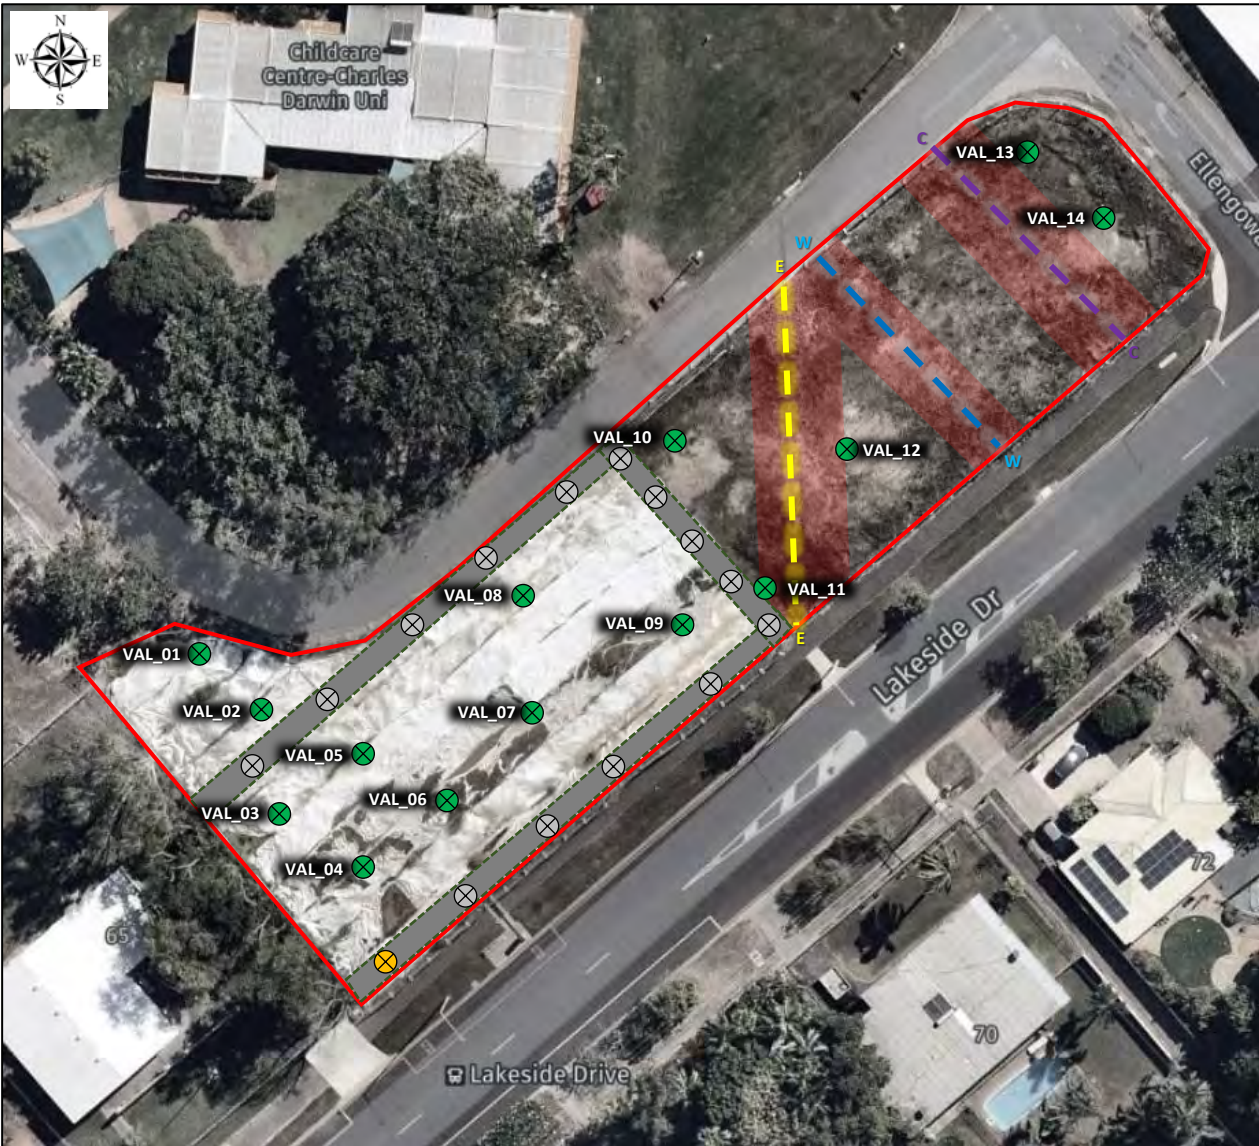
LEGEND

- Trench excavation (removal of asbestos fencing)
- Validation samples (trench) - pass
- Validation samples (trench) – residual asbestos at depth (not of concern)
- Validation samples wider site area – no asbestos

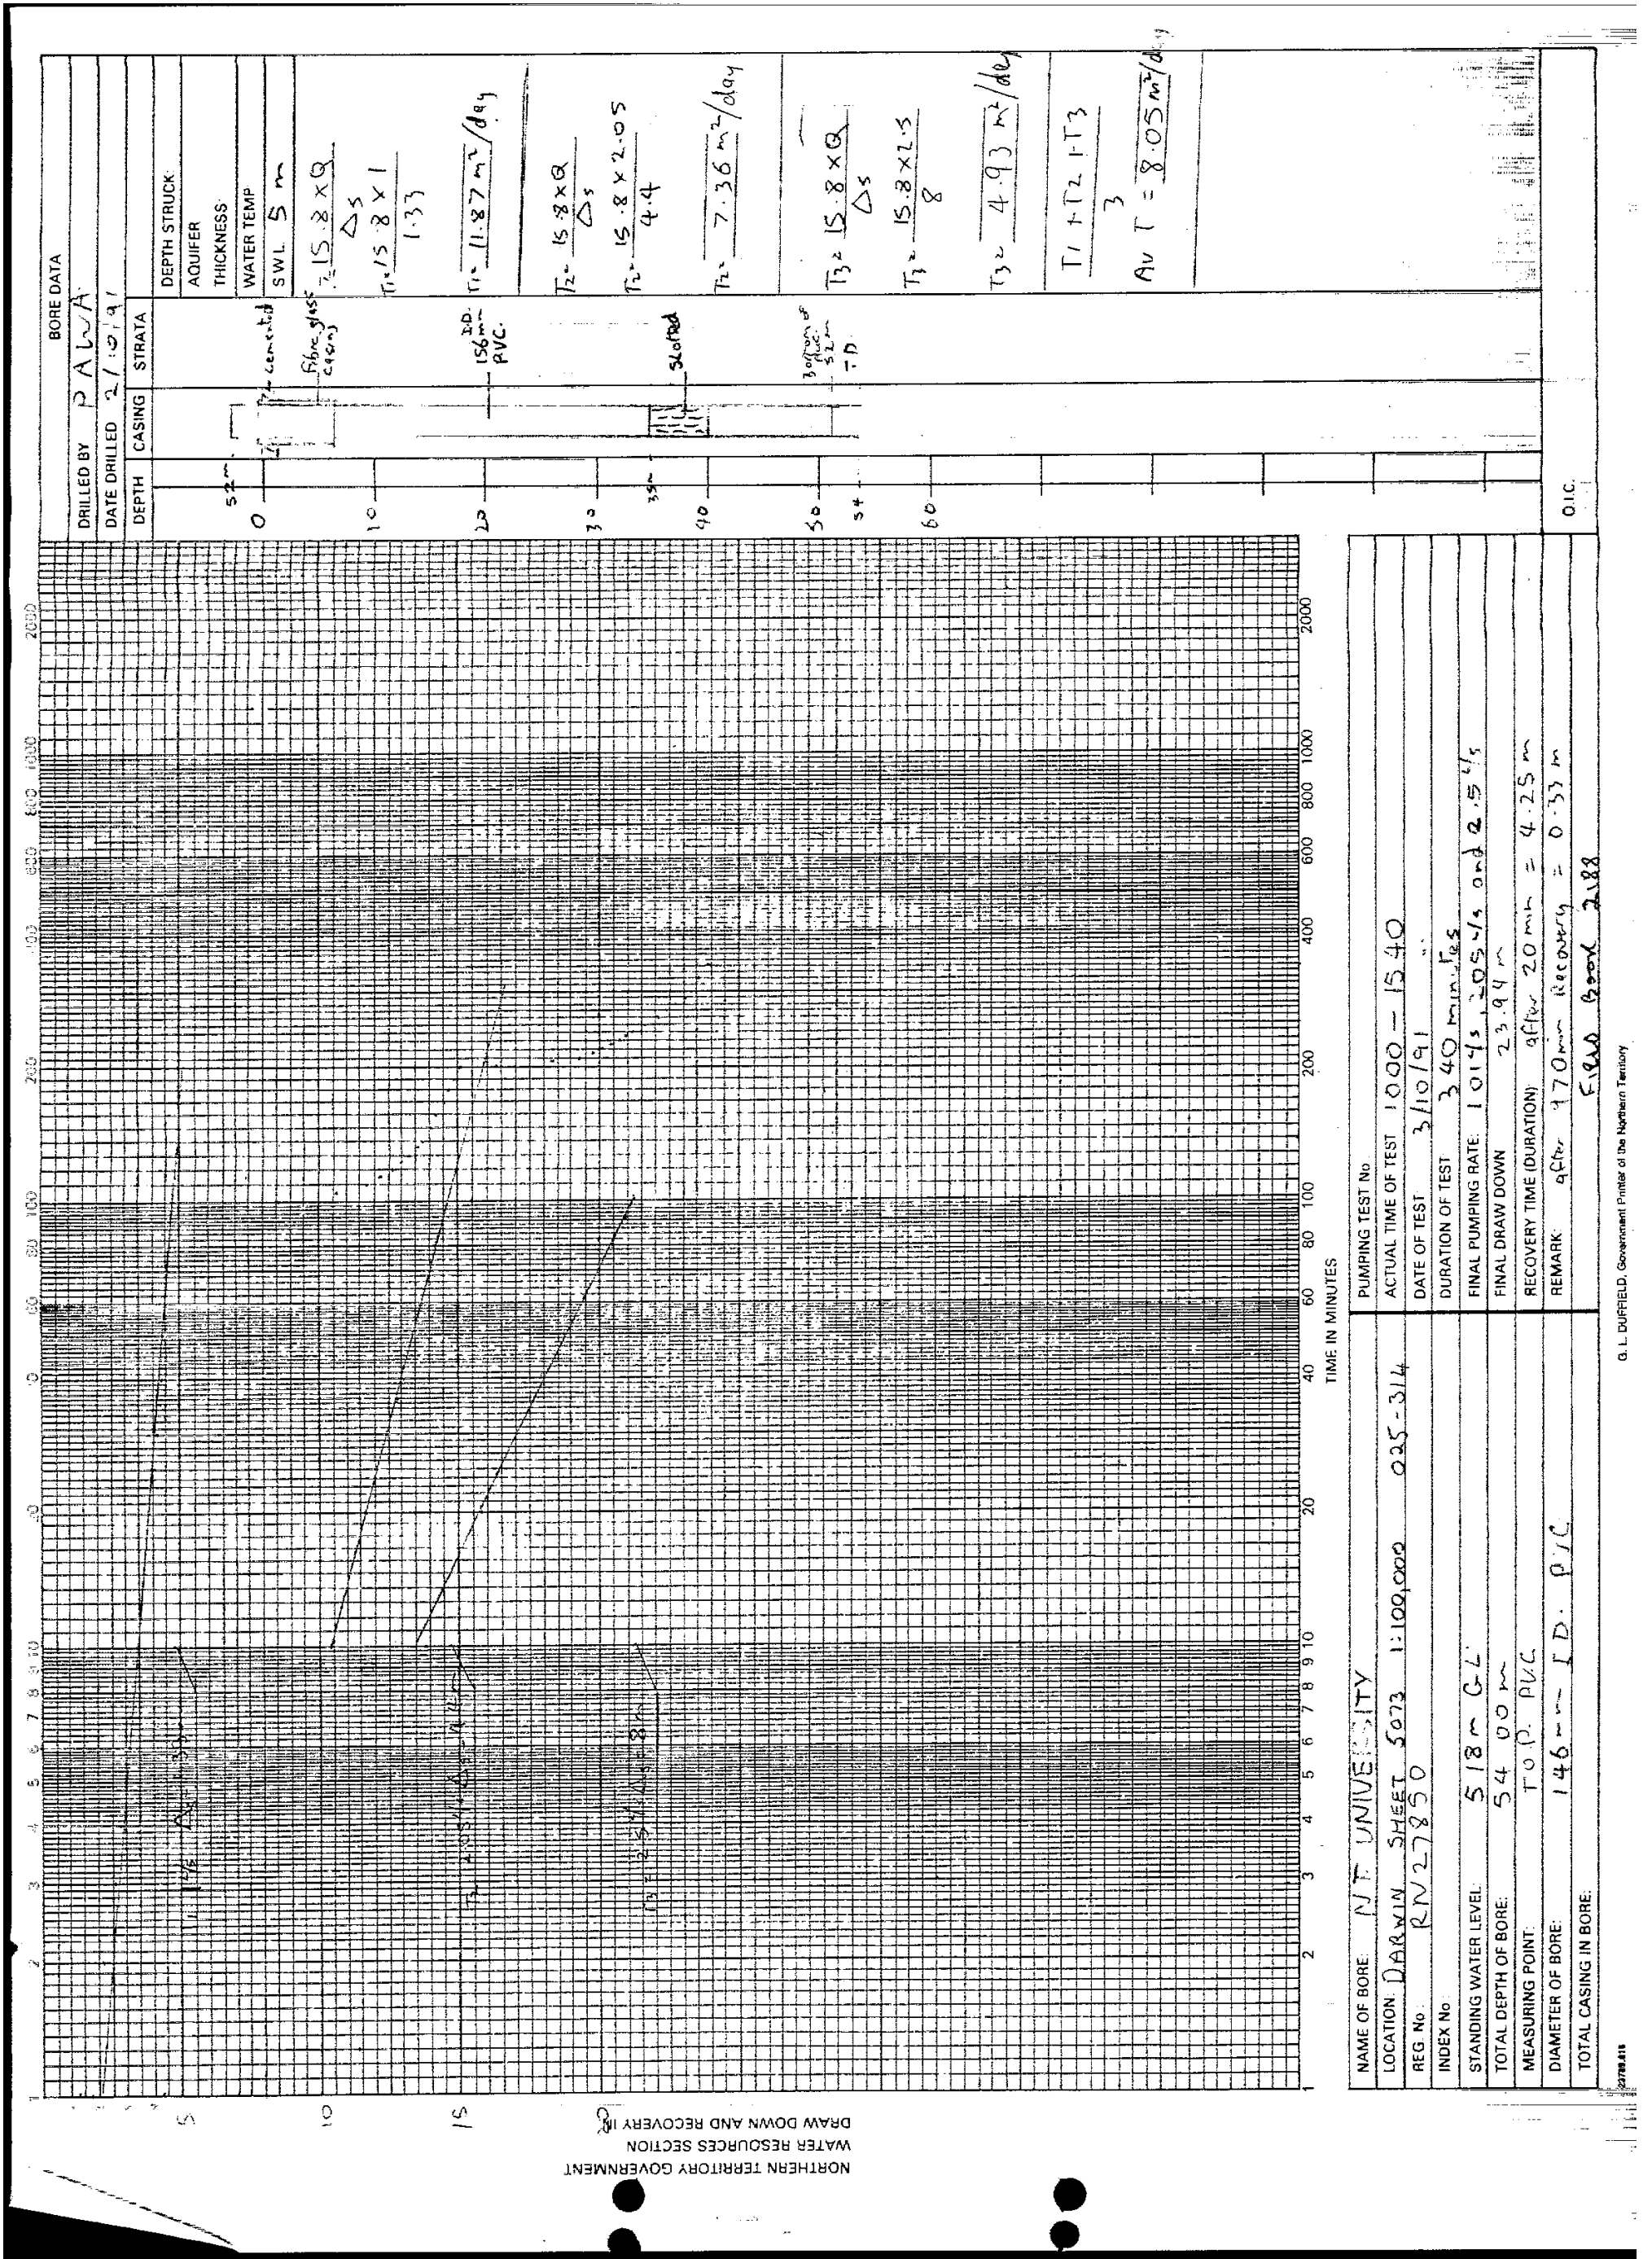
DEPTH	CASING	STRATA	DEPTH STRUCK	AQUIFER THICKNESS	WATER TEMP	SWL
0						5 m
10		concreted				15.8 x 9
20		156mm PVC				11.87 m ² /day
30						15.8 x 9
35		sloped				15.8 x 2.05
40						7.36 m ² /day
50		30mm PVC				15.8 x 9
54						15.8 x 2.5
60						4.93 m ² /day
						T1 + T2 + T3
						3
						Av T = 8.05 m ² /day

NAME OF BORE	NT UNIVERSITY
LOCATION	DARWIN SHEET 5073 1:100,000 025-314
REG No	RN27850
INDEX No	
STANDING WATER LEVEL	518 m G.L.
TOTAL DEPTH OF BORE	54.00 m
MEASURING POINT	T.O.P. PVC
DIAMETER OF BORE	146 mm I.D. PVC
TOTAL CASING IN BORE	
PUMPING TEST No	
ACTUAL TIME OF TEST	1000 - 1540
DATE OF TEST	3/10/91
DURATION OF TEST	340 minutes
FINAL PUMPING RATE	1014.205 l/s and 2.5 l/s
FINAL DRAW DOWN	23.94 m
RECOVERY TIME (DURATION)	after 20 min = 4.25 m
REMARK	after 470 min Recovery = 0.57 m
	FILED BOOK 2188

NORTHERN TERRITORY GOVERNMENT
WATER RESOURCES SECTION
DRAW DOWN AND RECOVERY

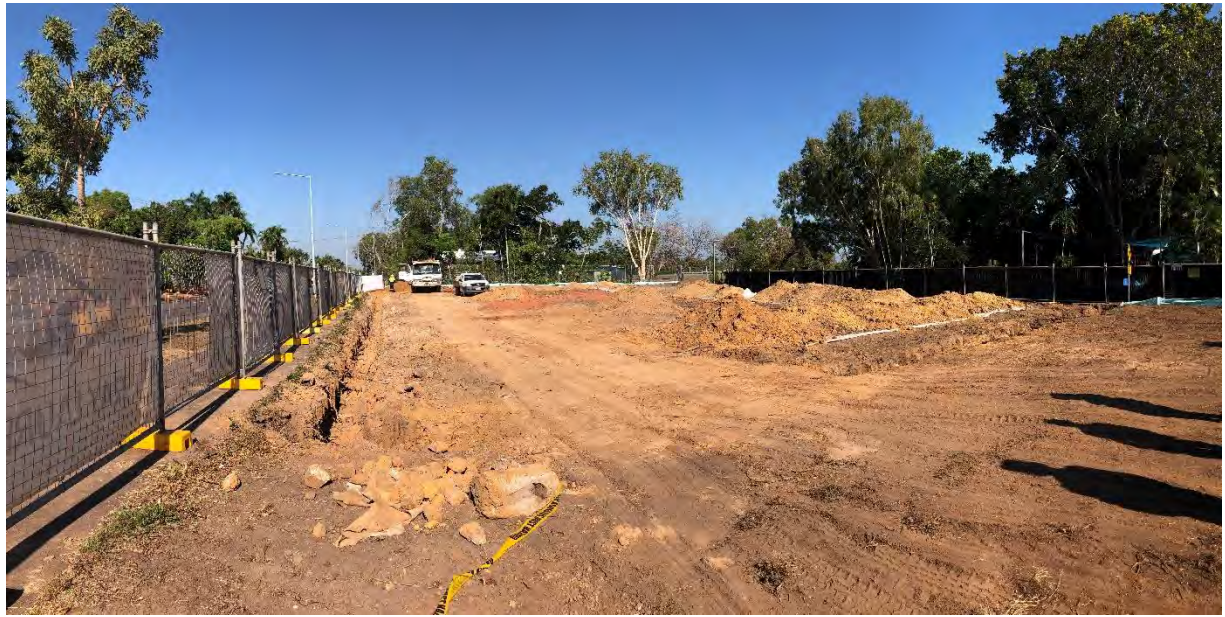
Plate 1: Site surface (view south-west)

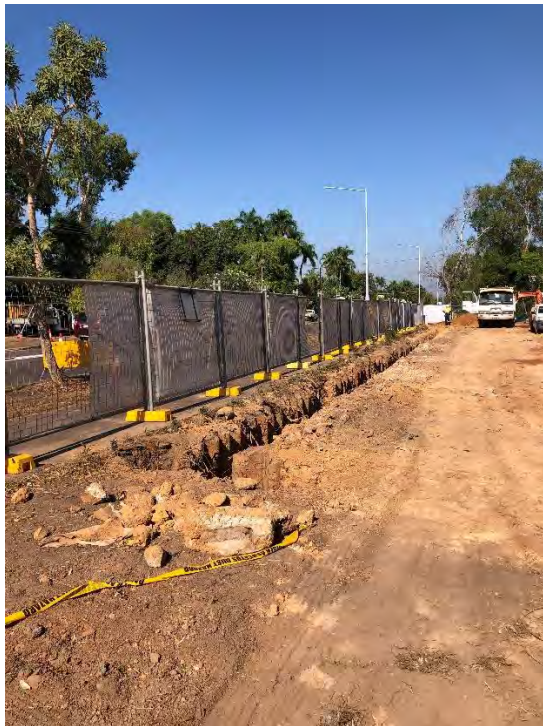
Plate 2: Trenching to remove corrugated asbestos fencing, southern site boundary.

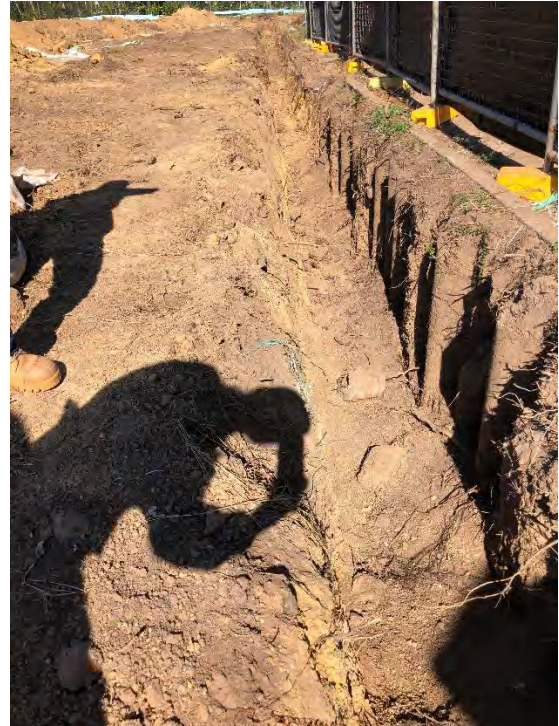
Plate 3: Trenching to remove additional corrugated asbestos fencing, identified along the northern site boundary.

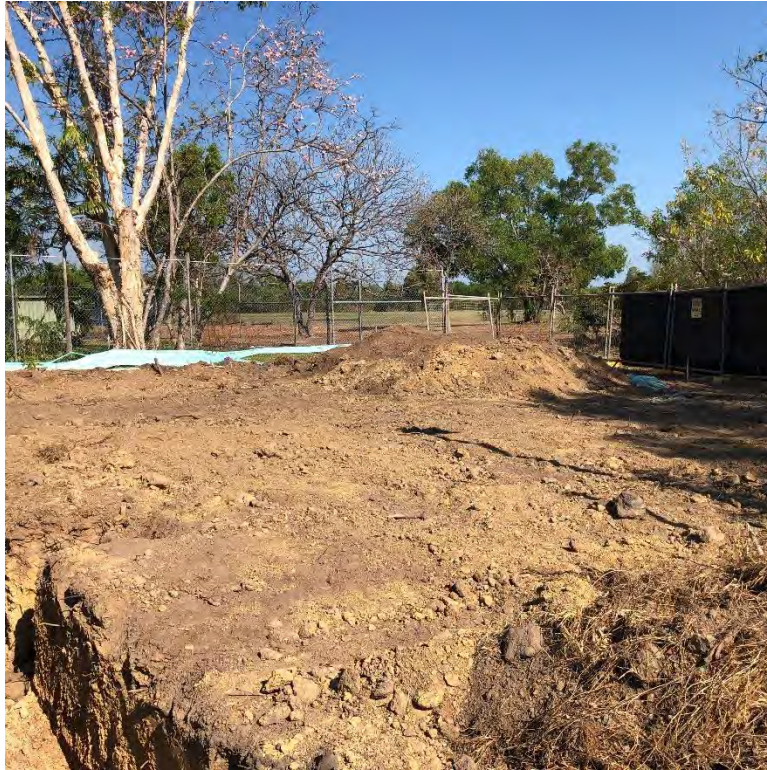
Plate 4: Proposed outdoor play area (south-west corner of the site). Additional, shallow trenching on a grid basis to confirm absence of ACM completed in this area following identification and removal of additional corrugated sheet fencing

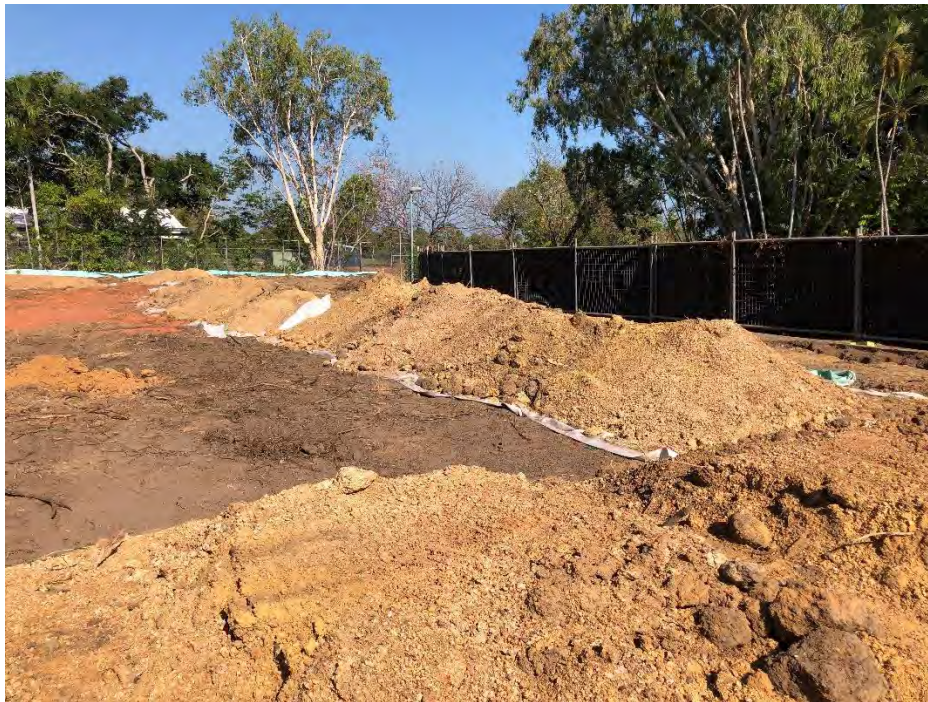
Plate 5: Processed "clean" stockpiles generated during trenching activities, stored on geofabric.
