# Information sheet for environmental audits and preliminary risk screen assessments (PRSAs)

**Environmental Audit Report**  
**Muirhead North Stage 1A – Portion of Lot 9370,**  
**Lee Point, Northern Territory**

Prepared for  
**Defence Housing Australia**

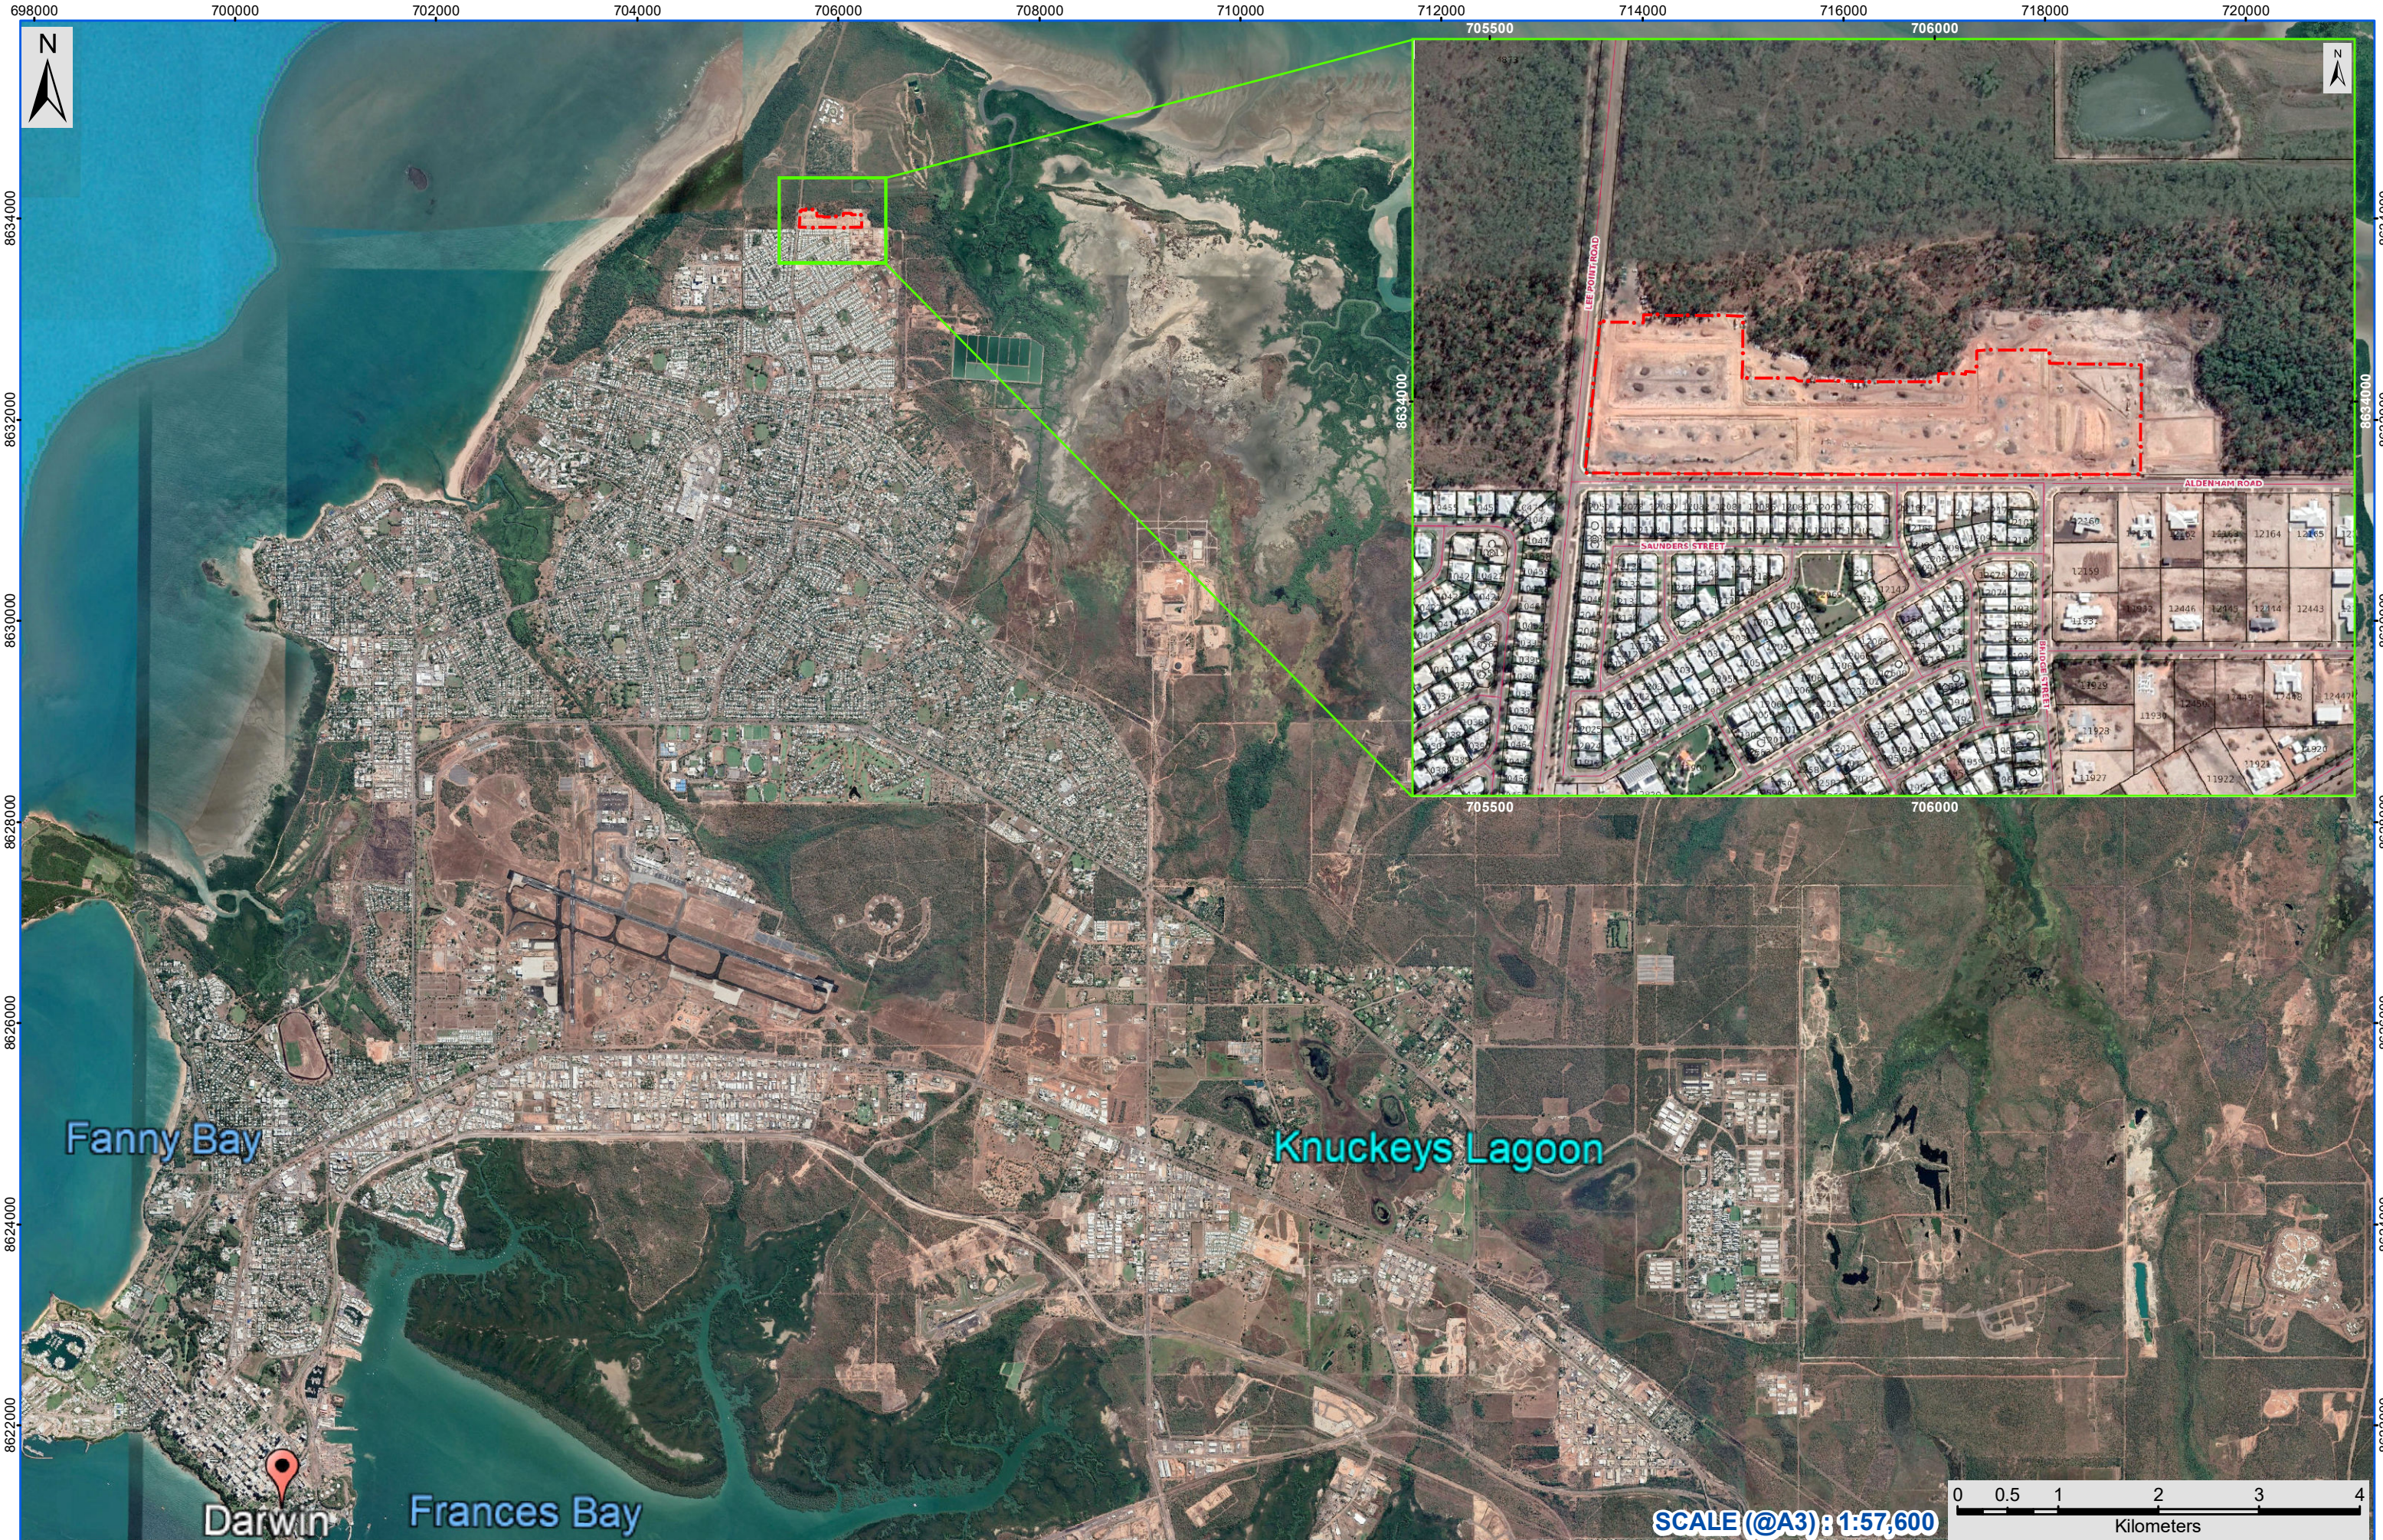
## Figure 1: Site Location Plan

The site is located on the Lee Point Peninsular approximately 17 km north of the Darwin central business district. The site location is shown in Figure 1, the certificate of title is included in Appendix B, and a plan showing the boundaries of the site is provided as Figure 3.

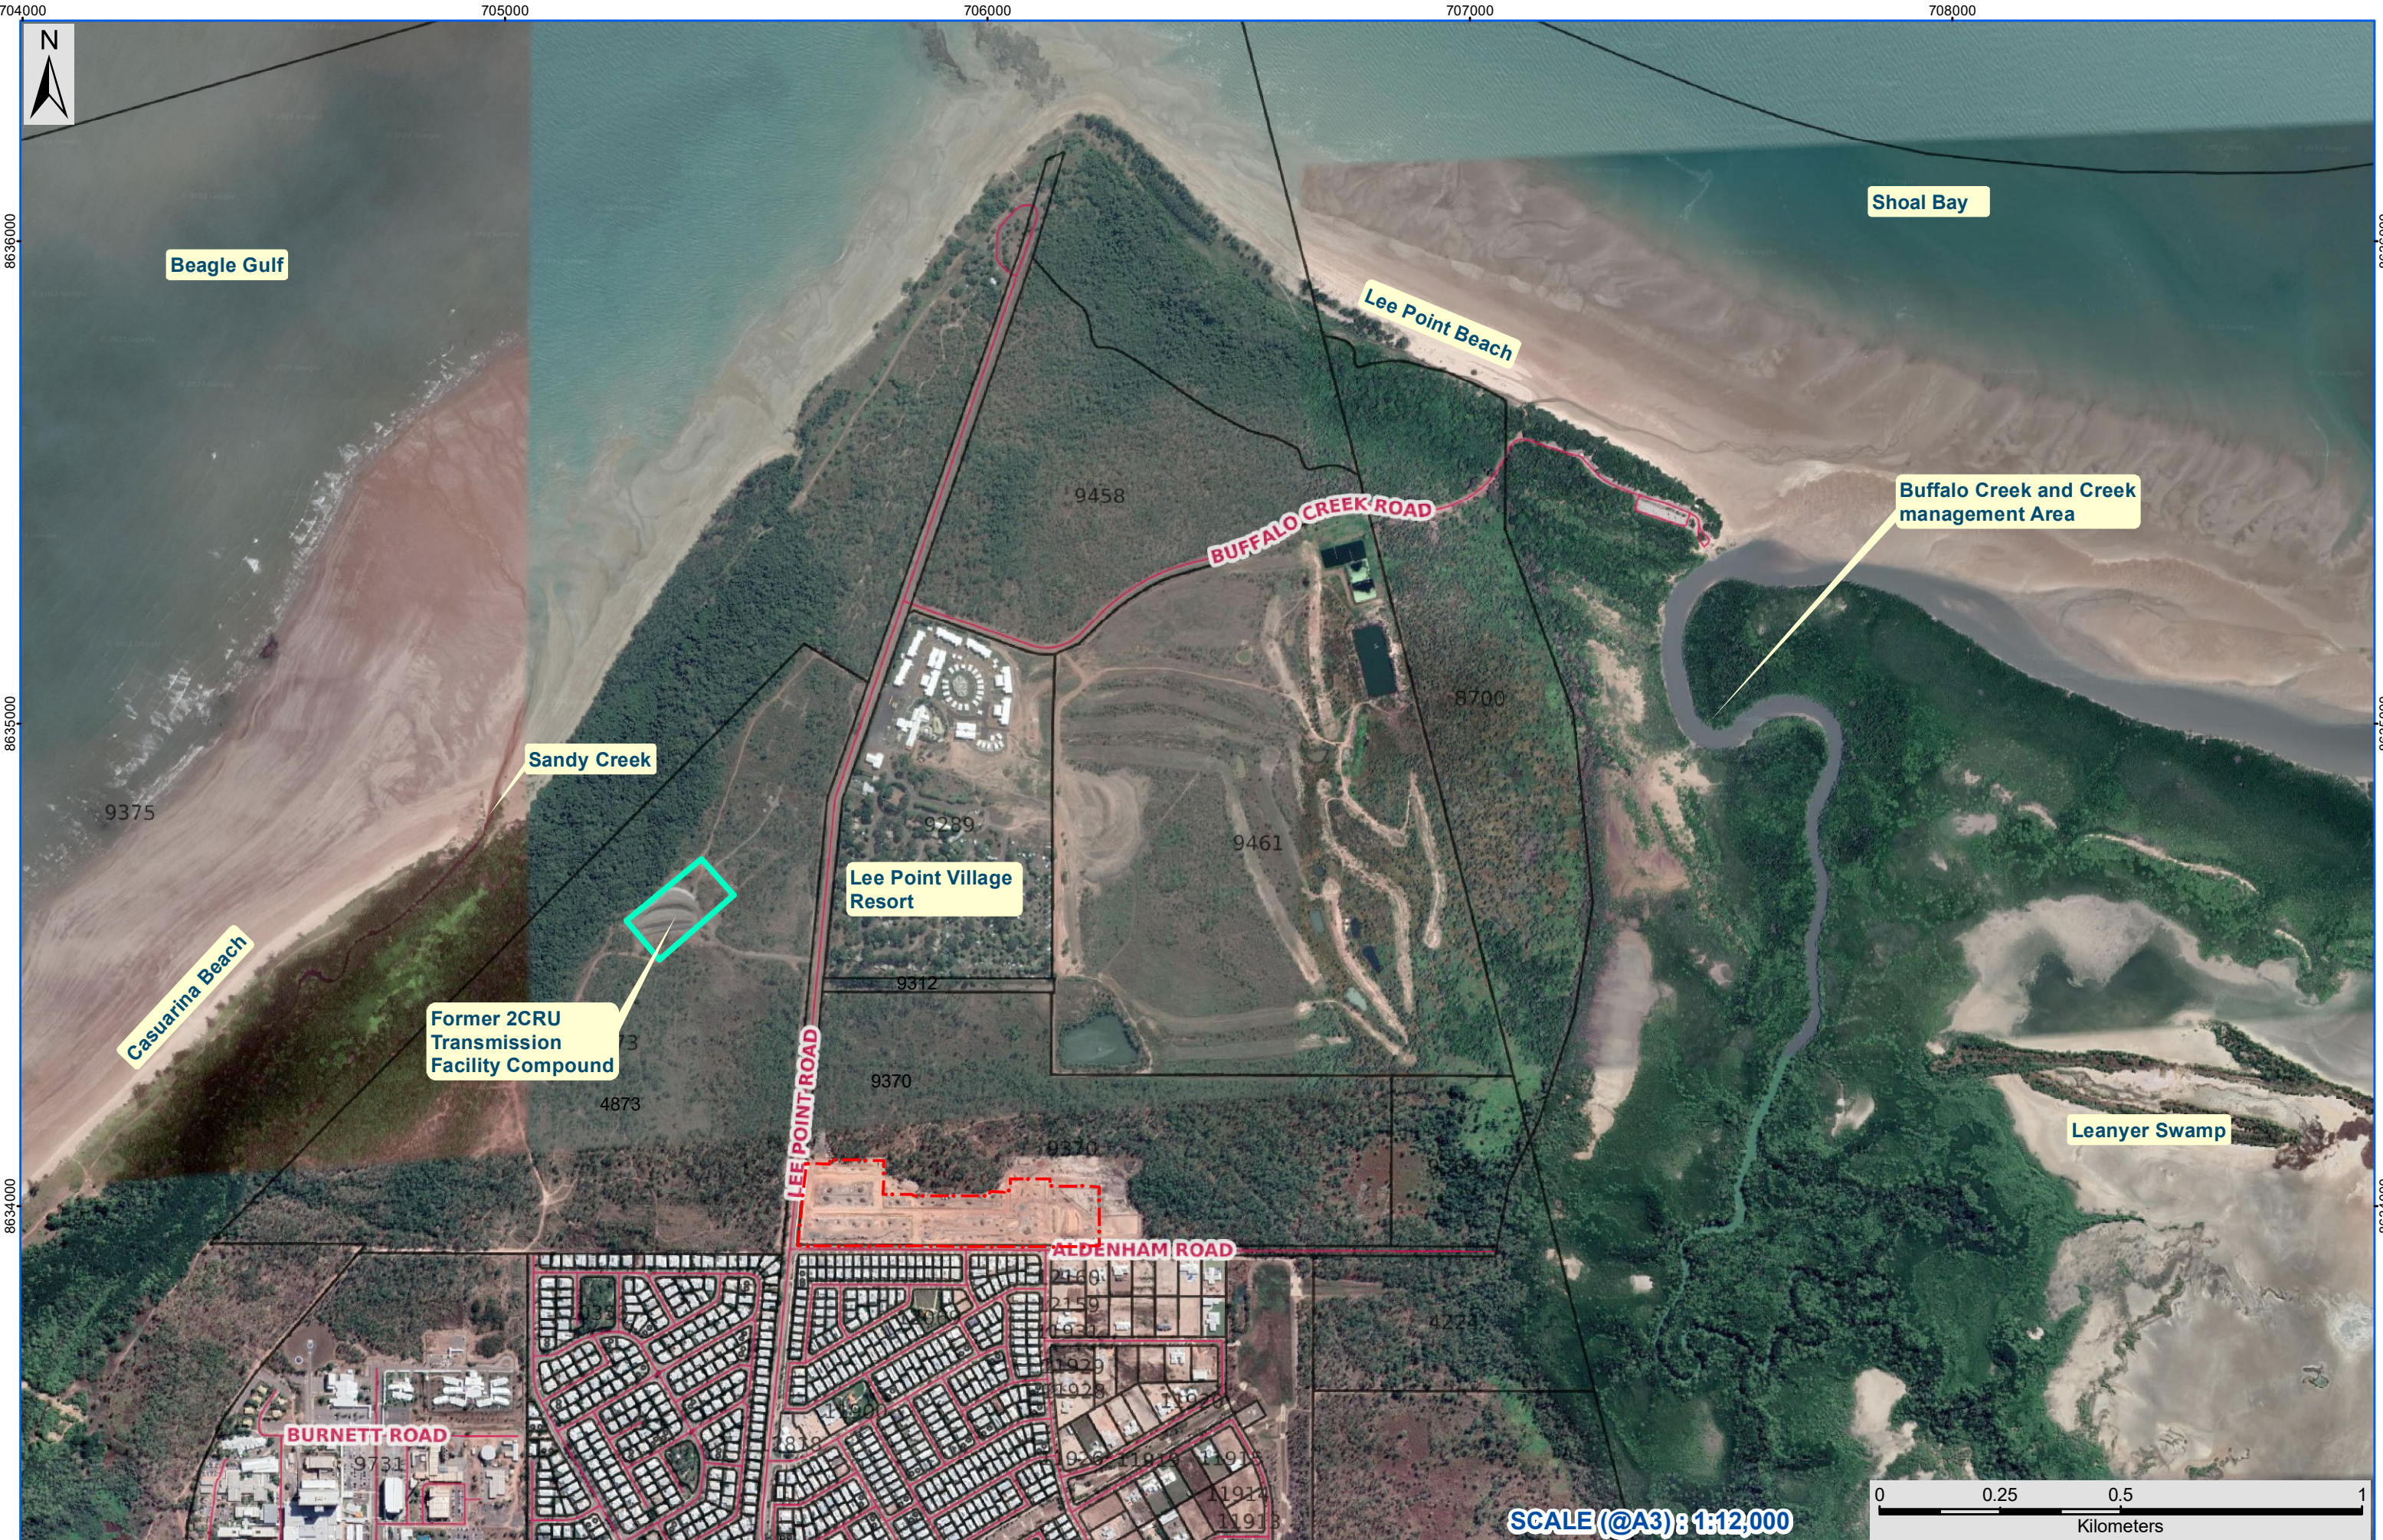
## Figure 2: Lot Plan

A figure showing the Lots referenced in this section is provided as Figure 2.
