Environmental Audit Report
6 Stuart Highway, Stuart Park
Darwin, Northern Territory 0800

Prepared for:
Mobil Oil Australia Ltd

Prepared by:
Australian Environmental Auditors Pty Ltd

**Environmental Audit Report
Former Mobil Darwin Coastal Bulk Plant
6 Stuart Highway (Dinah Beach Road), Stuart Park
Darwin, Northern Territory 0800**

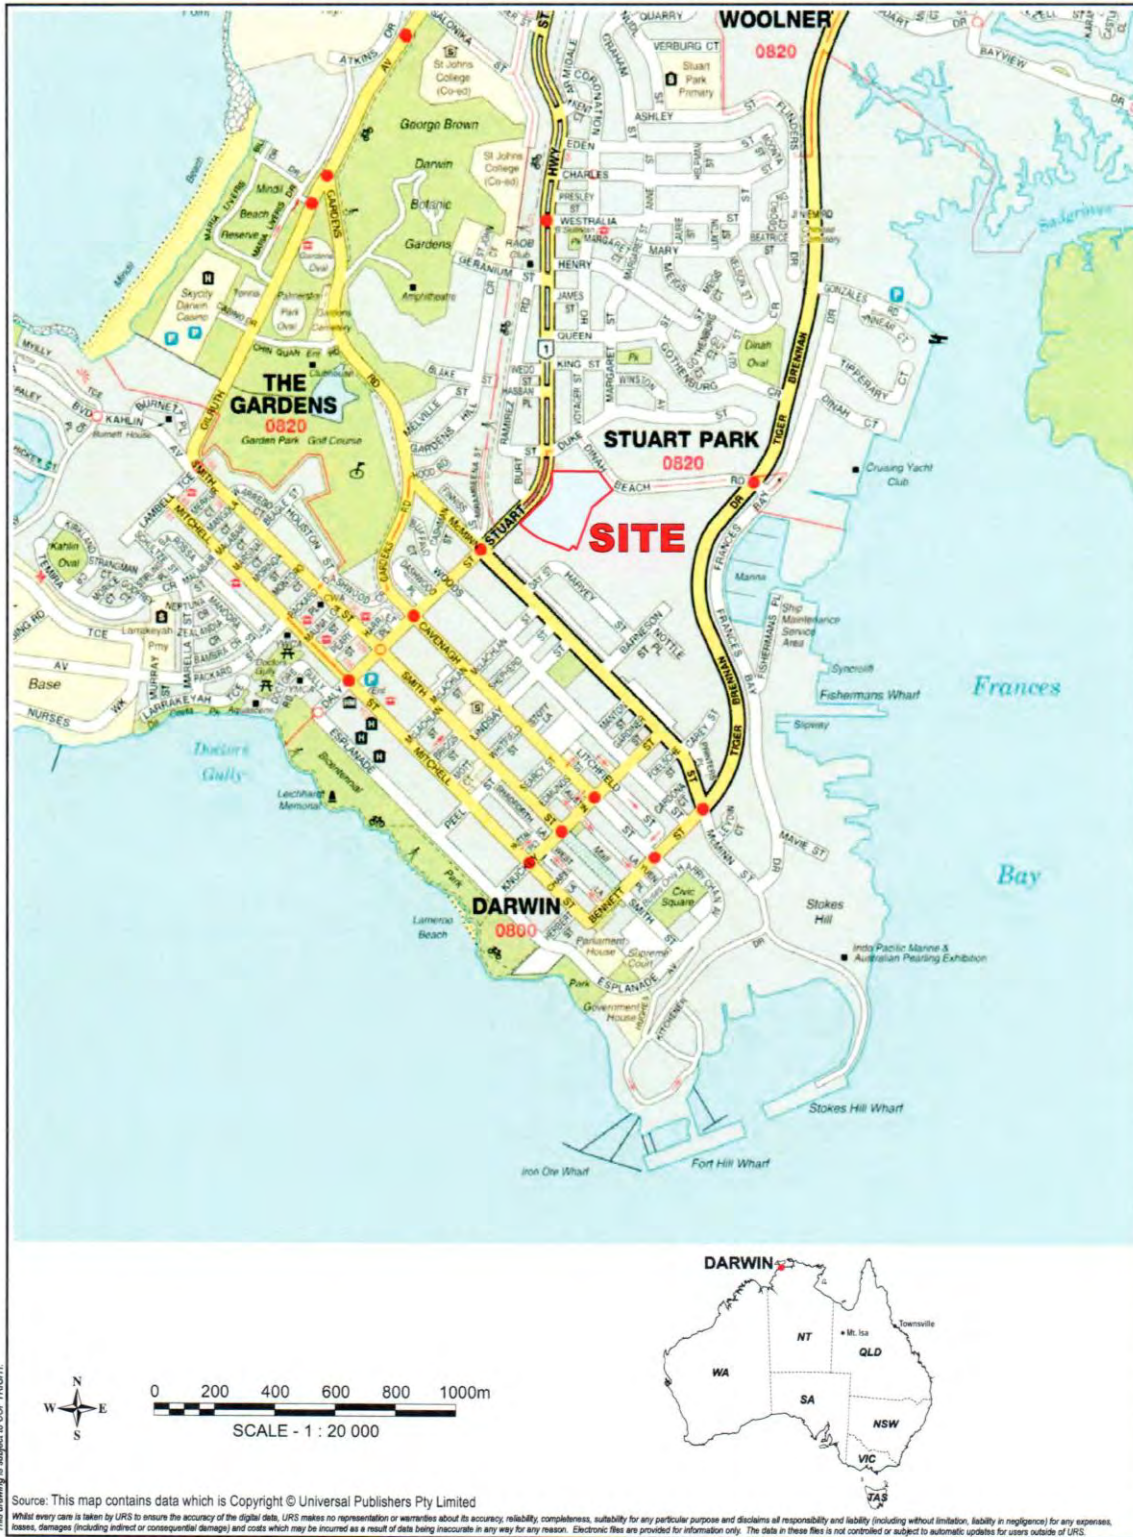
Figure 1 – Site Location (Source: URS 2013a)

A site location plan is provided as **Figure 1**. A plan displaying significant features at the site as reported prior to the present auditor’s involvement is provided in **Figure 2**.

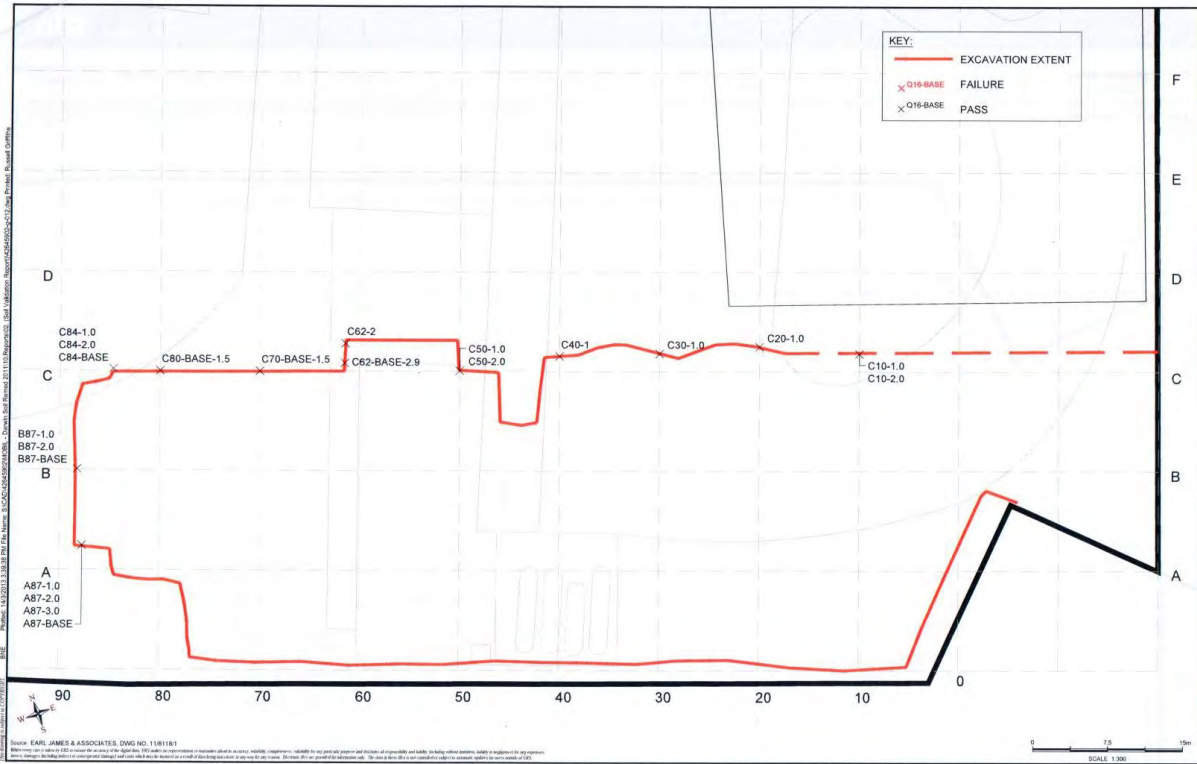
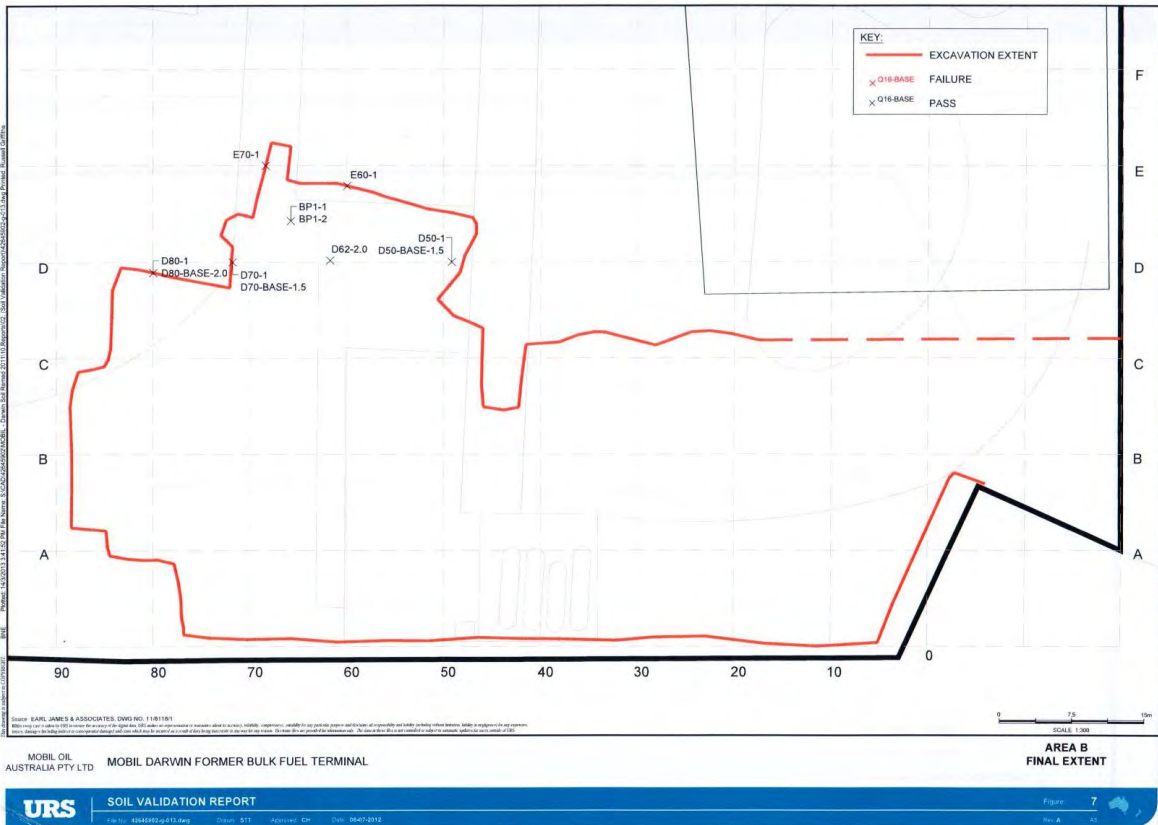
Figure 7 –Extent of ‘Area B’ Excavations (Source: URS 2013a)

Of the initial samples collected for validation purposes, 11 samples failed the RBTLs and required excavations to be extended and an additional 10 validation samples were collected and analysed. At the final extent of excavations all results were below the RBTLs.

(a) ‘Area B’ initial extent

(b) 'Area B' secondary step out

(c) 'Area B' final extent
