## **Environmental Audit Report (53V)**

**Marrara Detention Basin – 226 McMillans Road, Marrara NT**

Prepared for:  
**Department of Infrastructure, Planning and Logistics**

Date:  
**13 November 2019**

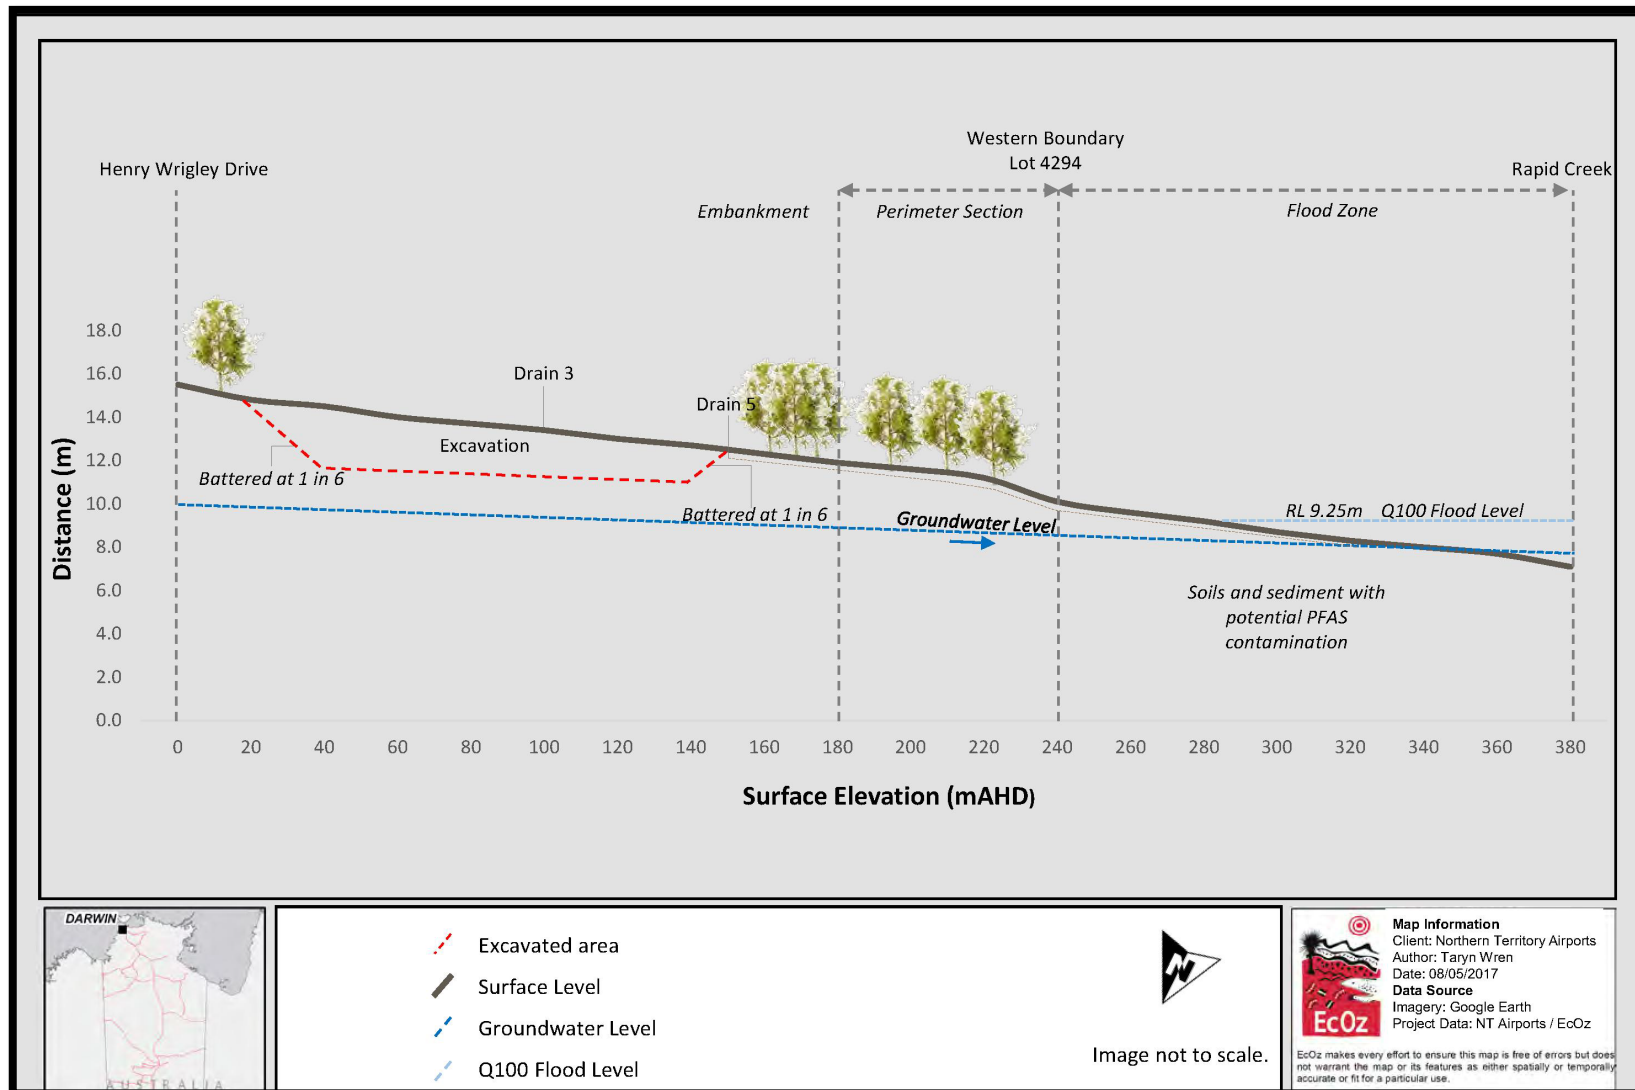
**Figure 3: Conceptual Site Model**  
(Source: EcOz)

A conceptual site model (CSM) was prepared by EcOz (2017). The Auditor considers the CSM prepared by EcOz to be representative of the site conditions.

Since all dry weight results and leachable concentrations of PFAS were below assessment criteria, potential for migration of contaminants to underlying groundwater and for contaminants to migrate off site via groundwater, are low. This potential risk is further mitigated by the reduced water infiltration due to the design and construction of the detention basin to be water retaining.

A copy of the EcOz CSM is included as Figure 3.
