ENVIRONMENTAL AUDIT REPORT

Lot 611 Wadeye Community

Report Number. 147663038-003-R-Rev0

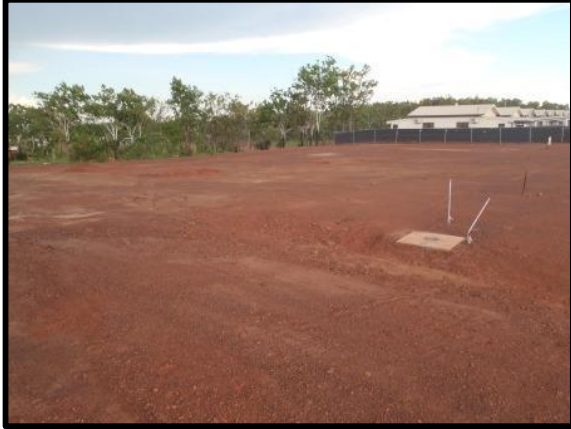
Photograph 1

LOT AND PLAN	FIELD OBSERVATIONS
Lot 611 on NT Portion 1637	The site comprised of near-level cleared land, devoid of any vegetation. All evidence of the fuel storage and airport apron had been removed prior to the inspection. No staining or indication (odours etc) of contamination within fill or natural materials beneath during the investigation.
Lot 215 on NT Portion 1637 (Neighbouring allotment)	Site infrastructure visible and remaining onsite which was observed was the former airport terminal building (existing) within semi-mature tress to the north.
Lot 613 on NT Portion 1637 (Neighbouring allotment)	Lot 613 to the south included a newly constructed residential dwelling and carport. The property was devoid of any vegetation, and gradually slopes towards the east.
Lot 142 on NT Portion 1637 (Neighbouring allotment)	Lot 142 to the north included the Wadeye School infrastructure, and contains single-storey classrooms and covered common areas. The site was observed to contain sporadic semi-mature trees and grasses.

Taken from south of TP02 facing westward

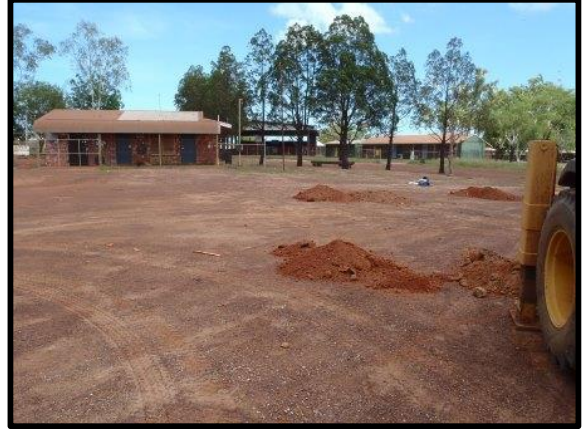
Photograph 2

Shot from TP04 facing north north west

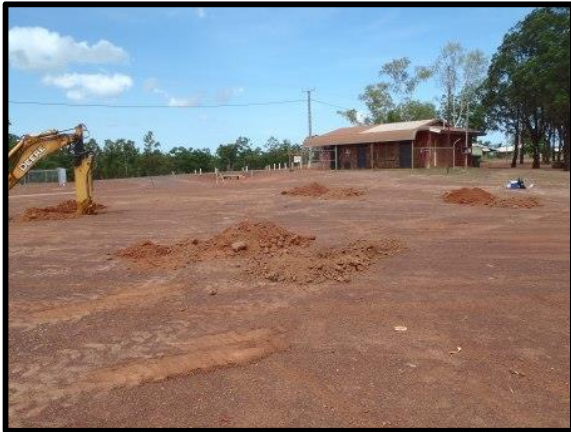
Photograph 3

Shot from TP03 towards the old terminal building

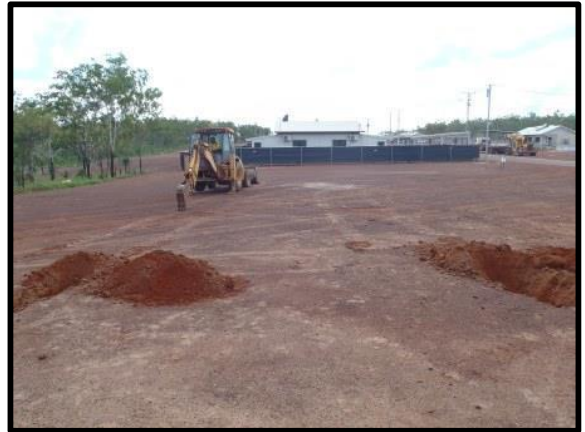
Photograph 4

Shot across site looking towards the south east
