Information sheet for environmental audits and preliminary risk screen assessments (PRSAs)

The audit was originally commissioned by the Ngurratjuta/Pmara Ntjarra Aboriginal Corporation, as the former owners of the audit site, to satisfy conditions of a notice to carry out an environmental audit program issued by the Northern Territory Environment Protection Authority (NT EPA) pursuant to Section 48(1) of the *Waste Management and Pollution Control Act 1998*.

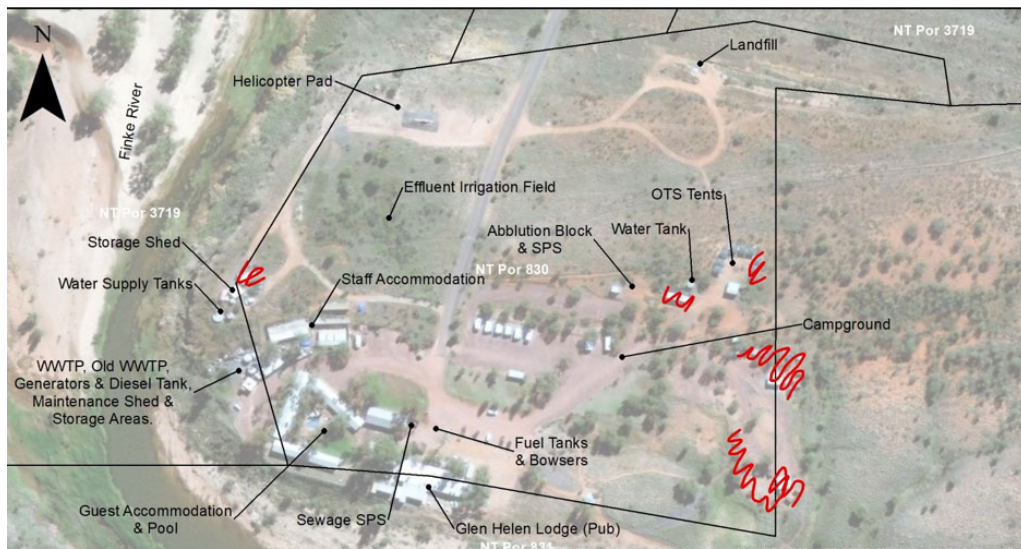
The area of interest for this audit program is the former fuel storage and bowser area which was located near the other lodge buildings and car parking areas. Fuel storage was noted to include two operational fuel tanks (1 x diesel approximately 5,000L capacity and 1 x petrol / opal product tank approximately 12,000L capacity). There was also suspected to be another possible redundant underground fuel tank present based on an additional vent pipe adjacent to the unleaded fuel bowser. Ultimately there were three USTs (underground storage tanks) identified in that location, which were removed during 2021 / 2022 with further details provided later.

Figure 3. Site Layout (Low Ecological, 2021)

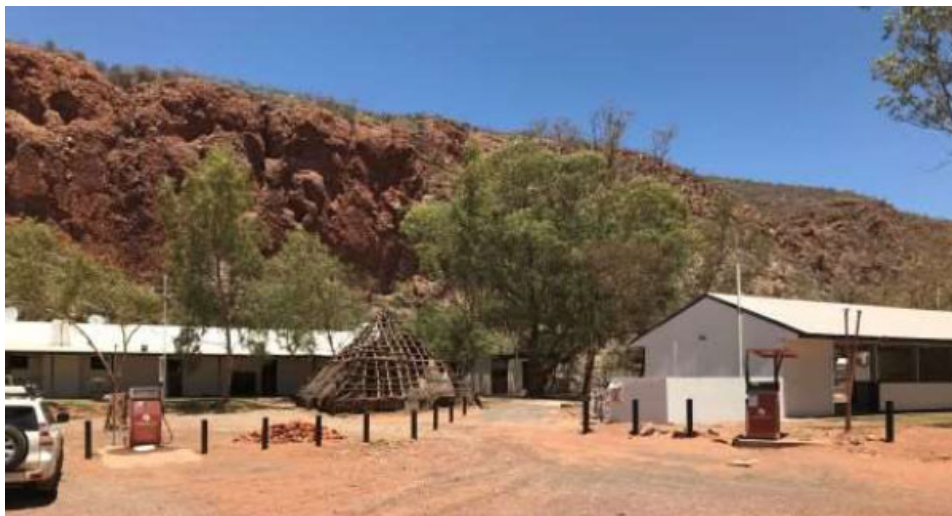
Figure 4. Fuel bowser area looking SW – Finke River and escarpment behind (Source:- Low Ecological)

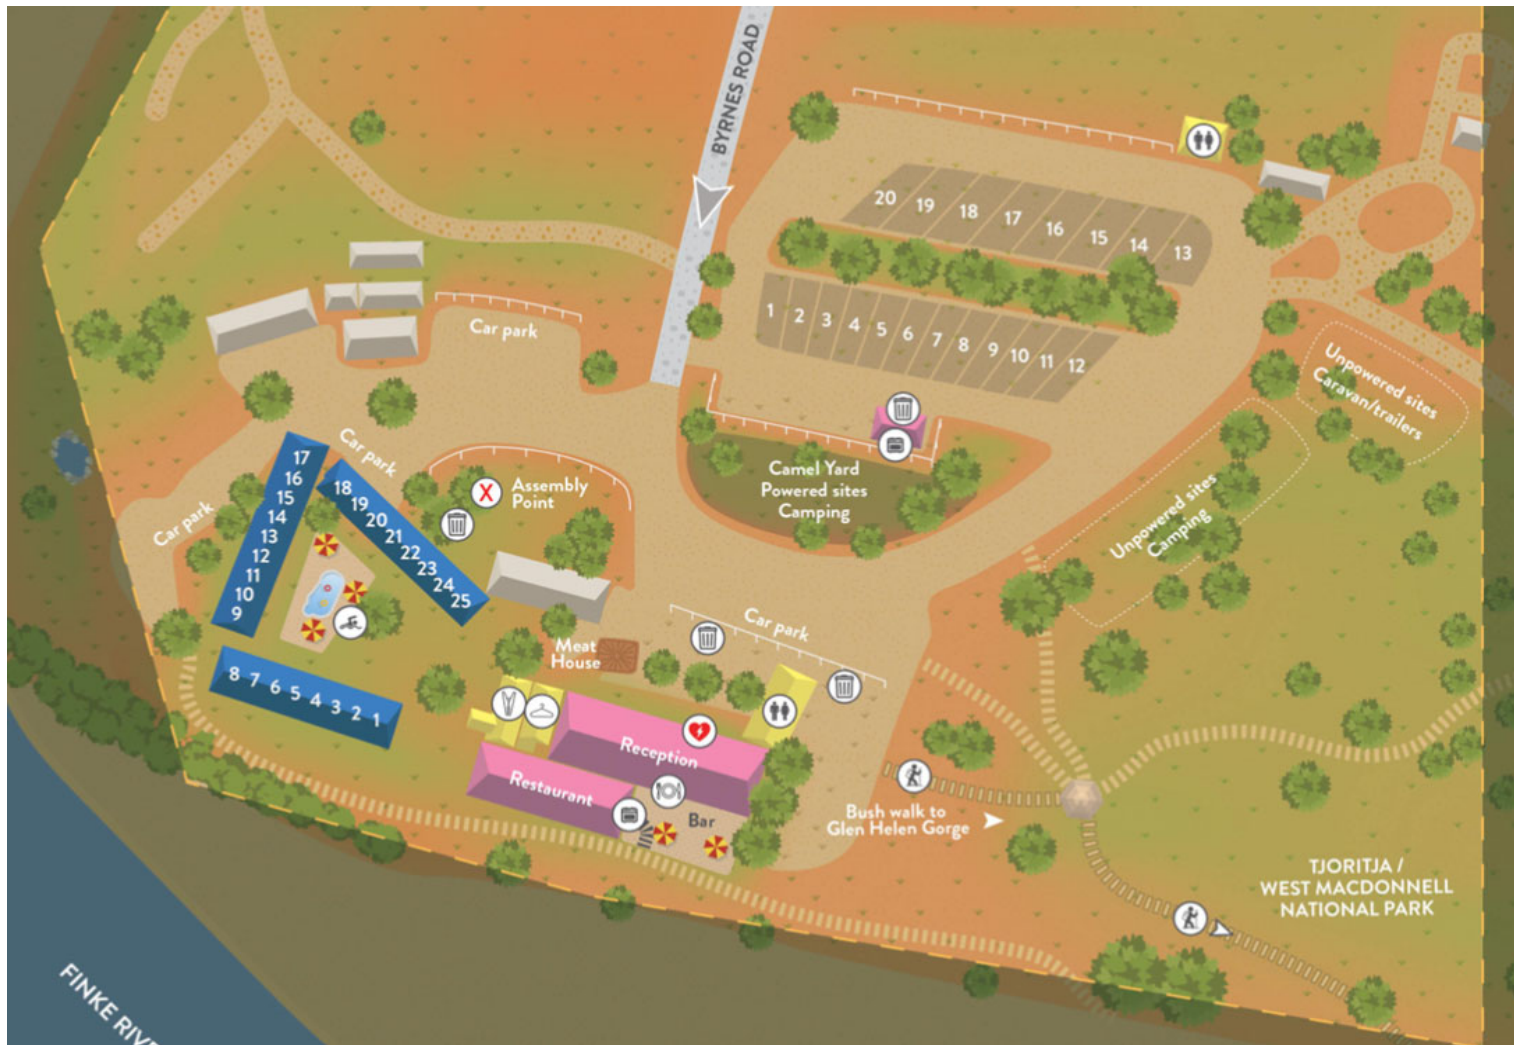
Figure 5. Layout of accomodation and related buildings (Discovery Parks, 2022)

At the time of this audit report, the accommodation facilities at Glen Helen are closed. It is understood that Discovery Parks intend to continue operating the property for short stay accommodation with powered and unpowered camping areas for caravans, tents and onsite cabins. A recent plan of the accommodation park is provided on the following page.

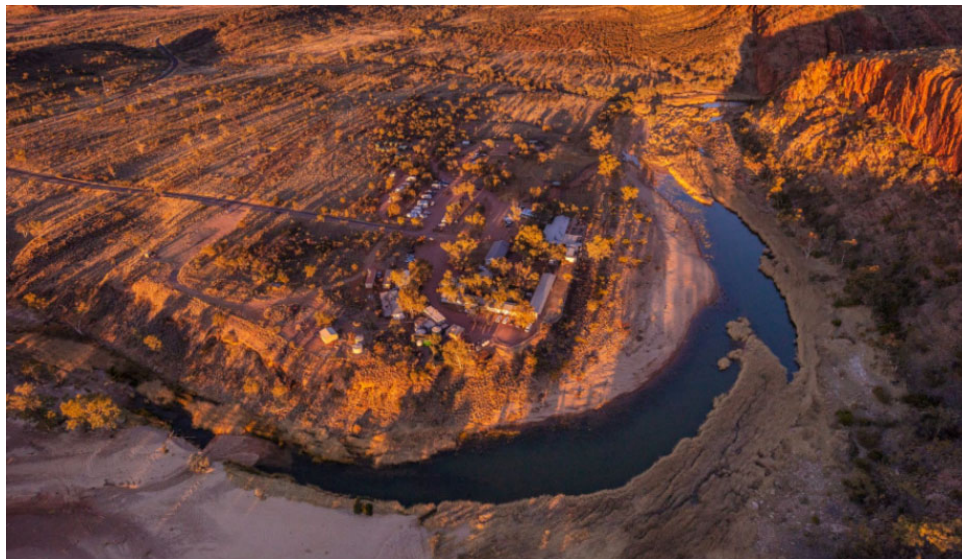
*Figure 6. Aerial photograph Glen Helen accommodation looking east
(Discovery Parks, 2022)*

The tourist accommodation / campsite areas at Glen Helen Lodge are on relatively flat land at an elevation of about 635m AHD. The MacDonnell Ranges are oriented approximately east-west with one of the ranges forming a large escarpment on the south side of the Finke River at Glen Helen Lodge, rising to about 800m AHD. The reporting discussed the surface drainage at Glen Helen Lodge - “the area around each of the fuel systems slopes towards the large carpark area to the east of the tanks” and “stormwater runoff flows from the carpark to the east into a vegetated lower lying area which then turns south and flows into the Finke River”. The reporting notes that Glen Helen Lodge does not extract any water from the Finke River, with its water for the site supplied by a groundwater bore – discussed in next section.

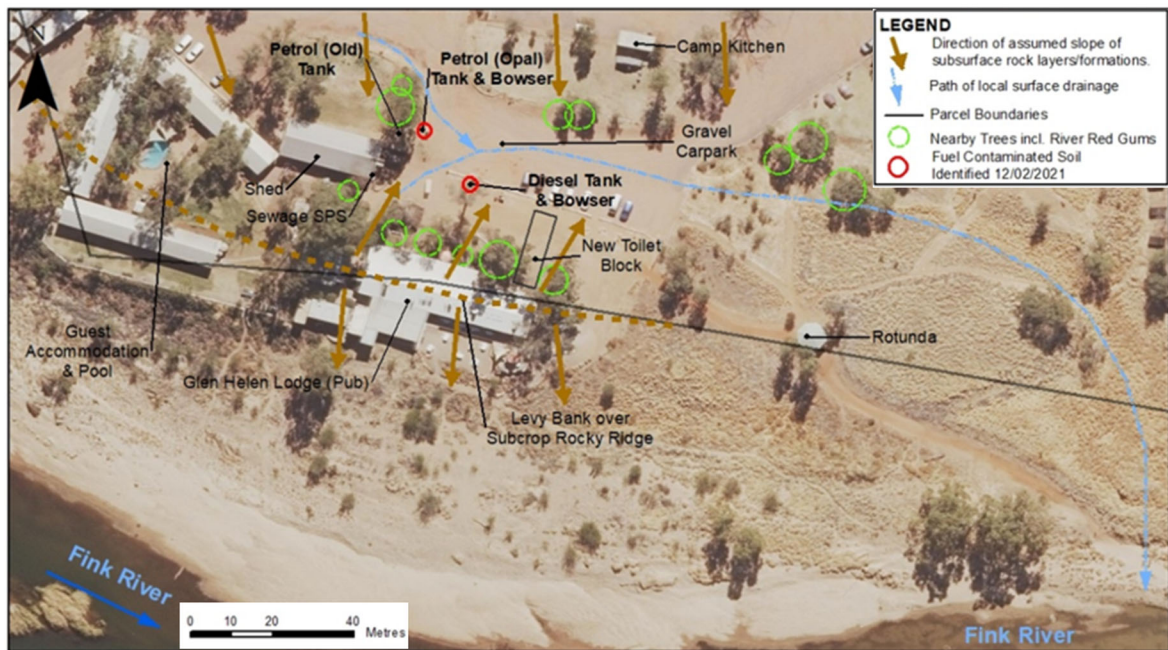
Figure 8. Site layout showing surface drainage and Finke River banks
(Low Ecological, 2021)

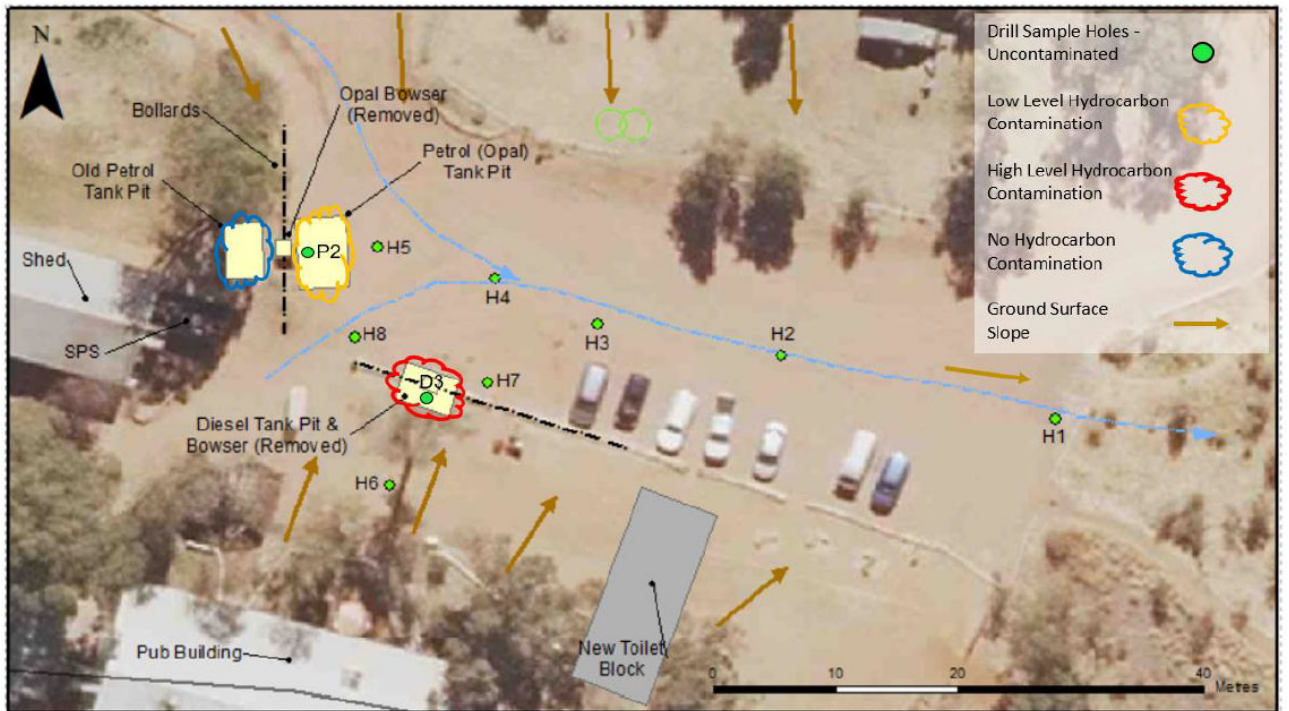
Figure 11. Test Locations – Further Soil Assessment, April 2021 (Low Ecological, 2021)

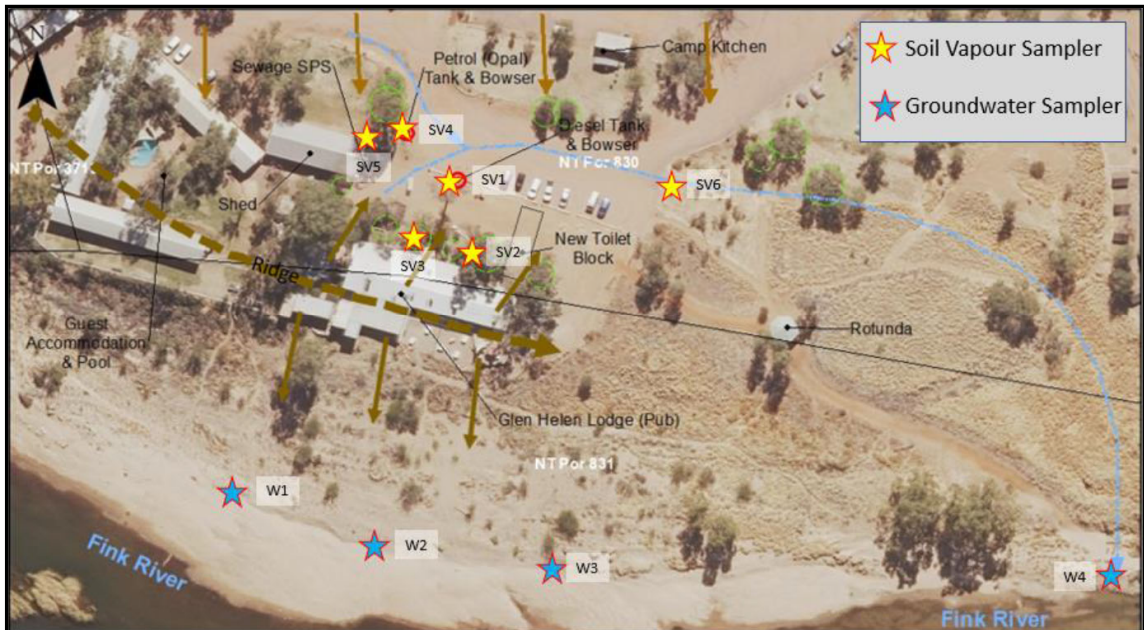
Figure 12. Test Locations – Soil vapour bores and surface water samples, September 2021 (Low Ecological, 2022)

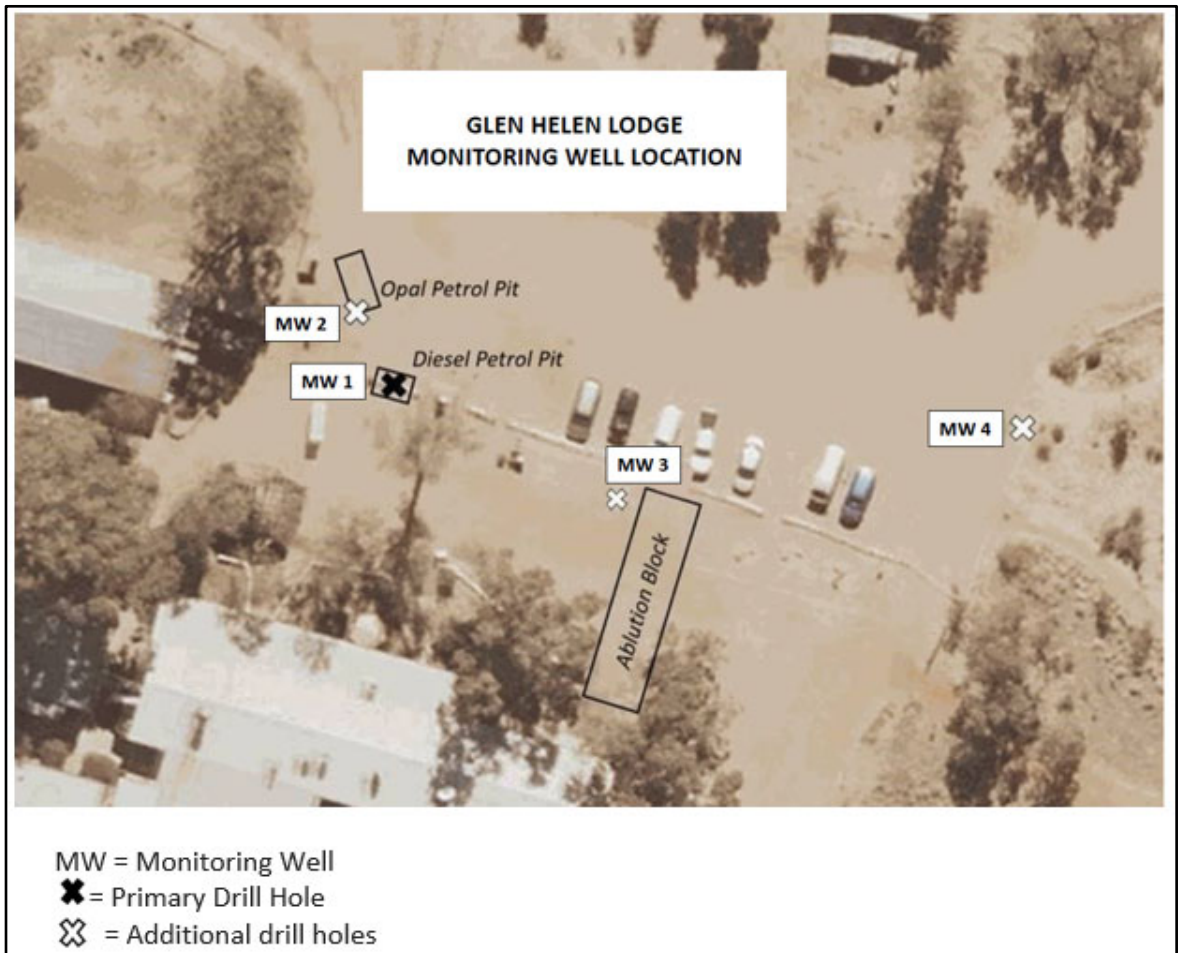
Figure 13. Test Locations – Groundwater bore locations (Low Ecological, 2022)

A network of groundwater monitoring bores has been established at the Site by Low Ecological. Bores were installed to depths varying from approximately 15-19m, targeting the upper portion of the water table aquifer, which is located within fractured rock believed to be limestone and dolostone of the Goyder Formation. Standing water levels varied from approximately 5.26 to 6.13m below ground level.

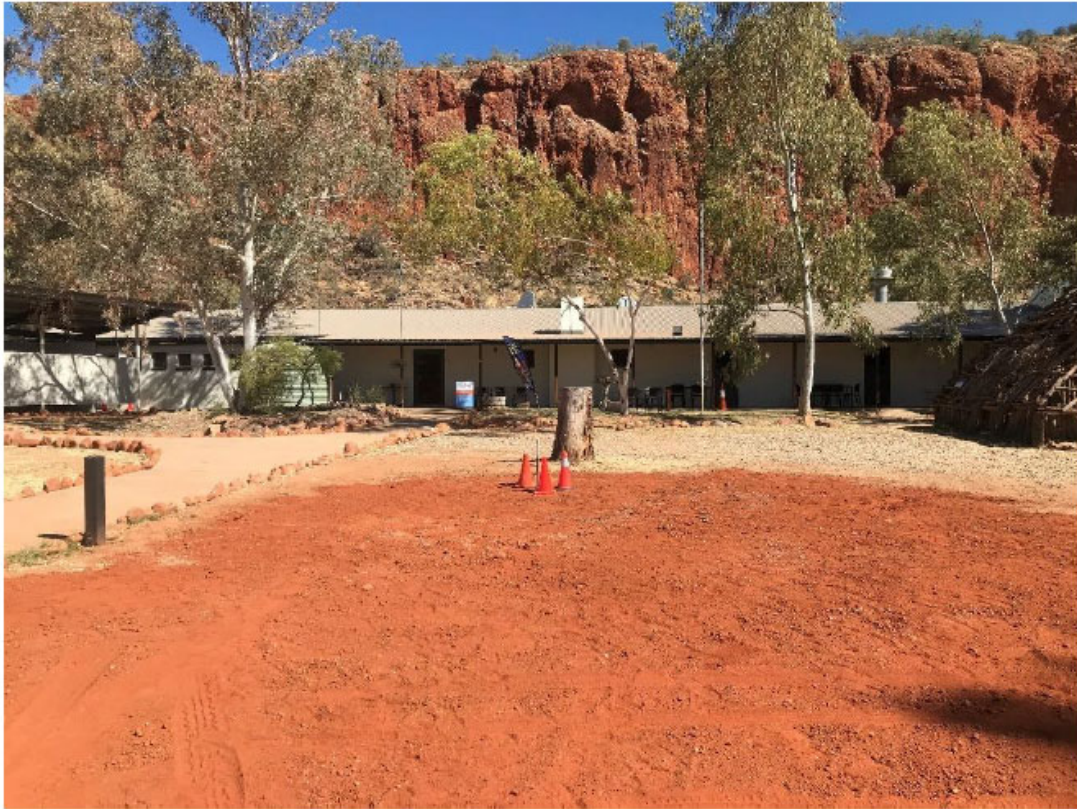
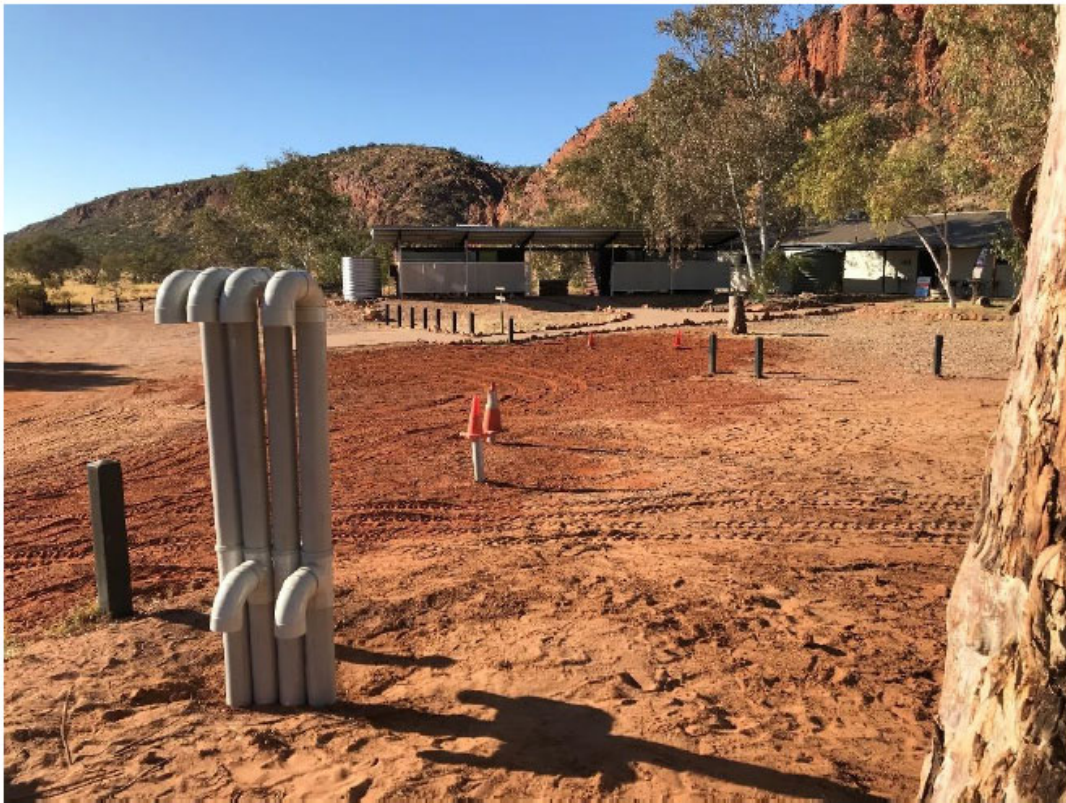
Perforated pipes were installed into the base of the diesel and petrol / Opal pits with the intention of providing a simple / passive connection between ambient air and the subsurface in the pits. It was thought this may improve the rate of natural biodegradation processes for the residual impacted soils in the base of those pits, as the depth of oxygen ingress for natural soils in this area is not well understood. The pipes were perforated PVC and were covered in a geotextile to protect them from becoming clogged. The pipes were connected to the surface via vertical riser pipes and vent outlets.

It was reported the pits were backfilled with a clean imported soil product obtained from Alice Springs. There were no further details provided in relation to the material source or assessment of its suitability for this purpose, other than noting it was a road base product with some clay content. Concept sketches of the planned reinstatement works are included in the audit report appendices.

*Figure 15. Reinstated Tank Pit Areas – diesel (top) and petrol / Opal (below)
(Photos by Low Ecological)*

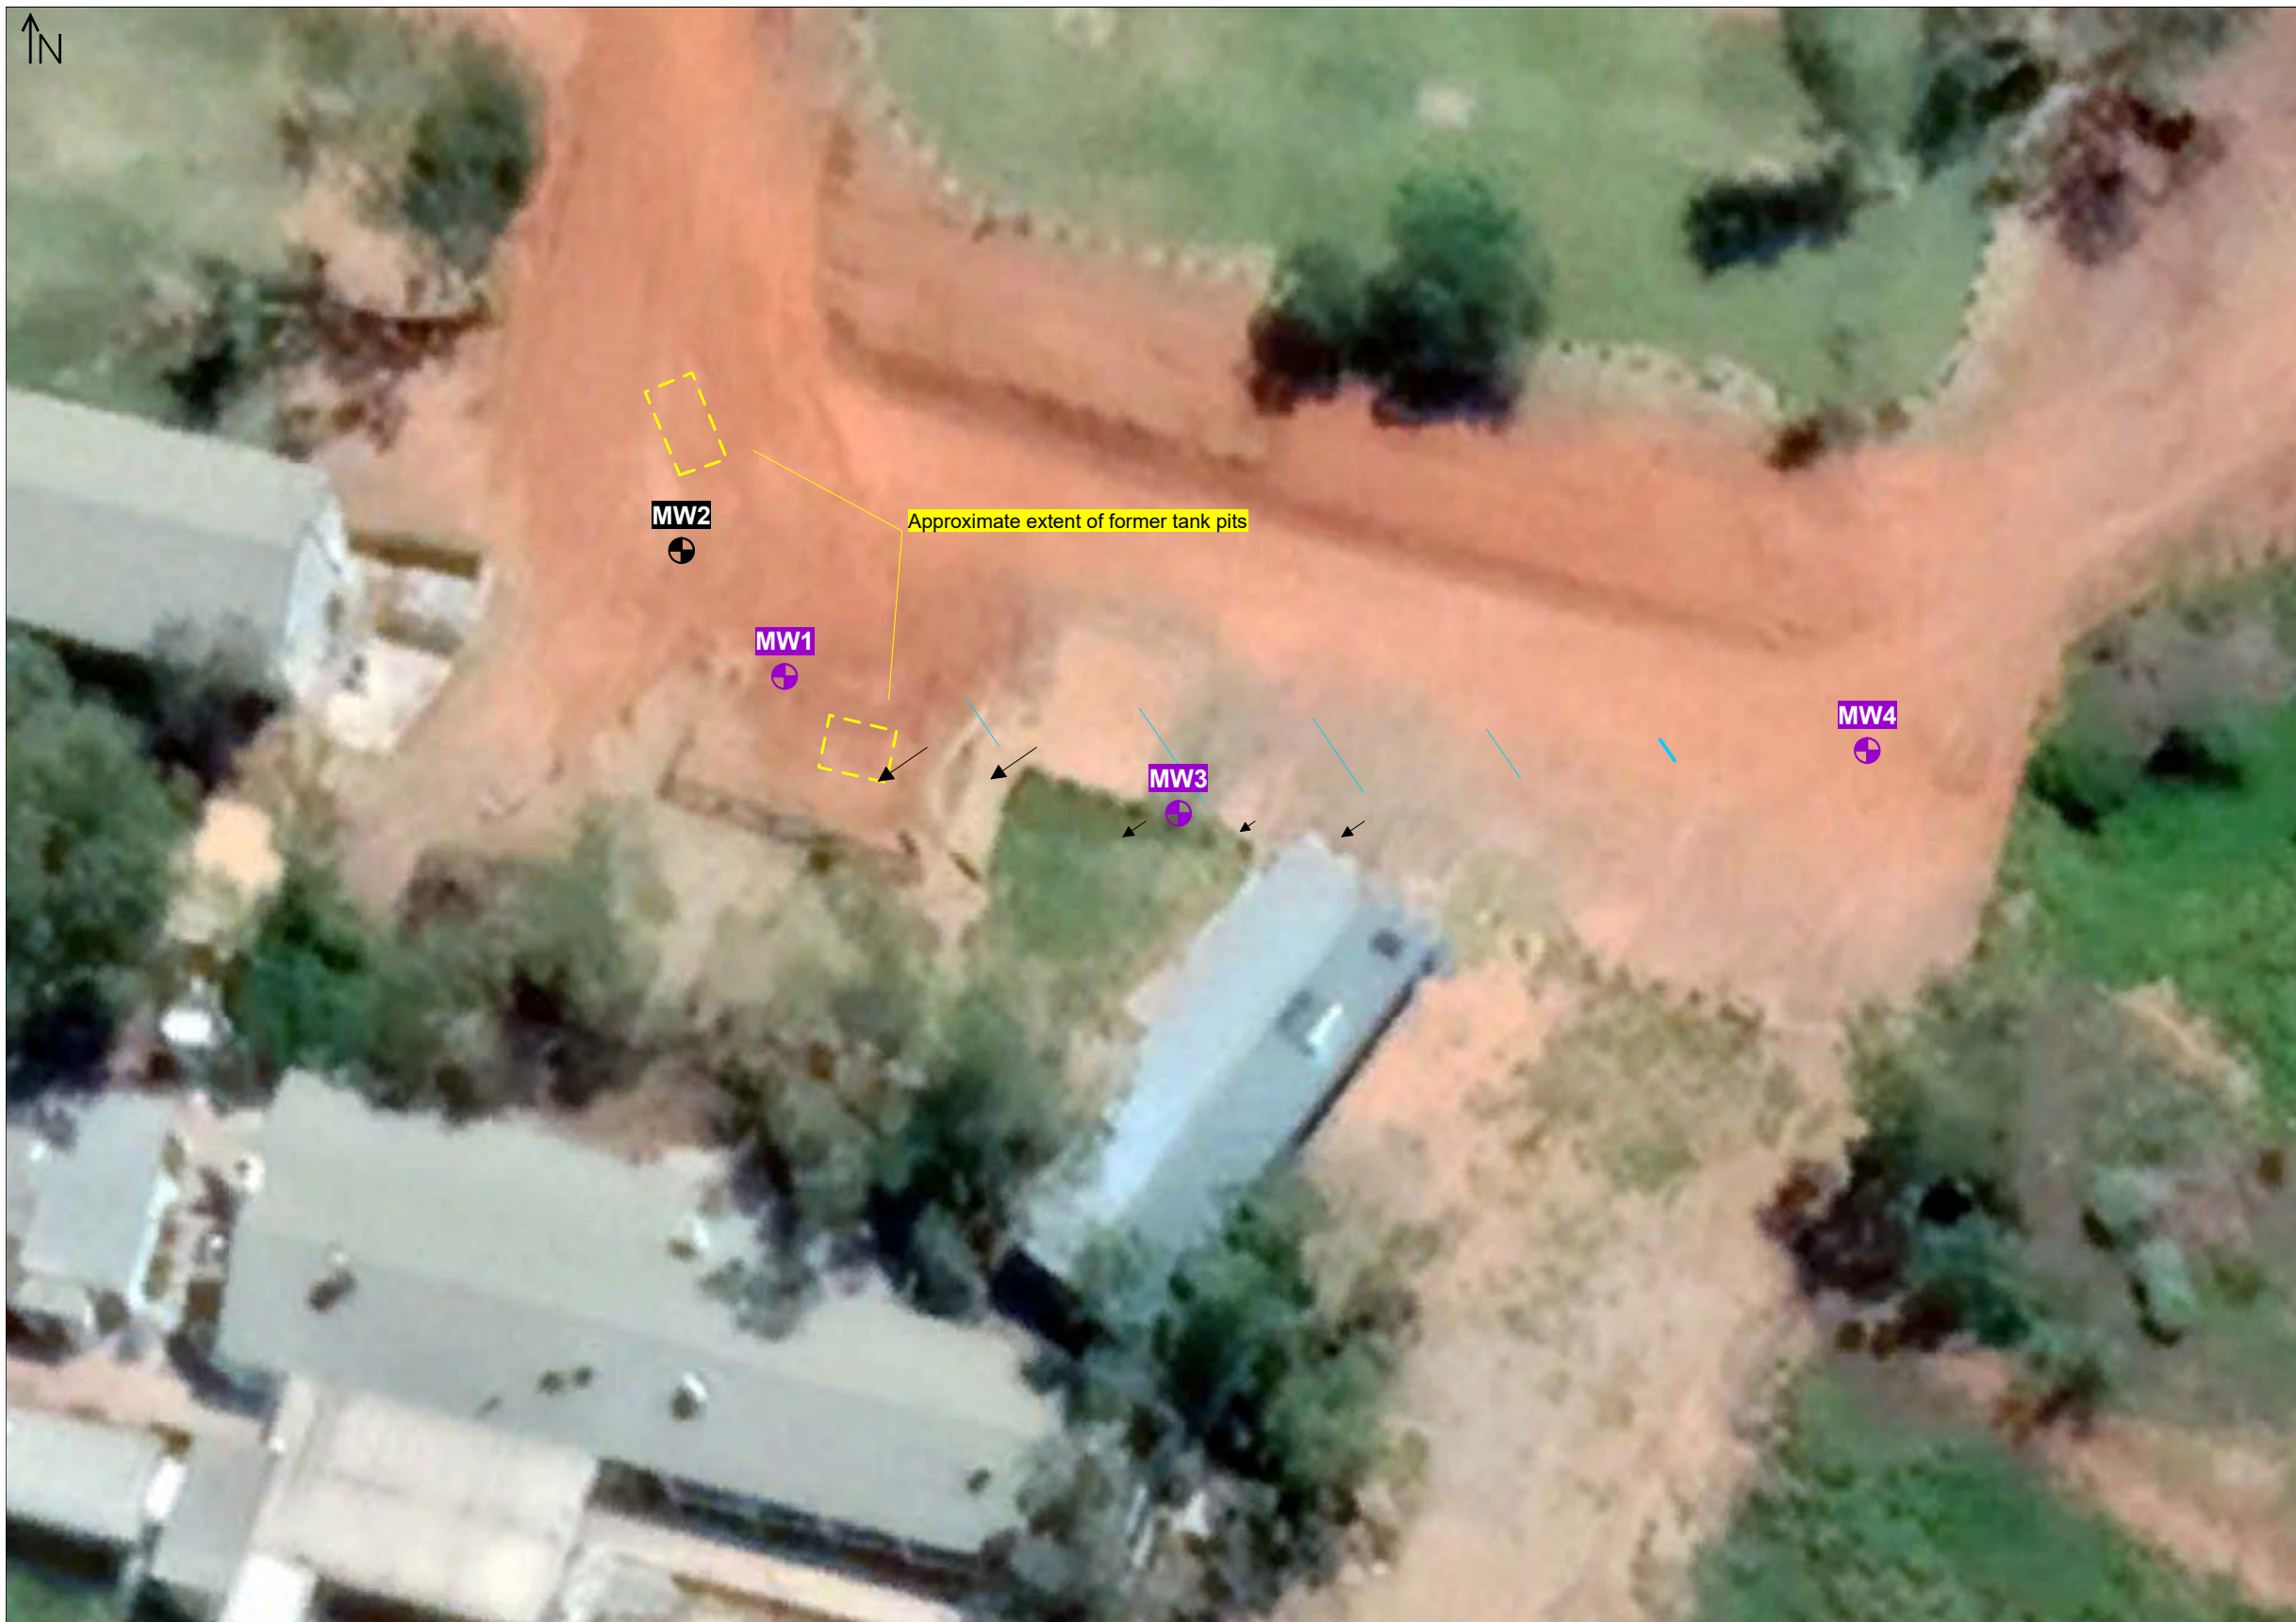
Figure 1 - Groundwater Well Locations
Glen Helen Discovery Park
Groundwater Monitoring Plan

1. The extent of the former tank pits are approximate based on a plan provided by Low Ecological Services.
2. The position of MW1, MW3 and MW4 is based on a survey. The position of MW2 is approximate and based on a plan provided by Low Ecological Services.
3. Groundwater contours generated by Surfer software with a grid generated using triangulation with linear interpolation.

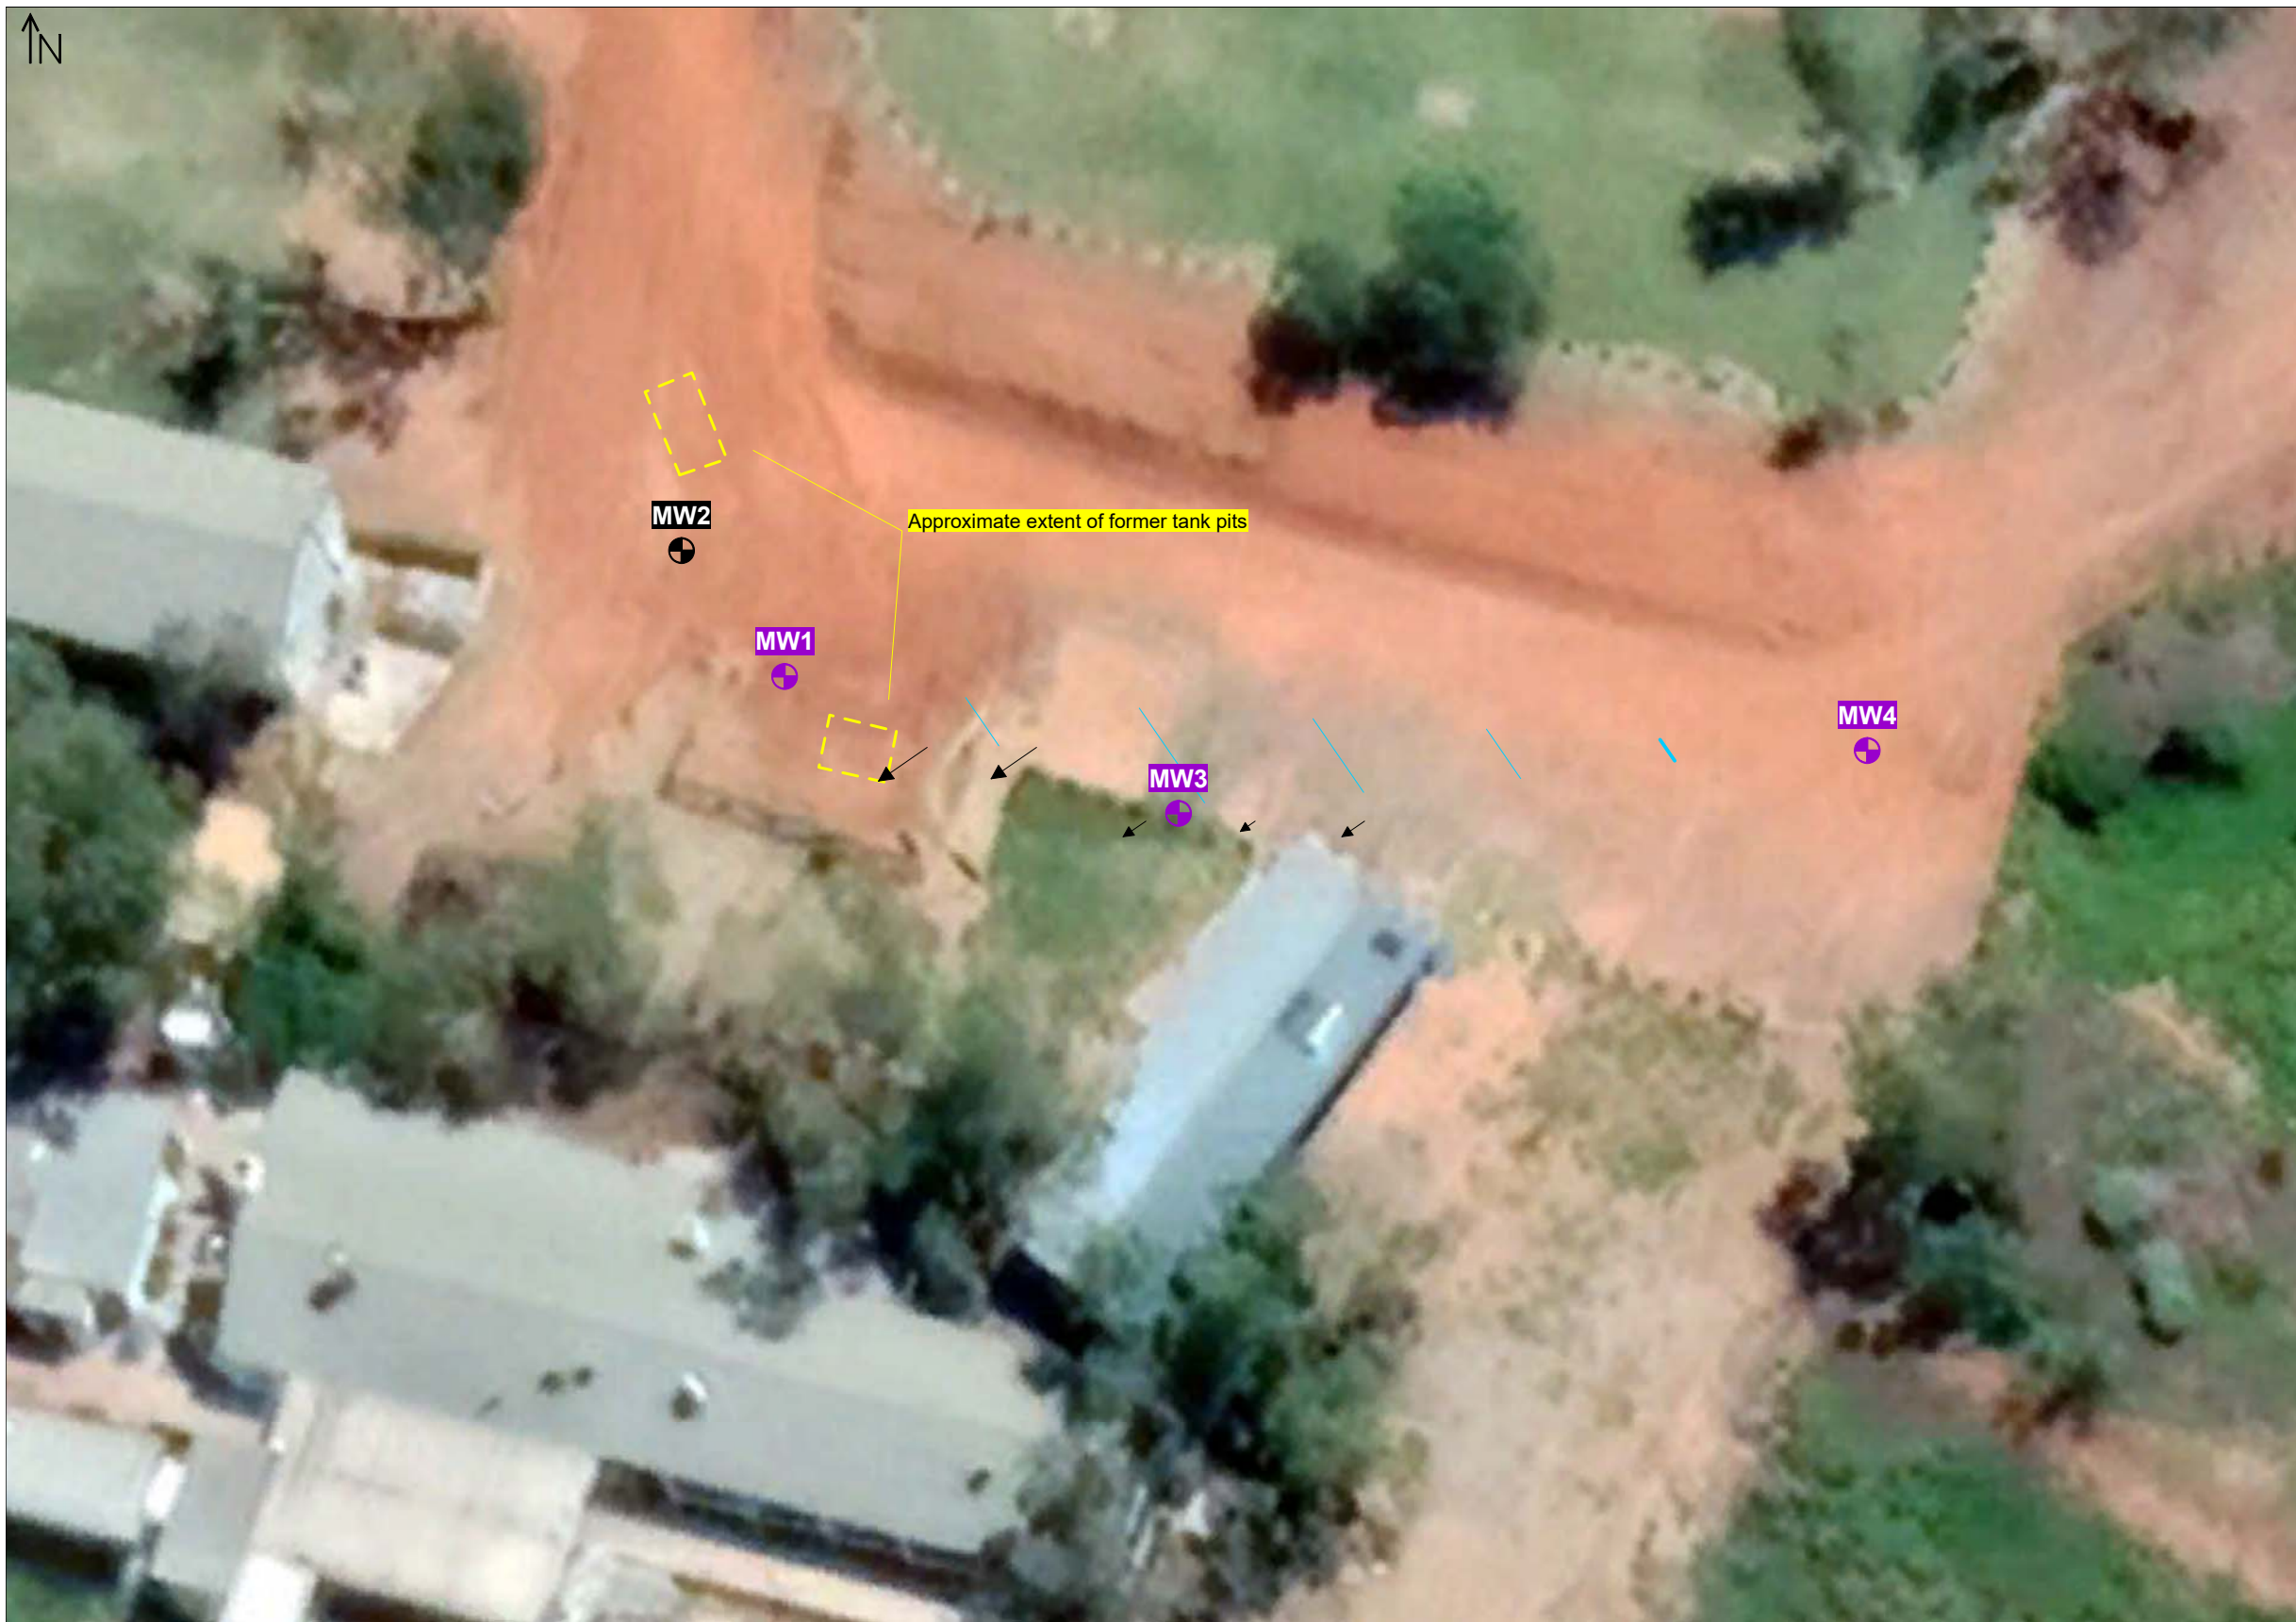
APPENDIX A
SITE PLAN

1. The extent of the former tank pits are approximate based on a plan provided by Low Ecological Services.
2. The position of MW1, MW3 and MW4 is based on a survey. The position of MW2 is approximate and based on a plan provided by Low Ecological Services.
3. Groundwater contours generated by Surfer software with a grid generated using triangulation with linear interpolation.
