# Information sheet for environmental audits and preliminary risk screen assessments (PRSAs)

5. The West McDonnell National Park is considered to be an area of ecological and cultural significance;
6. On 04 June 2021, LES submitted a report to the NT EPA titled "*Glen Helen Lodge Investigation for fuel Leakage from UPSS*" (the report), dated 03 June 2021;

# ATTACHMENT D LOCATIONS OF UPSS AND APPROXIMATE DRILLED DELINEATION BOREHOLES

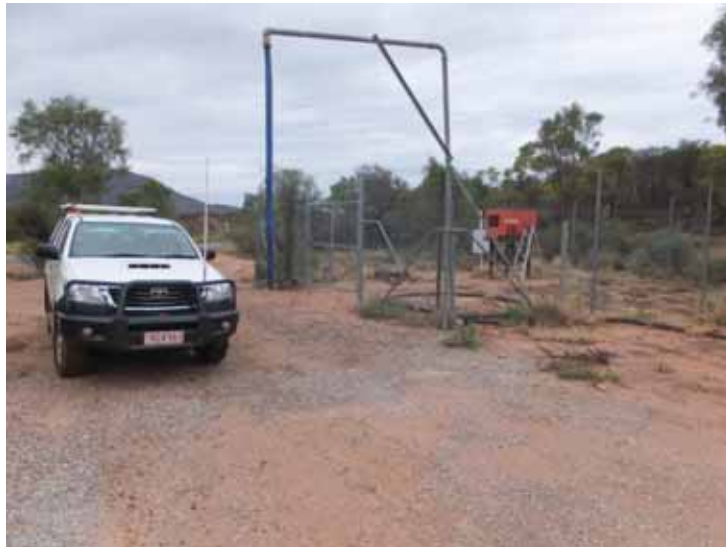
PHOTOGRAPH 1: VIEW OF THE NTG ROADS BORE RN18280, LOCATED ADJACENT TO NAMATJIRA DRIVE, 17KM WEST OF GLEN HELEN RESORT (E 247626, N 7384092)

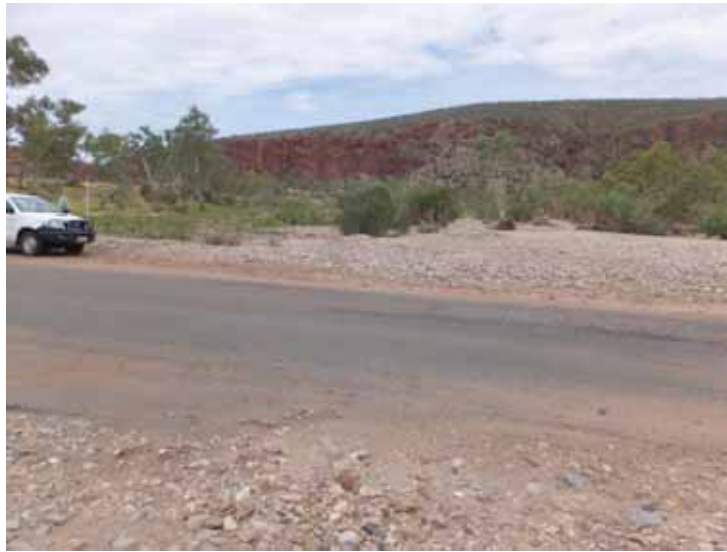
PHOTOGRAPH 2: NAMATJIRA DRIVE CHAINAGE (CH.) 85.7. VIEW OF THE FINKE RIVER CROSSING. THIS RIVER PROVIDES A SUBSTANTIAL OBSTACLE FOR THE CONSTRUCTION OF A PIPE LINE UNDER THE RIVER BED. ANY WORK WOULD REQUIRE AN AAPA AUTHORITY CERTIFICATE BECAUSE OF KNOWN SACRED SITES NEARBY.

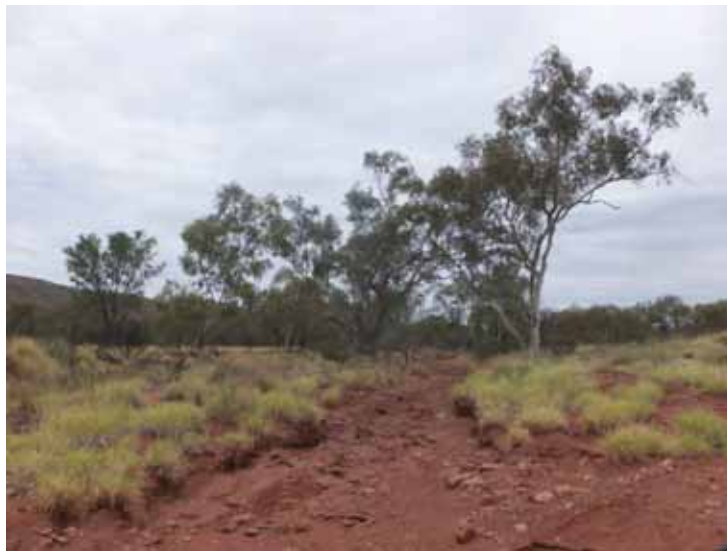
PHOTOGRAPH 3: NAMATJIRA DRIVE CH. 88.03. VIEW TO THE SOUTH OF A TYPICAL CREEK CROSSING. THERE ARE MORE THAN 10 OF THESE CREEKS THAT WOULD NEED TO BE TRENCHED FOR A PIPE LINE.

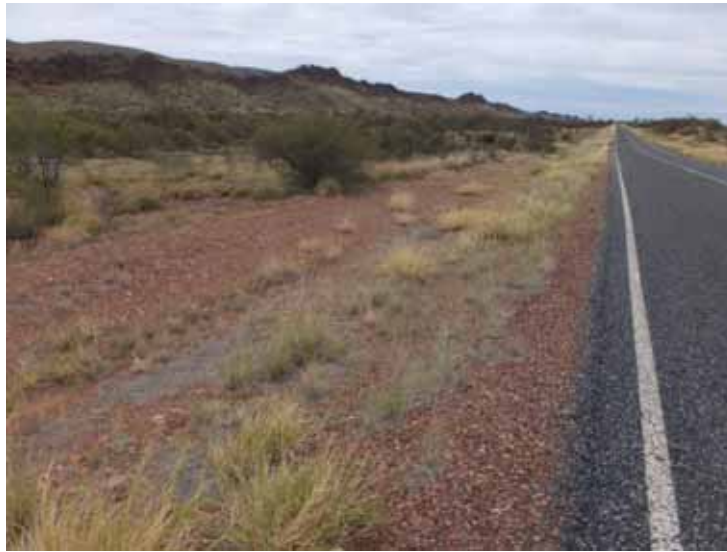
PHOTOGRAPH 4: NAMATJIRA DRIVE CH. 94. TYPICAL VIEW OF TABLE DRAIN AND VERGE. CONSTRUCTING A PIPE LINE ALONG THE ROAD WOULD REQUIRE TRENCHING IN VERY ROCKY SOIL. IMPORTED BEDDING AND PIPE EMBEDMENT MATERIAL WILL BE REQUIRED.

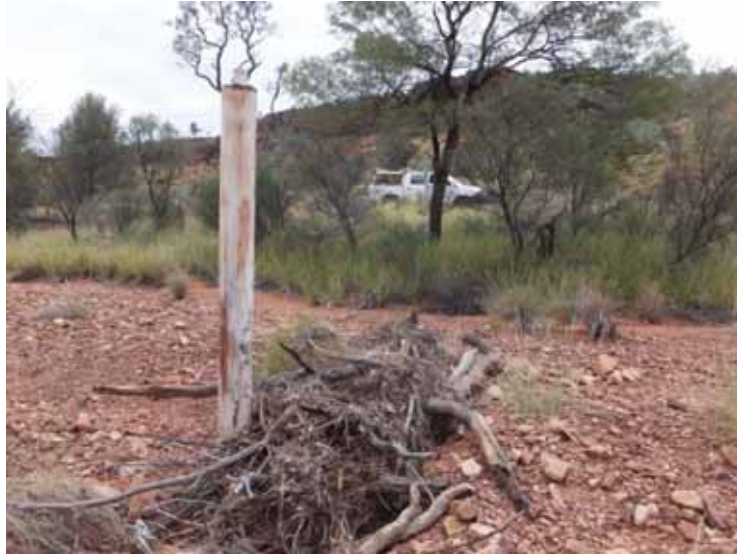
PHOTOGRAPH 6: VIEW OF BORE RN16354 LOCATED IN THE CREEK BED. IT WOULD BE PREFERABLE TO CLEAR A SITE ON THE BANK NEAR THE VEHICLE AND DRILL A NEW BORE TO 120M DEPTH.

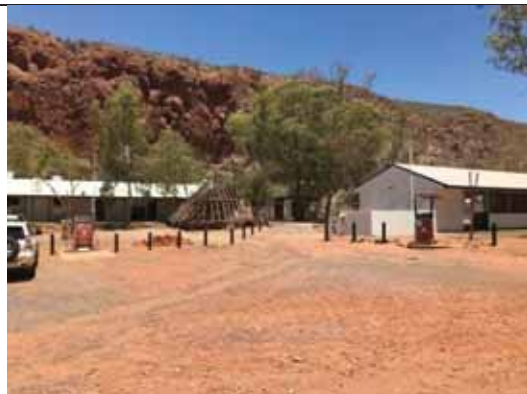
Photo: Fuel station on edge of gravel carpark.

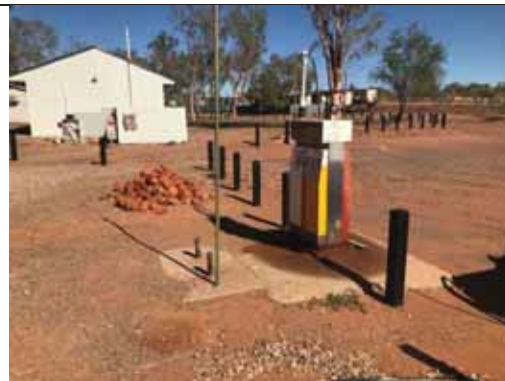
No significant contamination was observed from either bowser, tank or fill points. Fuel staining is present on the concrete and soil around the diesel bowser, and no staining was present around fill/dip points. There is likely minor fuel contamination of soil under the bowzers from small customer spillages. There were no other signs of leakage or spillage of fuel observed.

Photo: Diesel bowser, underground tank, fill and dip points, and vent – Note diesel staining on concrete around bowser.

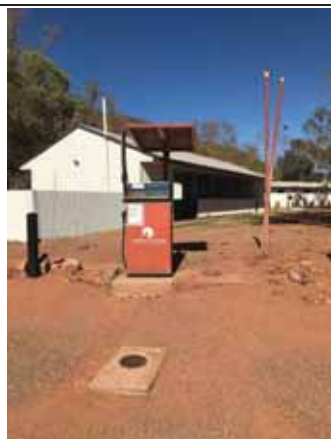
Photo: Unleaded bowser, fill/dip point, vent, and small canopy – Note two vent pipes and unknown filled opening adjacent to bowser.

Recommend reviewing condition of unleaded pipework in ground.

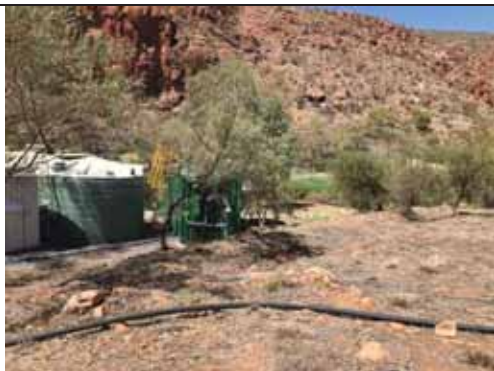
Photo: Wastewater Treatment System – Note stormwater diversion drain upslope, and Finke River waterhole behind.

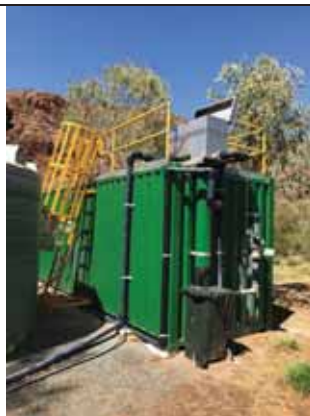
Photo: Inlet pipe and screen into wastewater treatment plant – Note evidence of leakage from inlet flowmeter.

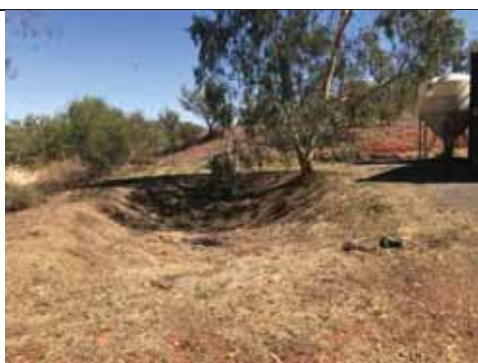
Photo: Old sludge/overflow/storage turkey nest dam – Note thin black plastic liner deteriorated/disintegrating at top of banks. Dry dark odourless composted biosolids present in bottom.

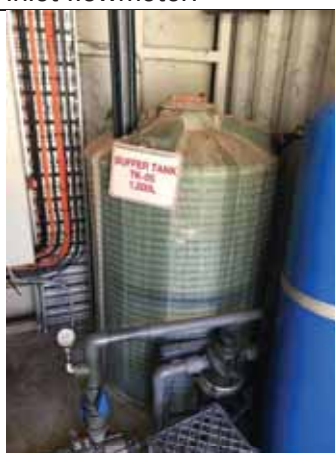
Photo: Evidence of overflow from effluent buffer tank into control/dosing room.

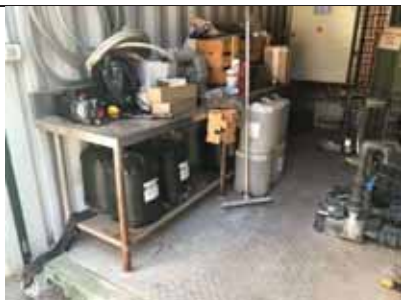
Photo: Chemical storage/stacking in control/dosing room.

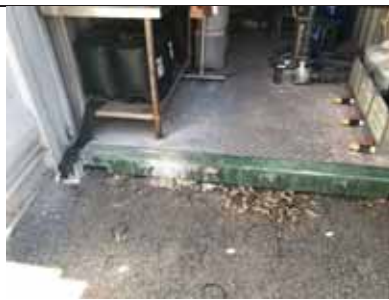
Photo: Evidence of effluent overflow onto ground from door of control/dosing room.

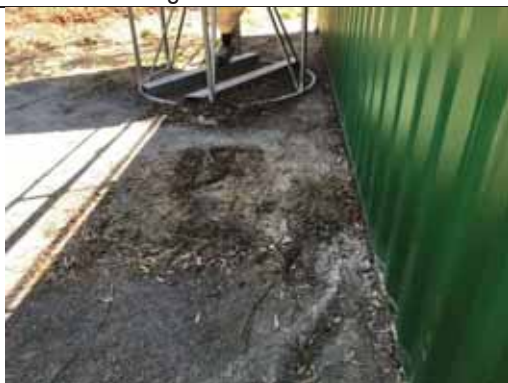
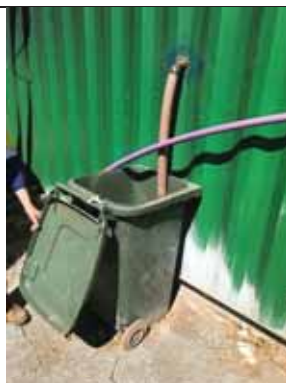
| Photo: Evidence of effluent overflow onto ground from side of control/dosing room. | Photo: Buffer tank overflow pipe into wheelie bin. |

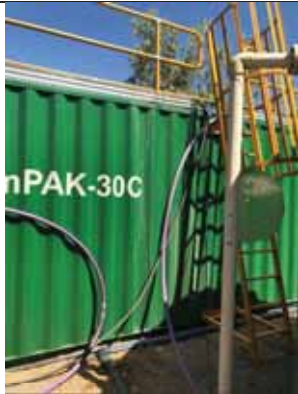
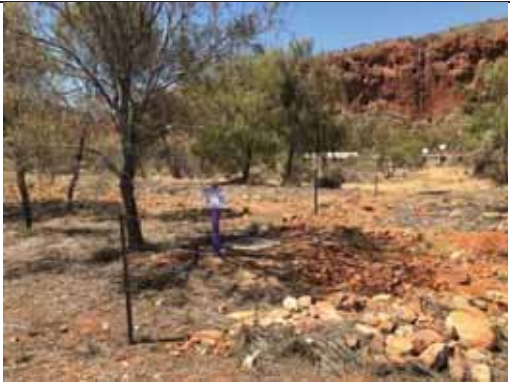
| Photo: Evidence of wastewater overflow from top of aeration tank. | Photo: Effluent irrigation field – note fenced and signage. |

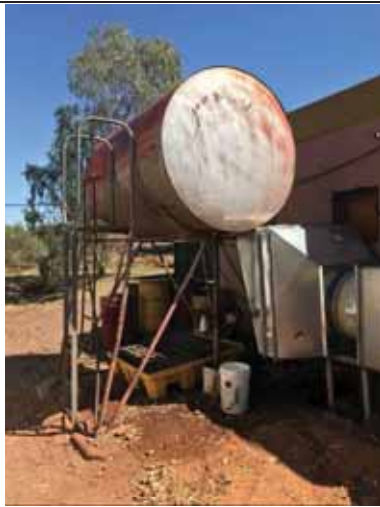
Photo: Above ground diesel storage tank – note stained soil under tank.

- Review bunding arrangement for generator building and diesel storage tank to prevent spills/leaks to soil.
- Review filling procedure for diesel storage tank to reduce spills.
- Redirect crank case breather hoses into oil collection containers to collect oil drips.
- Store waste oil and materials from generator maintenance in weatherproof bunded area to reduce risk of spill/leak to soil.
- Redirect and extend generator exhausts to avoid soot deposits on WWTP.

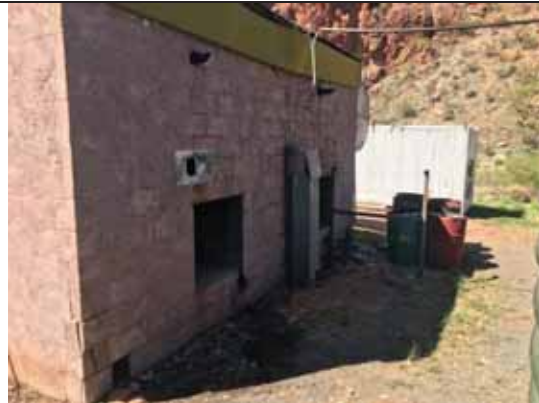
Photo: Back of generator building – note small patches of oil stained soil from crank case breather hoses, and 44 gallon drums stored on ground adjacent to building.

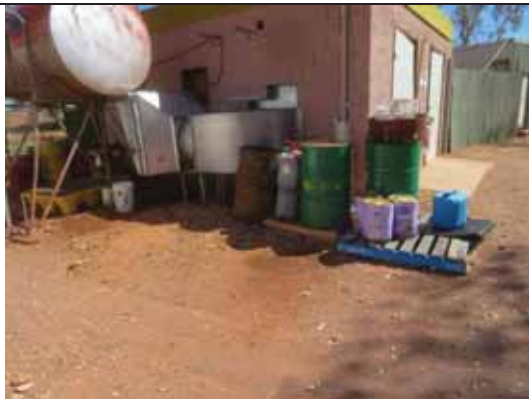
Photo: Waste oil, filters, drums etc stored on ground/pallets adjacent to building.

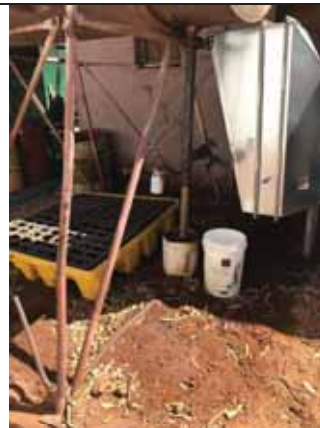
Photo: Catch bucket and bund under diesel tank – note diesel stained soil under.

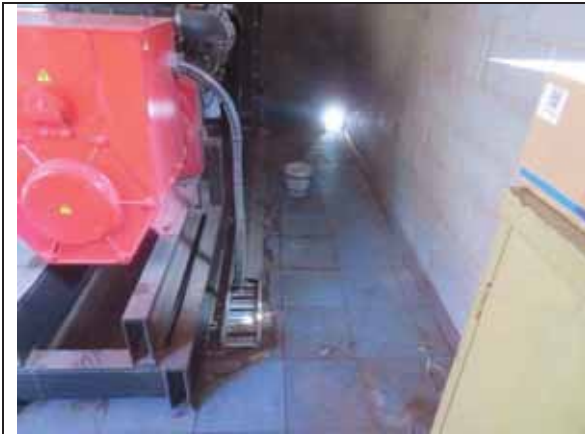
Photo: Generator building floor drains direct to ground/soil outside.

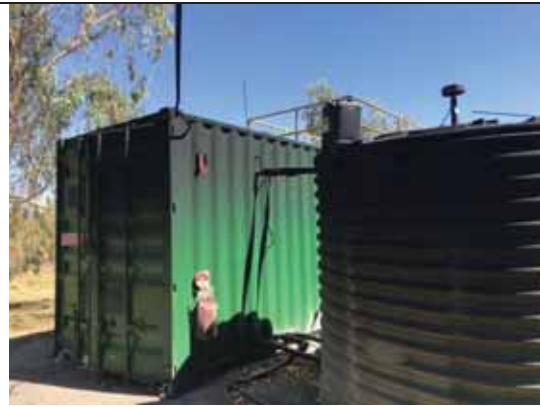
Photo: Soot from generator exhausts deposited on nearby WWTP.

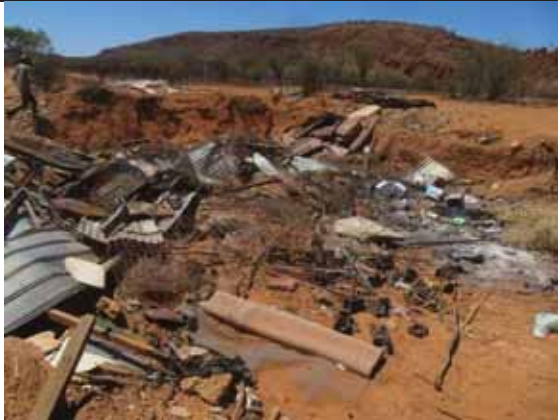
Photo: 2018 pit used for hard rubbish and more recently general garbage placed in here and burnt.

Recommend that if this landfill is continued to be used into the future it should be formalized and a management plan implemented to ensure good practice operation/management.

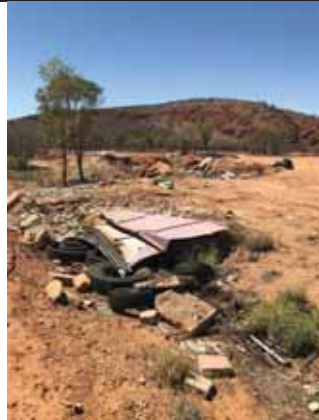
Photo: Current part of trench – note tyres under renovation rubble. Small quantity of pieces of cement sheet (possible ACM).

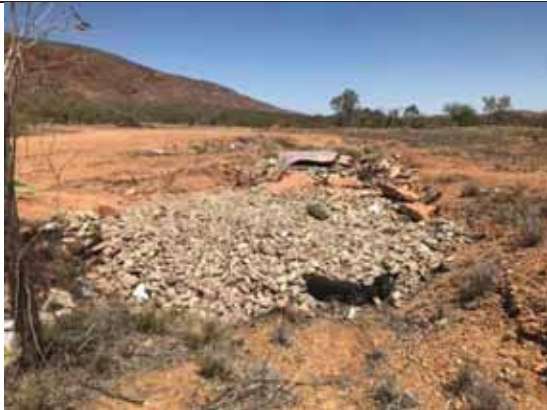
Photo: Current part of trench in foreground and previously filled/covered small area behind. This is mostly tiles and concrete rubble.

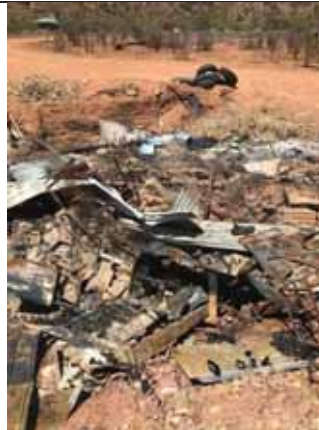
Photo: 2018 pit used for hard rubbish and more recently general garbage placed in here and burnt. Mostly scrap metal remains.

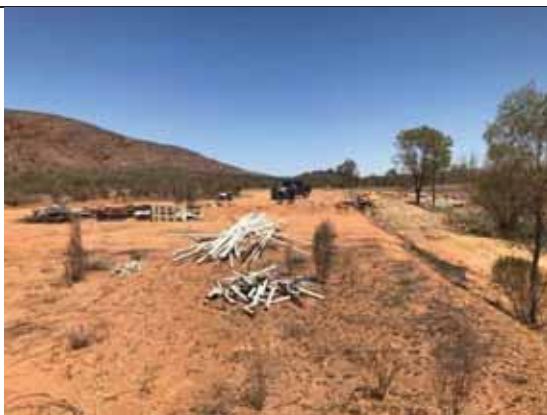
Photo: Scrap metal stockpiled on the site.

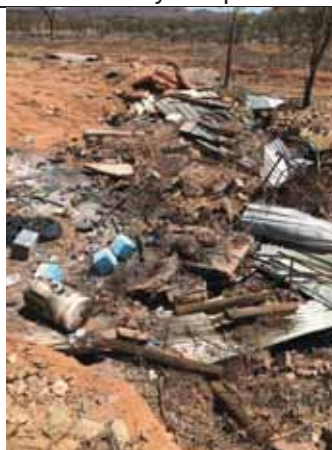
Photo: 2018 pit used for hard rubbish and more recently general garbage placed in here and burnt.

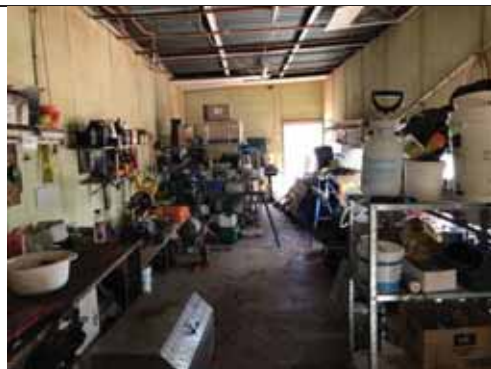
No contamination was identified in maintenance areas. The main maintenance shed has internal wall cladding which is likely Asbestos Cement Sheetting, which is broken in several areas. Broken ceiling cladding was more modern and unlikely to be asbestos cement sheetting. Chemicals and fuel stored in this shed are in un-bunded area on porous floor and not in cabinets. Recommend general review of chemical storage. Recommend test wall cladding and manage accordingly.

Photo: Main storage shed – wall cladding likely asbestos cement sheetting.

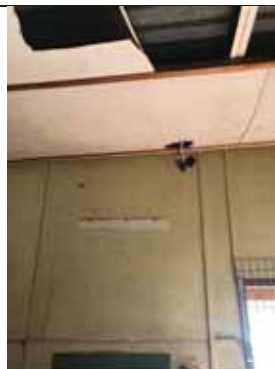
Photo: Broken/damaged wall cladding.

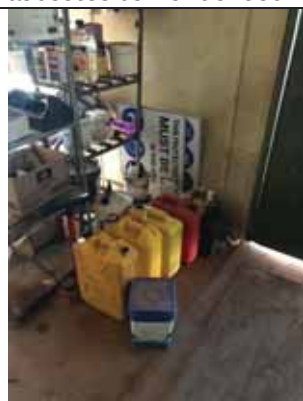
Photo: Chemical/flammables stored in maintenance shed on floor and shelf.

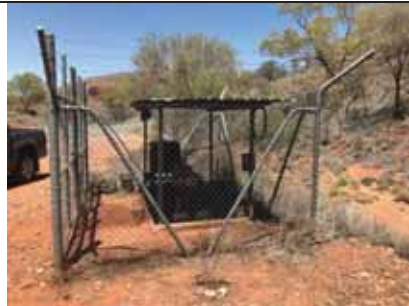
Photo: Bore pump diesel generator in locked enclosure.

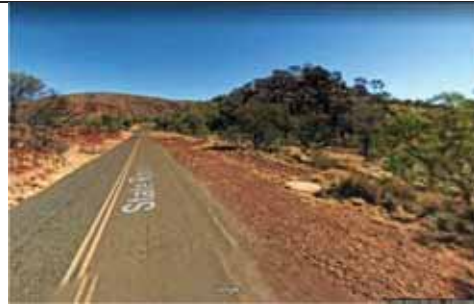
Photo: Production bore in pit adjacent to road upslope from generator (Photo-Google)

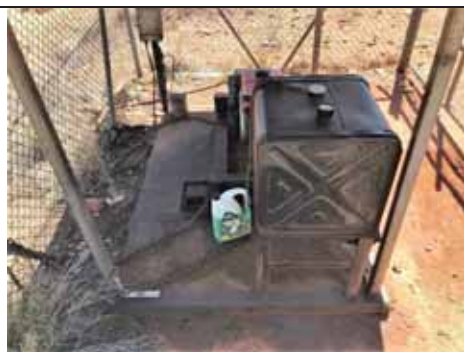
Photo: Generator plinth and diesel tank – note localised oil/diesel staining on and around plinth.

A dud/capped bore is located immediately adjacent to the generator plinth in the area of oil stained soil, recommend checking that this bore is adequately sealed to avoid contamination entry. Electrical cable from generator to pump appears to be direct buried rather than in a conduit – not to standard.

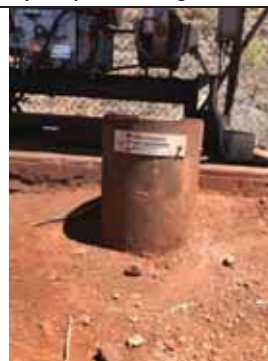
Photo: Dud/capped bore.

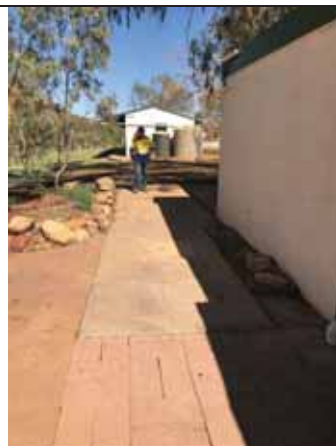
Two Items were noted on the site. Concrete infilled lid openings from what is likely an old septic tank located west of the grease trap between the pub and the southernmost guest accommodation wing. The old redundant wastewater treatment system located adjacent to the current operating wastewater treatment system. This redundant system contributes to congestion and may cause confusion between new and old system. Recommend that the redundant wastewater treatment system is dismantled and disposed off-site, and is checked and monitored until it is removed from site to ensure it doesn't become a hazard as it deteriorates.

Photo: Concrete filled lid openings, possible old septic tank.

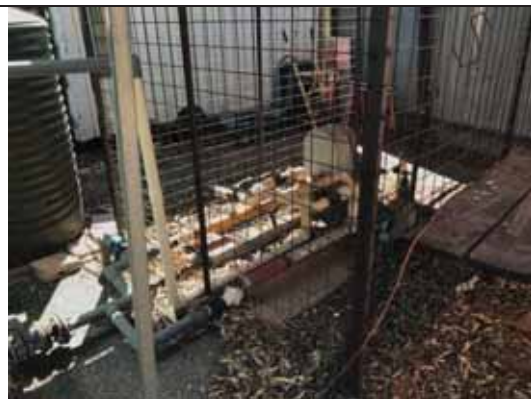
Photo: Old wastewater treatment system. Also several tanks.

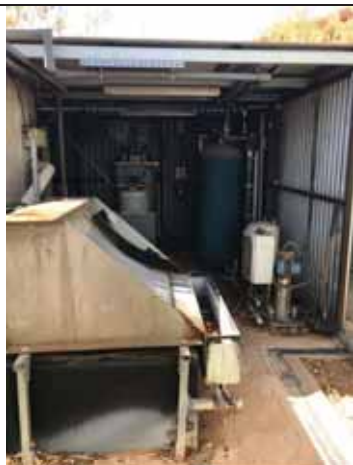
Photo: Old wastewater treatment system - Note liquid still in chemical dosing tank.

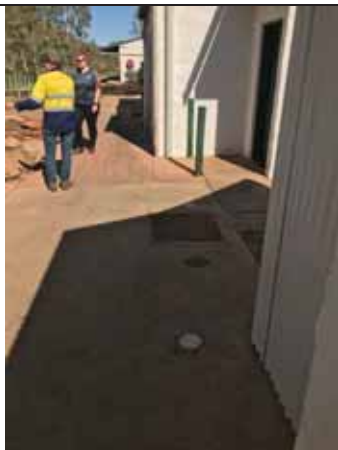
Photo: Grease trap cover.

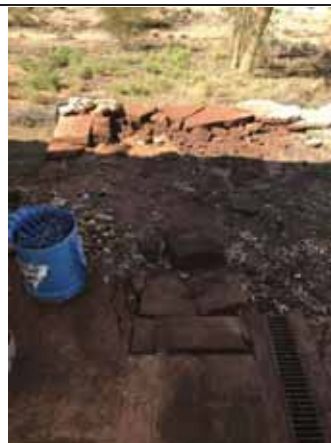
An area of grease/oil stained rocks/building rubble was observed near the back of the pub. This is where cleaners have thrown dirty kitchen floor mop water with cooking oil residue. Not a contamination issue but suggest change this practice.

Photo: Cooking oil residue staining on rocks.

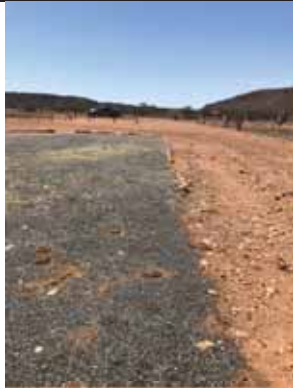
Photo: Helicopter pad area.

ground and wheeled out to re-fuel helicopter. Recommend review of process and possible bunded tank or drum area in future.

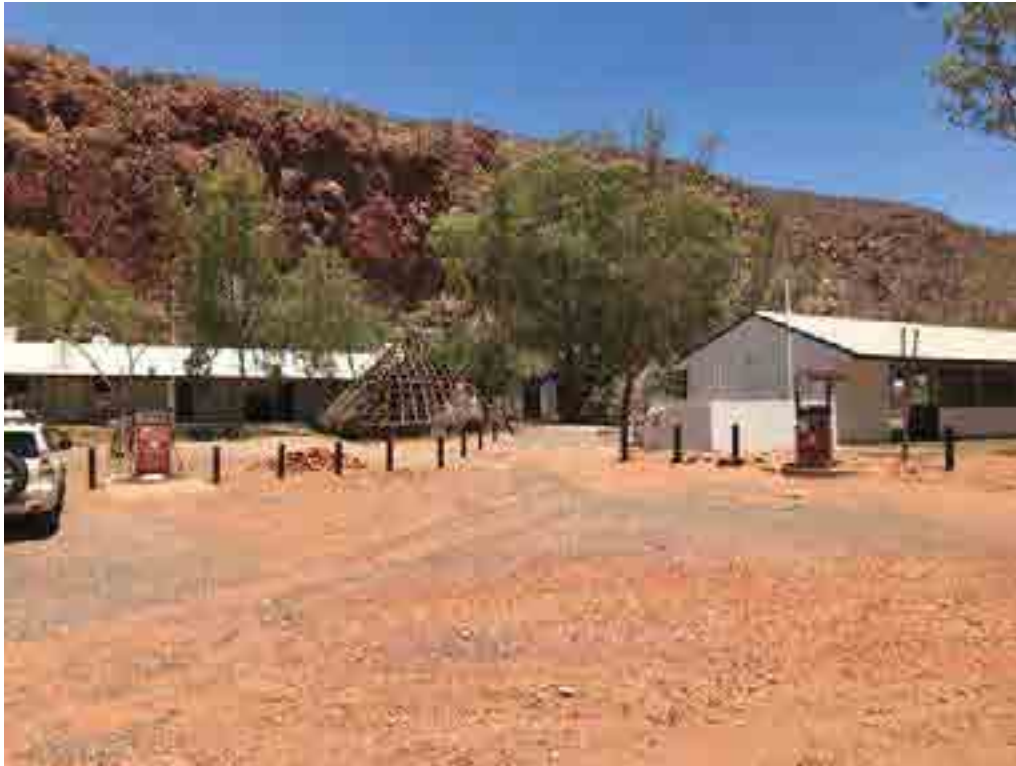
Fuel systems at edge of carpark prior to removal

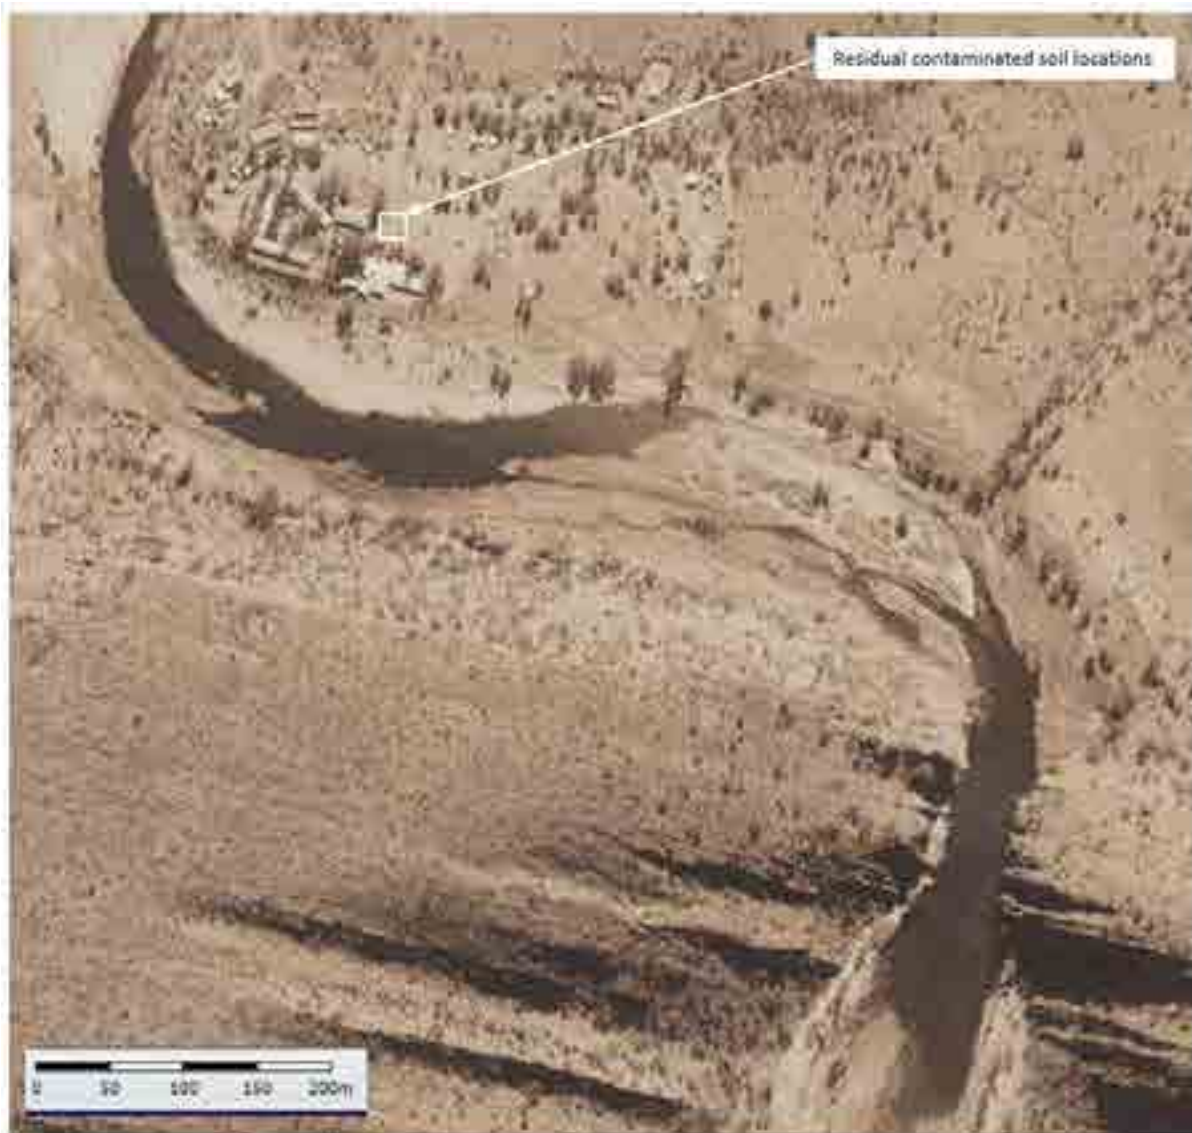
**Figure 12: Aerial view showing location and surrounding ecological features of residual contamination ((NR Maps).**

Given assessment of potential risks and likelihood, , active remediation or removal and disposal of the residual localised contaminated soil off-site is not required to manage site risks. Natural Source Zone Depletion of residual contaminated soil in situ is proposed. This avoids both the high economic and environmental costs such as use of fossil fuels and generation of greenhouse gases associated with active remediation or disposal of this soil offsite. A flow chart adapted from NEPM 2013 showing the decision process for the assessment and proposed remediation is included in Appendix O. It is suggested that 4-6 samples be taken of the residual soils at a depth of about 2.5m bgl to establish a baseline for hydrocarbon levels in the residual soil surrounding the pits.

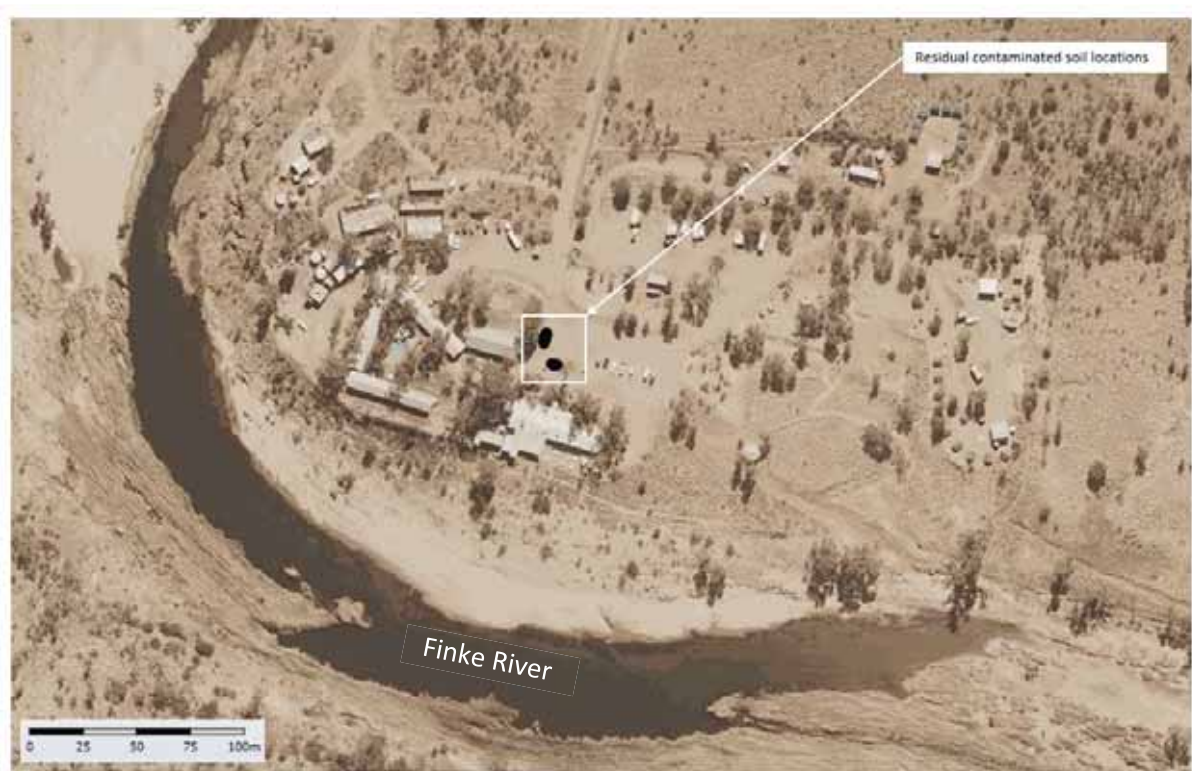
The Finke River is >100m away from the contaminated soil locations and Glen Helen Gorge is >400m away from the contaminated soil locations.

Figure 13: Site overview map showing contamination locations in relation to Glen Helen Lodge and associated infrastructures ((NR Maps)) .

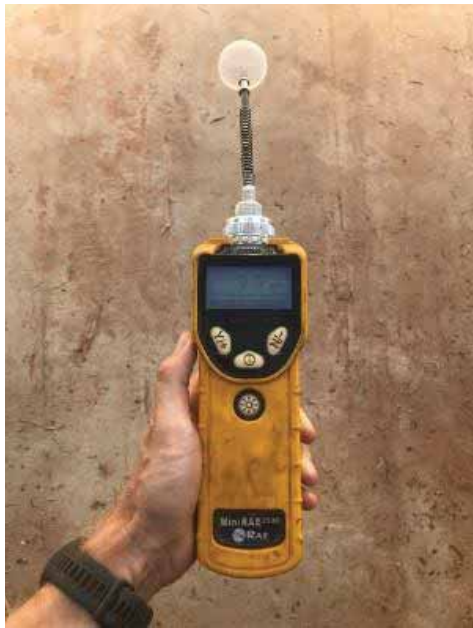
| | <p><b>Image 1.</b><br/><b>Portable Mini Rae 3000 Photoionisation Detector (PID) instrument used for vapour testing of soil samples on site.</b></p> |

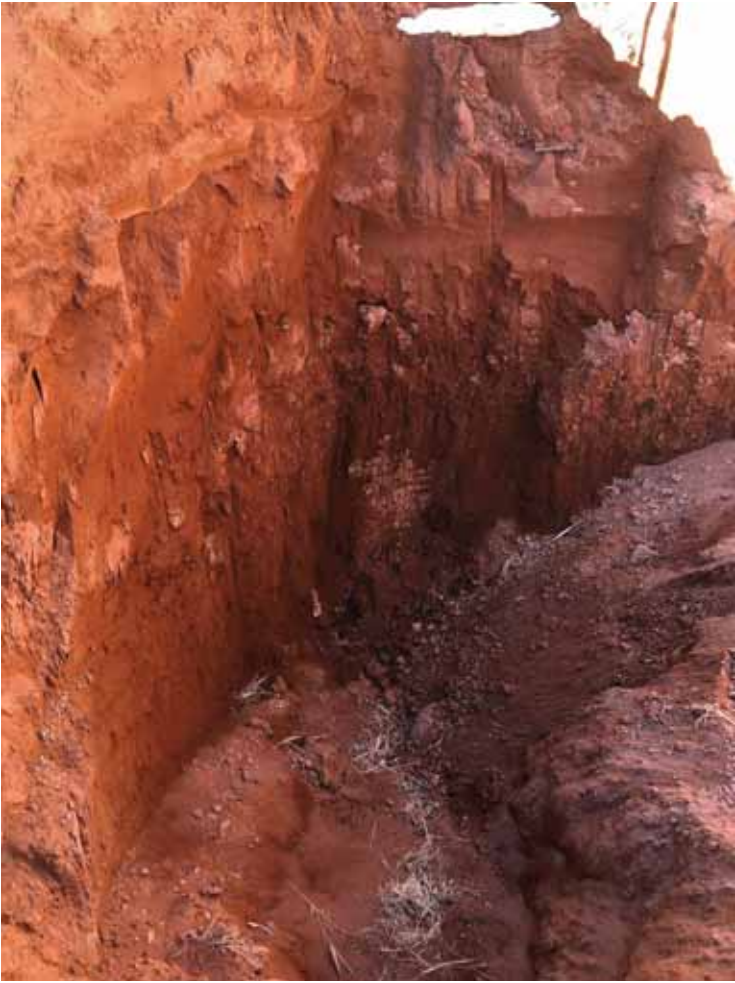
| | <p><b>Image 2.</b><br/><b>Bottom of northwest corner of diesel pit.</b></p> |

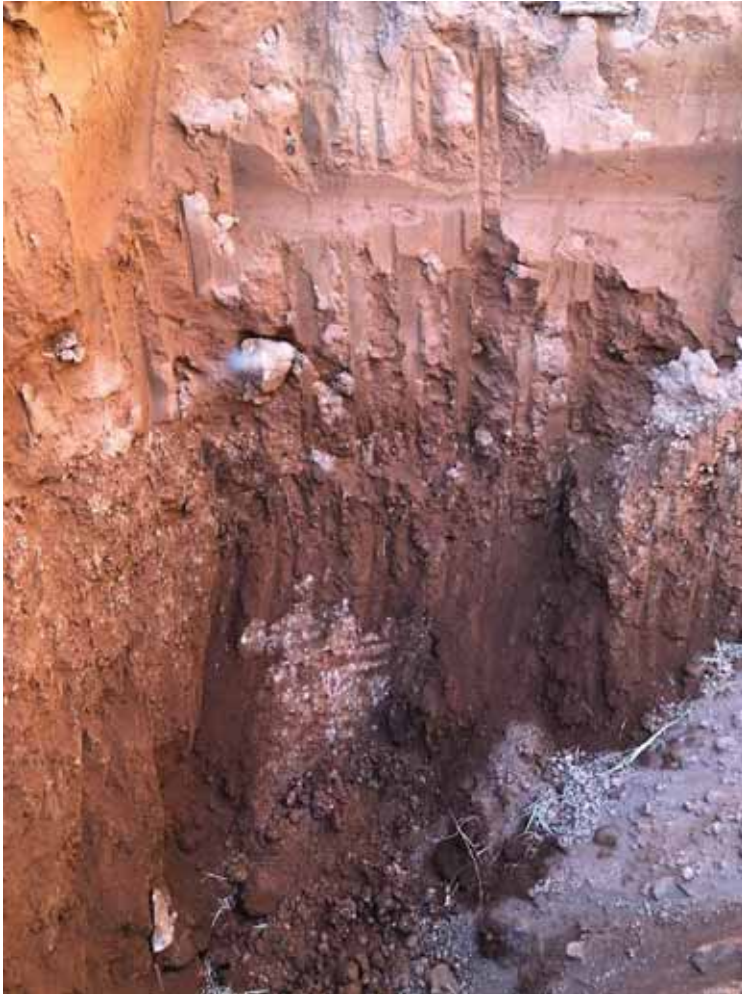
**Image 3.**  
Bottom of diesel pit where sample D3 was taken from the northwest wall of the pit after scraping back with a shovel.

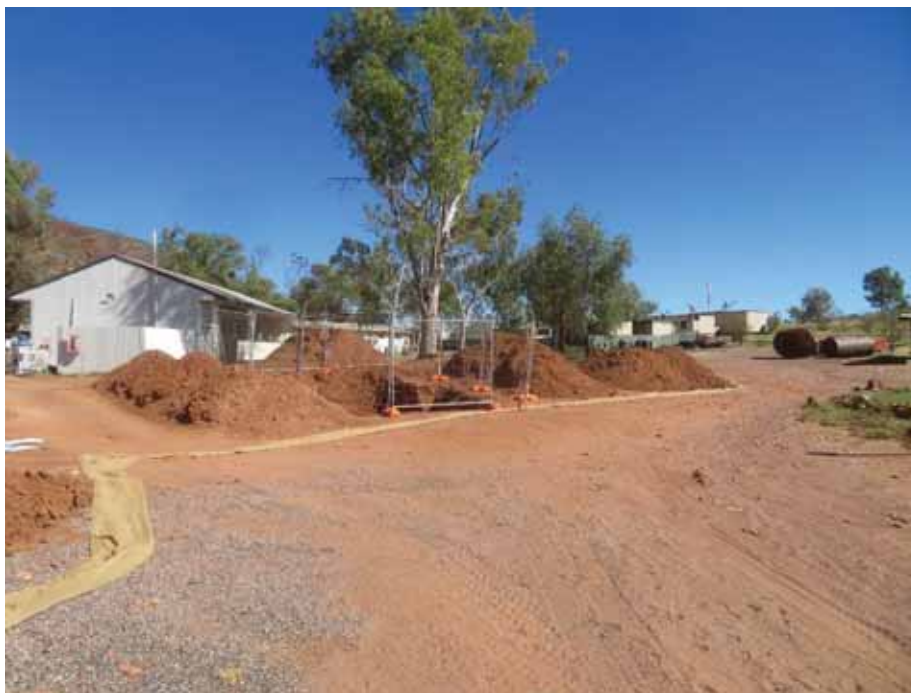
**Image 4.**  
Opal petrol pit with surrounding stockpiles (4, 5 and 6).

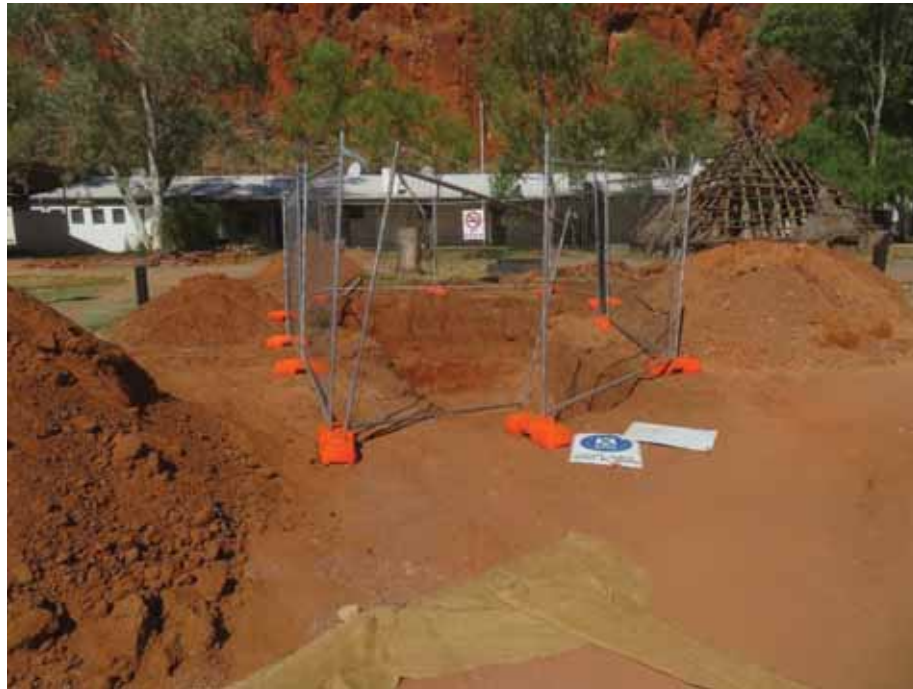
**Image 5.**

**Diesel pit with surrounding stockpiles (1, 2 and 3).**

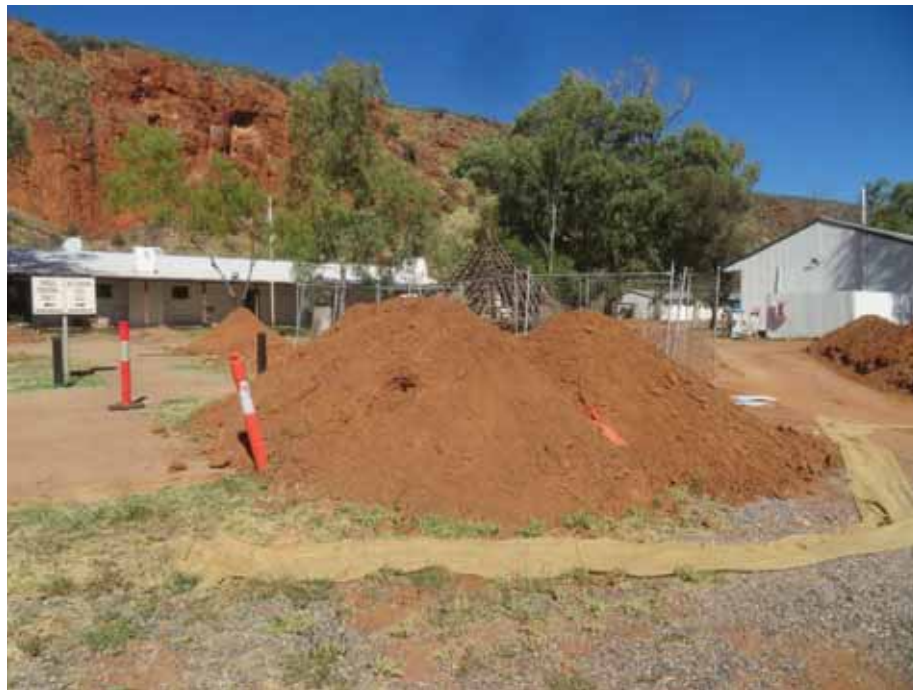
**Image 6.**

**Largest diesel stockpile (Stockpile 1).**

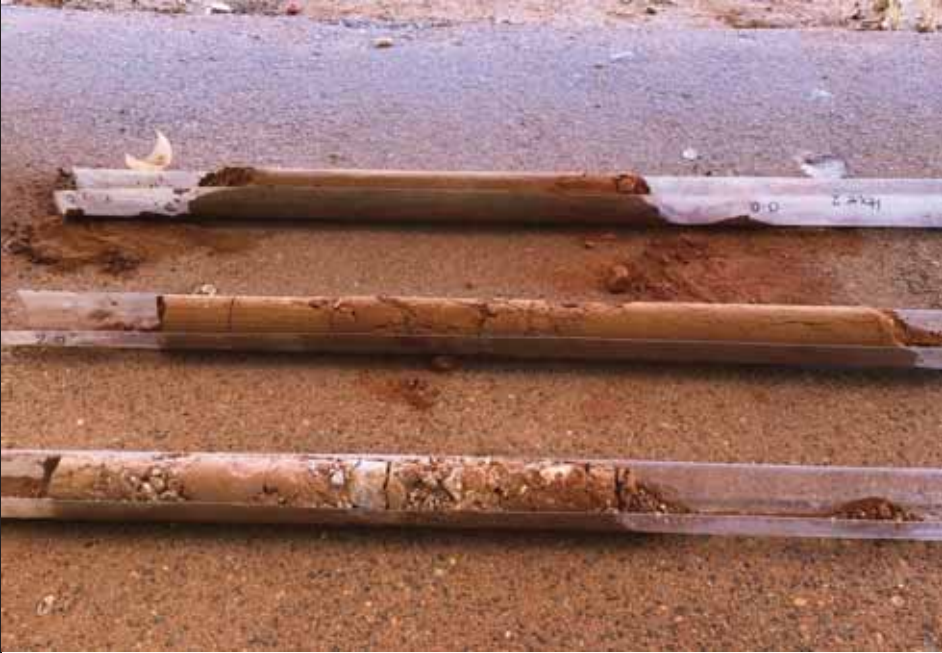
| | <p><b>Image 7.</b></p> <p><b>3 Geoprobe drill Rig soil tube samples from drill hole 2.</b> The sample tube furthest away is soil from 0.0m – 1.0m deep. The middle sample tube is soil from 1.0-2.0m deep and the closest sample tube shows the soil from 2.0m to refusal, in this case 2.7m deep. The soil was taken from varying sections of the tube to enable targeted sampling at specific depths of interest.</p> |

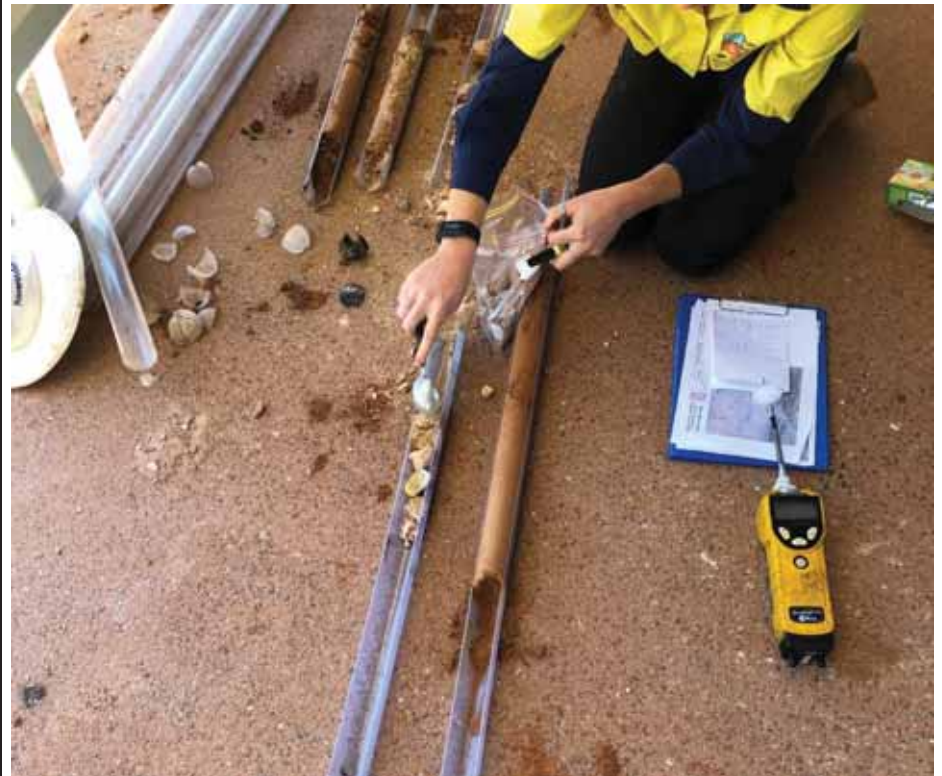
| | <p><b>Image 8.</b></p> <p>The sampling and PID analysis in process. Where specific soil is obtained from sample tube and placed in airtight ziplock bag. Sample ID and Depth was recorded on bag, the sample was left for 10 minutes as to allow time for any present gases to vaporise. The PID instrument was then used to penetrate the bag and record the vapour present. This gives a representation of the volatile nature of the sample.</p> |

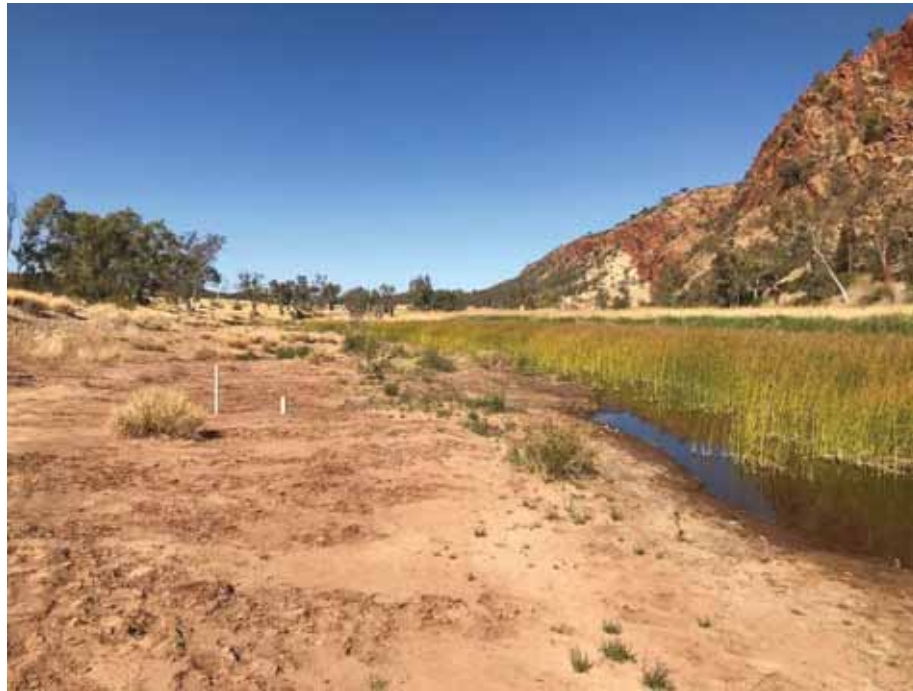
**Image 9.**  
**Groundwater**  
**sampling location**  
**W3 adjacent to the**  
**Finke river.**

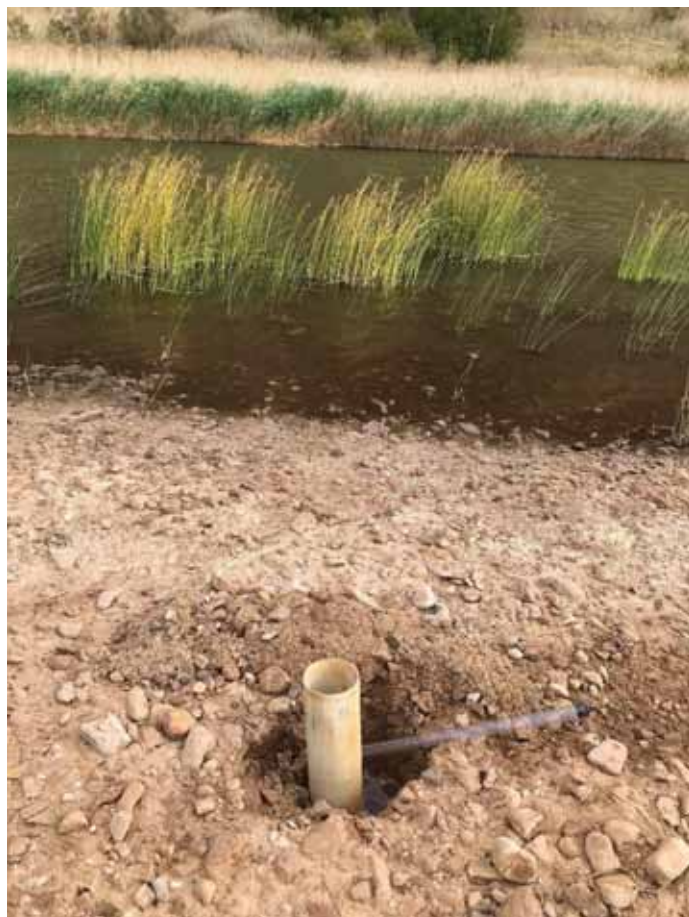
**Image 10.**  
**Groundwater**  
**sampling bore W2**  
**adjacent to the**  
**Finke river.**

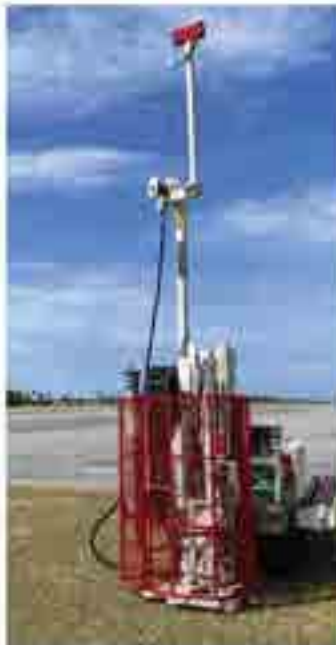
### GEOPROBE 6610DT

The design of the Geoprobe 6610DT ~~direct push~~ machine offers the complete package. The rig includes auxiliary power and compressor source capabilities, along with a workhorse hammer, a specially designed push probe head, two-speed high torque head, auger, auto SPT, and more. The rubber tracks allow this versatile machine to be used on concrete and pavement as well as off-road and rugged terrain. The dimensions along with remote control operation allow for excellent access to tight locations, creating safe and effective work areas. The 6610DT Geoprobe has all the modern safety features suitable for mine sites and can flexibly switch from environmental to geotechnical work including diamond coring with little time and effort.

- Solid Auger – 50m
- Hollow Flight Auger – 30m
- SPT – 20m
- PQ (114.3mm), HQ (88.9mm), NQ (69.9mm), BQ (55.6mm) – 50 meters
- Push Probe, Air Core RC, Rotary Flush – 50 metres

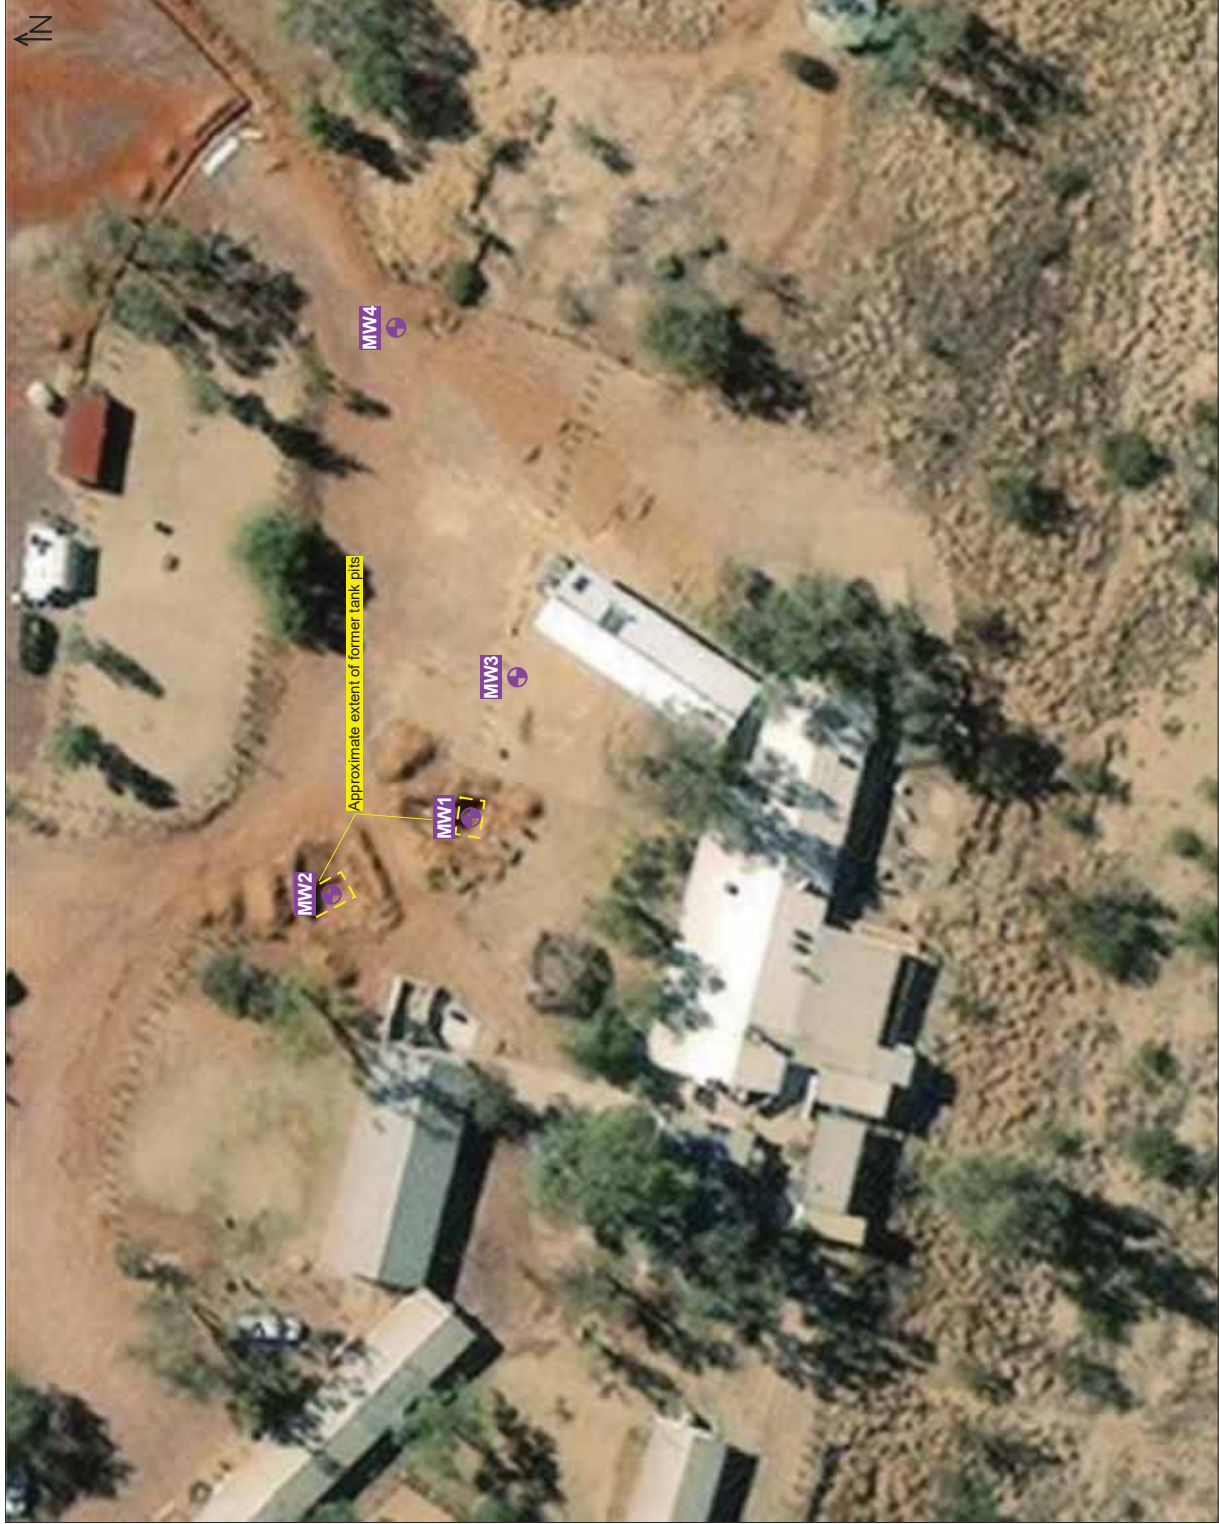
**APPENDIX A**  
**SITE PLAN**

1. Groundwater well locations and the extent of the former tank pits are approximate based on plan provided by Low Ecological Services.
