# Information sheet for environmental audits and preliminary risk screen assessments (PRSAs)

5. The West McDonnell National Park is considered to be an area of ecological and cultural significance;
6. On 04 June 2021, LES submitted a report to the NT EPA titled "*Glen Helen Lodge Investigation for fuel Leakage from UPSS*" (the report), dated 03 June 2021;

# ATTACHMENT D LOCATIONS OF UPSS AND APPROXIMATE DRILLED DELINEATION BOREHOLES

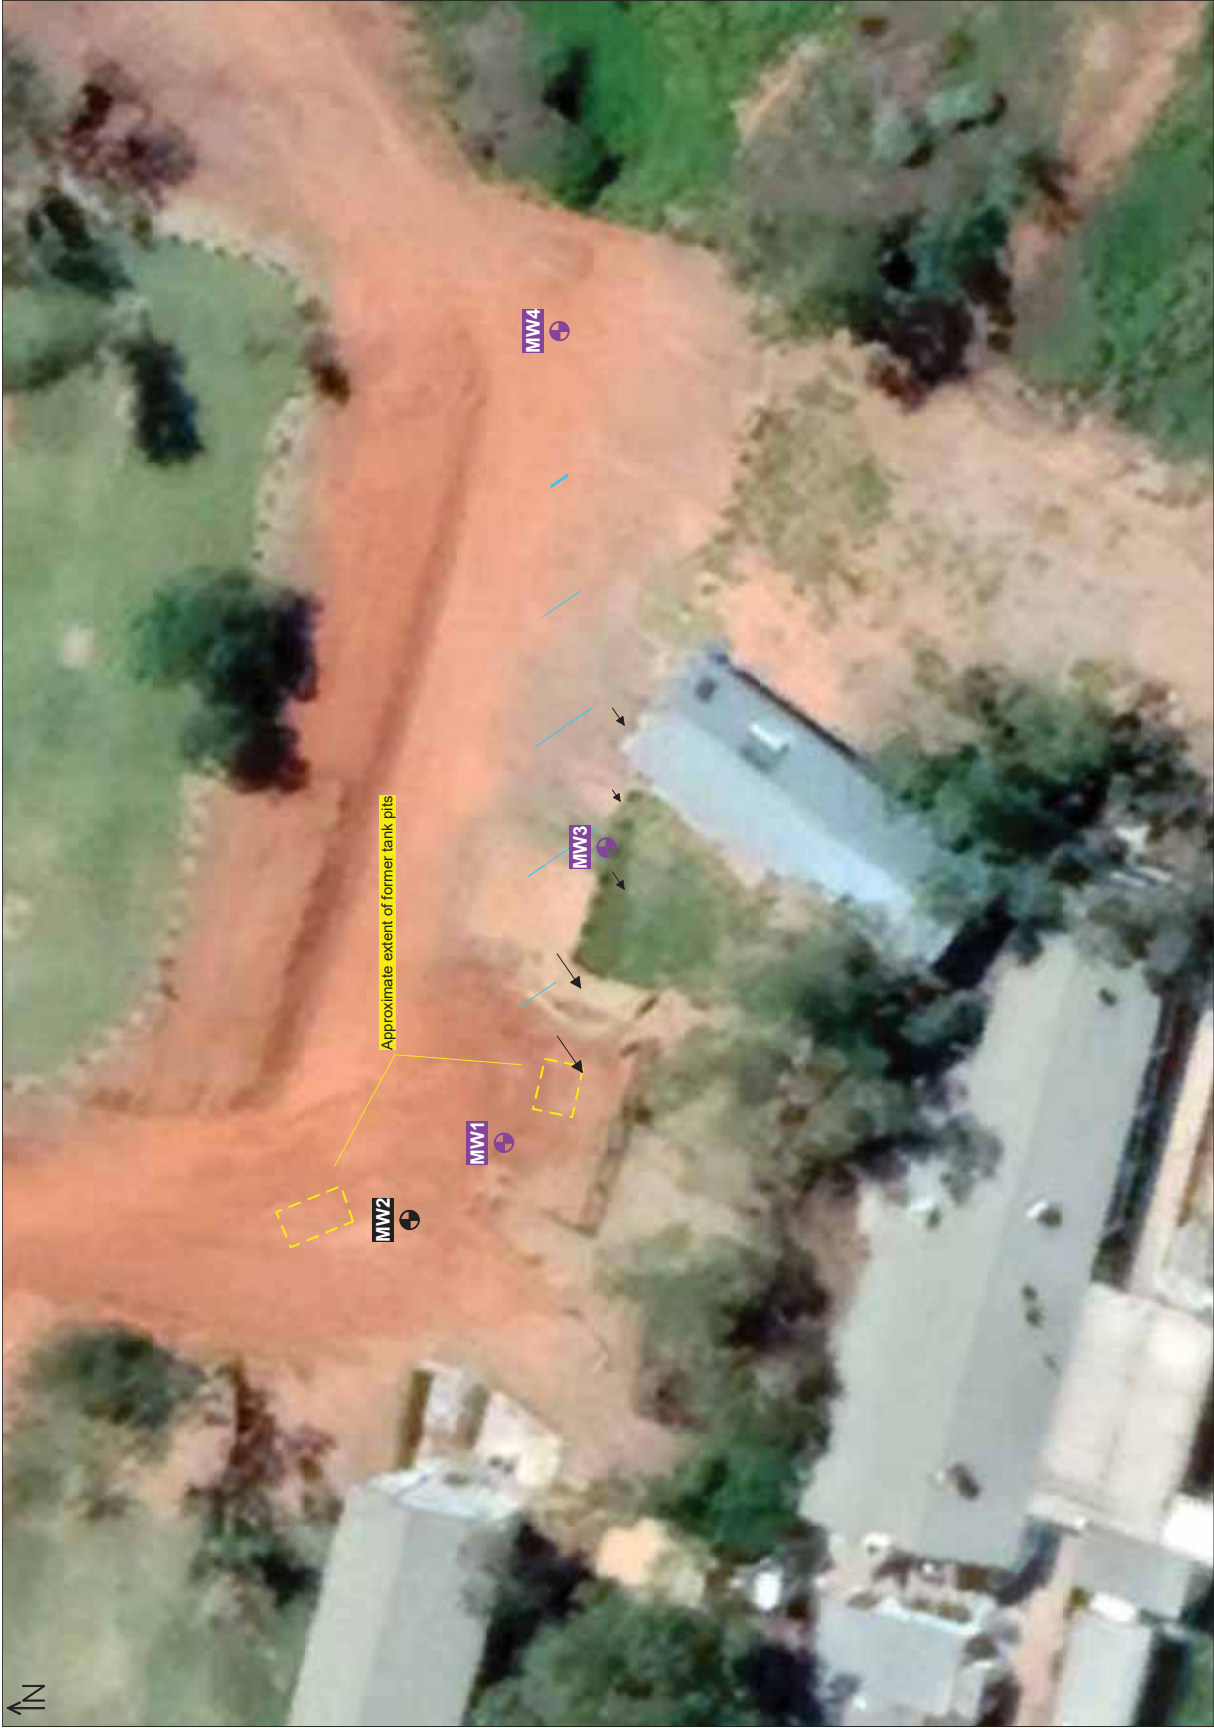
Figure 1 - Groundwater Well Locations  
 Glen Helen Discovery Park  
 Groundwater Monitoring Event - May 2023  
 Rev A, 6 July 2023

1. The extent of the former tank pits are approximate based on a plan provided by Low Ecological Services.
2. The position of MW1, MW3 and MW4 is based on a survey. The position of MW2 is approximate and based on a plan provided by Low Ecological Services.
3. Groundwater contours generated by Surfer software with a grid generated using triangulation with linear interpolation.

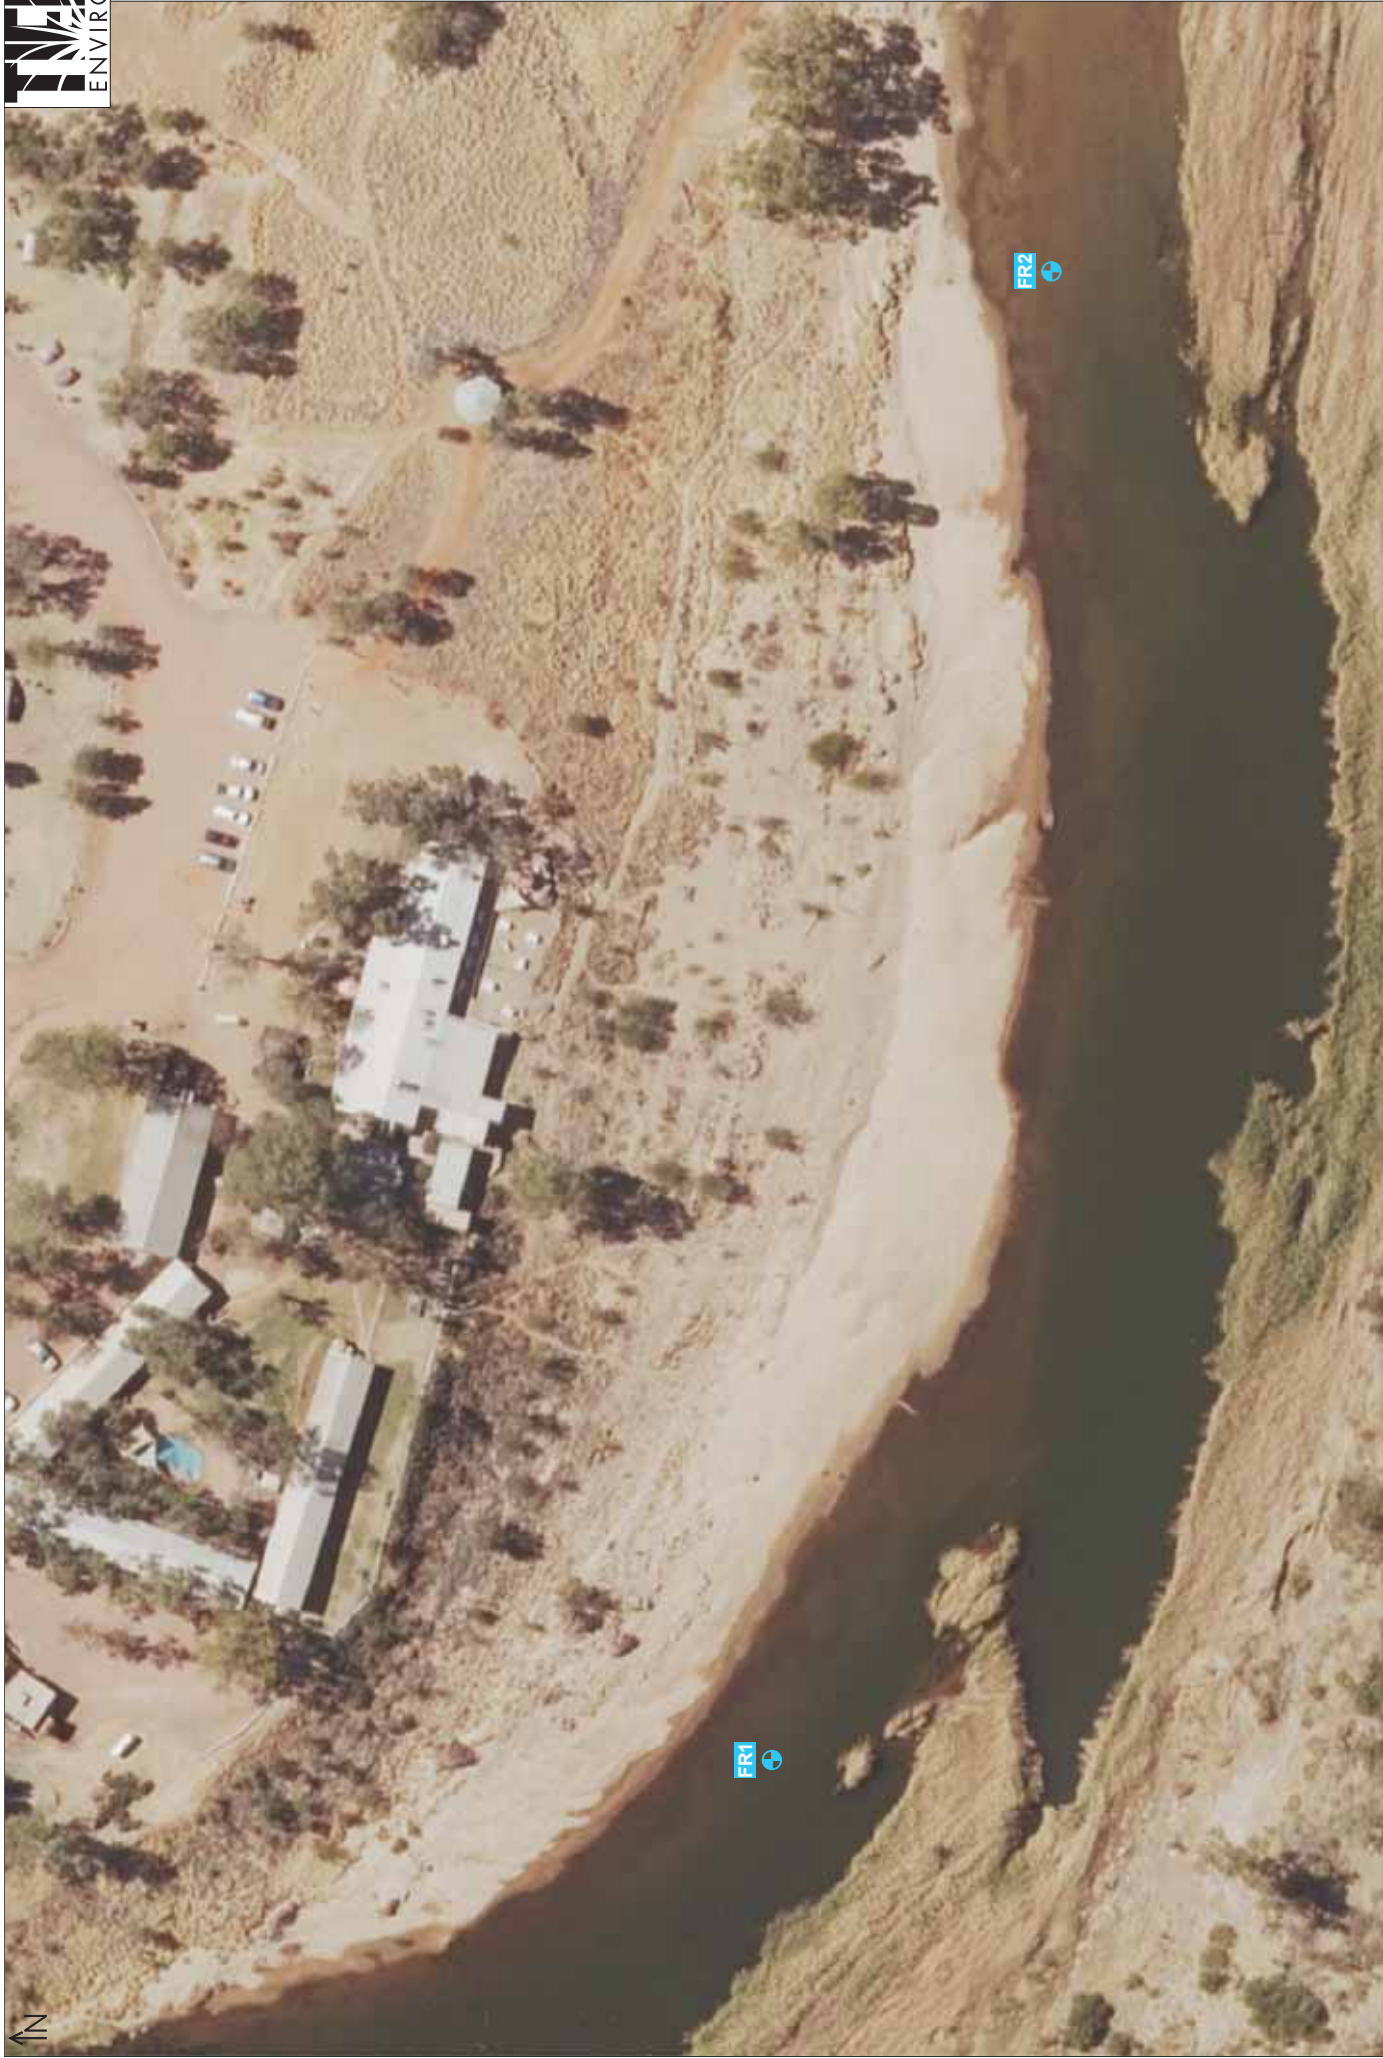
1. The surface water sampling locations are approximate and based on field records.

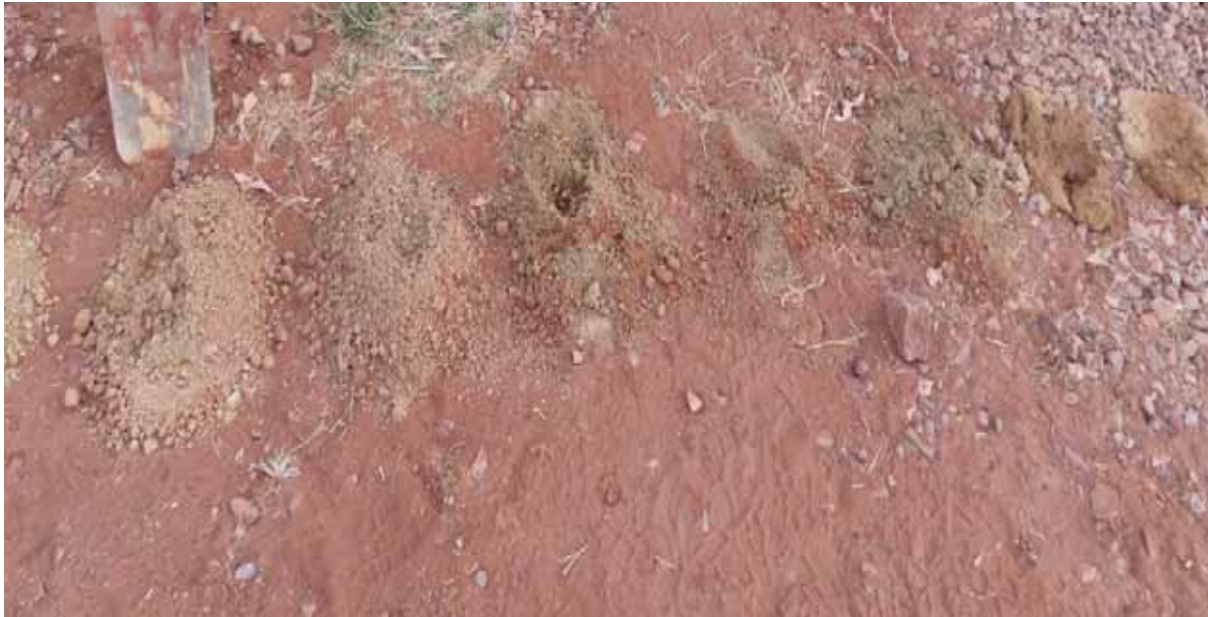
**Figure 3:** Samples of the rock-portfolio taken during drilling MW1. These soil samples belong to the old diesel petrol pit and show mostly rock and yellow claystone.

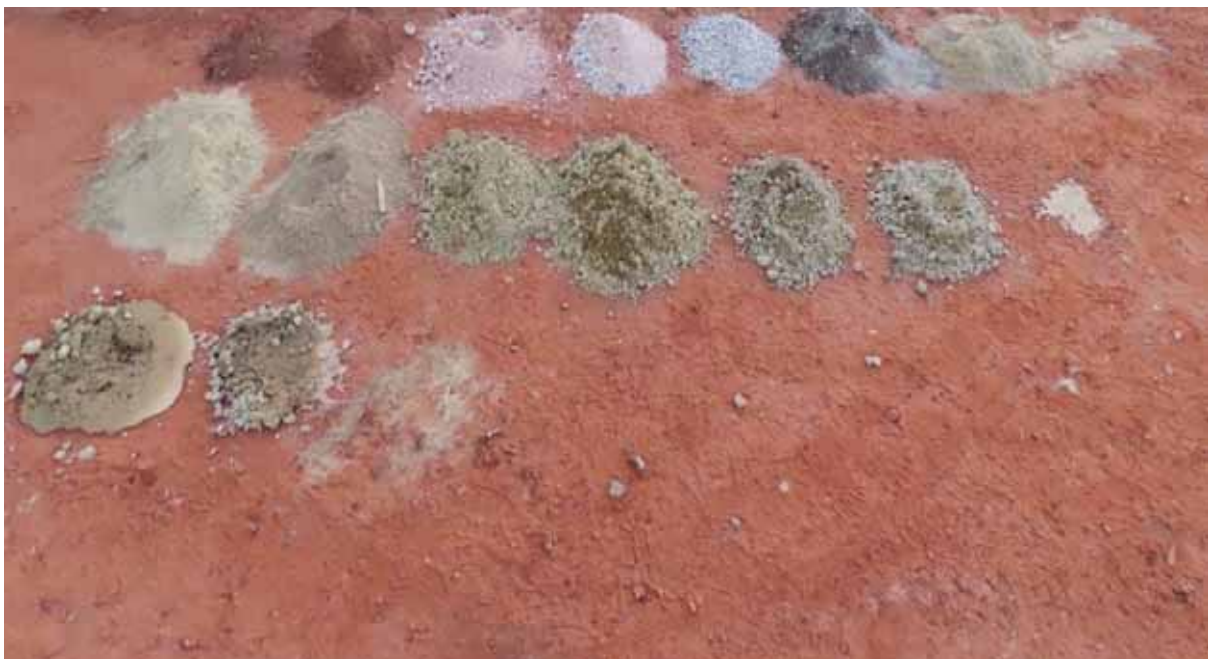
**Figure 4:** Samples of the rock-portfolio taken during the drilling of MW 2 (Opal petrol pit). From left to right, back to front: Top layer (backfill), grey rock quartz, white is silt stone, yellow clay, yellow clay moist, water quartz sandstone.

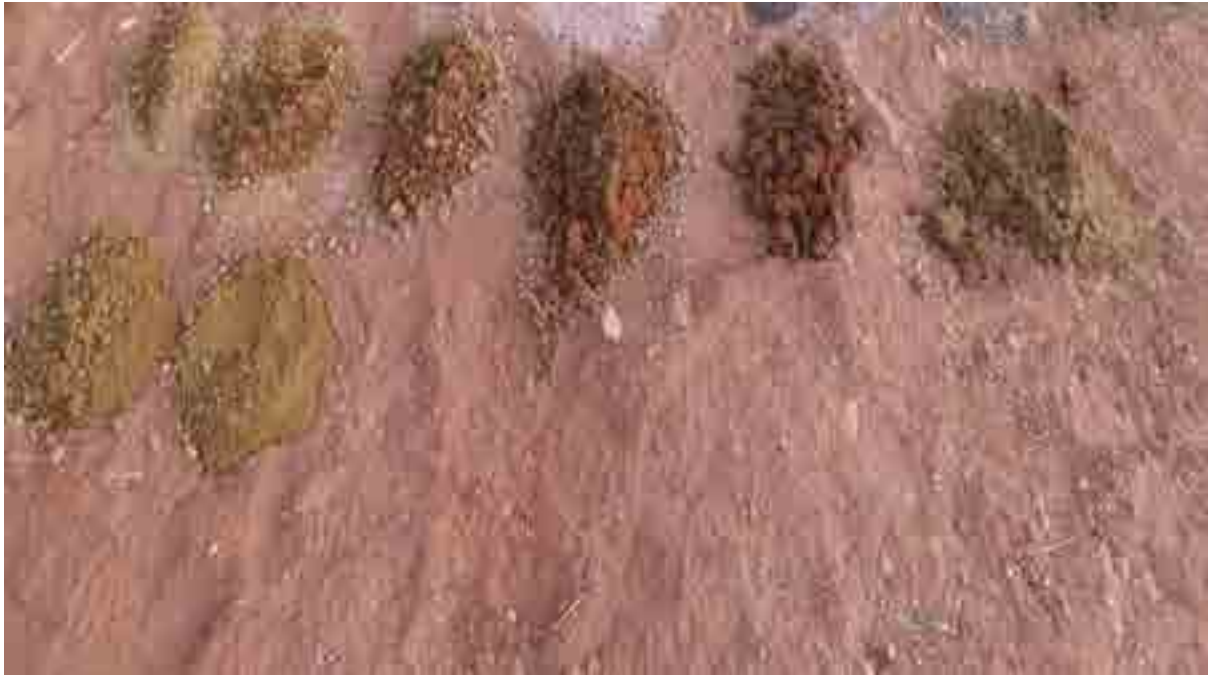
**Figure 5:** Samples of the rock-portfolio taken during drilling of MW 3. From left to right, back to front: Top layer (backfill), grey rock quartz, white is silt stone, black to yellow clay, yellow clay, water rock.

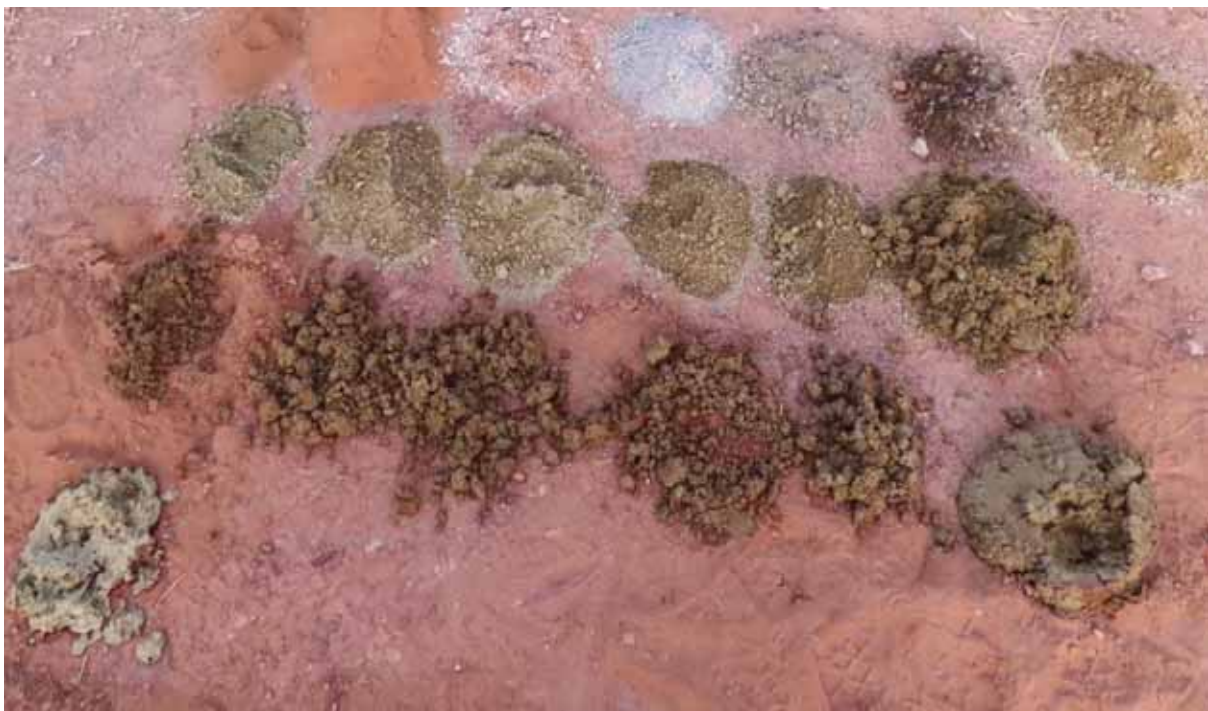
**Figure 6:** Samples of the rock-portfolio taken during drilling of MW 4. From left to right, back to front: Top layer (backfill), grey rock quartz, loose yellow clay, yellow clay, water rock.

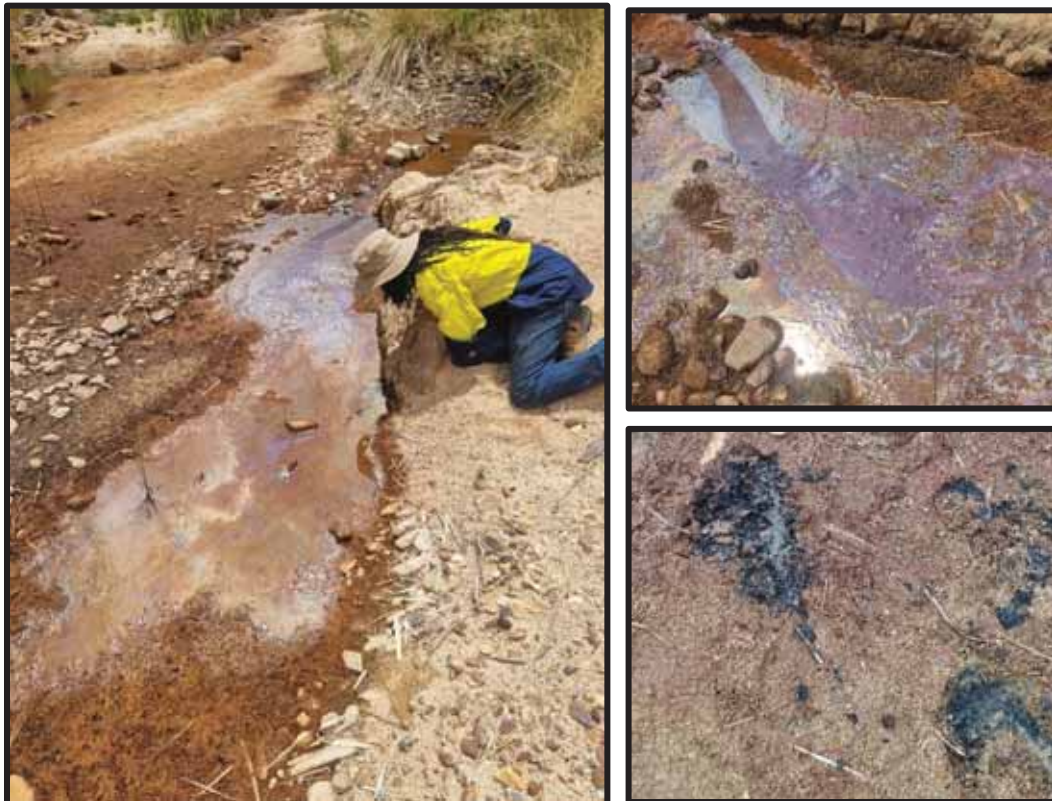
**Figures 7 and 8:** LES team member Danesh Antai inspecting water near the Finke River. The water appears to have a sheen on it. As it was a water source in line with the surface water run-off trajectory, it was decided to sample the soil and send it to ALS Environmental for analysis.

While the team was on site, the nearby Finke River has been visited to sample soil which looked black and had water with a clearly visible film on it (*Fig. 7 & 8*). As the sample area would be in line with the surface water run-off, the soil was sampled and sent to ALS Environmental to test for metals and signs of industrial pollution.

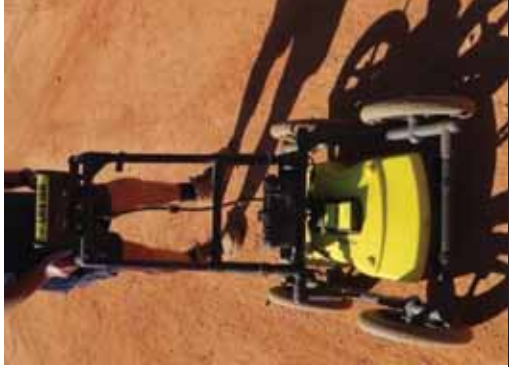
| A photograph showing a yellow and black LMX100 ground penetrating radar unit mounted on a yellow three-wheeled cart. The unit has a screen and several buttons. It is parked on a reddish-brown dirt surface. A person's legs and feet are visible in the background. | <p><b>Figure 10.</b><br/><i>LMX100 ground penetrating radar used to locate metallic and non-metallic utilities and depth of soil to geological base.</i></p> |

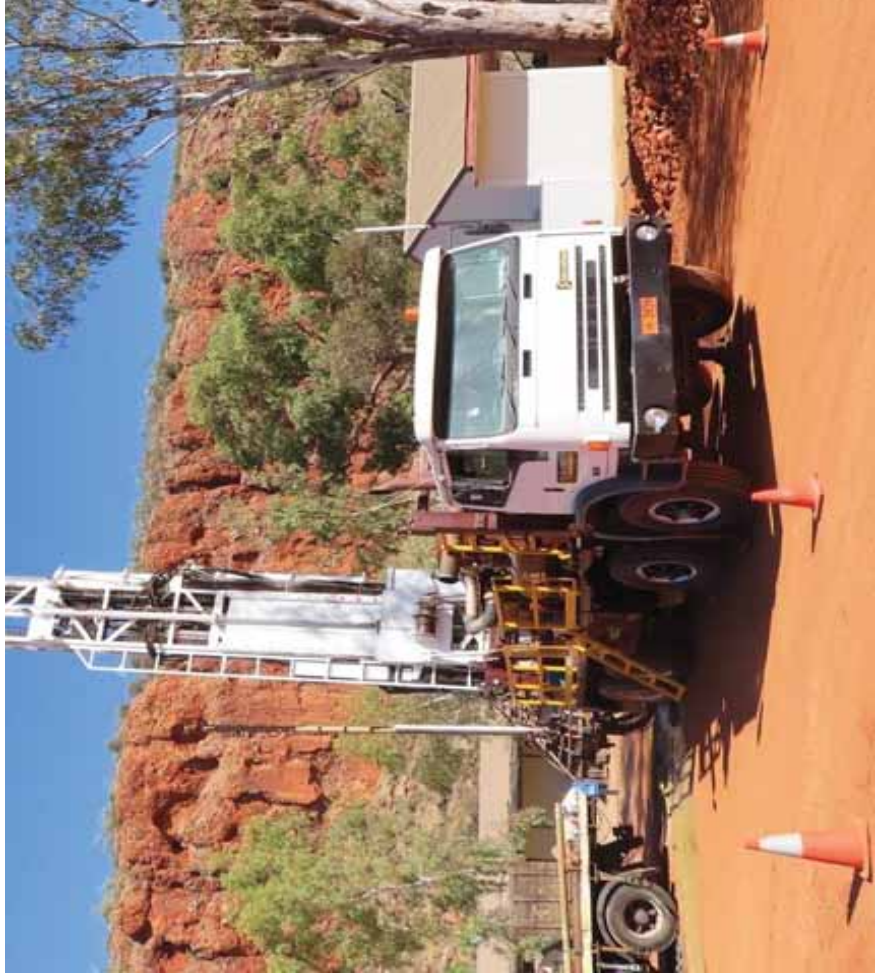
**Figure 12.**

*Shramm 685 truck mounted drill rig.*

*To drill the monitoring wells, LES hired Silver City Drilling Pty Ltd which supplied a mounted drill rig and trained and qualified staff to operate the machinery.*

On the 27<sup>th</sup> of May 2022, LES contracted Silver City Drilling Pty Ltd. to install four monitoring wells at Glen Helen Resort (images in APENDIX A). Rachael Harman, a representative for auditor Steven Kirsanovs of Kirsa Environmental (accredited under the Victorian EPA auditor scheme) was present during the drilling to oversee the operation, ensuring that the procedure met all regulatory and environmental obligations.

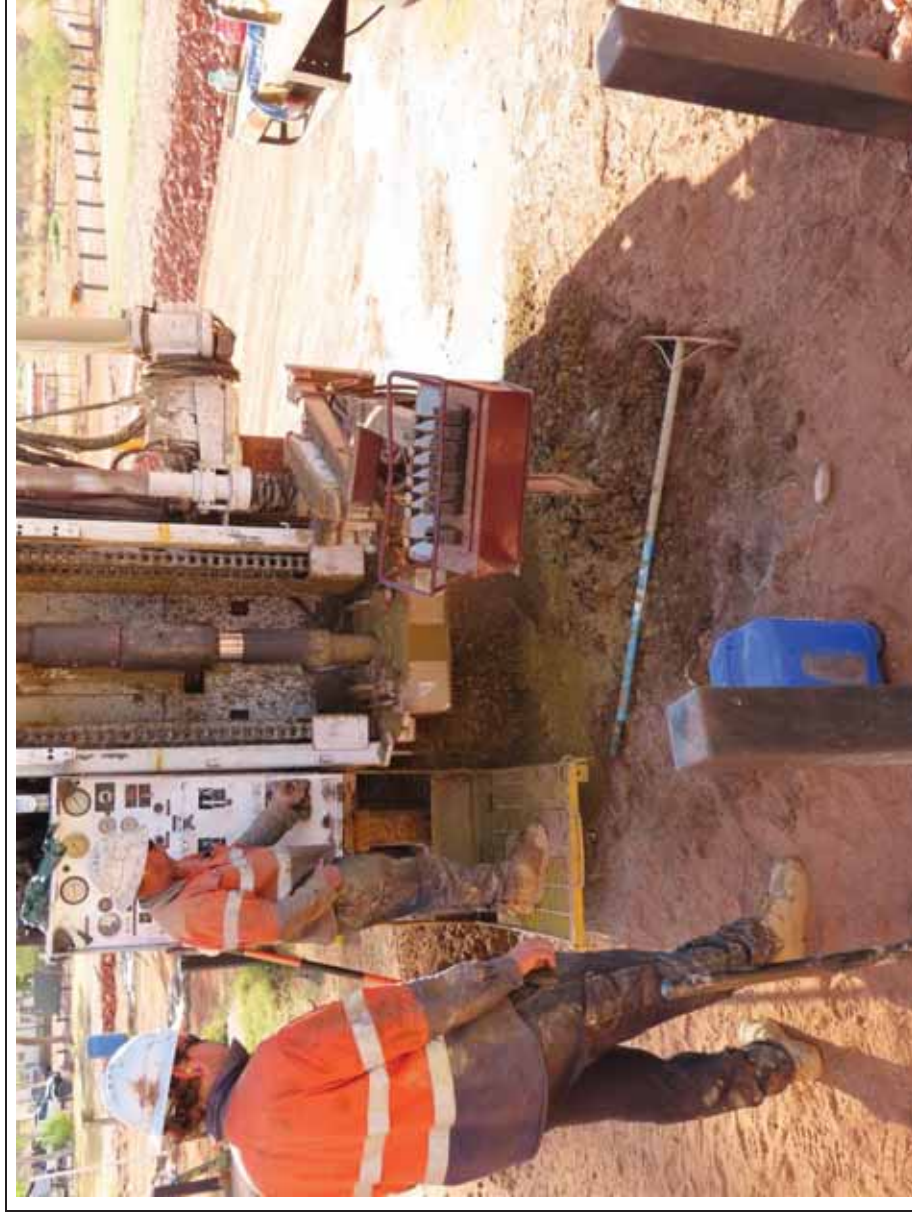
**Figure 14:** Wet drilling of the monitoring wells. After introducing FOAM X PLUS Foaming agent for Fresh and Saline water (MUDEX, Innovative Drilling), wet drilling commenced.

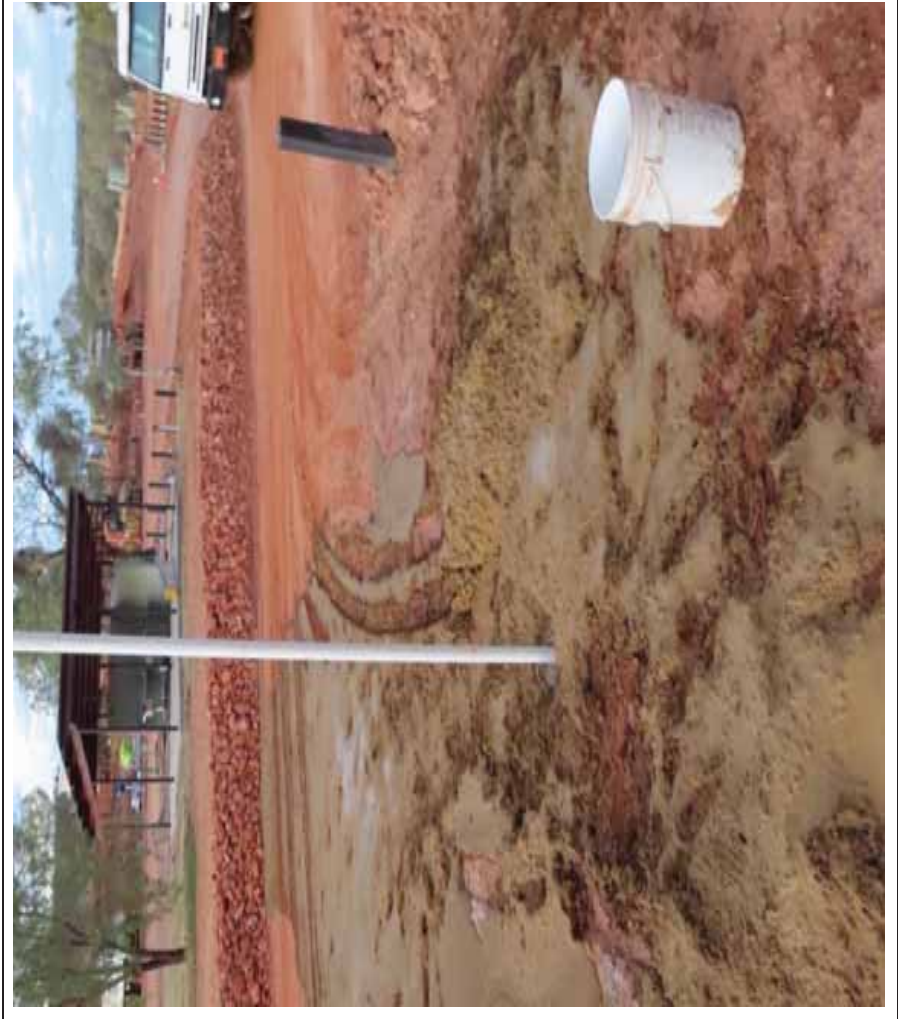
| | <p><b>Figure 15.</b><br/><i>The pipe for a monitoring well is in place.</i></p> |

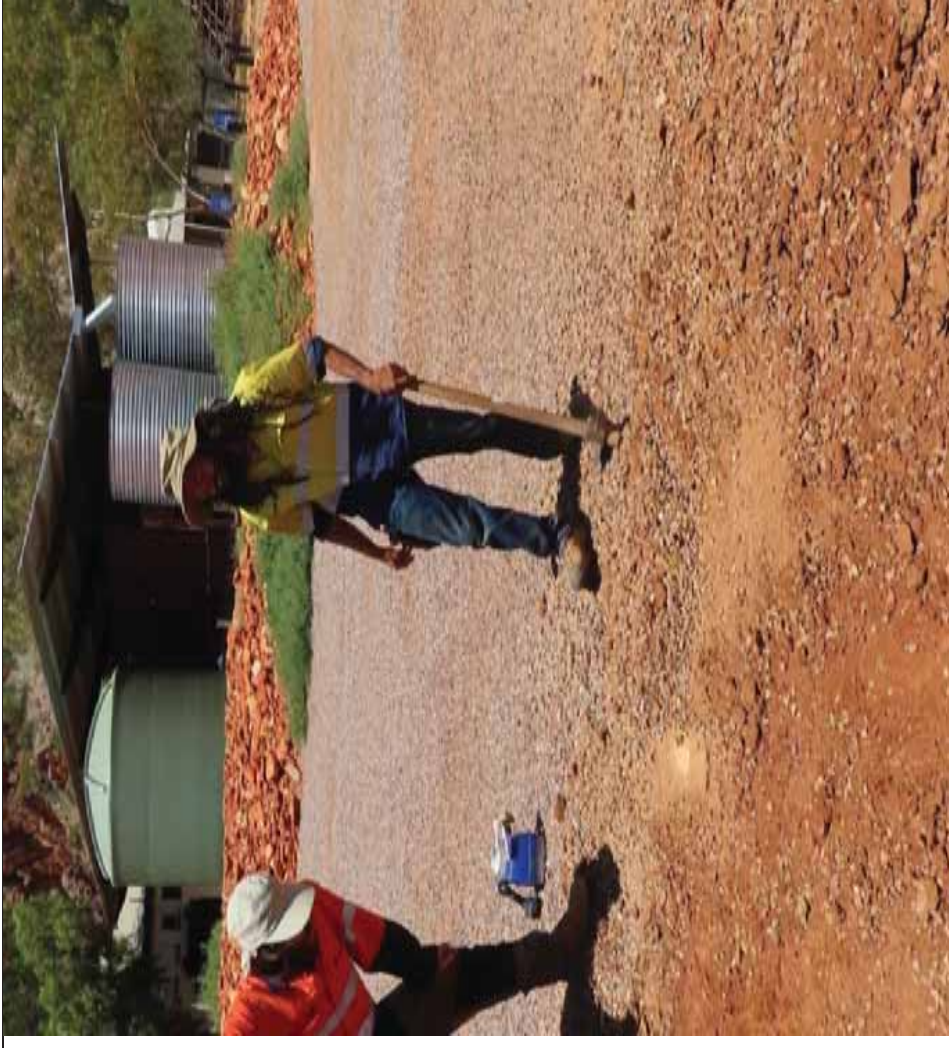
**Figure 16:**

Ryan Fritsch and Dansh Antia digging for MW 4. Heavy rainfall in June, September, and October caused challenging road conditions at Glen Helen Lodge, requiring gravel to be laid out to make the roads accessible again. During the gravelling of the road, signposts to the monitoring wells were removed and the monitoring wells buried.
