Appendix D - Report on Remediation Action Plan,
Proposed Residential Subdivision, Lot 3 Freds Pass
Road, Humpty Doo. May 2016 (DP Ref:
78156.01.R.003.Rev0)

Report on
Remediation Action Plan

Proposed Residential Subdivision
Lot 3 Freds Pass Road, Humpty Doo

Project : 78156.01
R.003.Rev1
16 May 2016

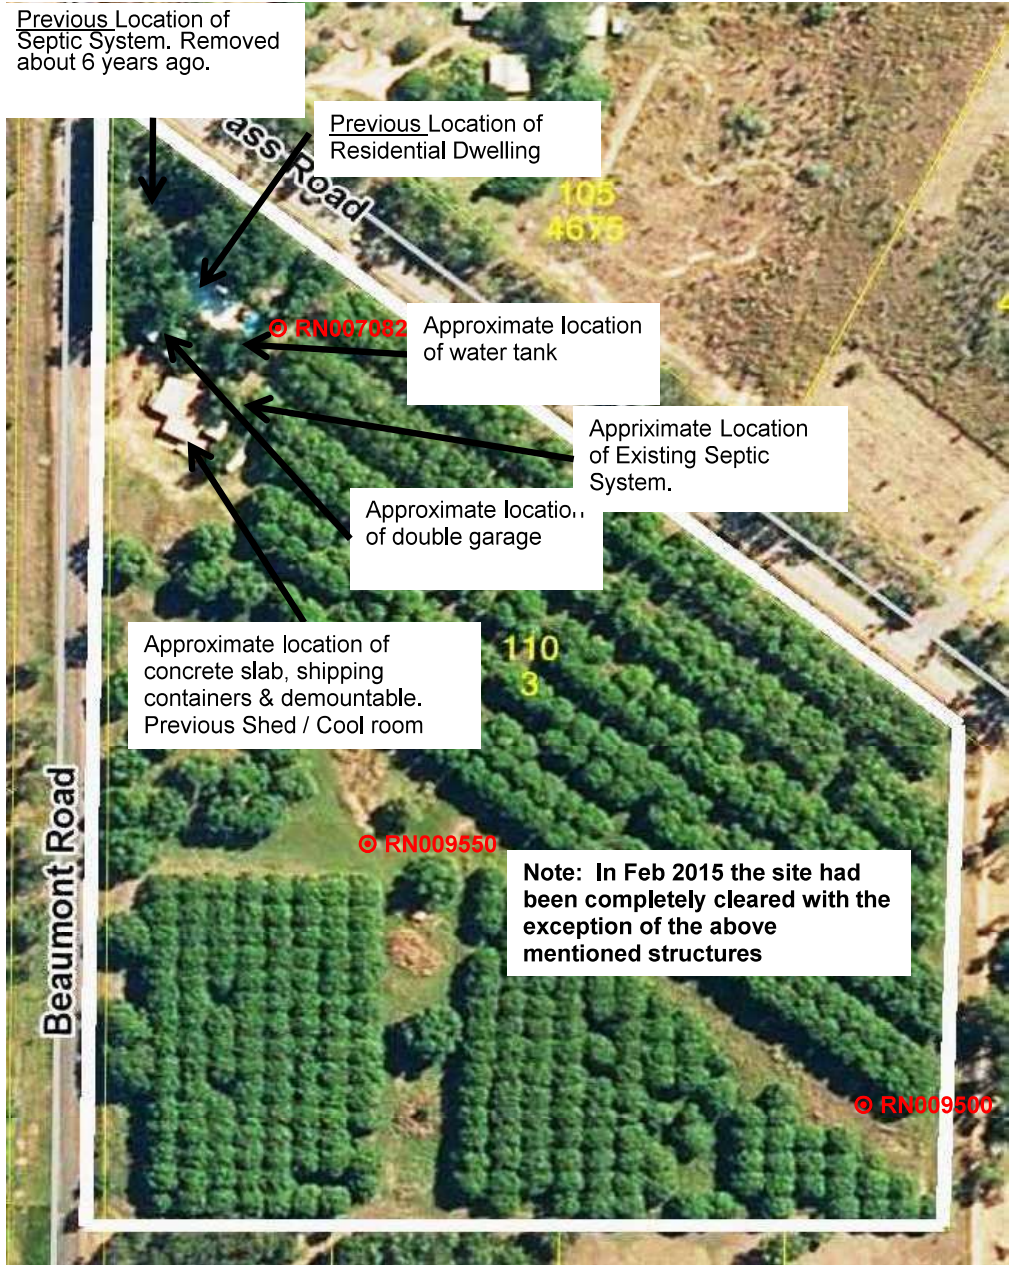
Site Location and Features Plan Proposed Residential Development Lot 3 Freds Pass Road Humpty Doo, NT	PROJECT: 78156.01
		DRAWING: 2
		REV: 1
	CLIENT: Tolinchlo Pty Ltd	DATE: 30-Mar-16

Previous Location of Septic System. Removed about 6 years ago.

⊙ - Approximate Location of Registered Groundwater Bore

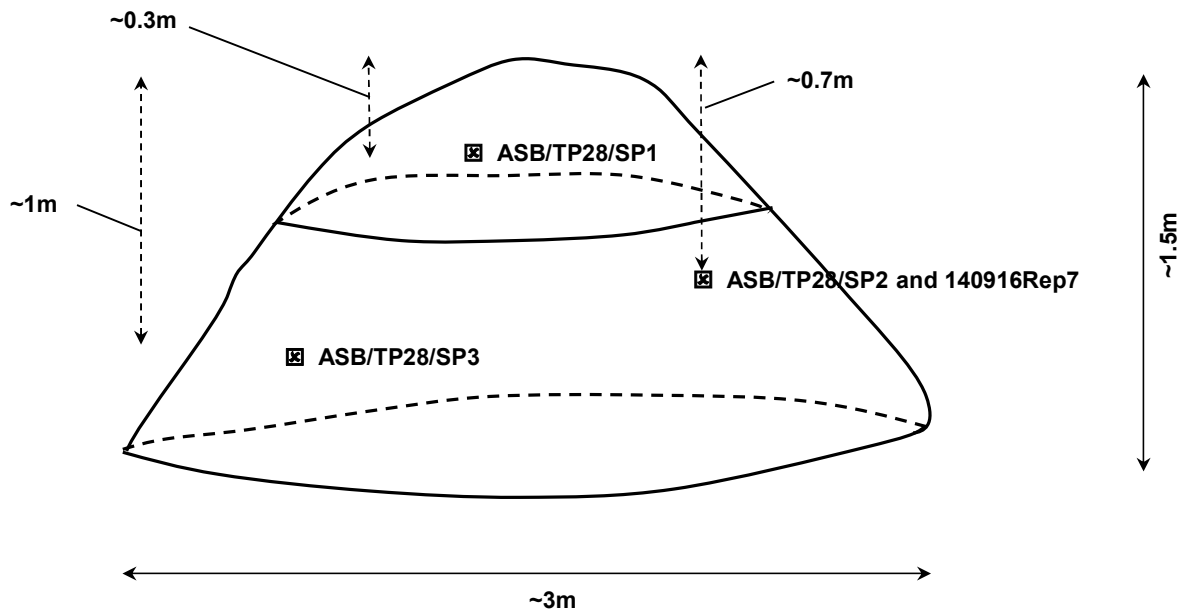
Sketch of ASB Stockpile from TP28

1. denotes approximate location of sample
2. Sketches are Not to Scale
3. Dimensions are approximate only
4. Stockpile volume estimated to be about 8m³ (no bulking factor) based on excavation dimensions.

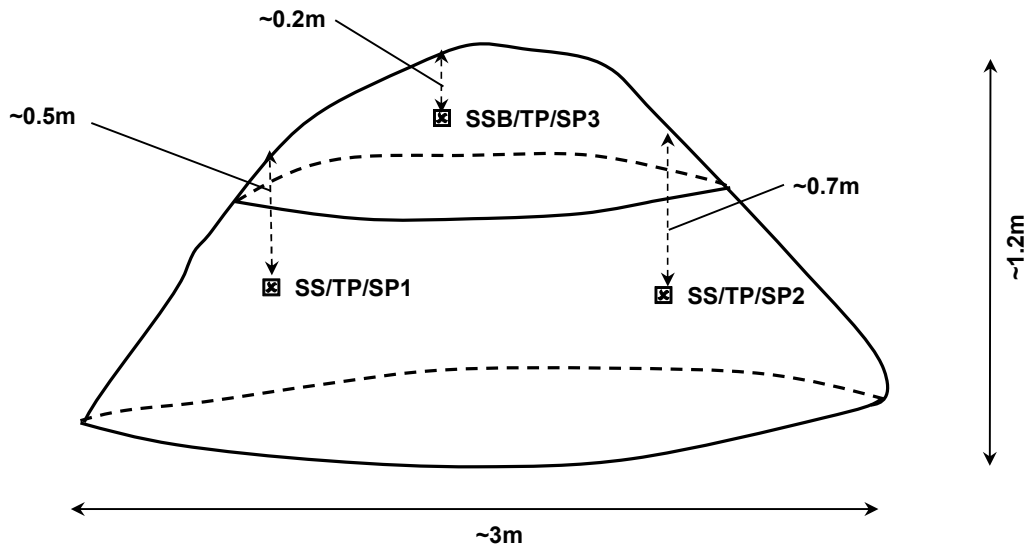
Sketch of SS Stockpile

1. denotes approximate location of sample
2. Sketches are Not to Scale
3. Dimensions are approximate only
4. Stockpile volume estimated to be about 8m³ (no bulking factor).

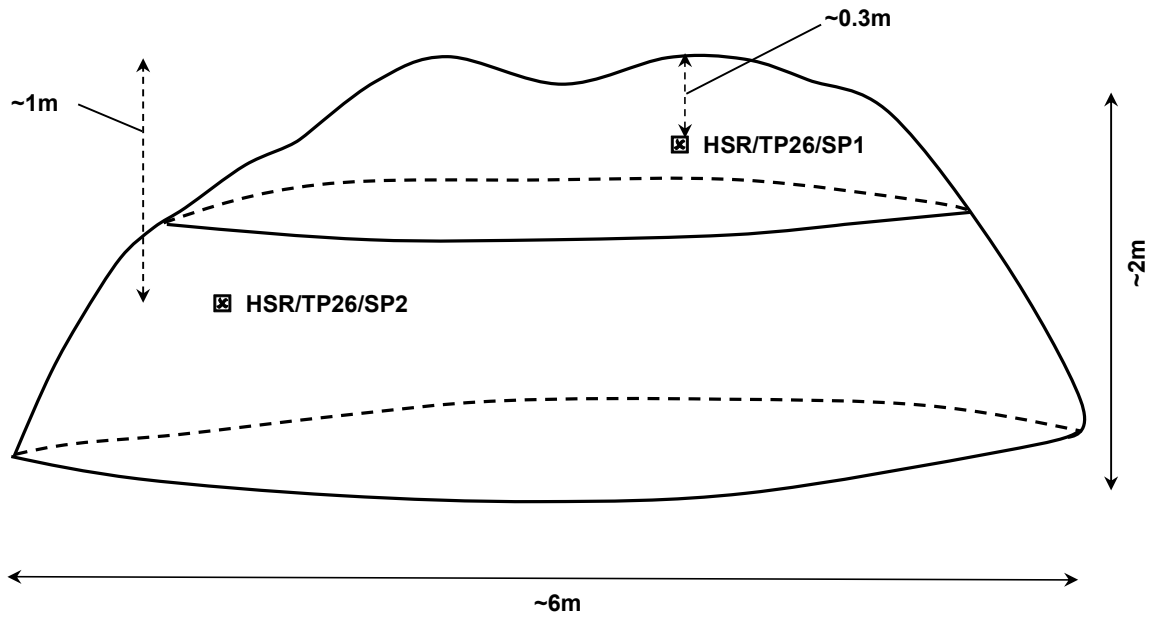
Sketch of HSR Stockpile from TP26

1. denotes approximate location of sample
2. Sketches are Not to Scale
3. Dimensions are approximate only
4. Stockpile volume estimated to be about 38m³ (no bulking factor) based on excavation dimensions.

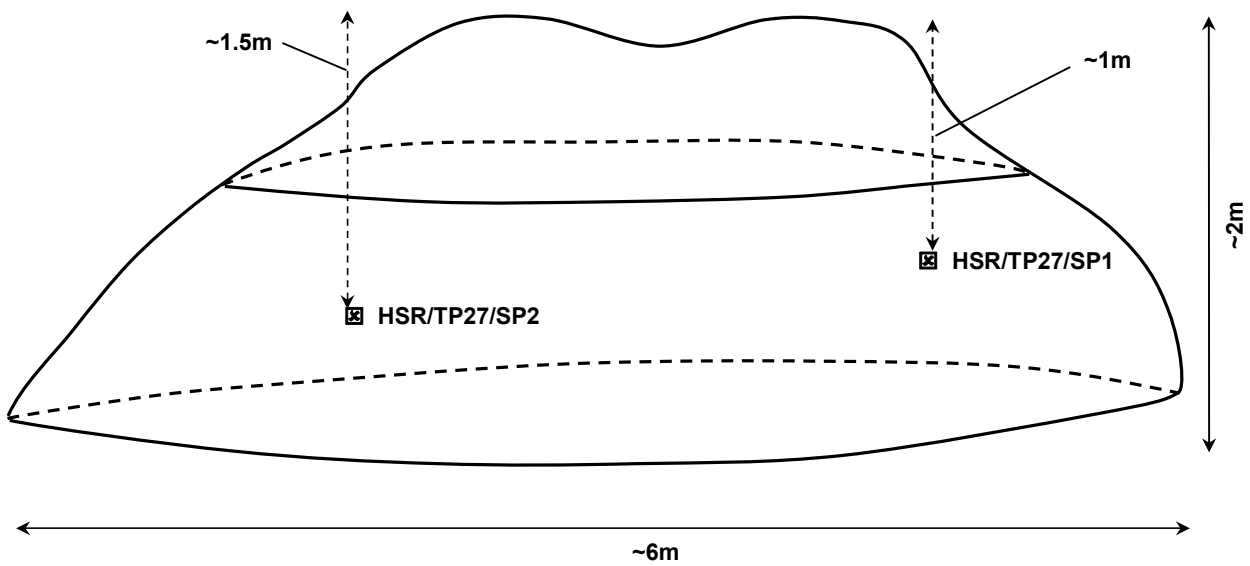
Sketch of HSR Stockpile from TP27

1. denotes approximate location of sample
2. Sketches are Not to Scale
3. Dimensions are approximate only
4. Stockpile volume estimated to be about 40m³ (no bulking factor) based on excavation dimensions.

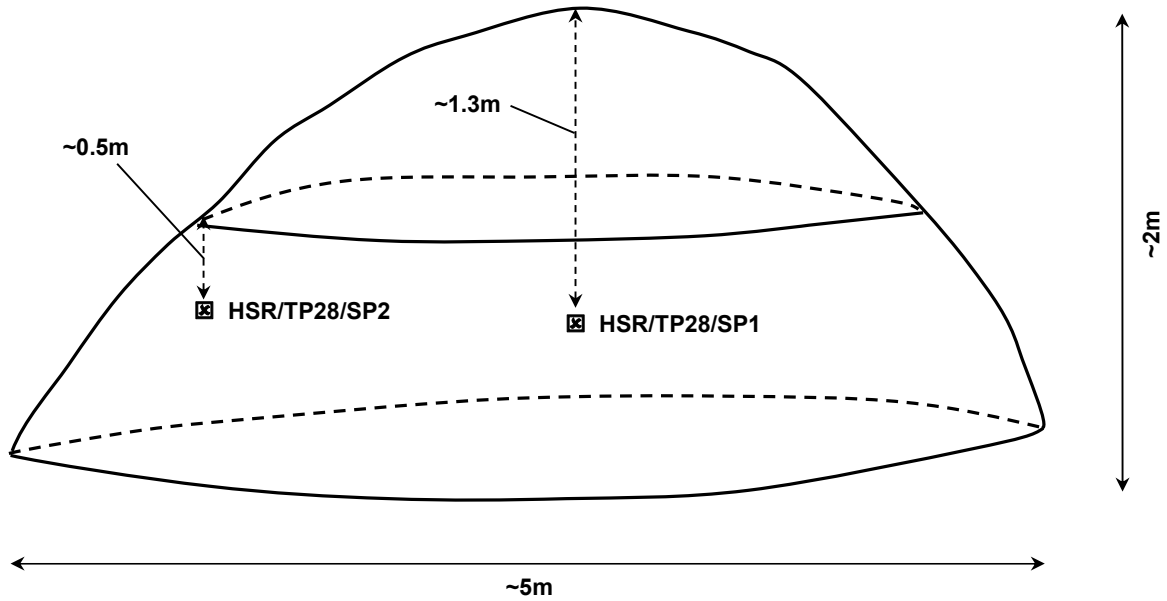
Sketch of HSR Stockpile from TP28

1. ☒ denotes approximate location of sample
2. Sketches are Not to Scale
3. Dimensions are approximate only
4. Stockpile volume estimated to be about 38m³ (no bulking factor) based on excavation dimensions.

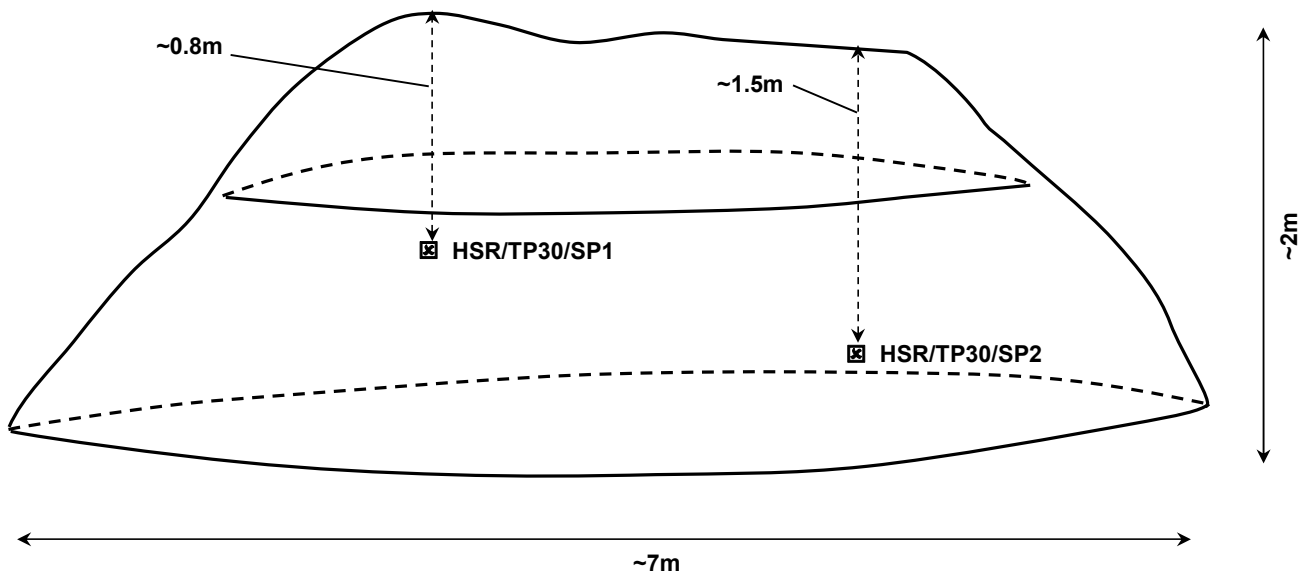
Sketch of HSR Stockpile from TP30

1. ☒ denotes approximate location of sample
2. Sketches are Not to Scale
3. Dimensions are approximate only
4. Stockpile volume estimated to be about 41m³ (no bulking factor) based on excavation dimensions.

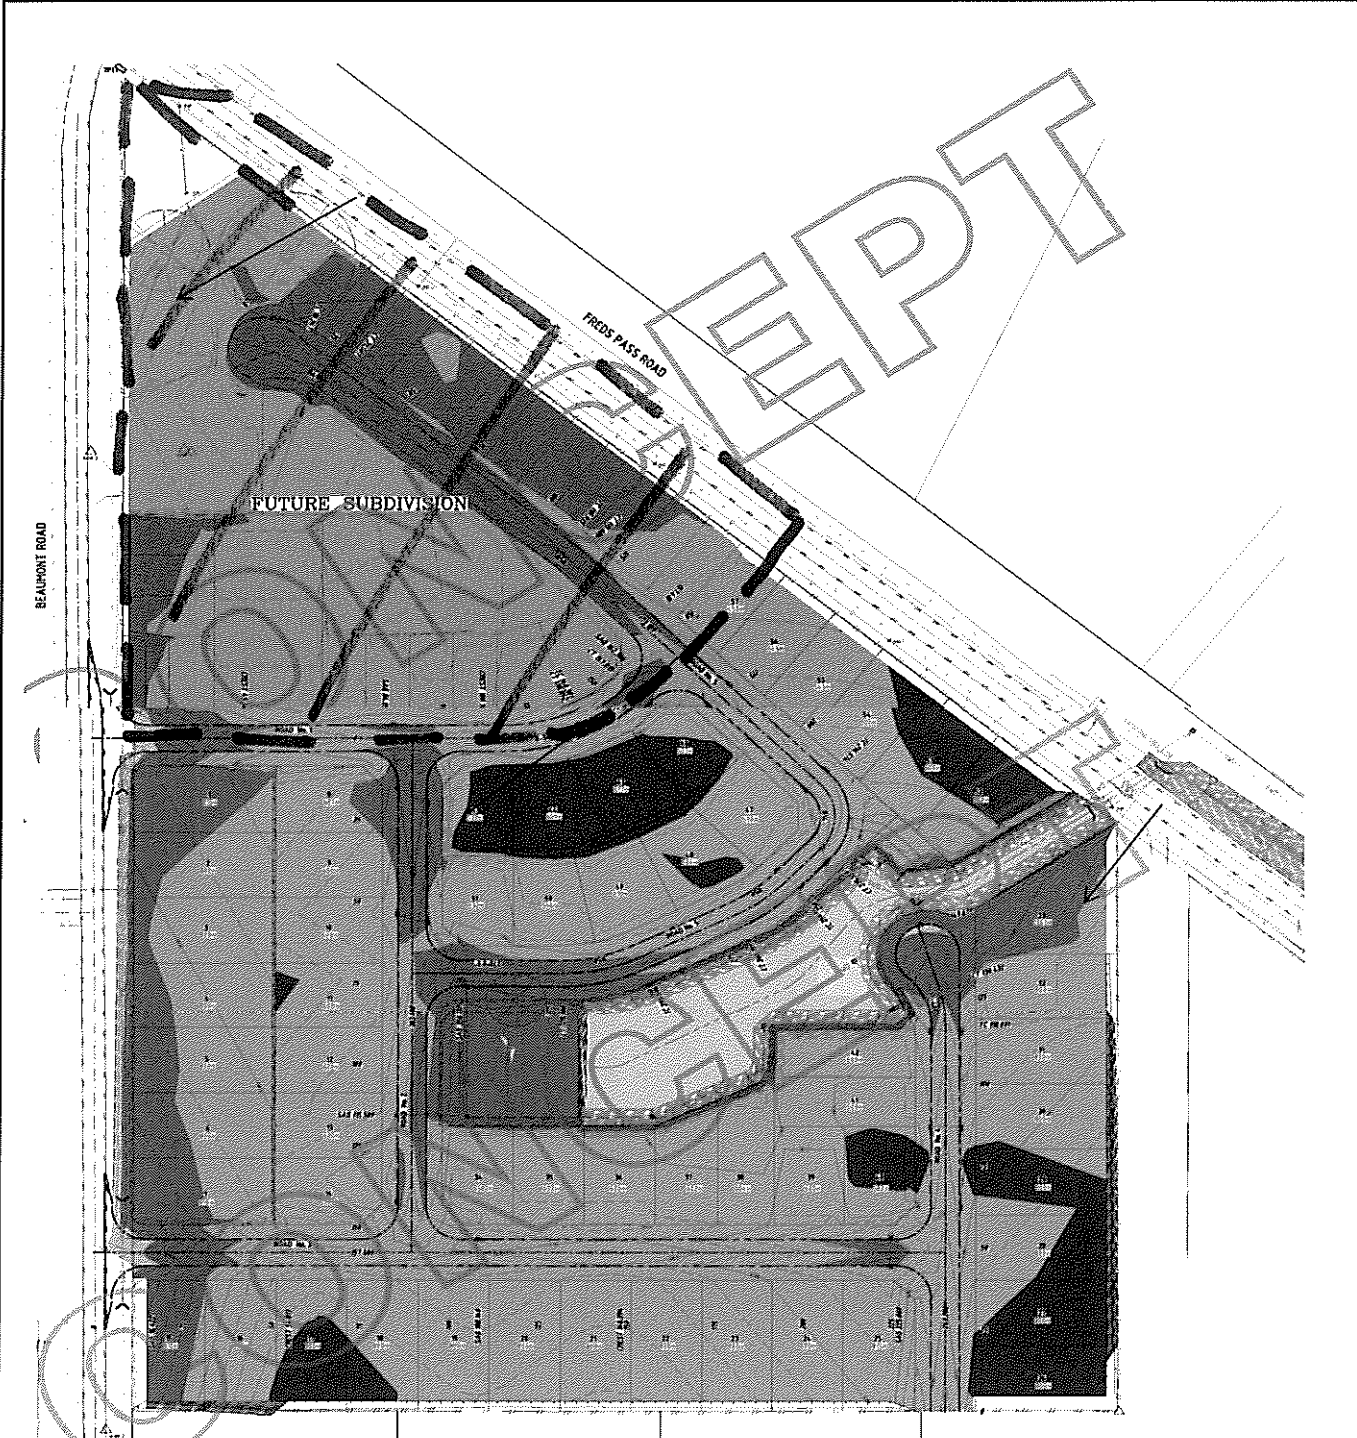
Douglas Partners Geotechnics Environment Groundwater	Earthworks Plan Overlay Proposed Residential Subdivision Lot 3 Freds Pass Road Humpty Doo, NT	Project 78156.01
		DRAWING: 4
		REV: 0
	CLIENT: Tolinchlo Pty Ltd	DATE: 5-Apr-16

Proposed cut/fill depths

- Fill 0-0.5 m
- Fill 0.5-1.0 m
- Fill 1.0-1.5 m
- Fill 1.5-2.0 m
- Cut 0-0.5 m
- Cut 0.5-1.0 m

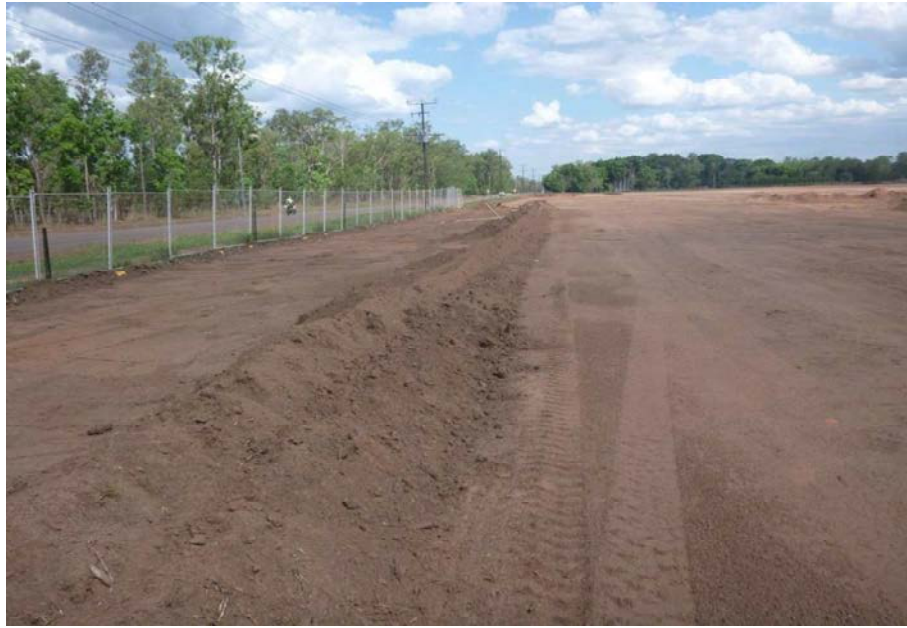
Photo 1: Windrow of topsoil, prior to removal from MD Zone

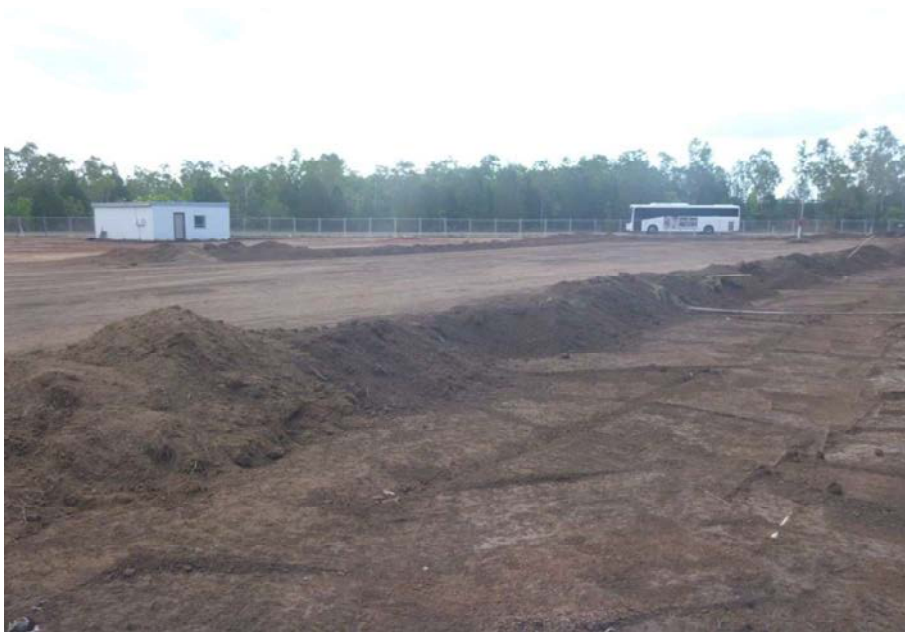
Photo 2: Windrows of topsoil, prior to removal from MD Zone

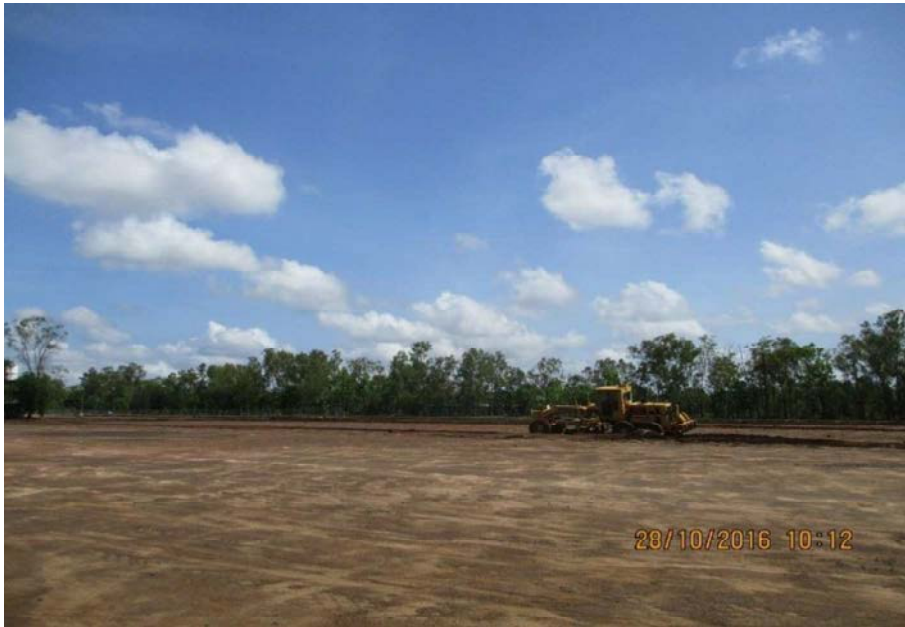
Photo 4: Tying on the MD site

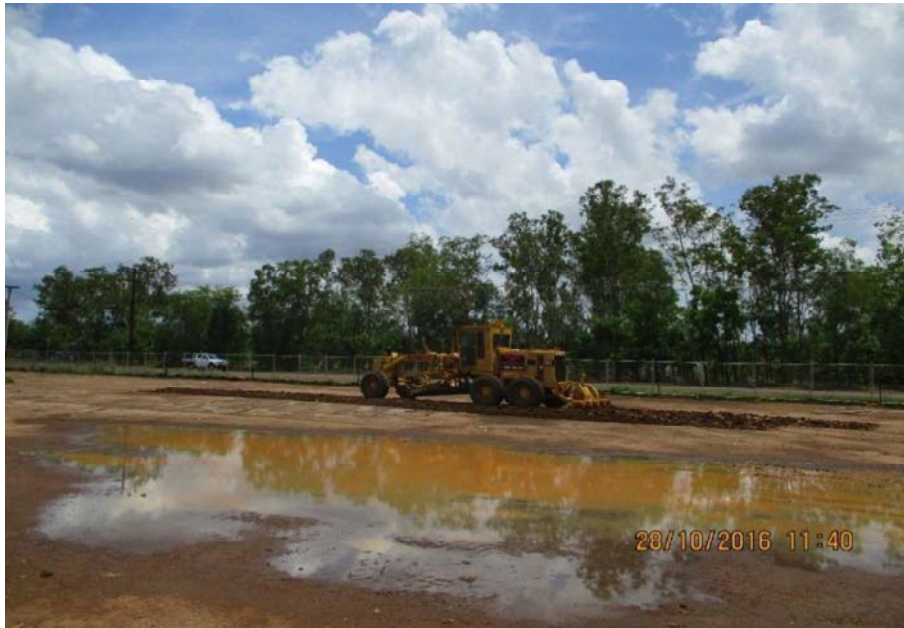
Photo 5: Tying on the MD site. Ponding water due to rain in foreground.

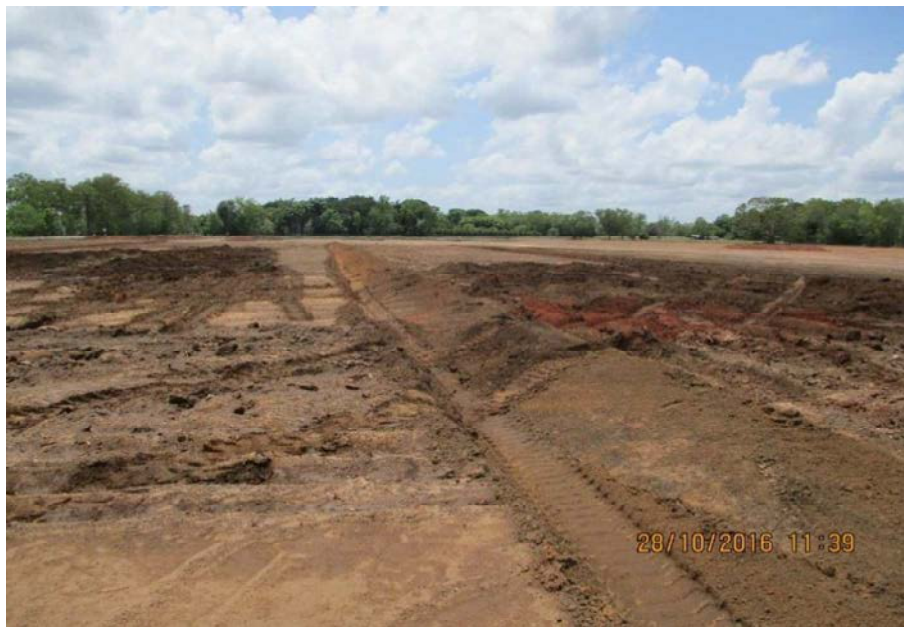
Photo 6: Forming a drain to the east end of the site during mixing to allow rainfall to runoff more effectively

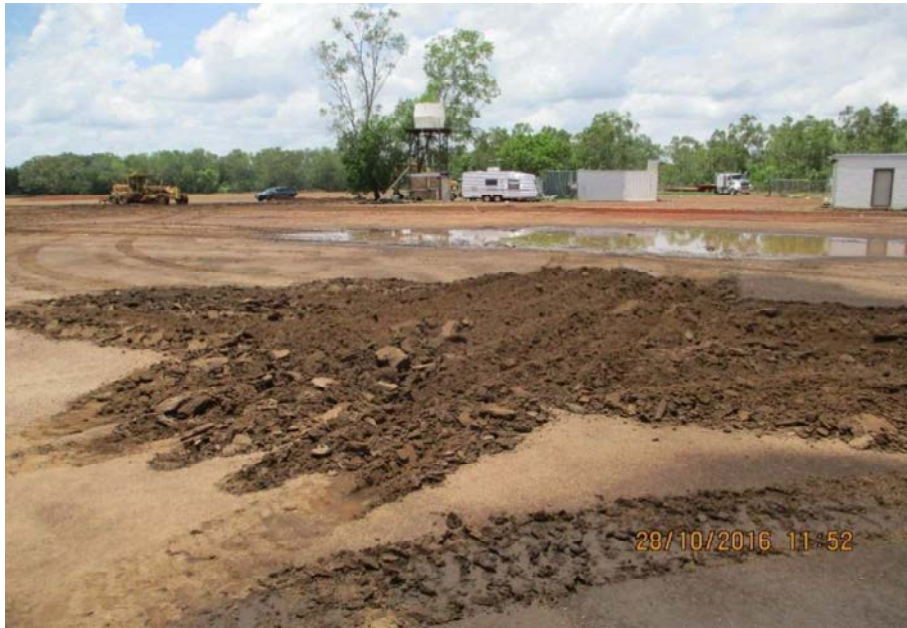
Photo 7: Example of tyning in two directions where shallow laterite was encountered

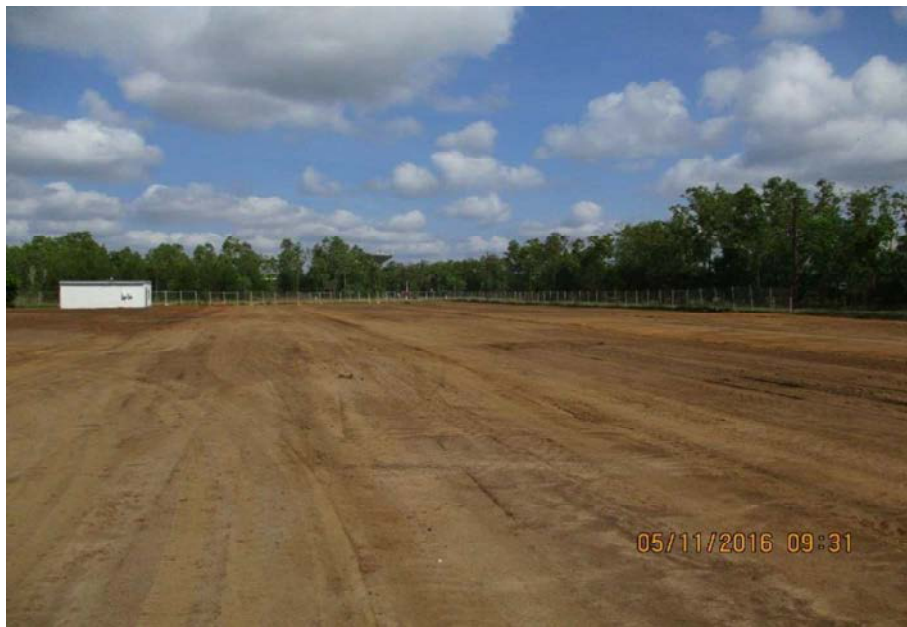
Photo 8: Finished surface after re-compaction
