Appendix B: Notifications and Relevant Regulatory Correspondence

AUTHORISED OFFICER DIRECTION

Re: ALLEGED NON-COMPLIANCES WITH THE WASTE MANAGEMENT AND POLLUTION CONTROL ACT 1998 – SHOW CAUSE

One Rail Show Cause Response

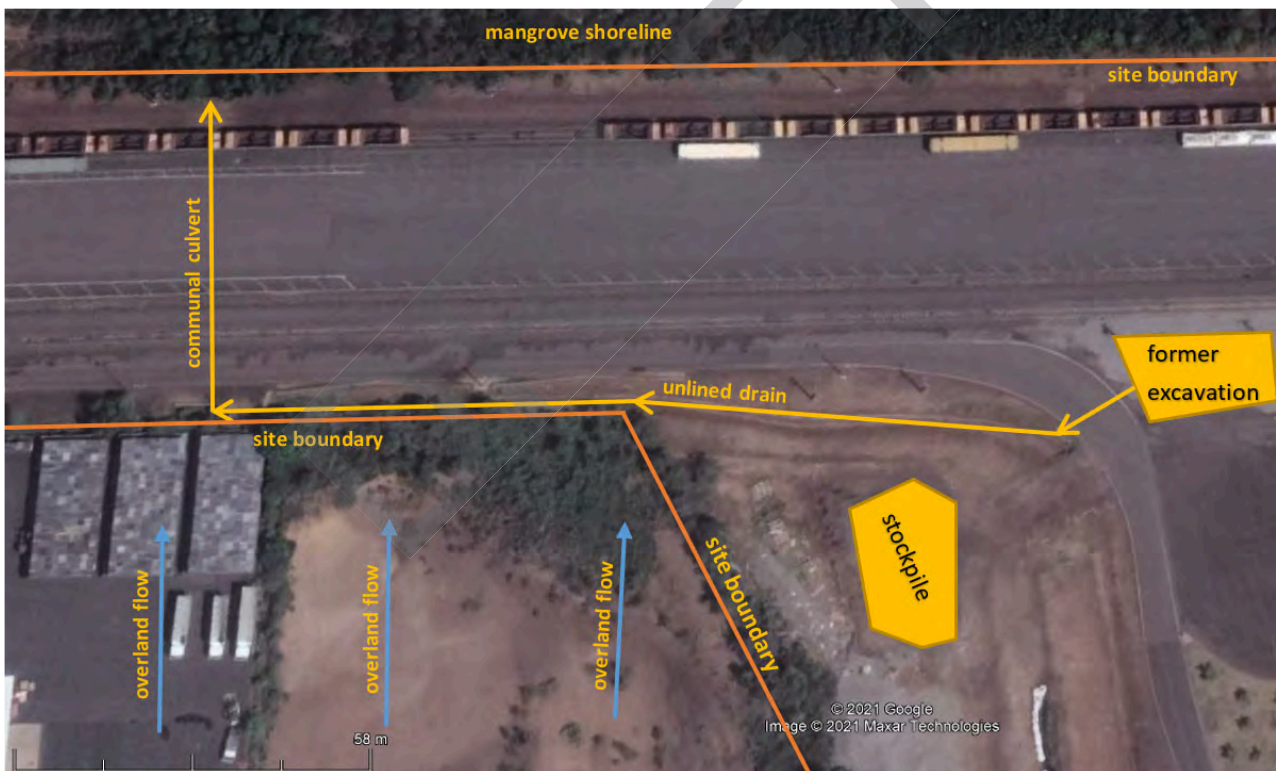
The initial spill occurring in May 2020 occurred in the Berrimah One Rail Terminal, with soils stockpiled in the vicinity of the spill location temporarily, prior to long term management elsewhere on the site after the 2020/2021 wet season. The 1100 tonne soil stockpile is located approximately 10 metres adjacent an onsite stormwater culvert, which then joins to a communal concrete-lined drainage culvert 120 metres west, before passing under the container pad and expelling at the mangroves 55 metres north of this location. The DSI (Section 10.4) identifies the intertidal mangrove community as a potential source-pathway-receptor.

Several offsite sources feed both the communal culvert (as designed) but also overland flow from neighbouring properties contributes to the onsite unlined drainage culvert.

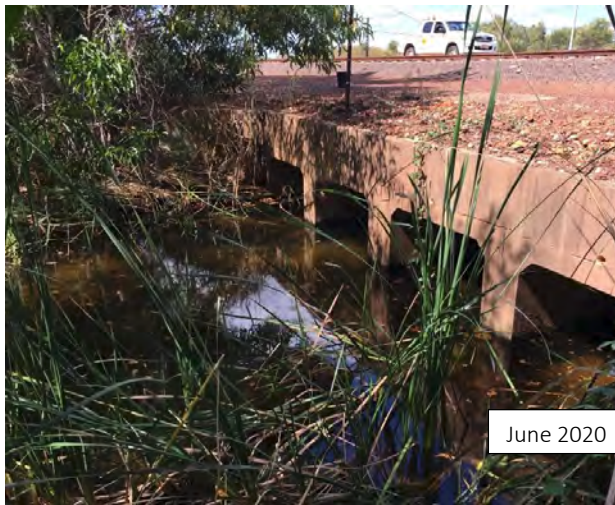
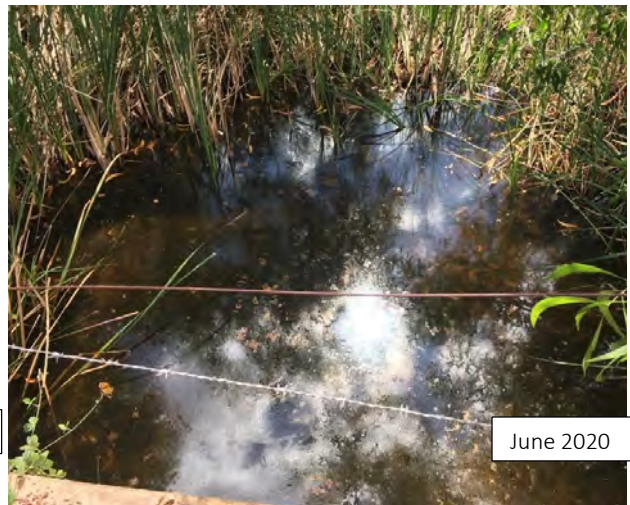
Visual sheens have historically been identified at the communal drain outfall in June 2020 as part of environmental monitoring of the shoreline conducted by Grencap. This was not associated with the One Rail site, and NT EPA were notified of this observation at the time. A sample taken by Grencap of this area did not confirm the presence of petroleum hydrocarbons, nor was the potential source of the sheen identified.

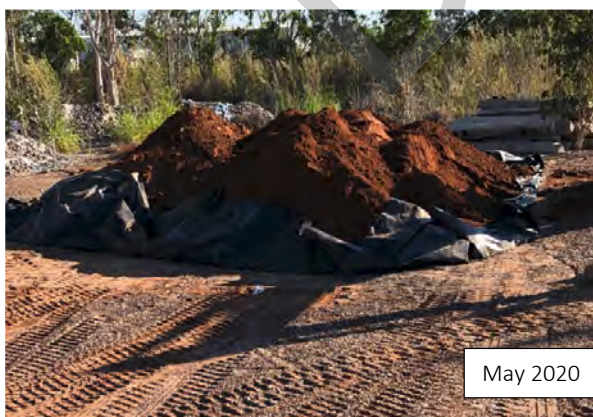
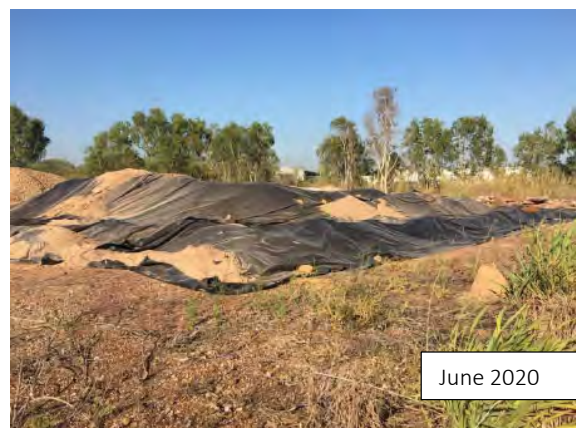
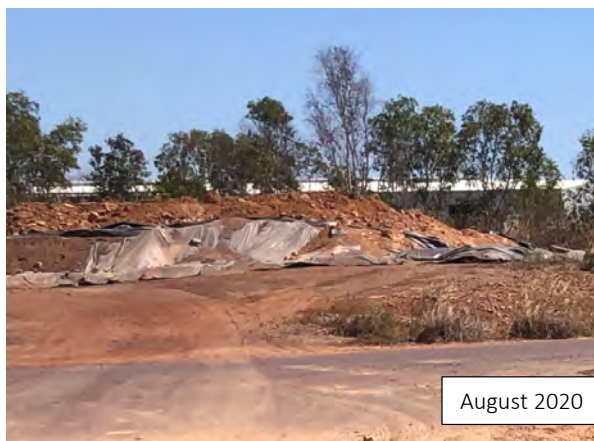
Throughout the excavation and remedial works undertaken, heavily impacted soils have been stored on plastic and covered with plastic periodically during each stage of works. Photos of the stockpile taken during excavation works are included below.

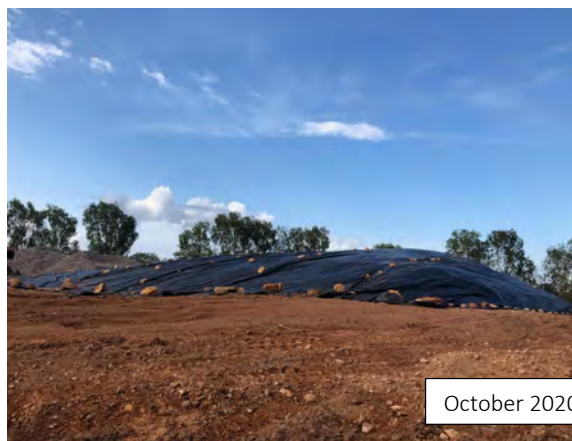
October 2020

A final plastic covering was placed over the stockpile in October 2020, however, was subsequently removed in December 2020 citing safety concerns of the plastic tearing loose in high winds, presenting a risk to neighbouring properties, terminal operations, or the mangroves.

Heavily impacted soils are to be placed on and covered with 1.5mm thick plastic HDPE liners to withstand wet-season conditions. Liners are continuous in construction and allow a greater level of reinforcement to be used to prevent tearing in high winds.

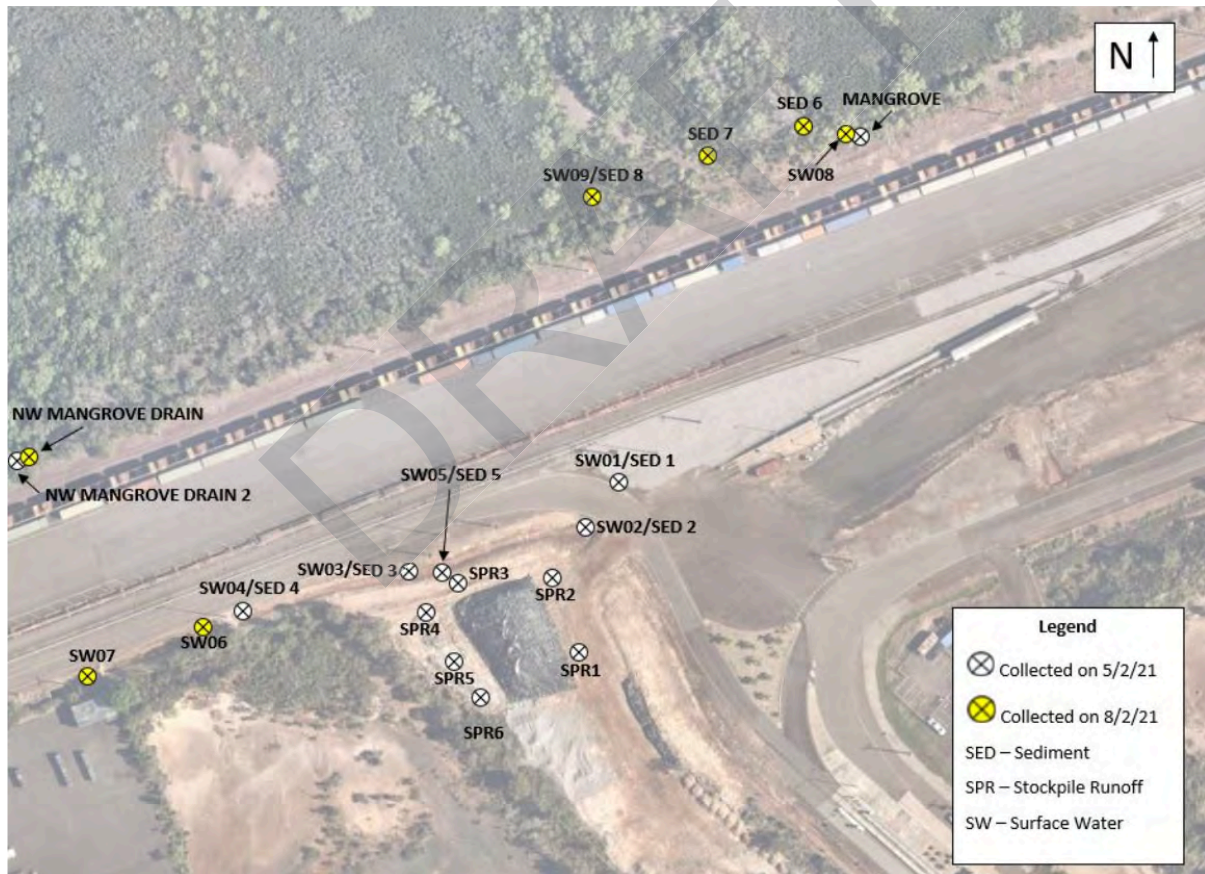
Sample location plan is included below.

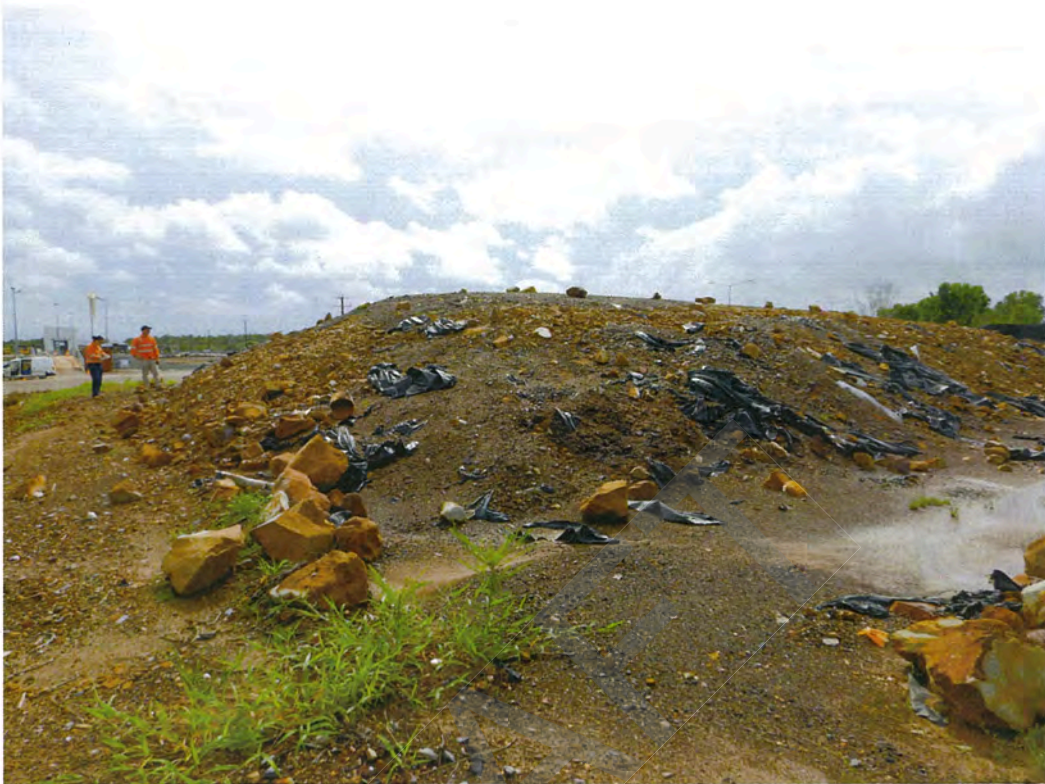
Photograph 1: Stockpiled material facing east. Stockpile is uncovered with no erosion or sediment controls in place.

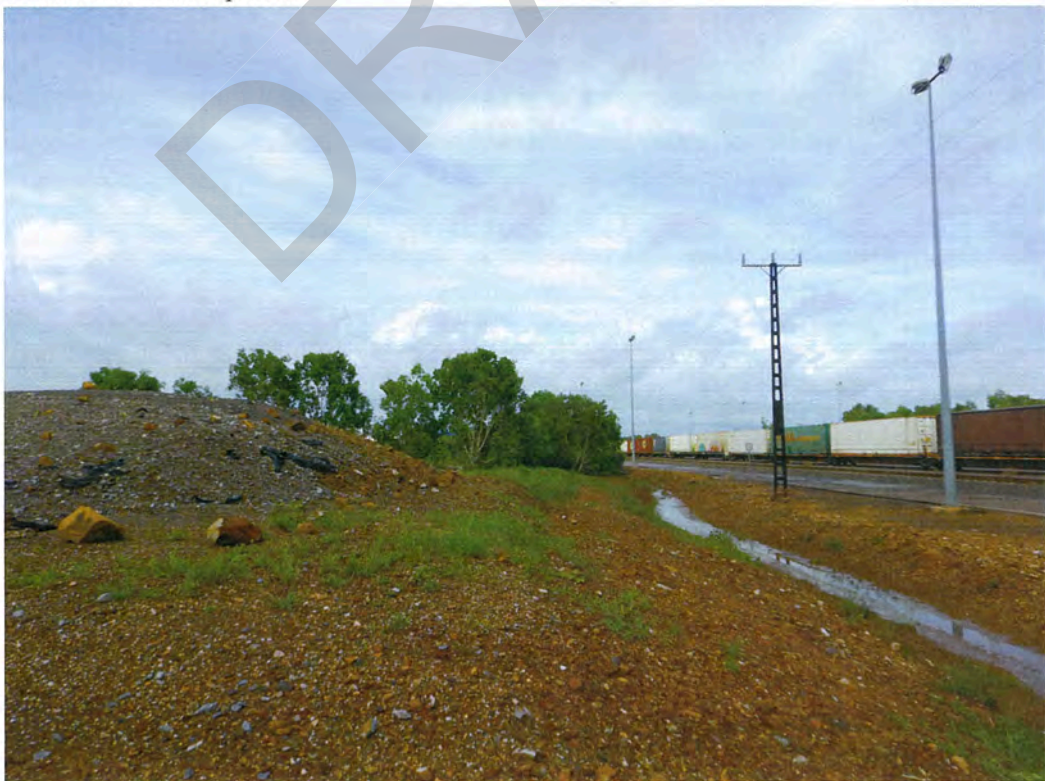
Photograph 2: Stockpiled material facing west. Earthen stormwater drain visible on far right of image, flowing west.

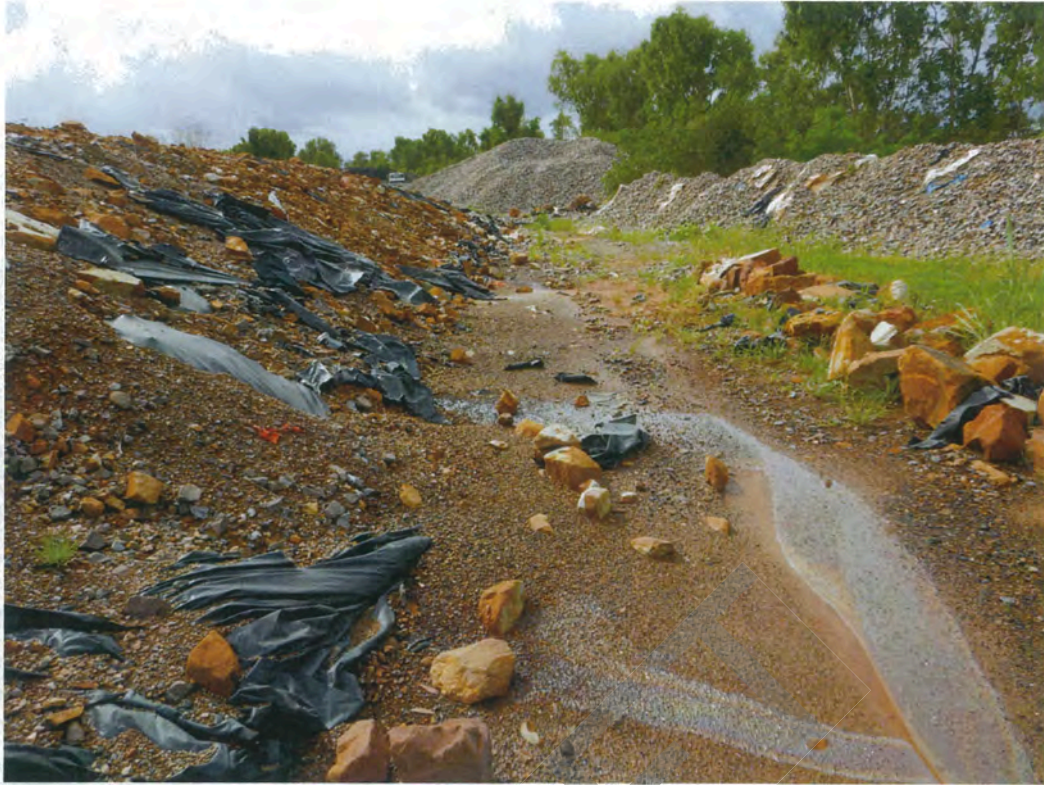
Photograph 3: *Stockpiled material facing south. Visible hydrocarbon-like sheen leaching out of stockpile and pooling in surface water adjacent the stockpile.*

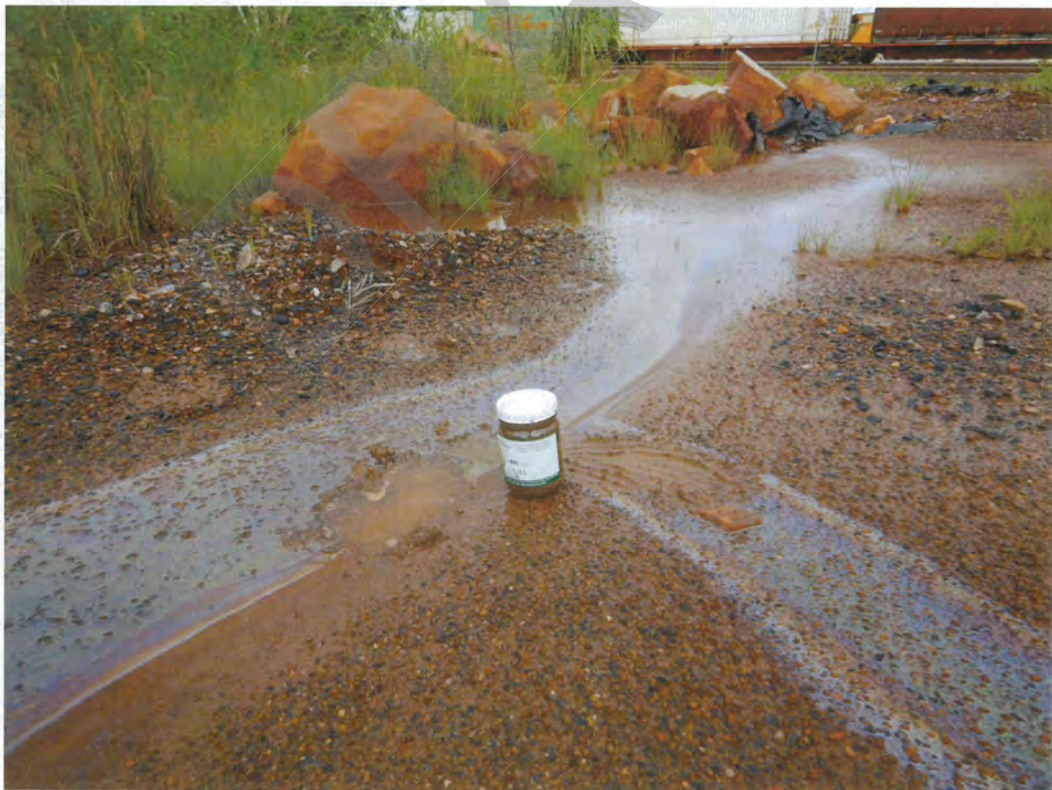
Photograph 4: *Visible hydrocarbon-like sheen atop ground surfaces and pooling in surface water adjacent stockpile.*

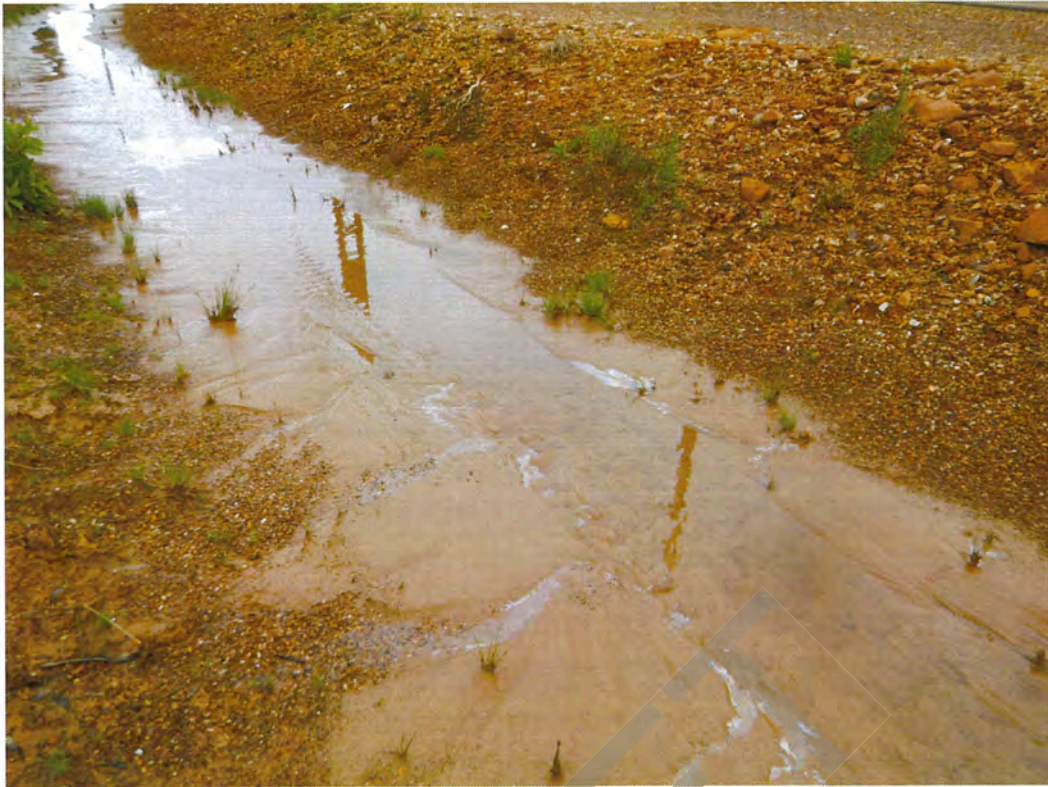
Photograph 5: Earthen stormwater drain located north of the stockpile. Visible hydrocarbon-like sheen visible in water and on surrounding ground surfaces.

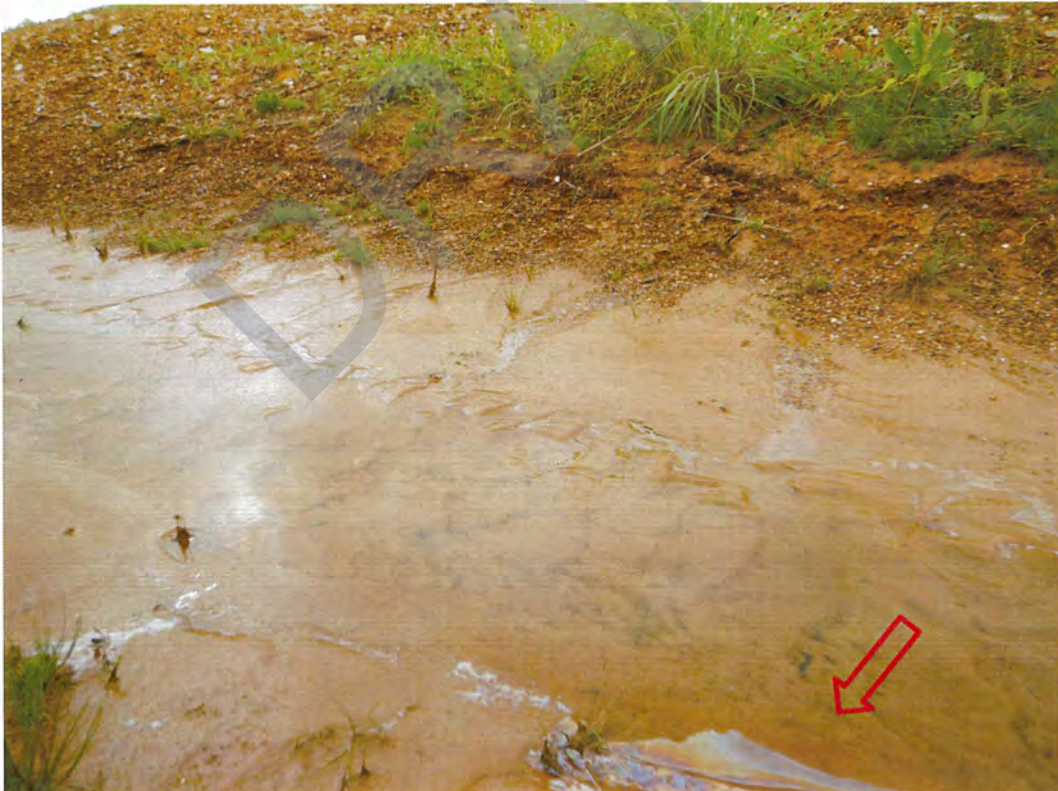
Photograph 6: Earthen stormwater drain located north of the stockpile. Visible hydrocarbon-like sheen visible in water and on surrounding ground surfaces.

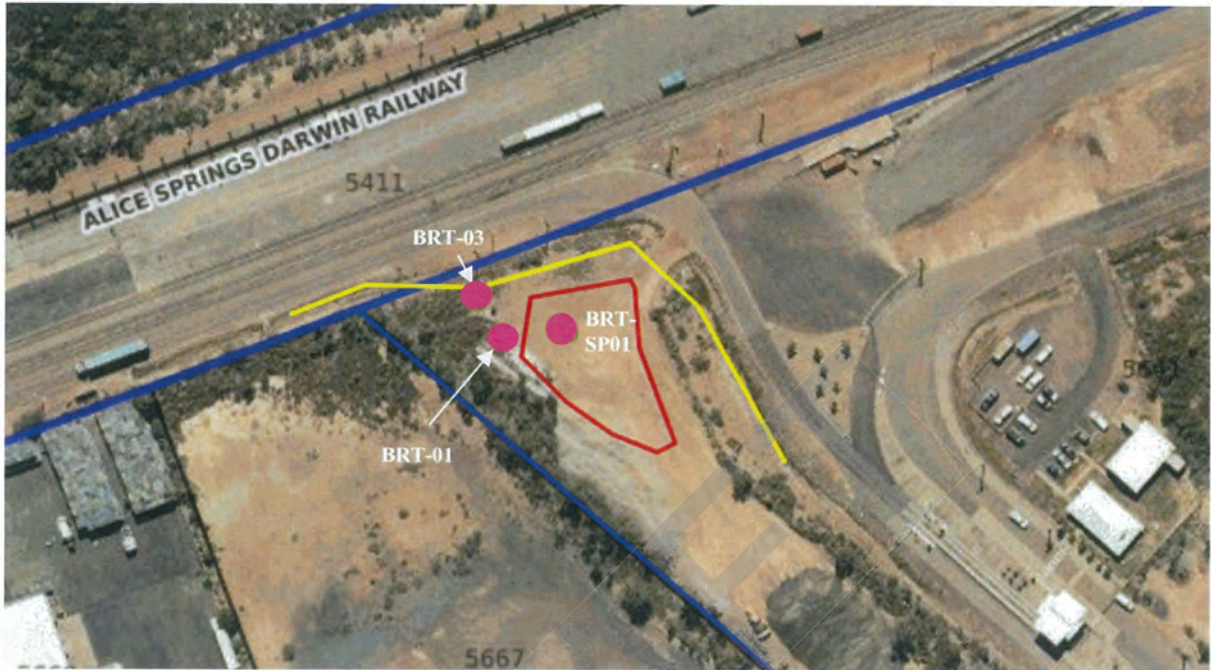
**INVESTIGATION AREA
APPROXIMATE LOCATION OF STOCKPILE, EARTHEN STORMWATER DRAIN
AND COLLECTED SAMPLE LOCATIONS**

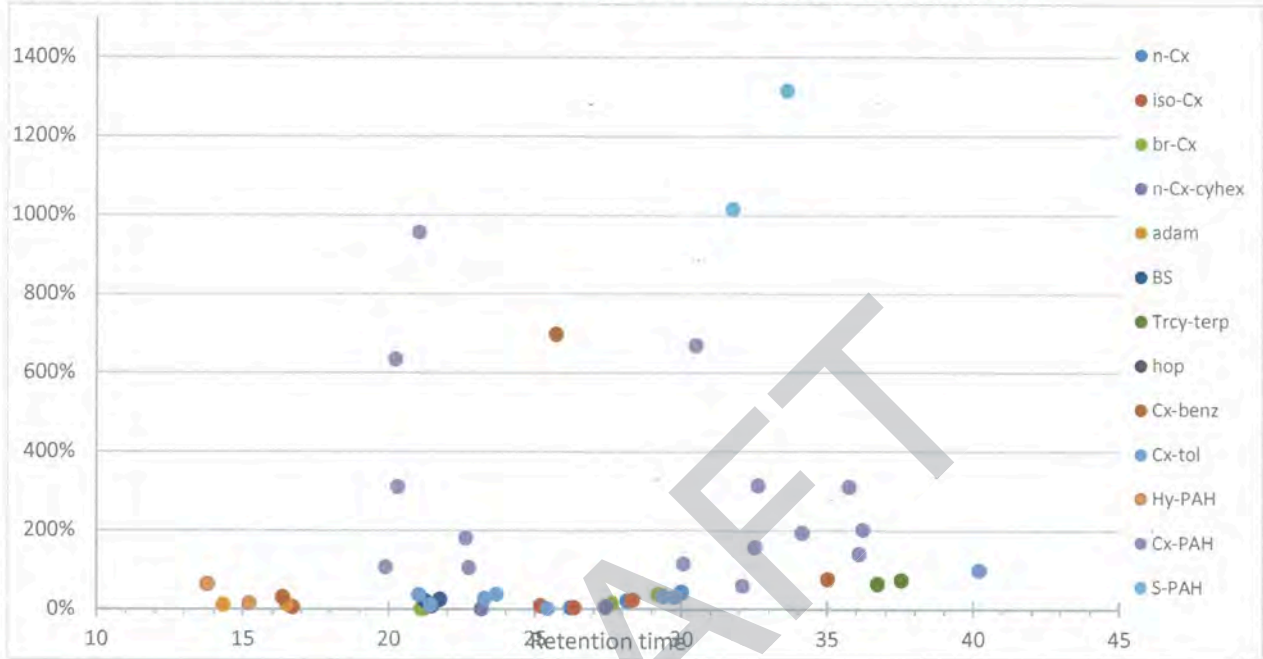
The PW plot in Figure 9 shows that sample 1 and sample 3 appear to be different hydrocarbons. There are some trends visible, indicating that they may have had a common source, with extreme weathering reducing the more volatile compounds, and water-washing enhancing the more soluble compounds (noting that sample 3 was a water sample).

Figure 9: PW plot of sample 20S3454/003 (BRT-03) compared to sample 20S3454/001 (BRT-SP01)

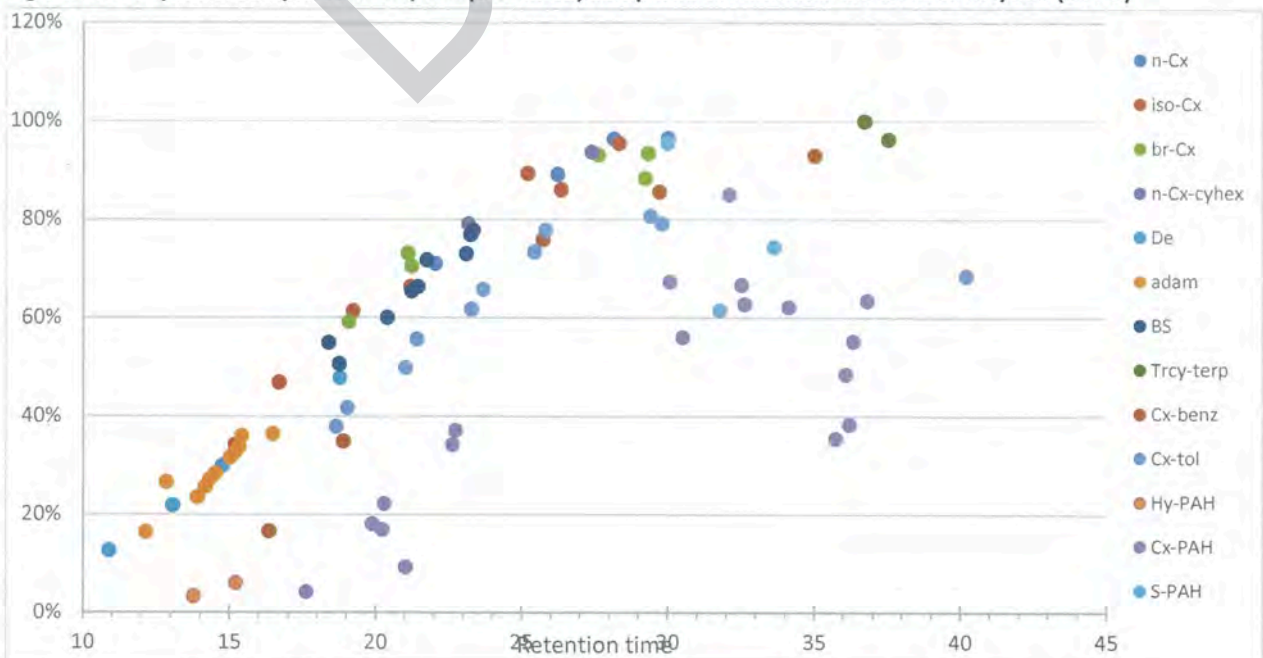
The PW plot in Figure 10 shows that sample 1 matches the reference diesel, with the water-washing of the alkyl-PAH and alkyl-benzene compounds more apparent, and some evaporation of sample 1 also visible.

Figure 10: PW plot of sample 20S3454/001 (BRT-SP01) compared to reference diesel 20S0458/001 (BYT 5)

The PW plot in Figure 11 shows that sample 2 matches the reference diesel, with a similar pattern of degradation to sample 1. Comparing Figure 11 to Figure 10 shows that sample 2 is more impacted by evaporation, and sample 1 is more impacted by water-washing of the alkyl-PAH and alkyl-benzene compounds.
