RE: BERRIMAH FREIGHT RAIL TERMINAL DIESEL SPILL – UPDATED INTERIM REMEDIATION ACTION PLAN

Greencap Pty Ltd (Greencap) was commissioned by One Rail Australia (ORA) to prepare a Remediation Action Plan (RAP) following a diesel spill at the Berrimah Freight Rail Terminal, 75 O’Sullivan Circuit, Berrimah, Northern Territory (NT) (the Site).

BERRIMAH FREIGHT RAIL TERMINAL DIESEL SPILL

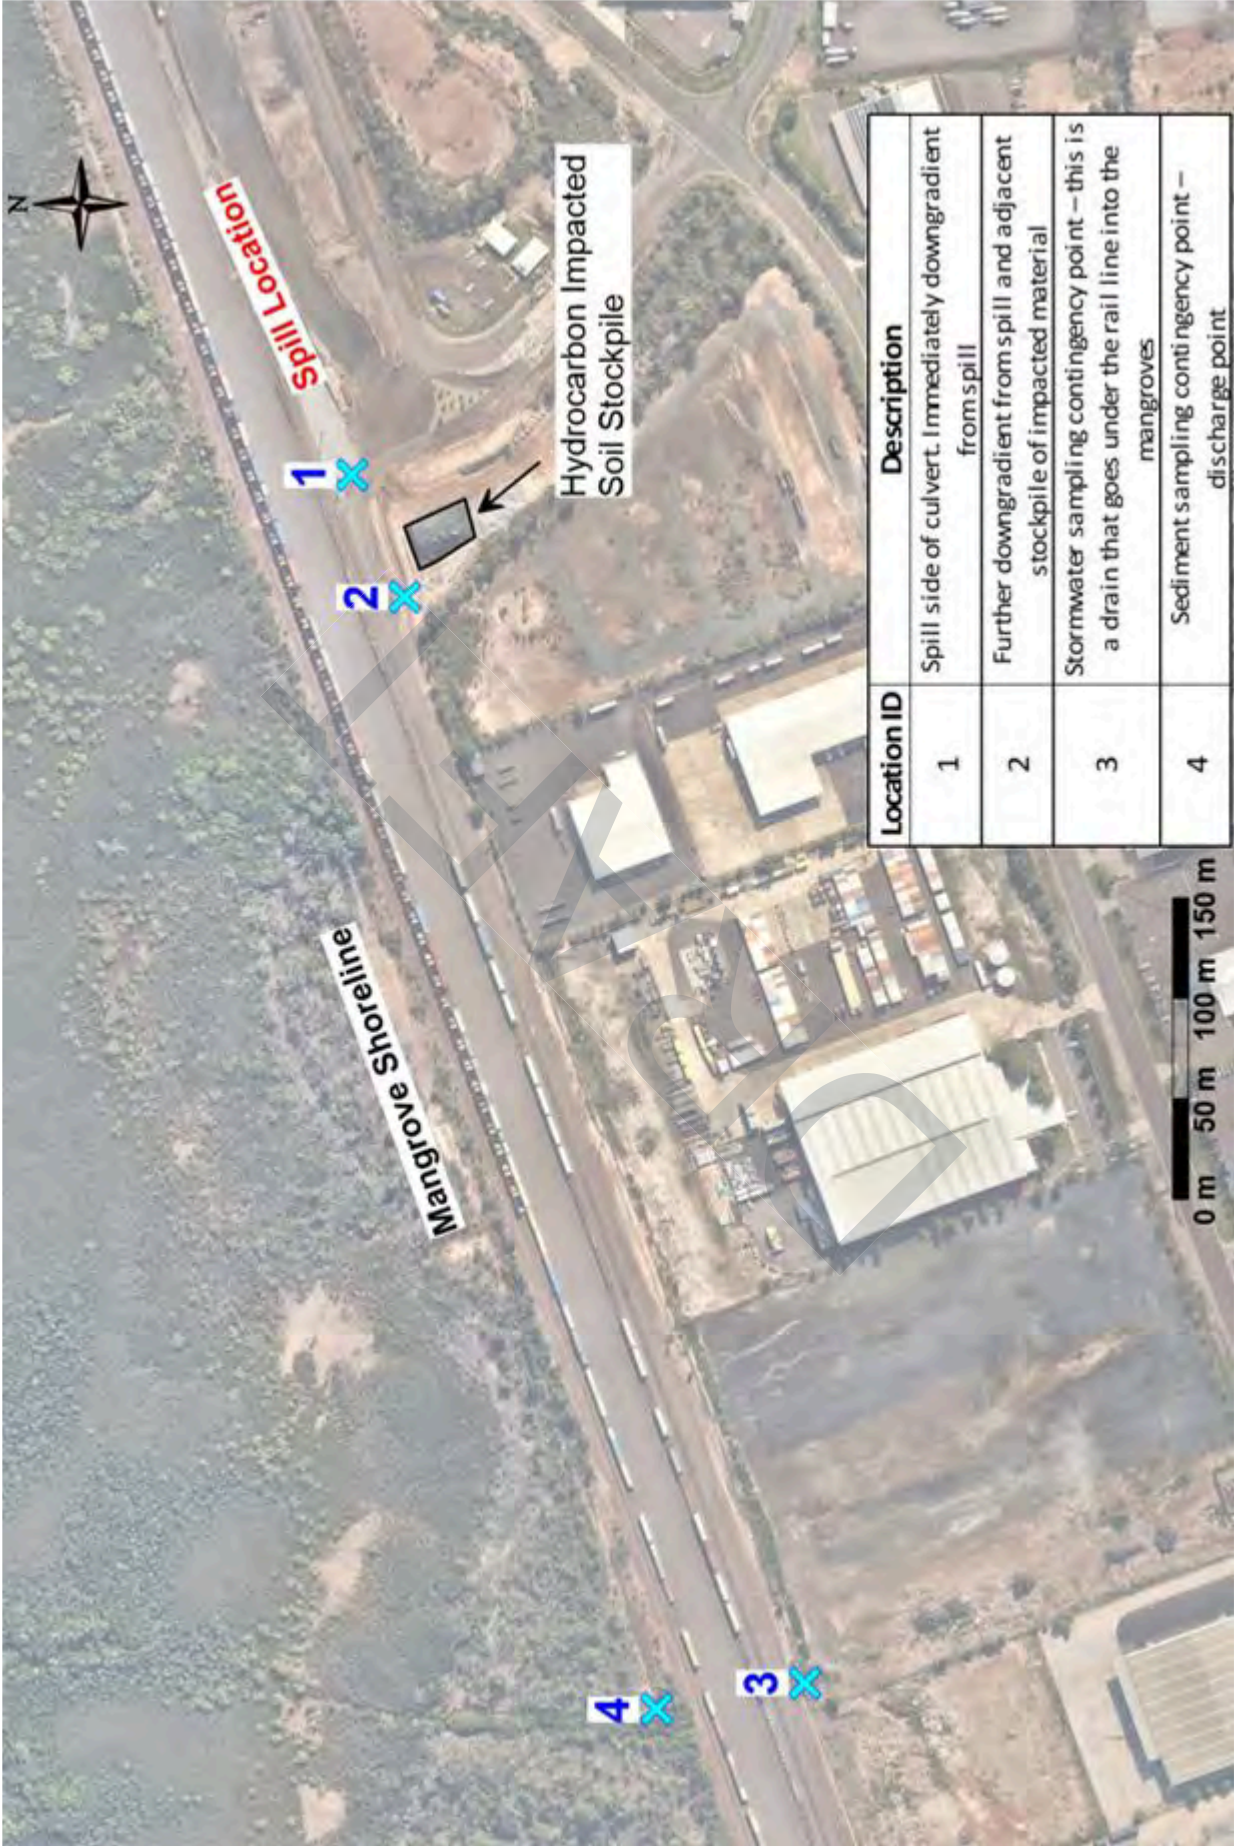
Attachment 7: Surface Water and Sediment Location Plan

Location ID	Description
1	Spill side of culvert. Immediately downgradient from spill
2	Further downgradient from spill and adjacent stockpile of impacted material
3	Stormwater sampling contingency point – this is a drain that goes under the rail line into the mangroves
4	Sediment sampling contingency point – discharge point

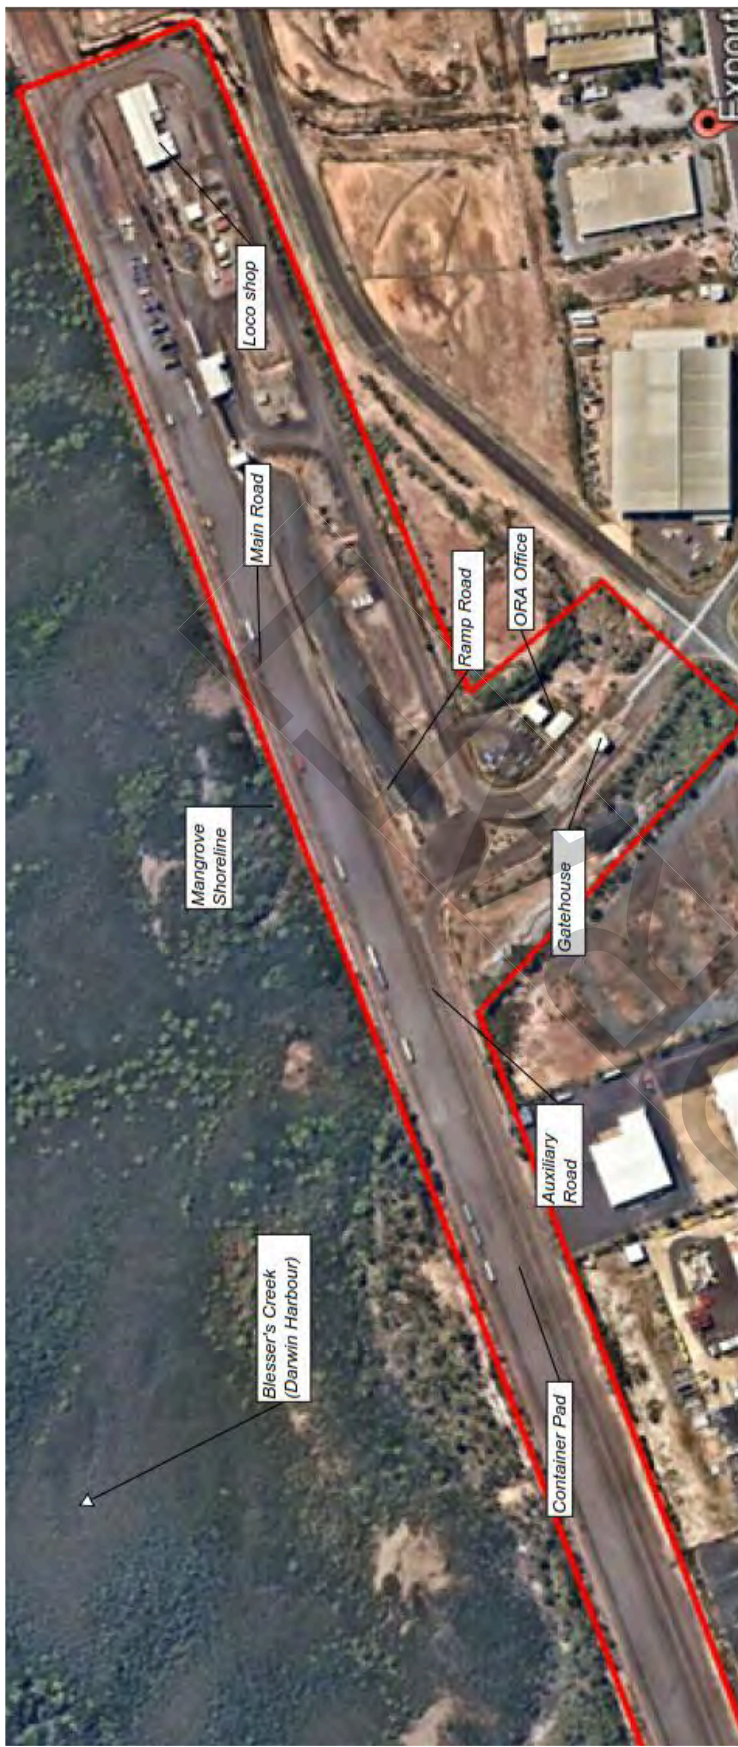
Figure 2-1 – Site Plan (source: Nearmap)

The spill occurred on the 1 Road rail line, to the north of the office building and spread under the Auxiliary Road and Ramp Road rail lines to the south, and along an unlined Vee-drain to the west where a temporary interception sump was excavated and used to recover some of the diesel. The Vee-drain continues west past the recovery/interception sump and a second vee drain exists to the south of the spill site, approximately 20 m to the south of the Ramp Road at its closest point. Directly to the north of the spill site is the asphalt lined container pad, further afield is the edge of the intertidal mangrove community located downgradient of the spill site, approximately 40 metres away. The rail lines are covered by ballast material which is also present on the surface between the rail lines. South of the Ramp road is a cover of unsealed fine crushed rock/gravel material. A spill site plan is presented in **Figure 2-1**.
