Sampling, Analytical and Quality Plan

One Rail

Berrimah Terminal

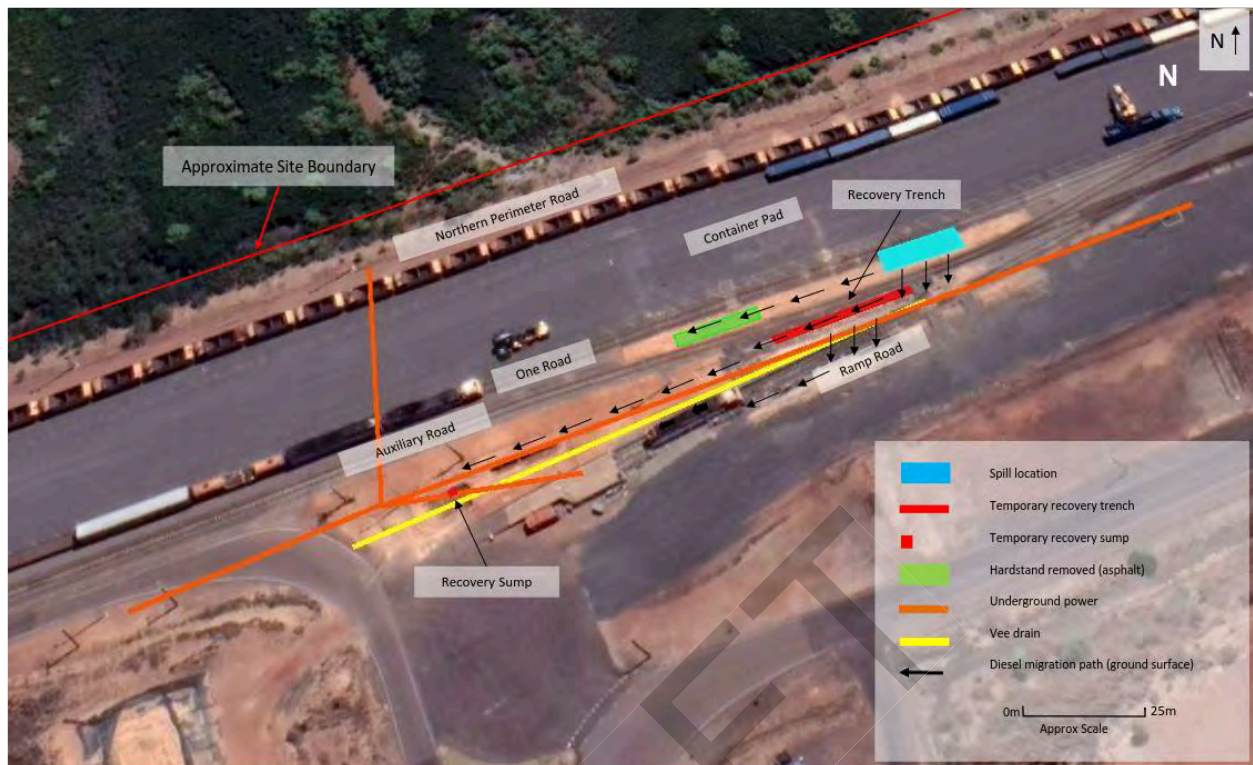
Figure 2. Spill Location

A diesel spill occurred on the 1 Road rail line, to the north of the office building and spread under the Auxiliary Road and Ramp Road rail lines to the south, and along an unlined vee-drain to the west where a temporary interception sump was excavated and used to recover some of the diesel. The vee-drain continues west past the recovery/interception sump and a second vee drain exists to the south of the spill site, approximately 20 metres to the south of the Ramp Road at its closest point. Directly to the north of the spill site is the asphalt lined container pad, further afield is the edge of the intertidal mangrove community located downgradient of the spill site, approximately 40 metres away. The rail lines are covered by ballast material (very coarse gravel and cobbles) which is also present on the surface between the rail lines. South of the Ramp Road is a cover of unsealed fine crushed rock/gravel material. A figure presenting the spill location is presented in Figure 2.

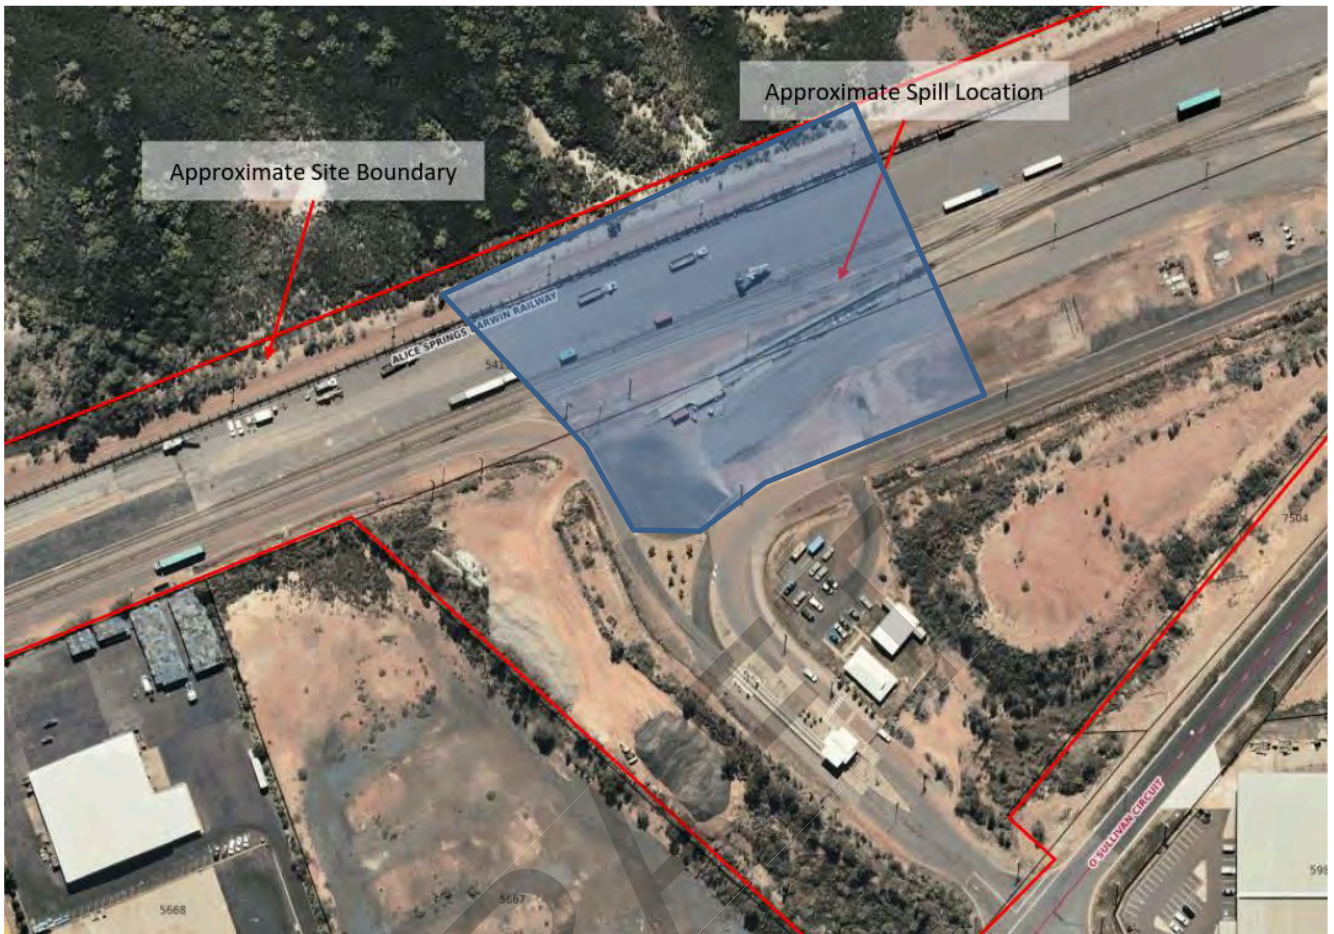
Figure 3. Investigation Site Boundaries

- The greater site has a total area of approximately 19 hectares. The subject site in which the spill occurred is restricted to an area as described in Section 2.4 and presented in Figure 3.
- The spatial extent of the soil investigation is spill extent as described in Section 2.4 and Figure 2.
- The spatial extent of the groundwater investigation is bound by:
 - North – mangrove fringe along Northern Perimeter Road
 - East – Ramp Road / Auxiliary Road junction
 - South – Ramp Road
 - West – Access Road and culvert
- Temporal boundaries of the investigation are limited by occurrence of the spill event.

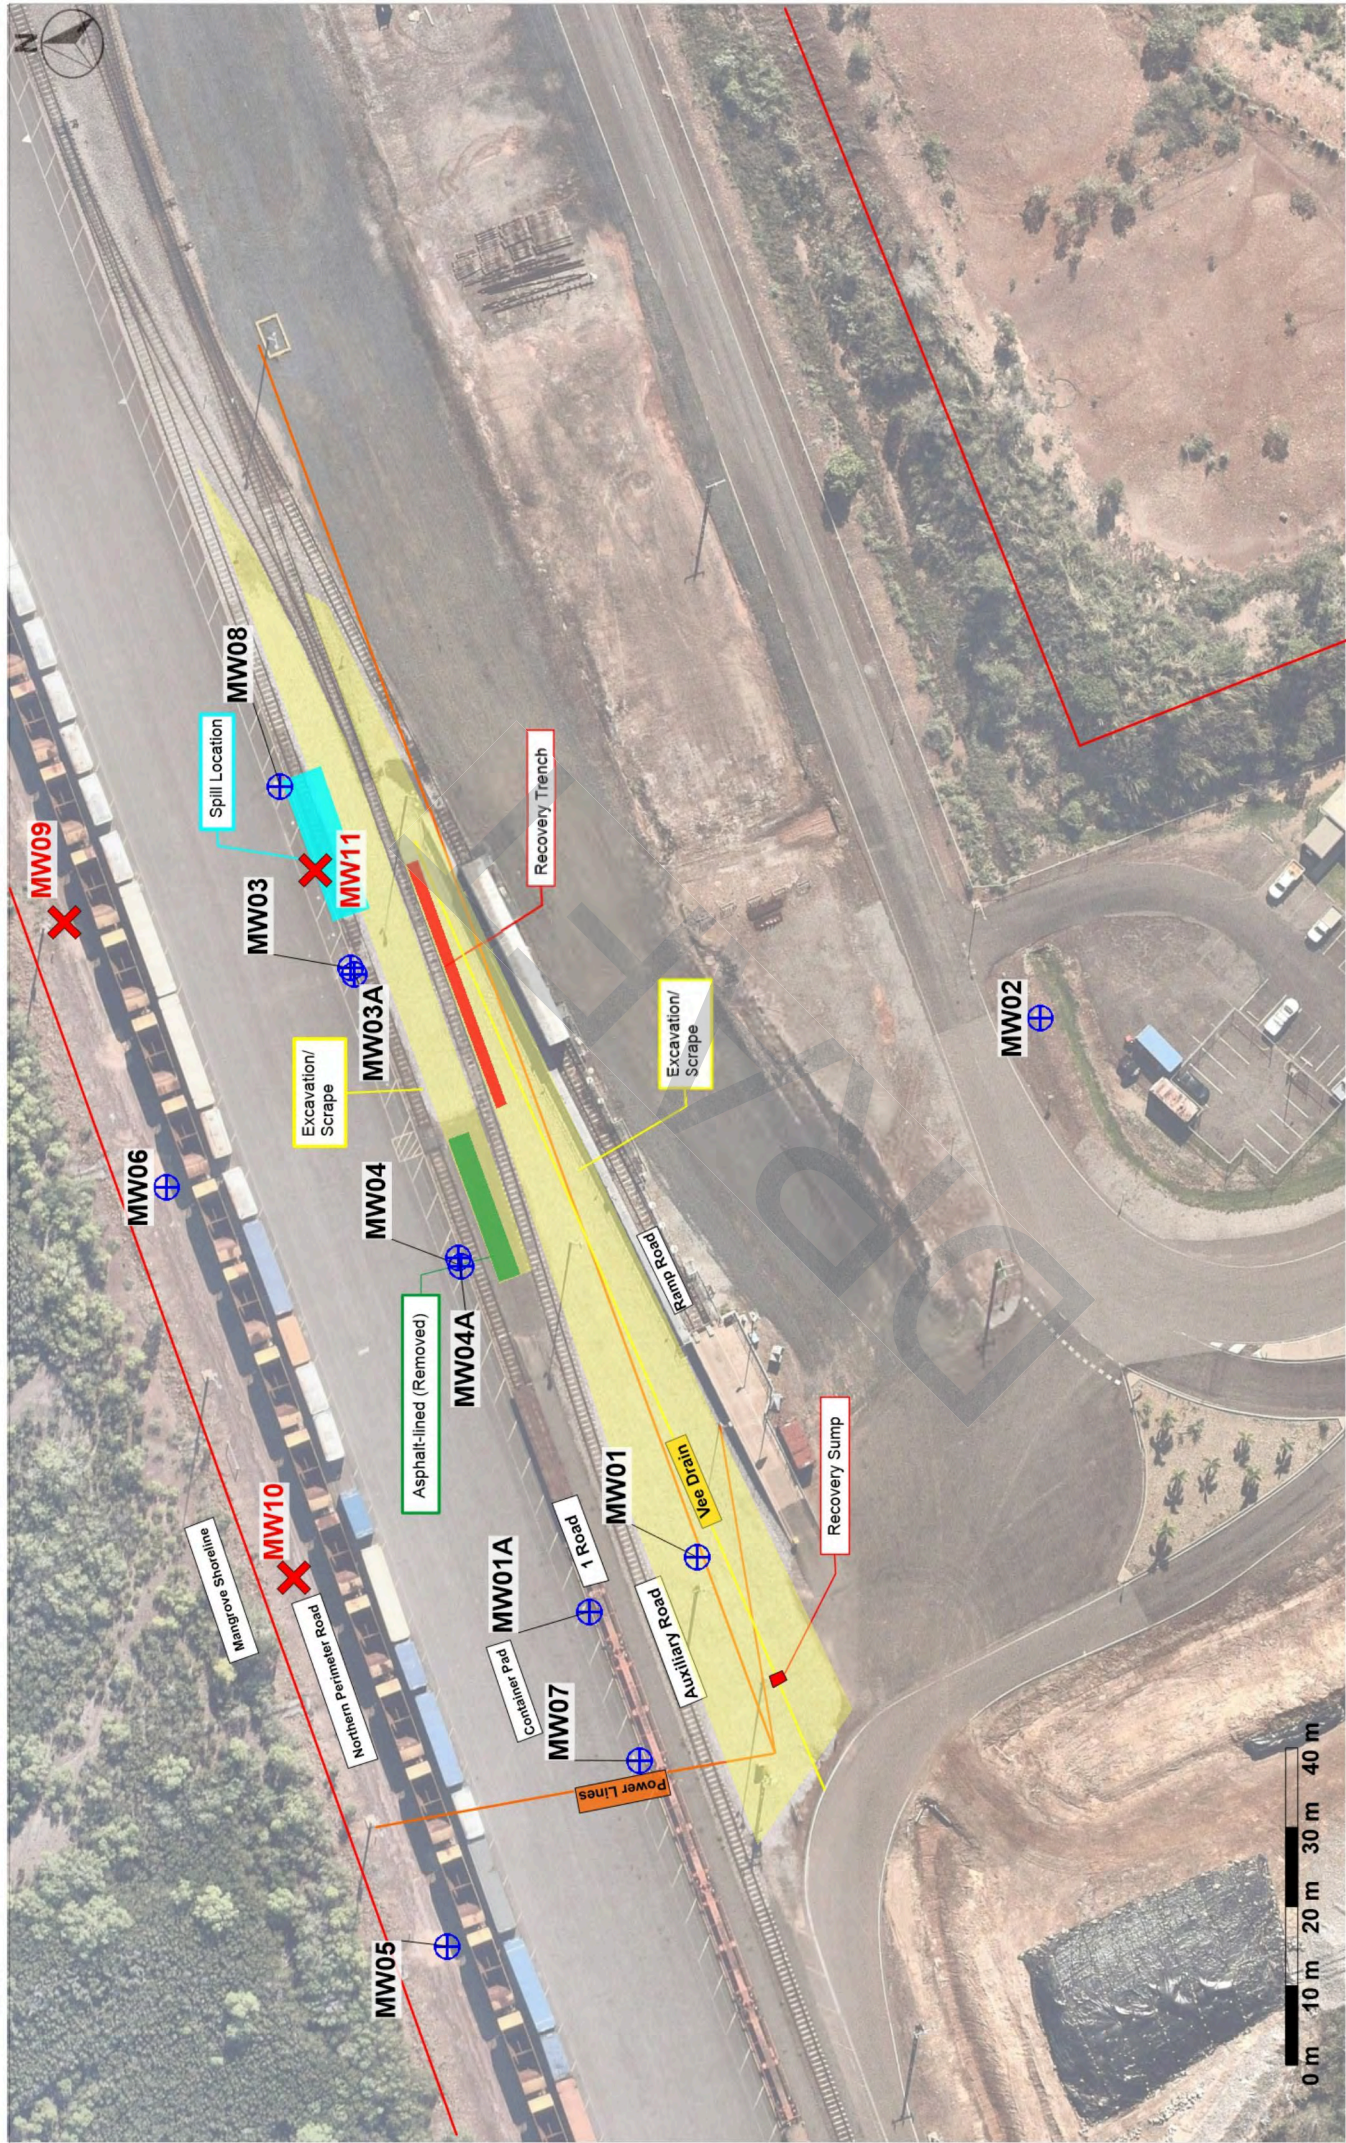
- Drill to a depth of approximately two metres below water strike (target depth 5 mbgl) and install with a 3-3.5 metre length of slotted PVC screen at the base of the well, and solid PVC to the surface.
- Install sand pack around the screen extending 0.5 metres above the top of the screen.
- Install bentonite plug above the sand pack to prevent infiltration of rainfall.
- Grout to surface and install lockable gatic cover concreted in place level with the ground surface.
- Following installation, development of the groundwater wells will remove excess silt / entrained sediments to ensure representative groundwater is flowing into the well.
- A licensed surveyor will survey the groundwater wells to the Australian Height Datum to enable an assessment of the inferred groundwater flow direction across the site.

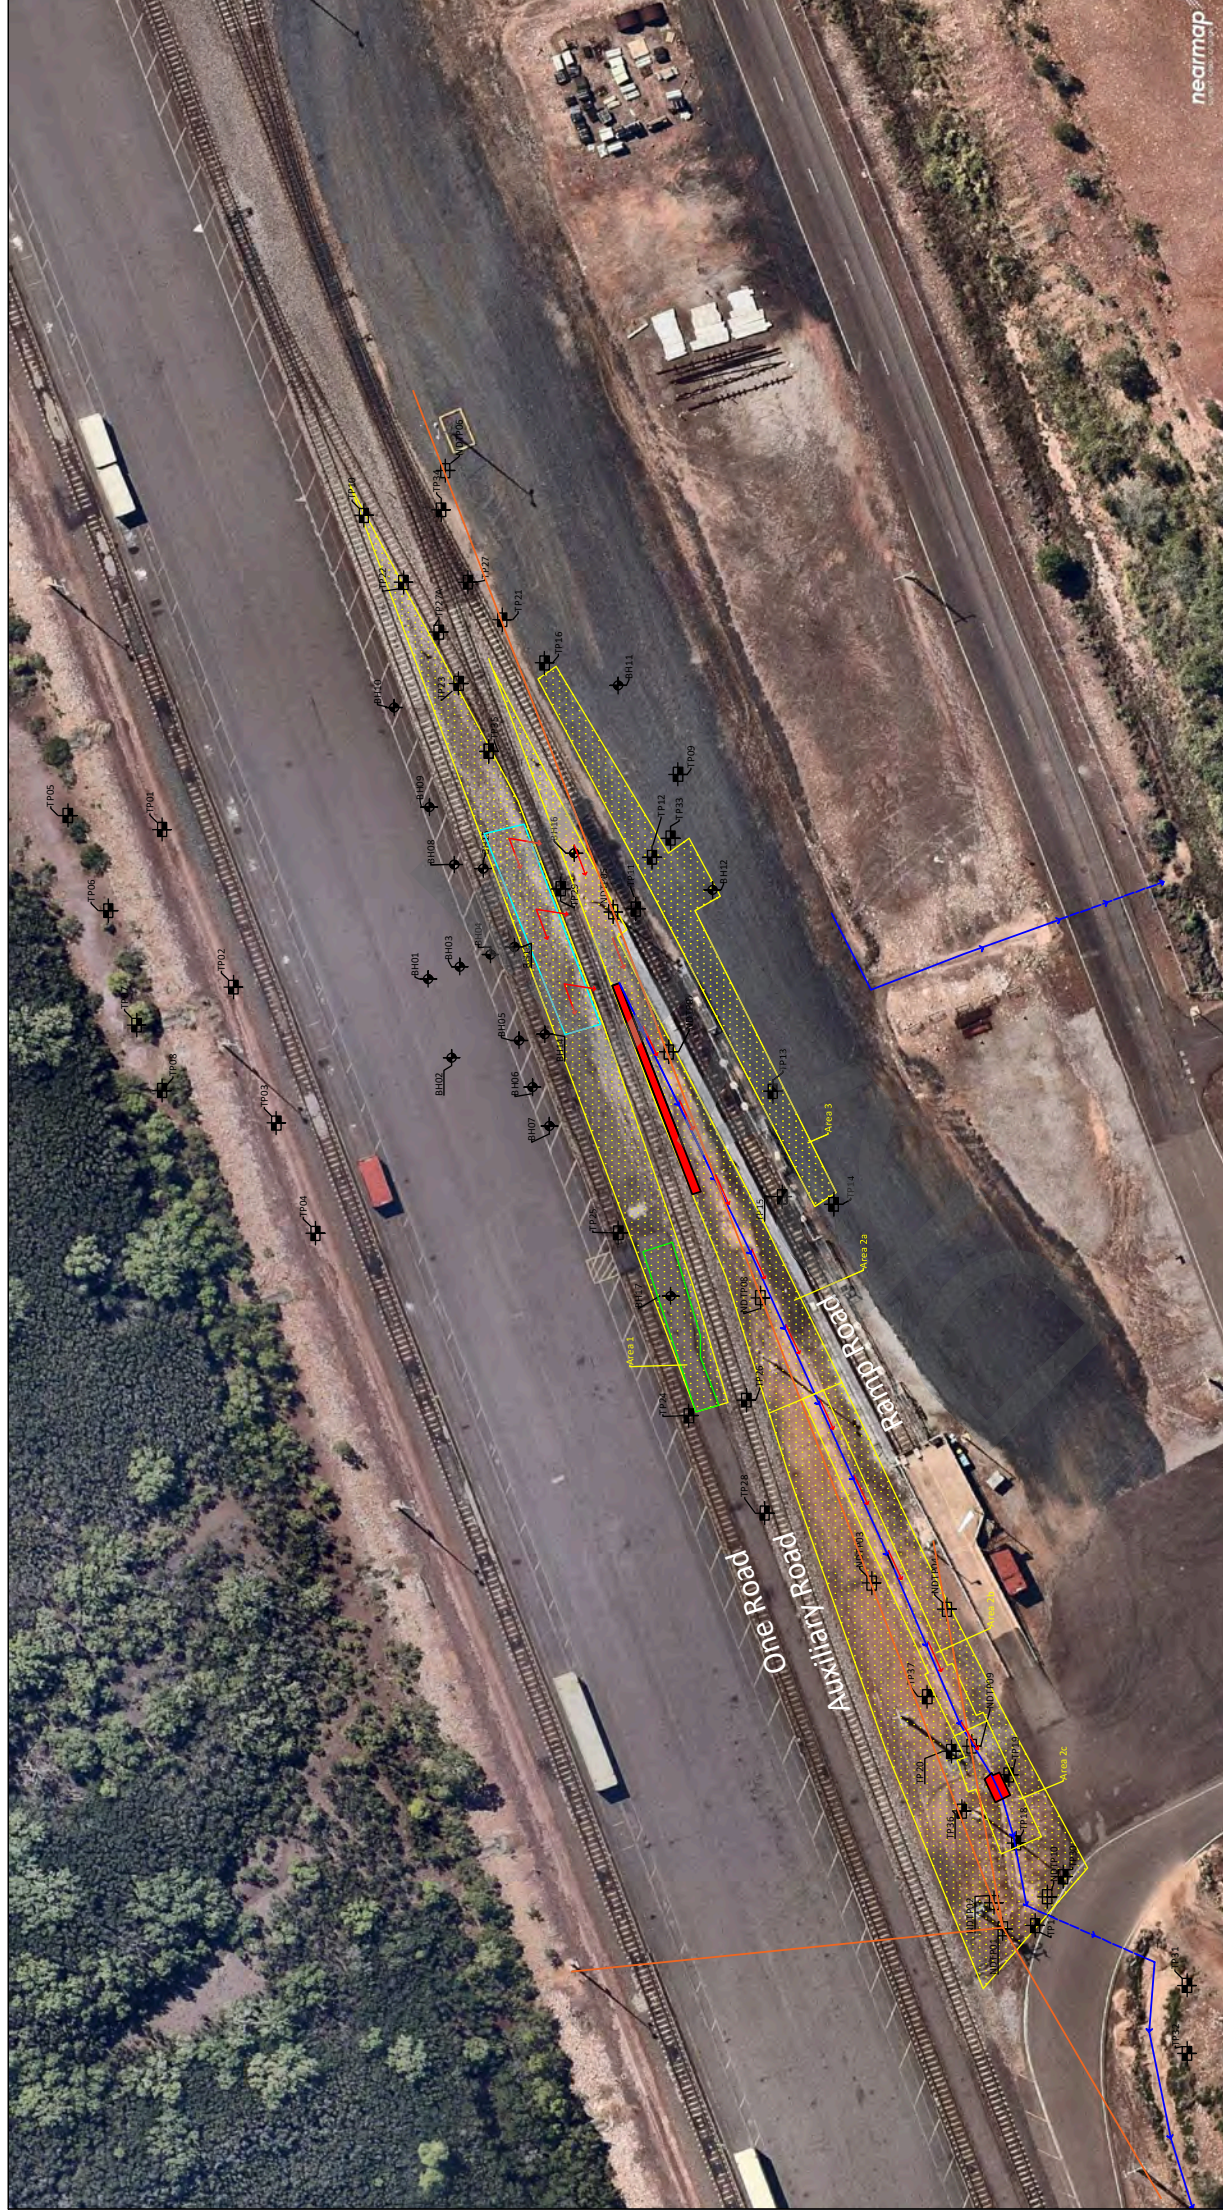
FIGURE 1 Sample Location Plan

Figure 1 (updated *Figure 8* from DSI) presents all investigation sampling locations. Figure 2 (updated *Figures 9a* and *9c* from DSI) and Figure 3 (updated *Figure 9b* from DSI) present all validation sampling locations.

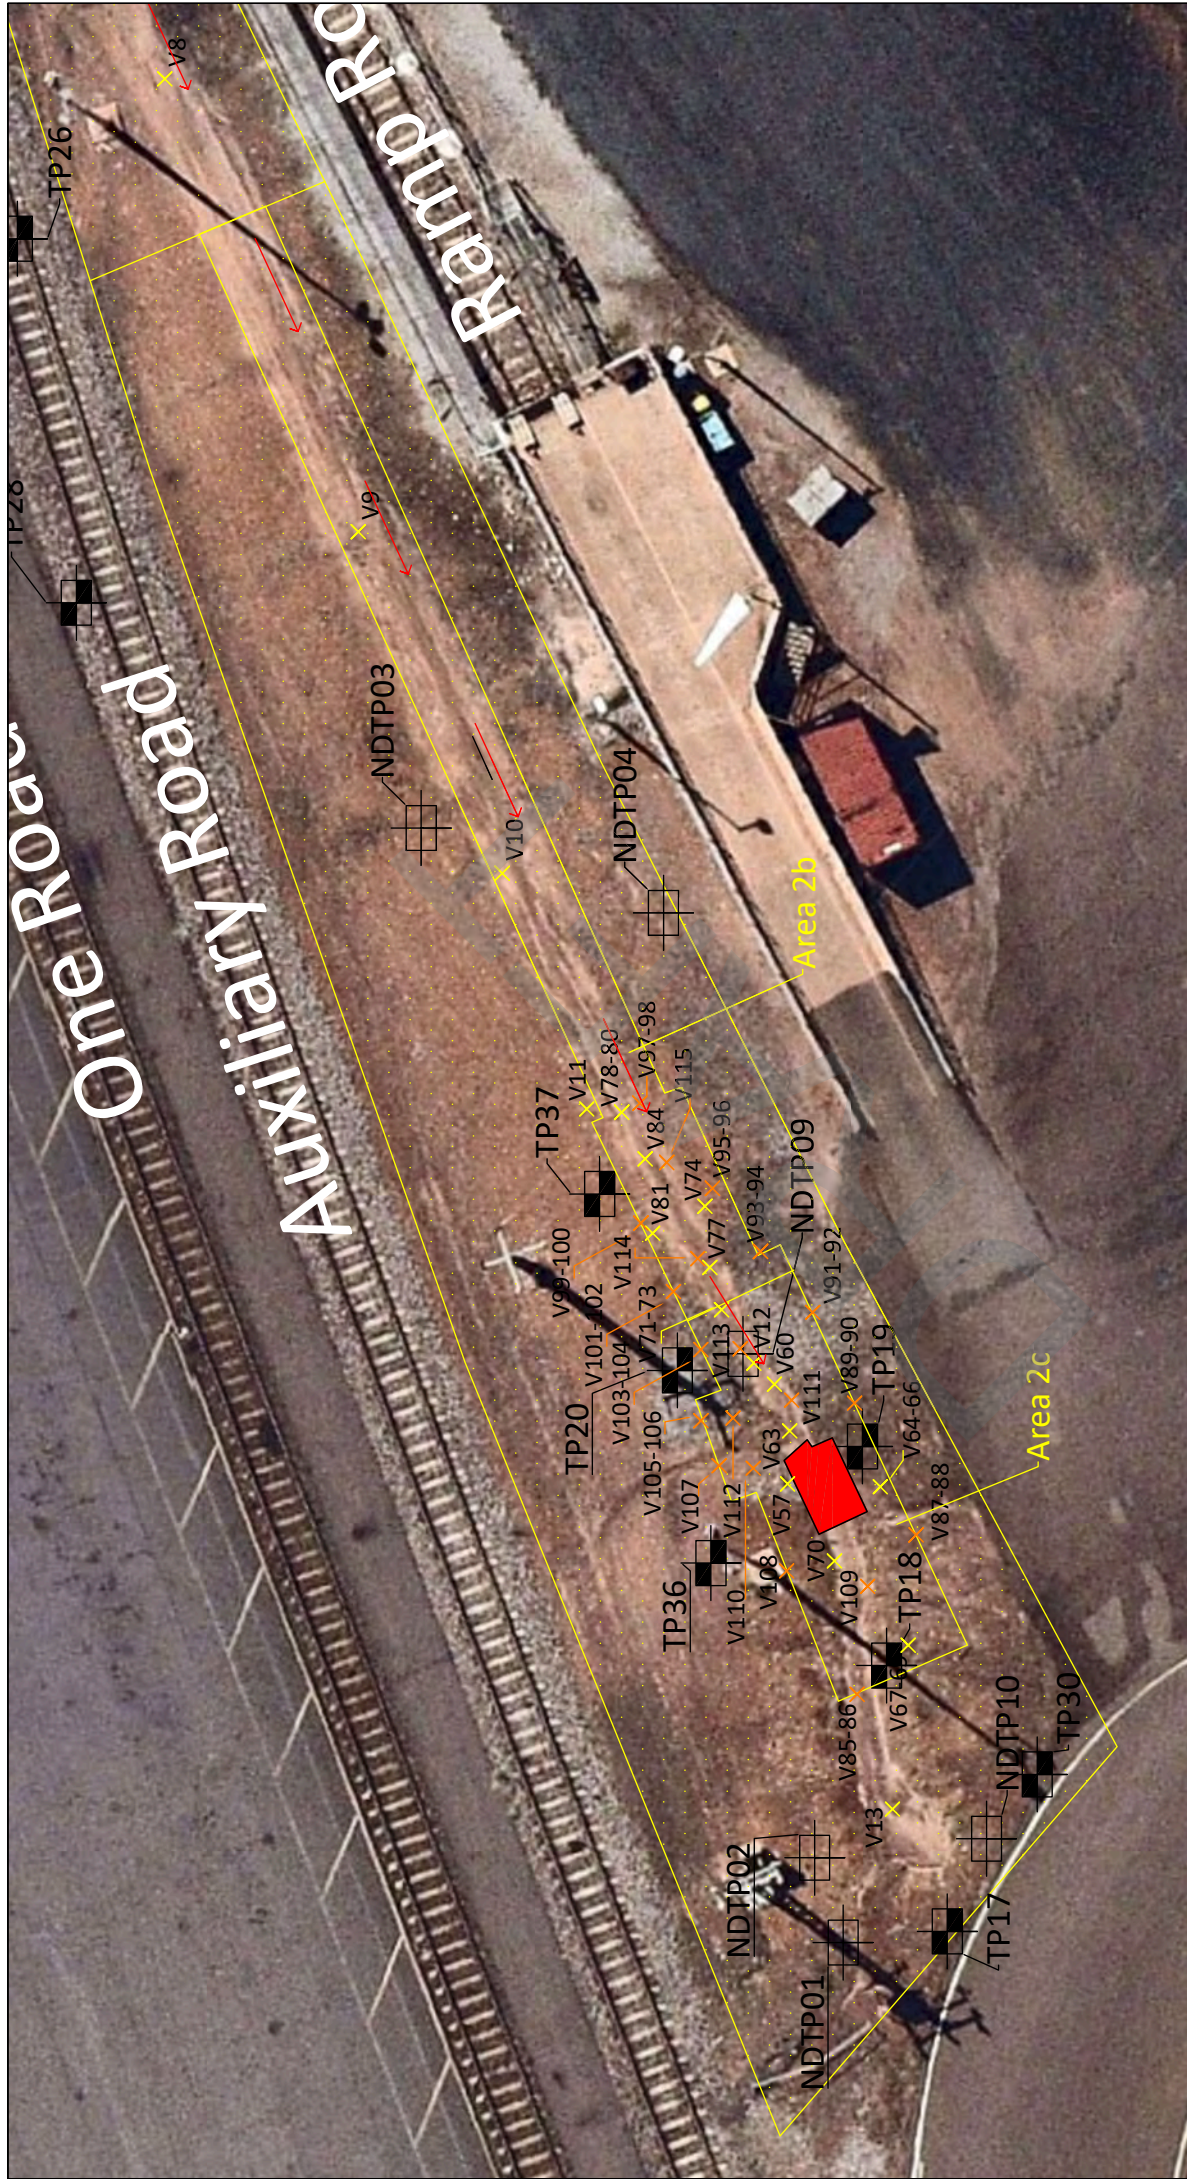
Project: Detailed Site Investigation - Addendum		
Location: Berrimah Freight Terminal - Export Dr, Berrimah NT		
Job Ref: J168829		
Drawn: VB	Checked: DB	
Date: 20/06/22		
Figure 3 Validation Sample Location Plan (Areas 2b and 2c)		
TP 	Test Pit Non-destructive Test Pit 	Spill Location Temp Recovery Sump/ Trench
NDTP 	Soil Bore 	Spill migration along unlined drain
BH 	Validation Sample (initial) 	Remediation Footprint
V 	Validation Sample (final) 	Hardstand Removed

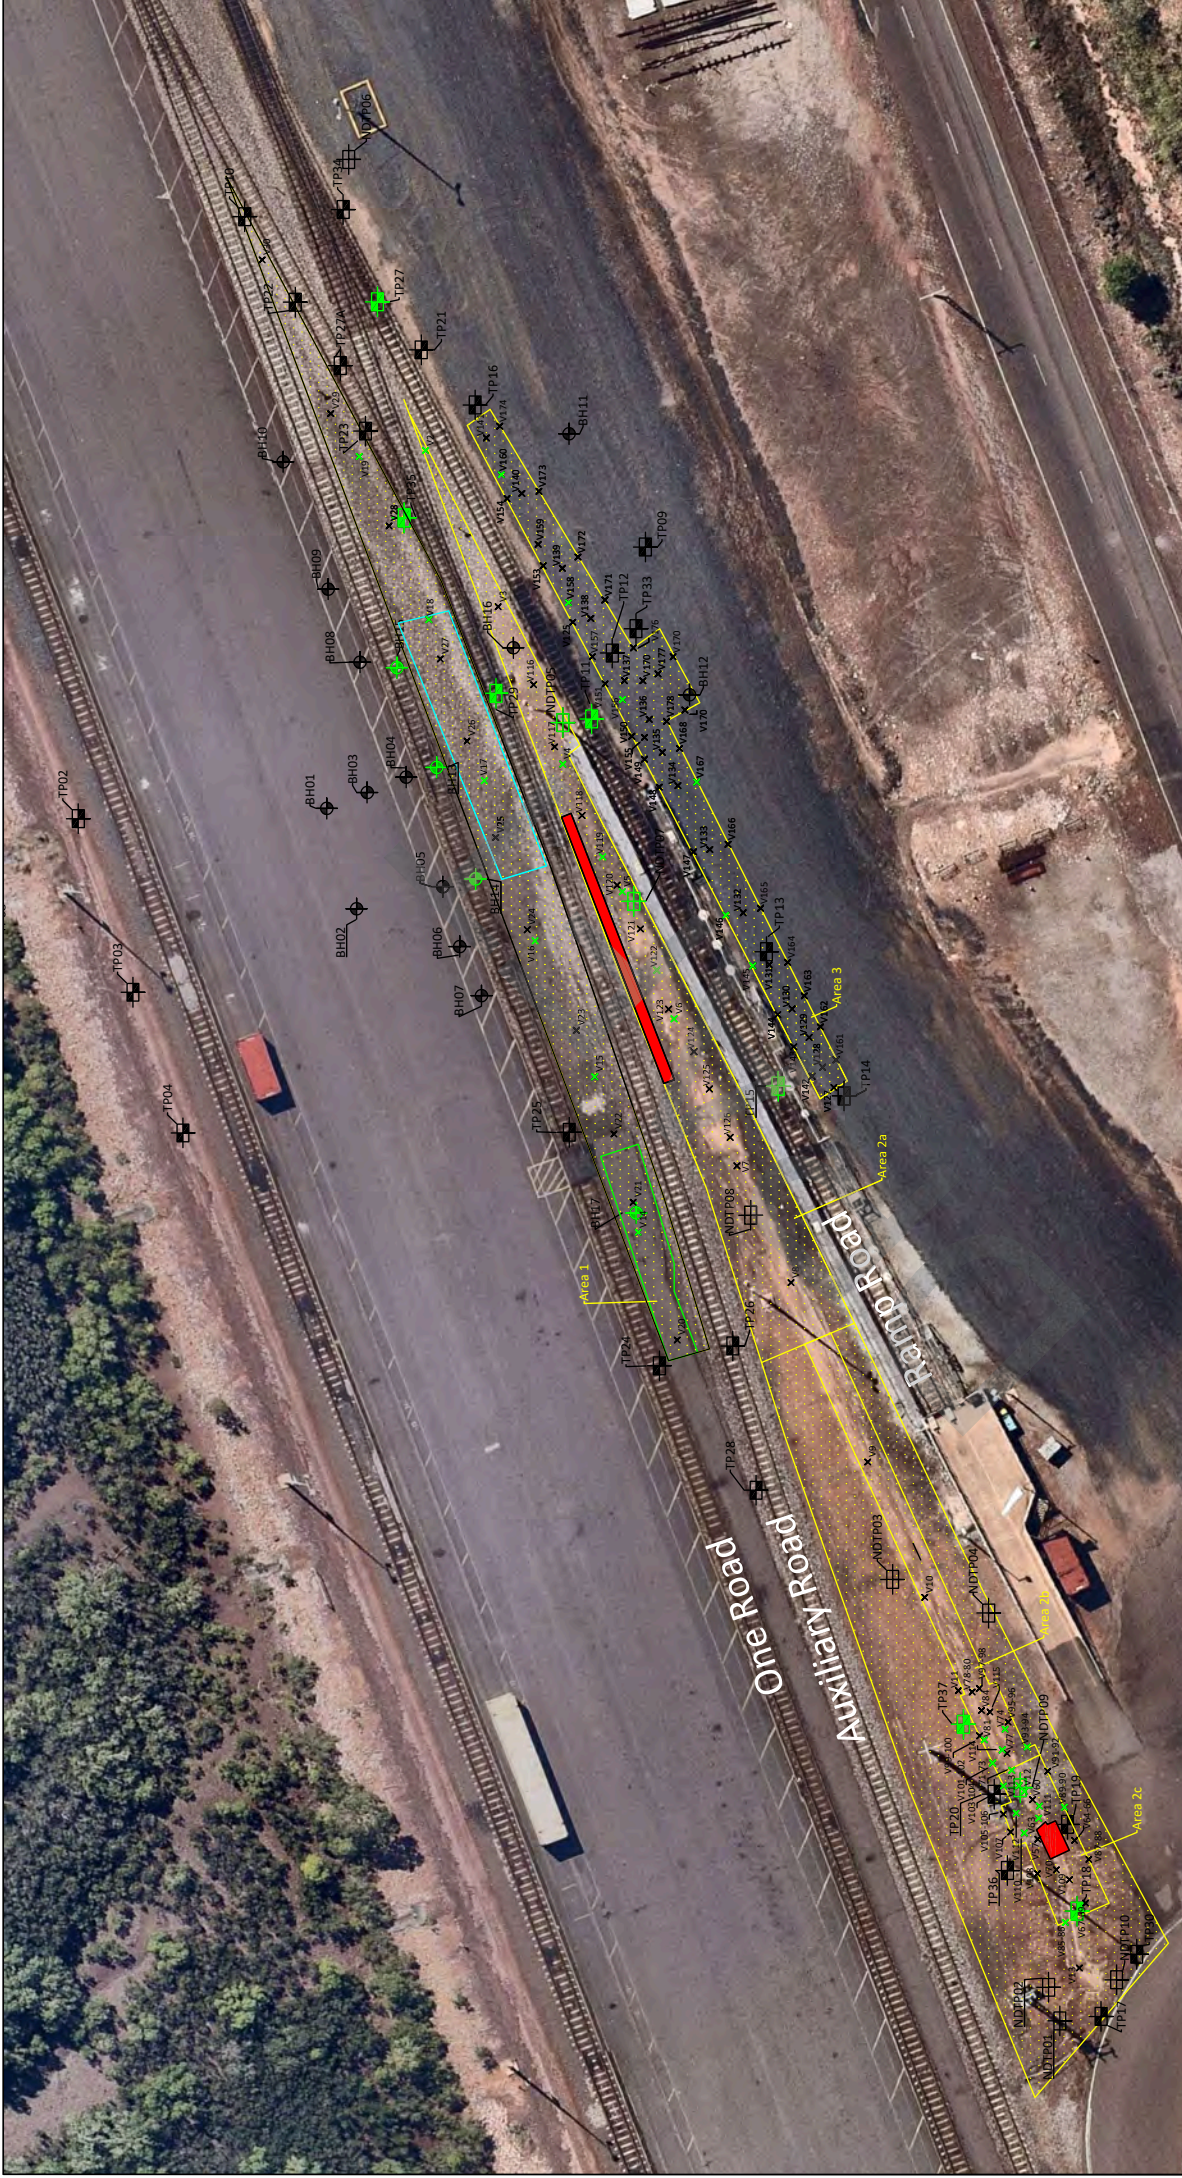
FIGURE 4a
Initial Investigation
and Preliminary
Validation Results >
ESLS

Validation sample results exceeding of the various screening criteria following the completion of the assessment (soil bores and test pits) and initial spill response remedial works (preliminary validations) are presented on Figure 4a (initial ESL exceedances), Figure 5a (initial VI HSL exceedances) and Figure 6a (initial ML exceedances). A summary of exceedances of the various screening criteria are presented for the remediation areas (Table 5) and by location (Section 4.3).

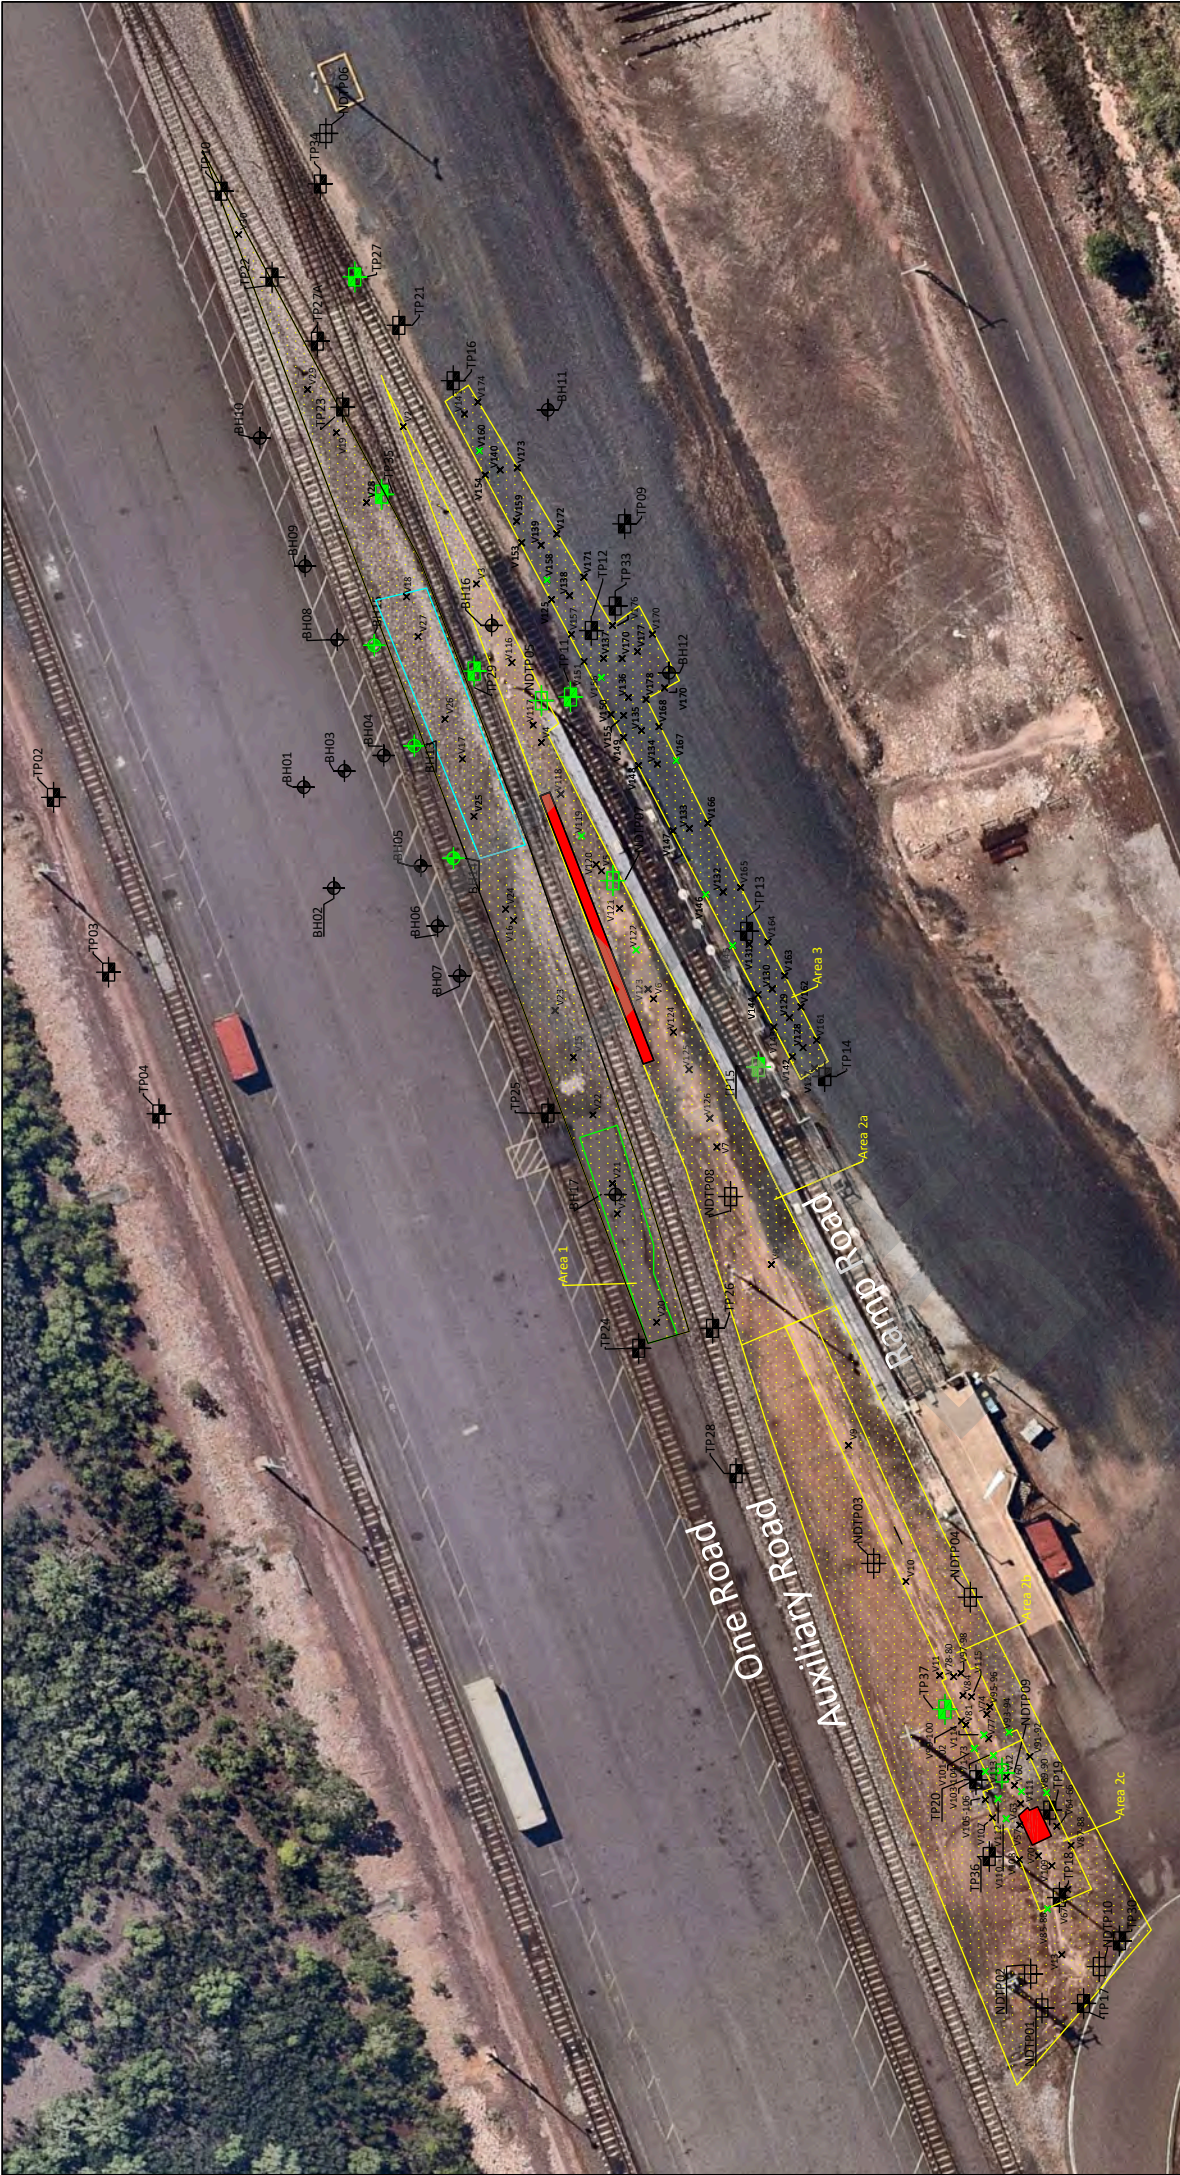
FIGURE 4b
Final Investigation and Validation Results > ESLs

Results exceeding of the various screening criteria following the completion of all spill response remedial works (final validations) are presented on Figure 4b (final ESL exceedances), Figure 5b (final VI HSL exceedances) and Figure 6b (final ML exceedances).

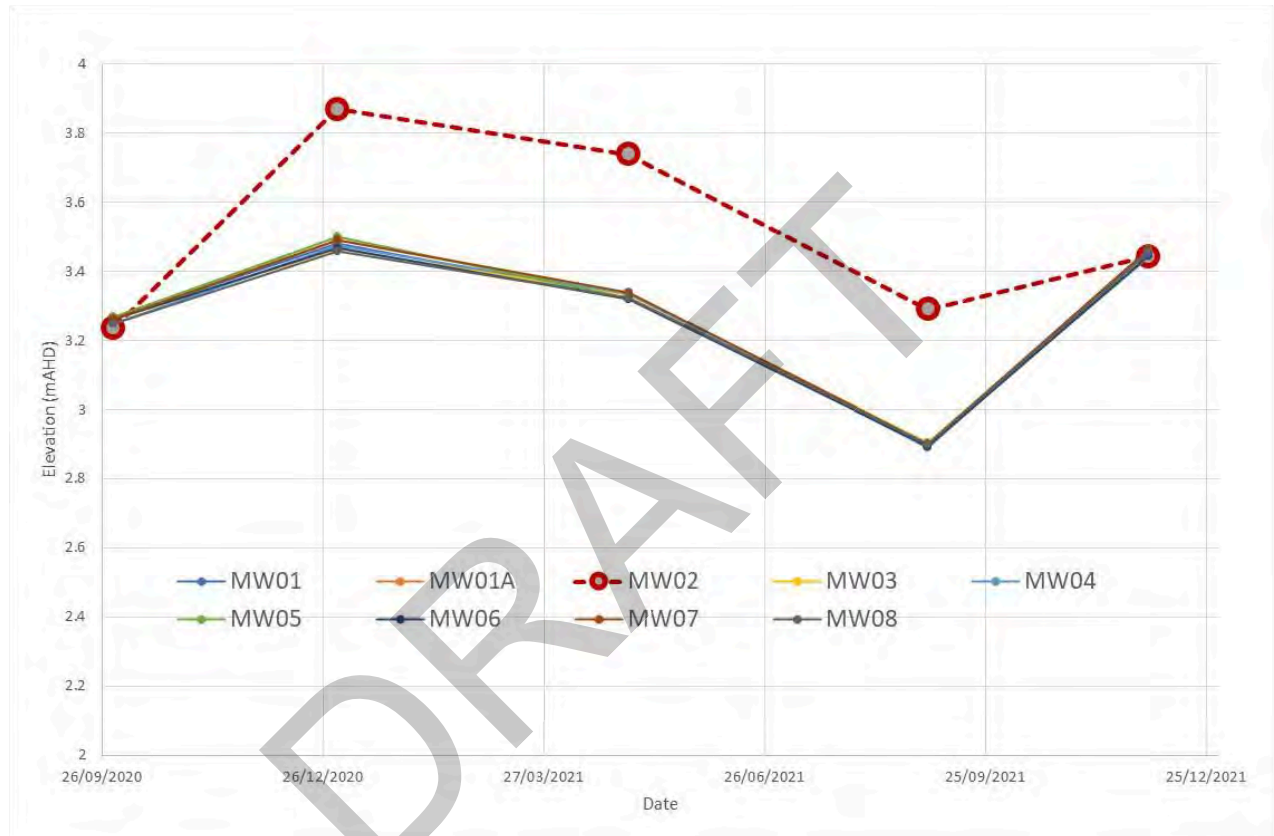
Figure 8: Hydrographs

Diesel within groundwater, resultant from surface infiltration may have resulted in the creation of a smear zone caused by seasonal fluctuation of groundwater levels. Groundwater level hydrographs shown on Figure 8 indicate that the smear zone thickness may be in order of 0.5-0.7m.

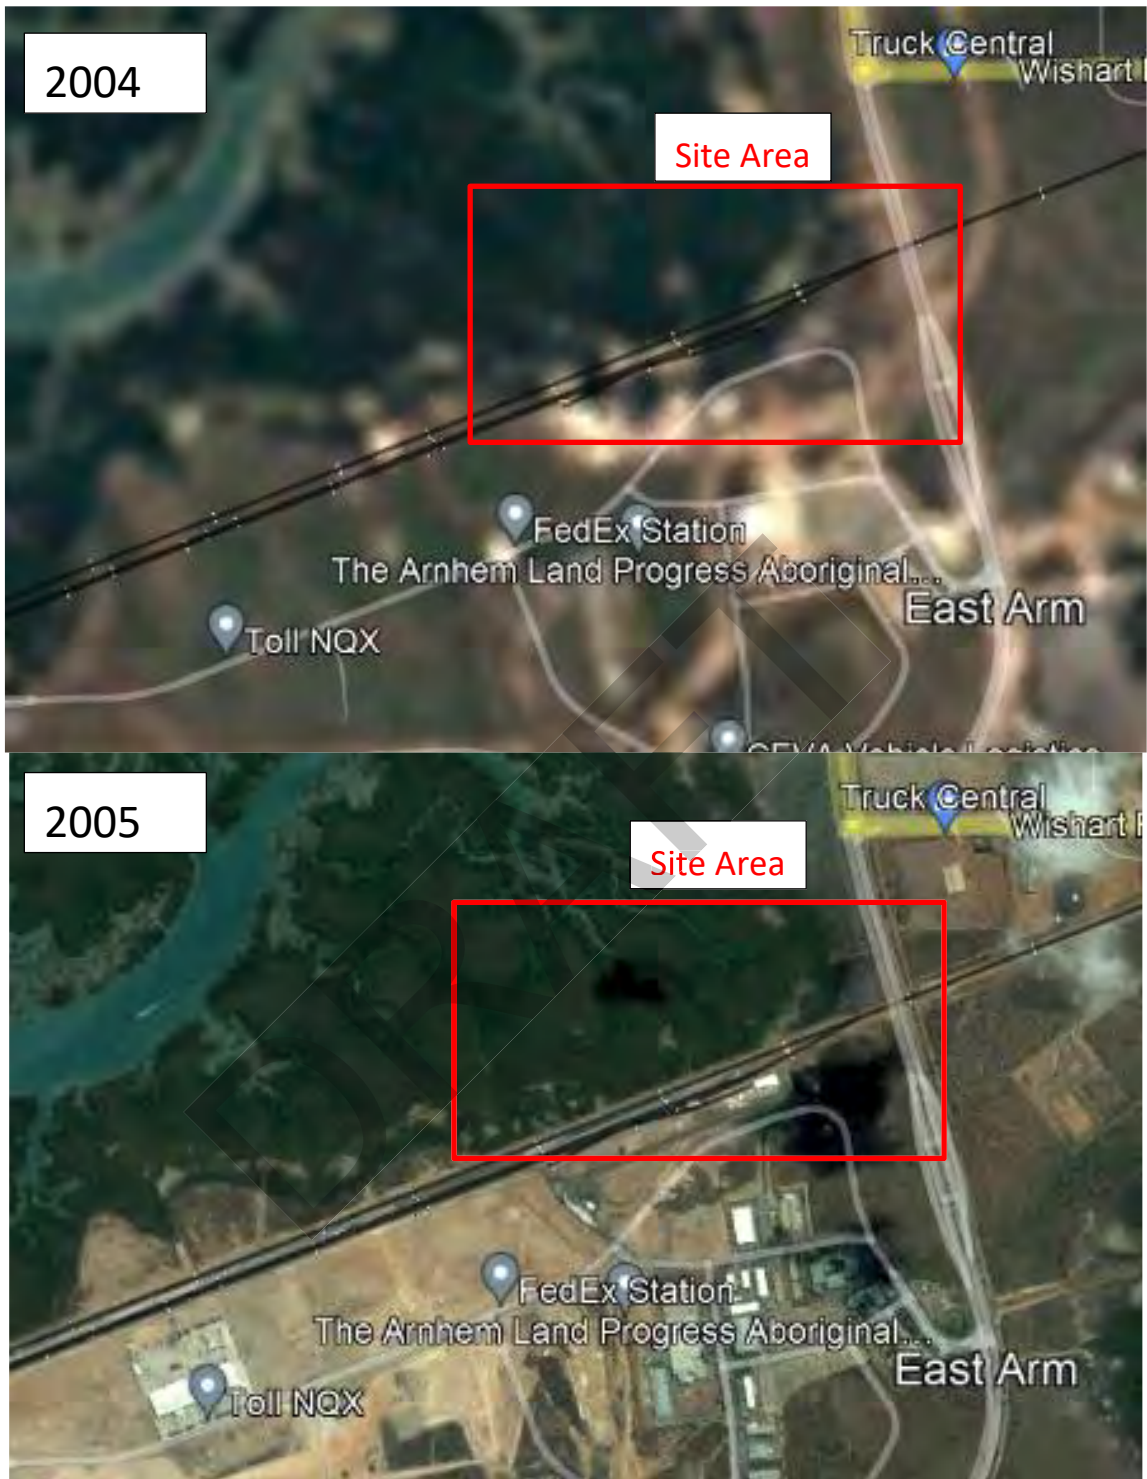
Figure 10: 2004 and 2005 Site Images (source: Google Earth)

A review of historical arial photographs from Google Earth showed that the site area was developed after 2004 involving likely filling a portion of mangrove forest as illustrated on Figure 10. A schematic cross section illustrating conceptual site settings is shown as Figure 11.

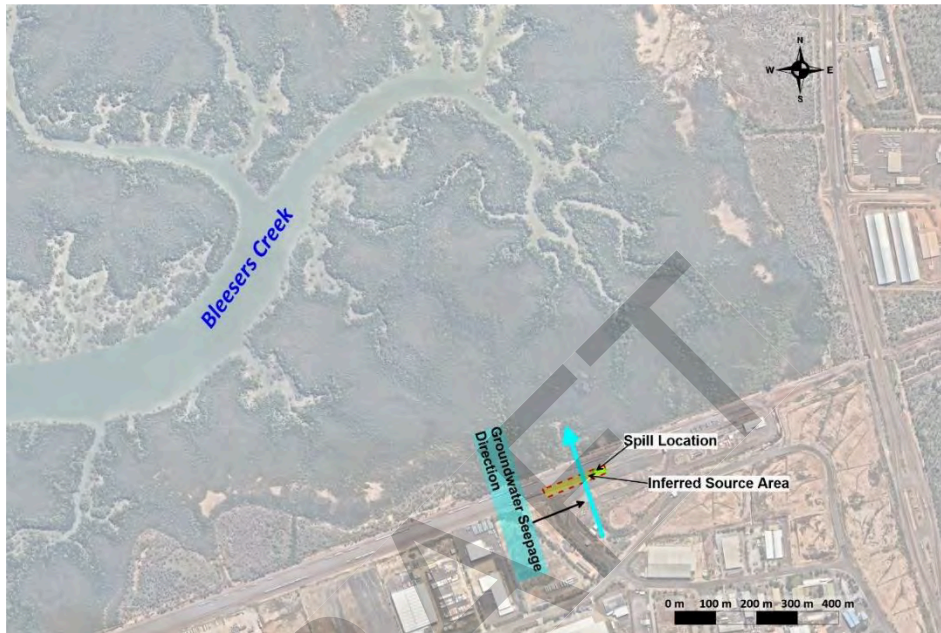
Figure 12: Bleesers Creek Location

The direction of the groundwater flow is inferred to be generally to the north, northwest towards Bleesers Creek which discharges into Frances Bay of the Darwin Harbour (Figure 12). Therefore, the marine aquatic ecosystem of Bleesers Creek is considered a sensitive environmental receptor. Considering the presence of multiple tributaries of the creek extending towards the site, the nearest to the site tributary is approximately 45 metres down inferred hydraulic gradient of the spill area (refer Figure 13).

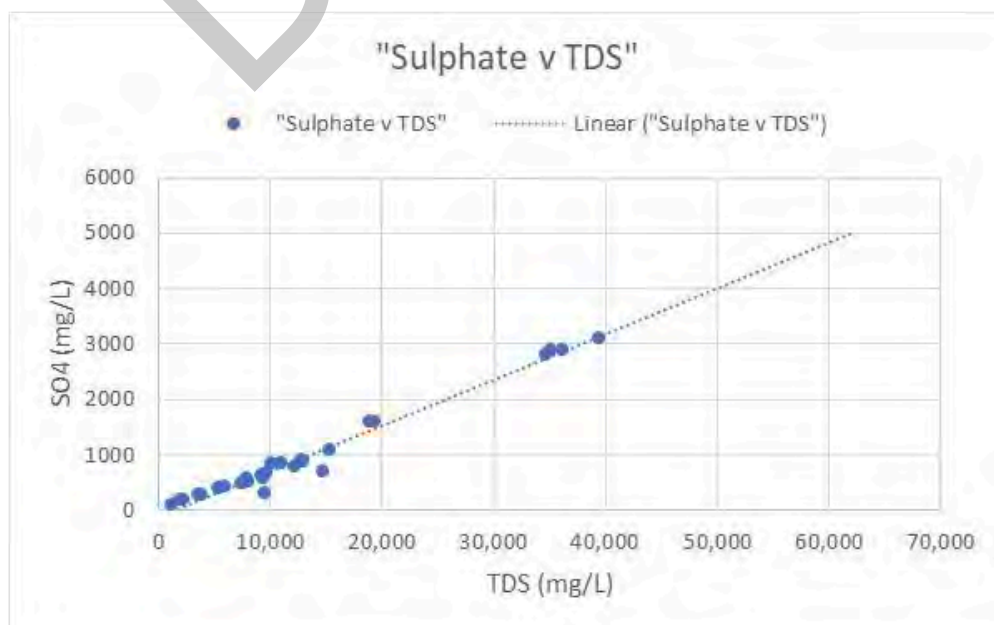
Figure 14: Sulphate versus TDS Concentrations

The concentrations of sulphate were assessed against TDS as shown on Figure 14. Figure 14 demonstrates a direct relationship between the sulphate and TDS concentrations indicating that variations in sulphate concentrations are likely attributable to seasonal variations in the groundwater salinity rather than a result of biodegradation of hydrocarbons causing a depletion in sulphate concentrations by bacteria. Based on this, a '0' value for delta SO₄ was adopted in the model.

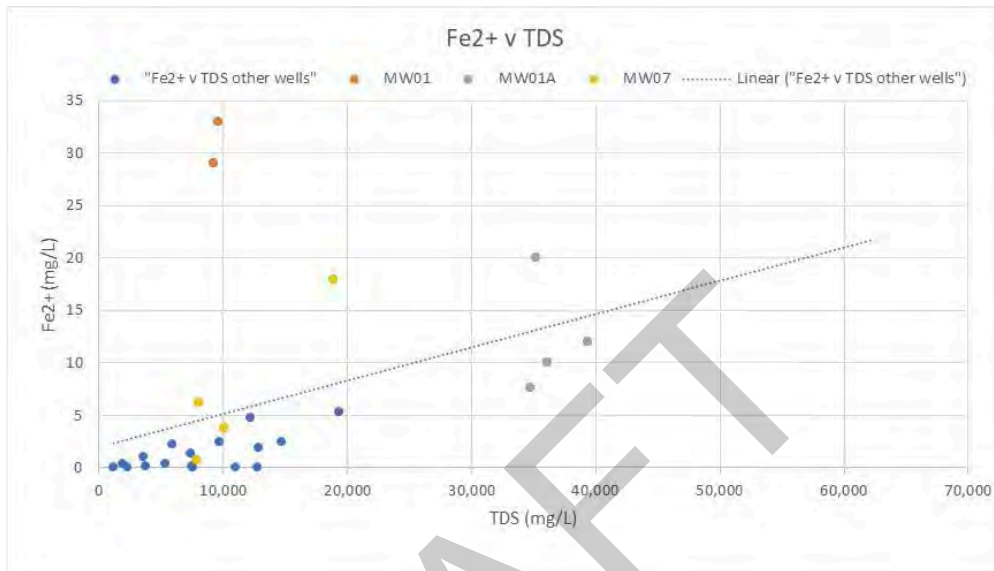
Figure 15: Ferrous Iron versus TDS Concentrations

The concentrations of ferrous iron were compared to groundwater salinity as presented in Figure 15. There is general correlation between ferrous iron and TDS concentrations. The concentrations of Fe^{2+} reported at MW01 and MW07 located along the spill impacted area show increased concentrations, potentially indicative of reducing conditions created by biodegradation bacteria. Due to limited sampling rounds conducted for MW01 to verify whether natural levels of Fe^{2+} are high at this location, only data from MW07 was used and an average conservative value of 8 mg/L was adopted in the model.

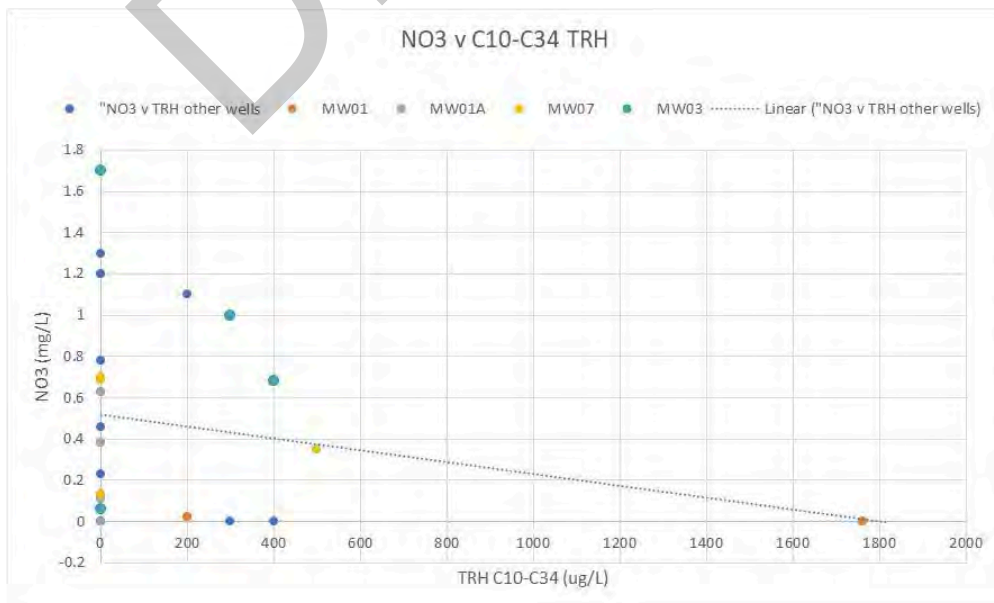
Figure 16: NO_3 versus TRH C_{10} - C_{34} Concentrations

Delta NO_3 was assessed by plotting NO_3 concentrations against C_{10} - C_{34} hydrocarbons. A decreasing trend is noted at MW03 as shown on Figure 16. Other locations do not show clear trends possibly due to seasonal variation in hydrocarbon concentrations. Despite this the overall concentrations of NO_3 were noted to decrease in the monitoring wells where the presence of hydrocarbons was reported. Based on the above, delta NO_3 of 1 mg/L has been adopted as a conservative input parameter for the model.
