NOTICE TO CARRY OUT ENVIRONMENTAL AUDIT PROGRAM

ISSUED TO: One Rail Australia Pty Ltd
ACN 079 444 296

Client Project: Berrimah Rail Terminal – PRL9059

REPORT ON THE ANALYSIS OF SPILLED HYDROCARBONS

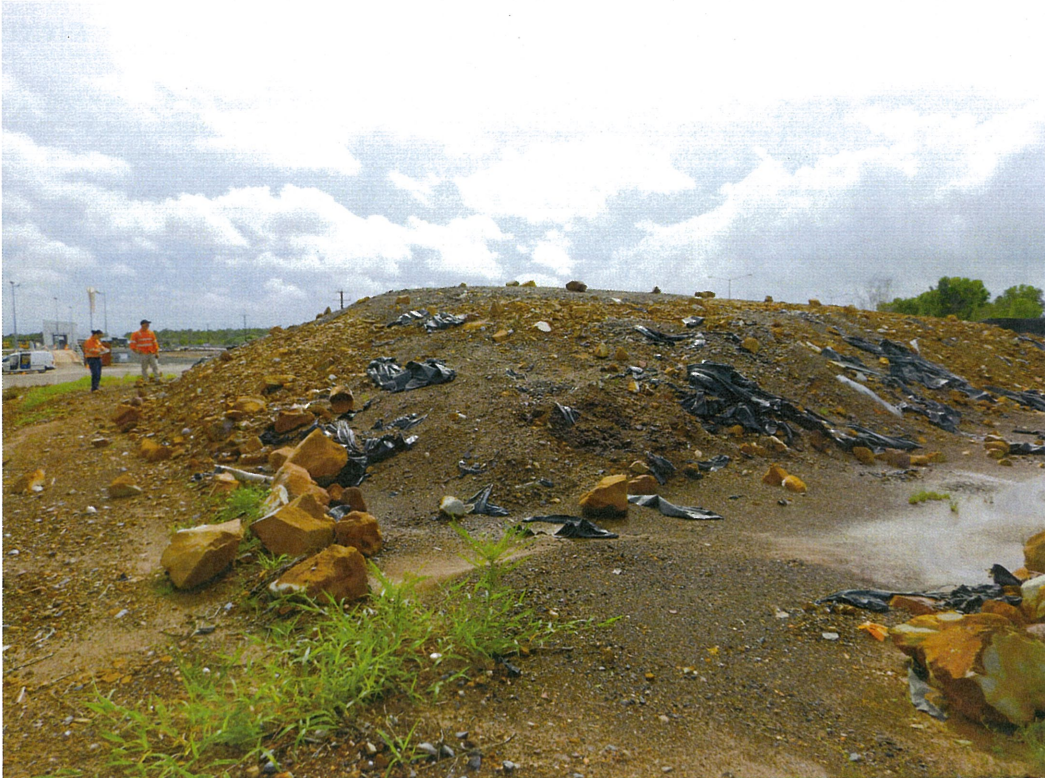
Photograph 1: *Stockpiled material facing east. Stockpile is uncovered with no erosion or sediment controls in place.*

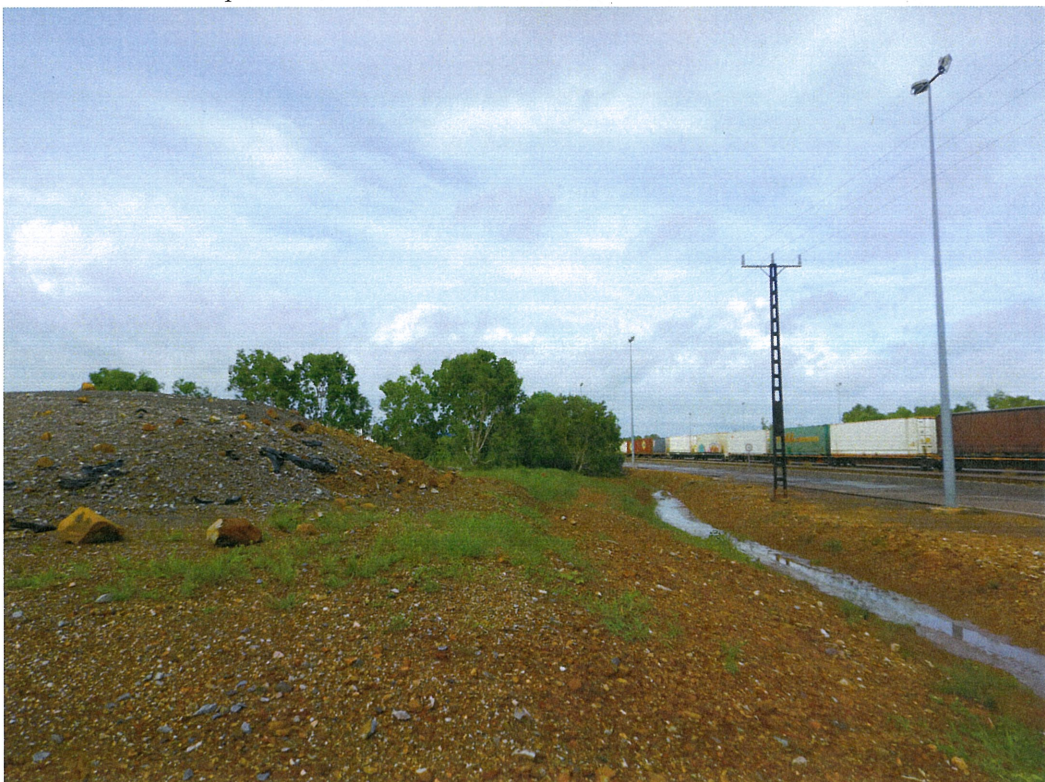
Photograph 2: *Stockpiled material facing west. Earthen stormwater drain visible on far right of image, flowing west.*

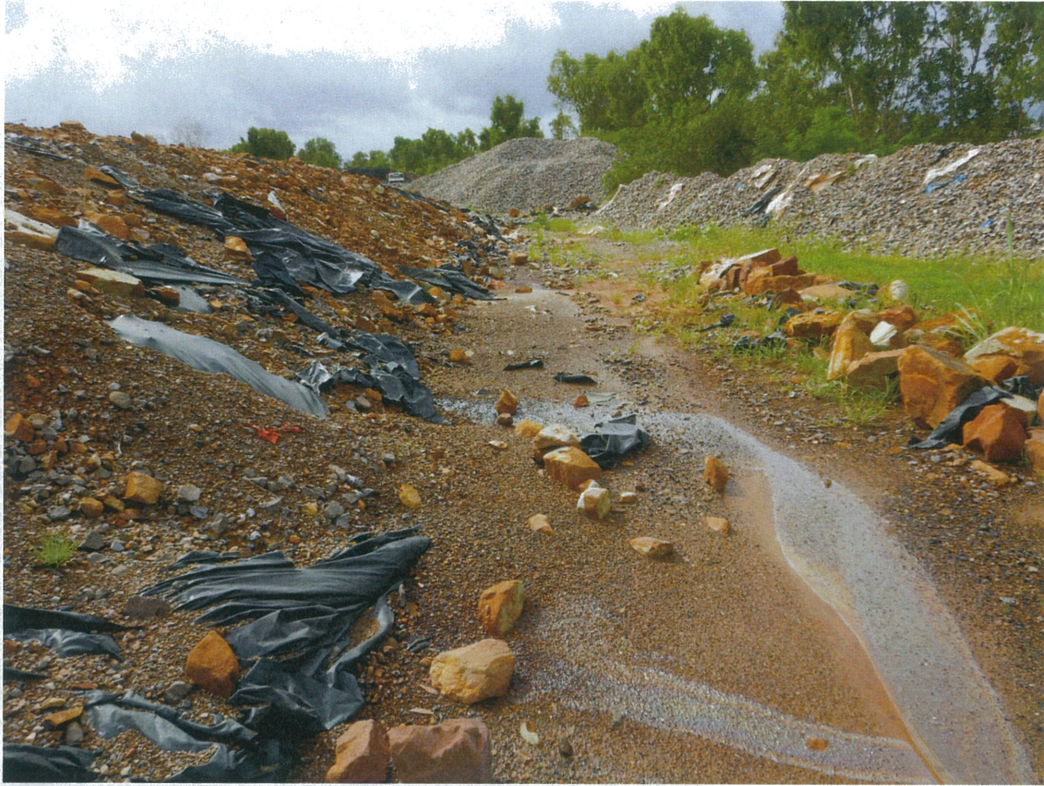
- c. A hydrocarbon-like sheen seeping from the stockpile into adjacent soils and stagnant surface water (photos are provided in **Attachment “E”**); and

Photograph 3: *Stockpiled material facing south. Visible hydrocarbon-like sheen leaching out of stockpile and pooling in surface water adjacent the stockpile.*

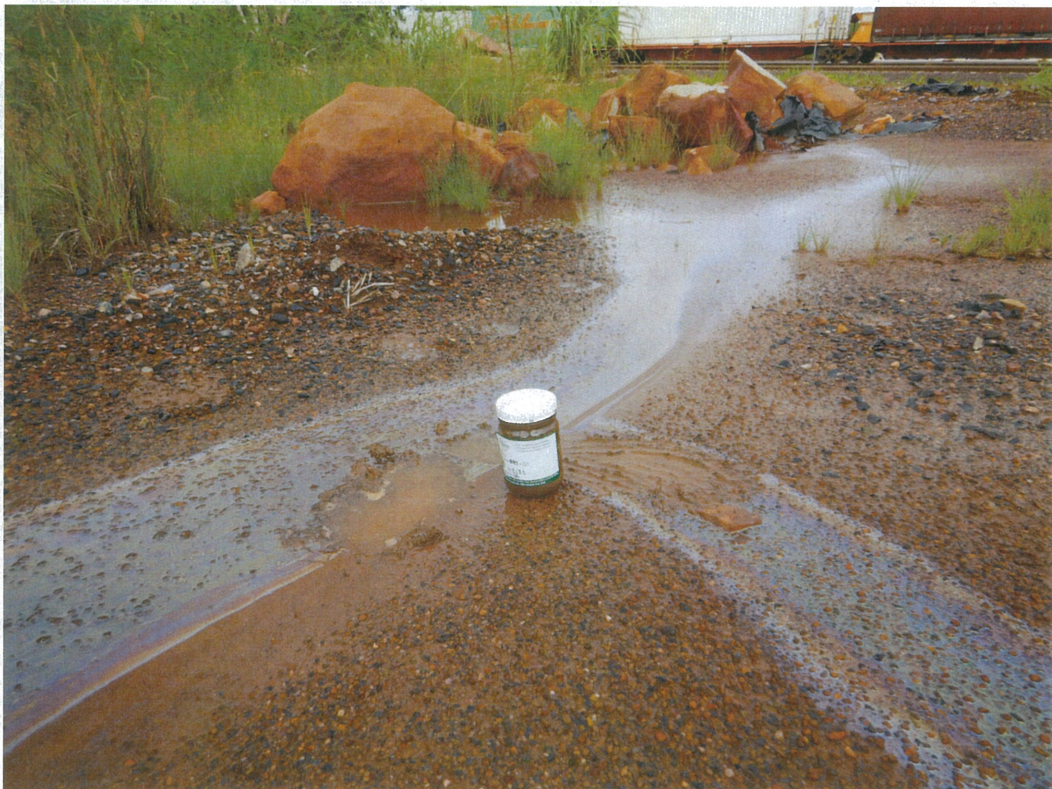
Photograph 4: *Visible hydrocarbon-like sheen atop ground surfaces and pooling in surface water adjacent stockpile.*

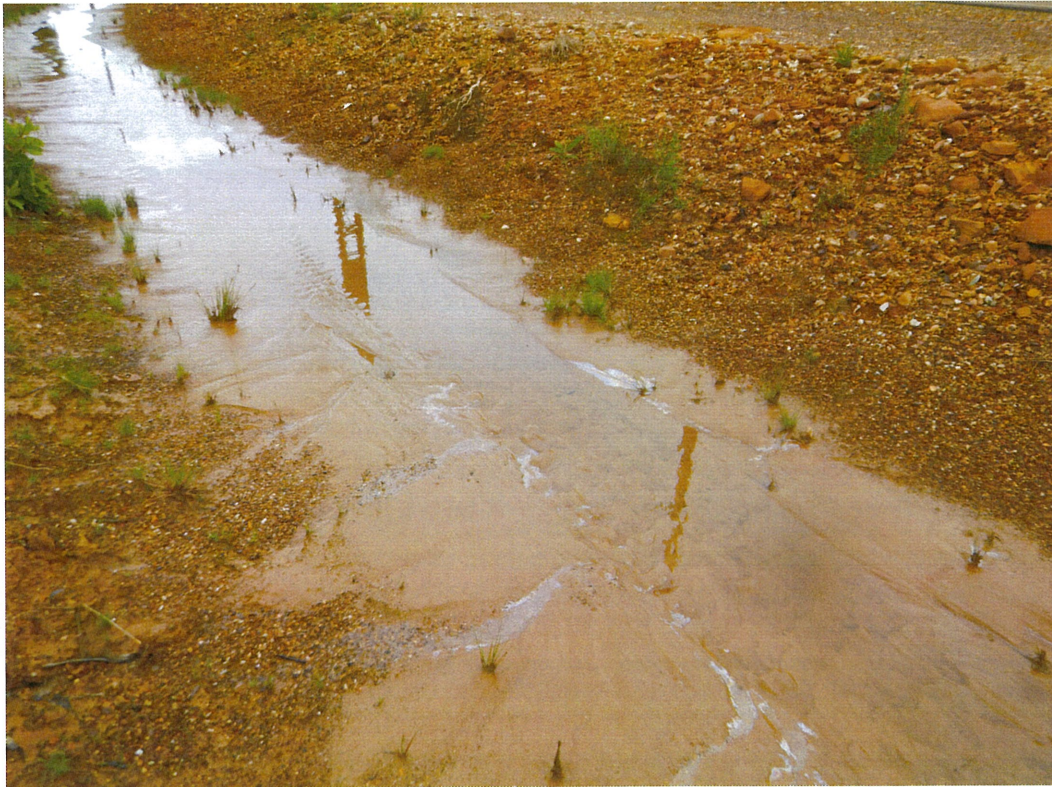
- d. A hydrocarbon-like sheen within the adjacent earthen stormwater drain (photos are provided in **Attachment “E”**);
 11. During the investigation, NT EPA officers obtained a copy of the stormwater drainage plan for the premises, provided in **Attachment “F”**;

Photograph 5: Earthen stormwater drain located north of the stockpile. Visible hydrocarbon-like sheen visible in water and on surrounding ground surfaces.

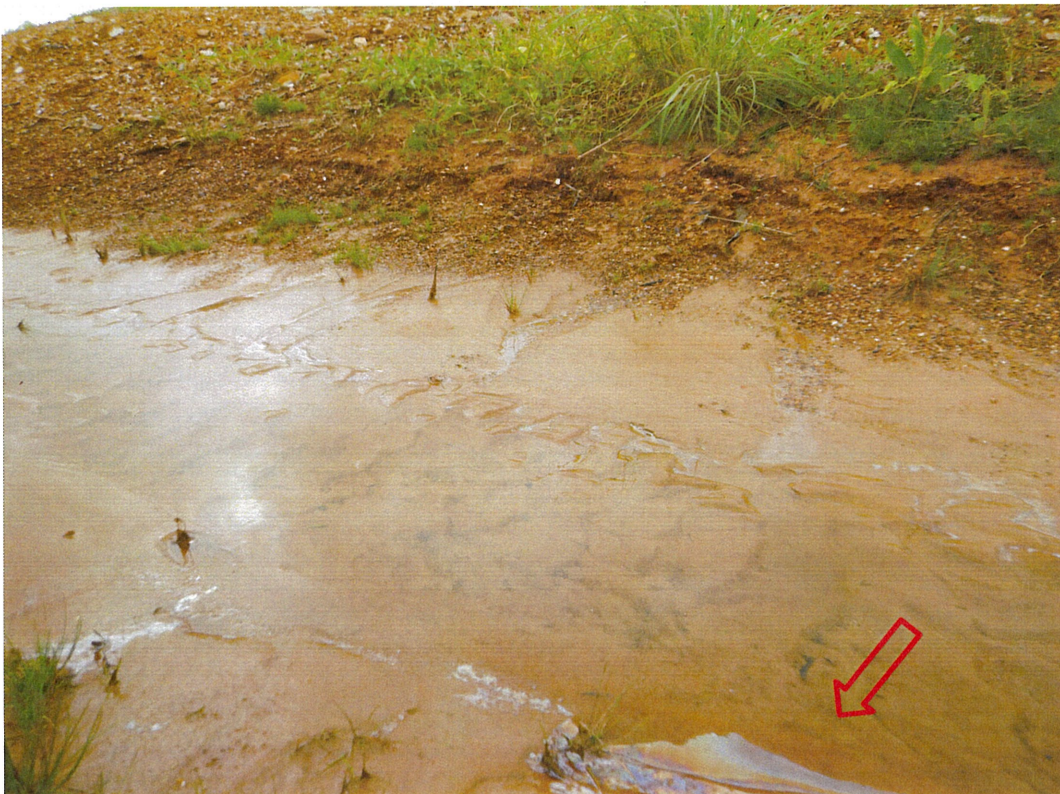
Photograph 6: Earthen stormwater drain located north of the stockpile. Visible hydrocarbon-like sheen visible in water and on surrounding ground surfaces.

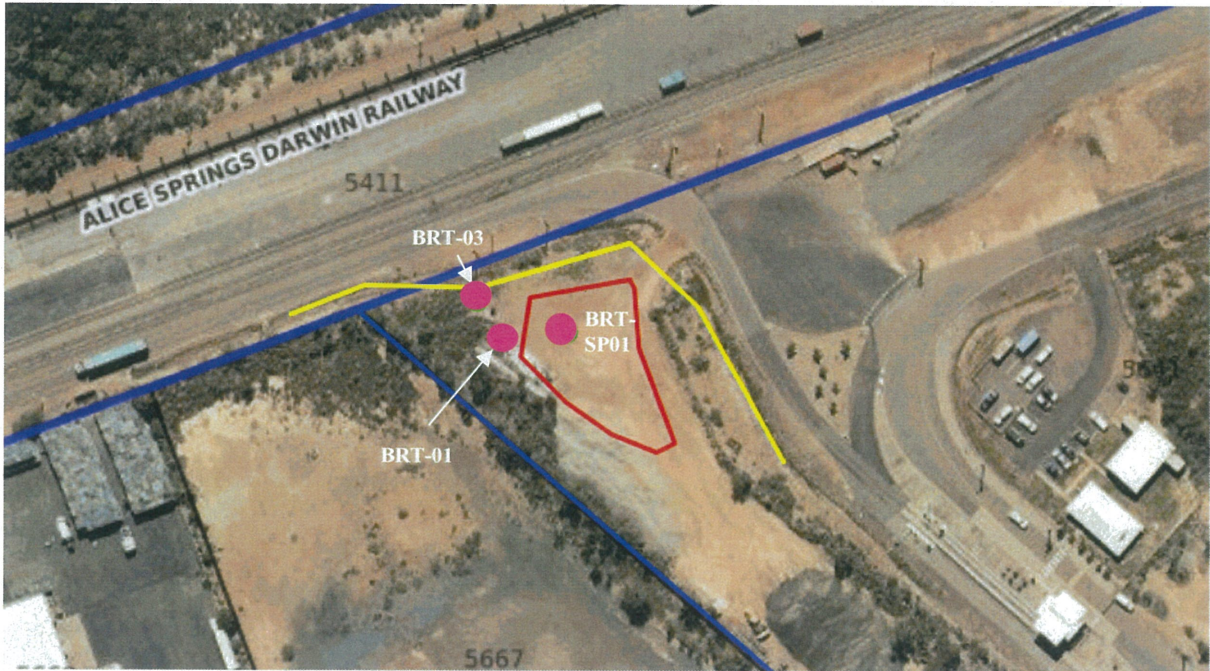
14. The location of collected samples, referred to in **13** above, are shown in pink in **Attachment “G”** and laboratory analytical results, provided in **Attachment “H”** show that:

**INVESTIGATION AREA
APPROXIMATE LOCATION OF STOCKPILE, EARTHEN STORMWATER DRAIN
AND COLLECTED SAMPLE LOCATIONS**
