**Re: SAMPLING PLAN, LOT 05120, TOWN OF ALICE SPRINGS (PIONEER PARK RACECOURSE)  
(Greencap Ref: J133974)**

## **1.0 INTRODUCTION**

## **SAMPLING PLAN**

Project: Preliminary Site Investigation

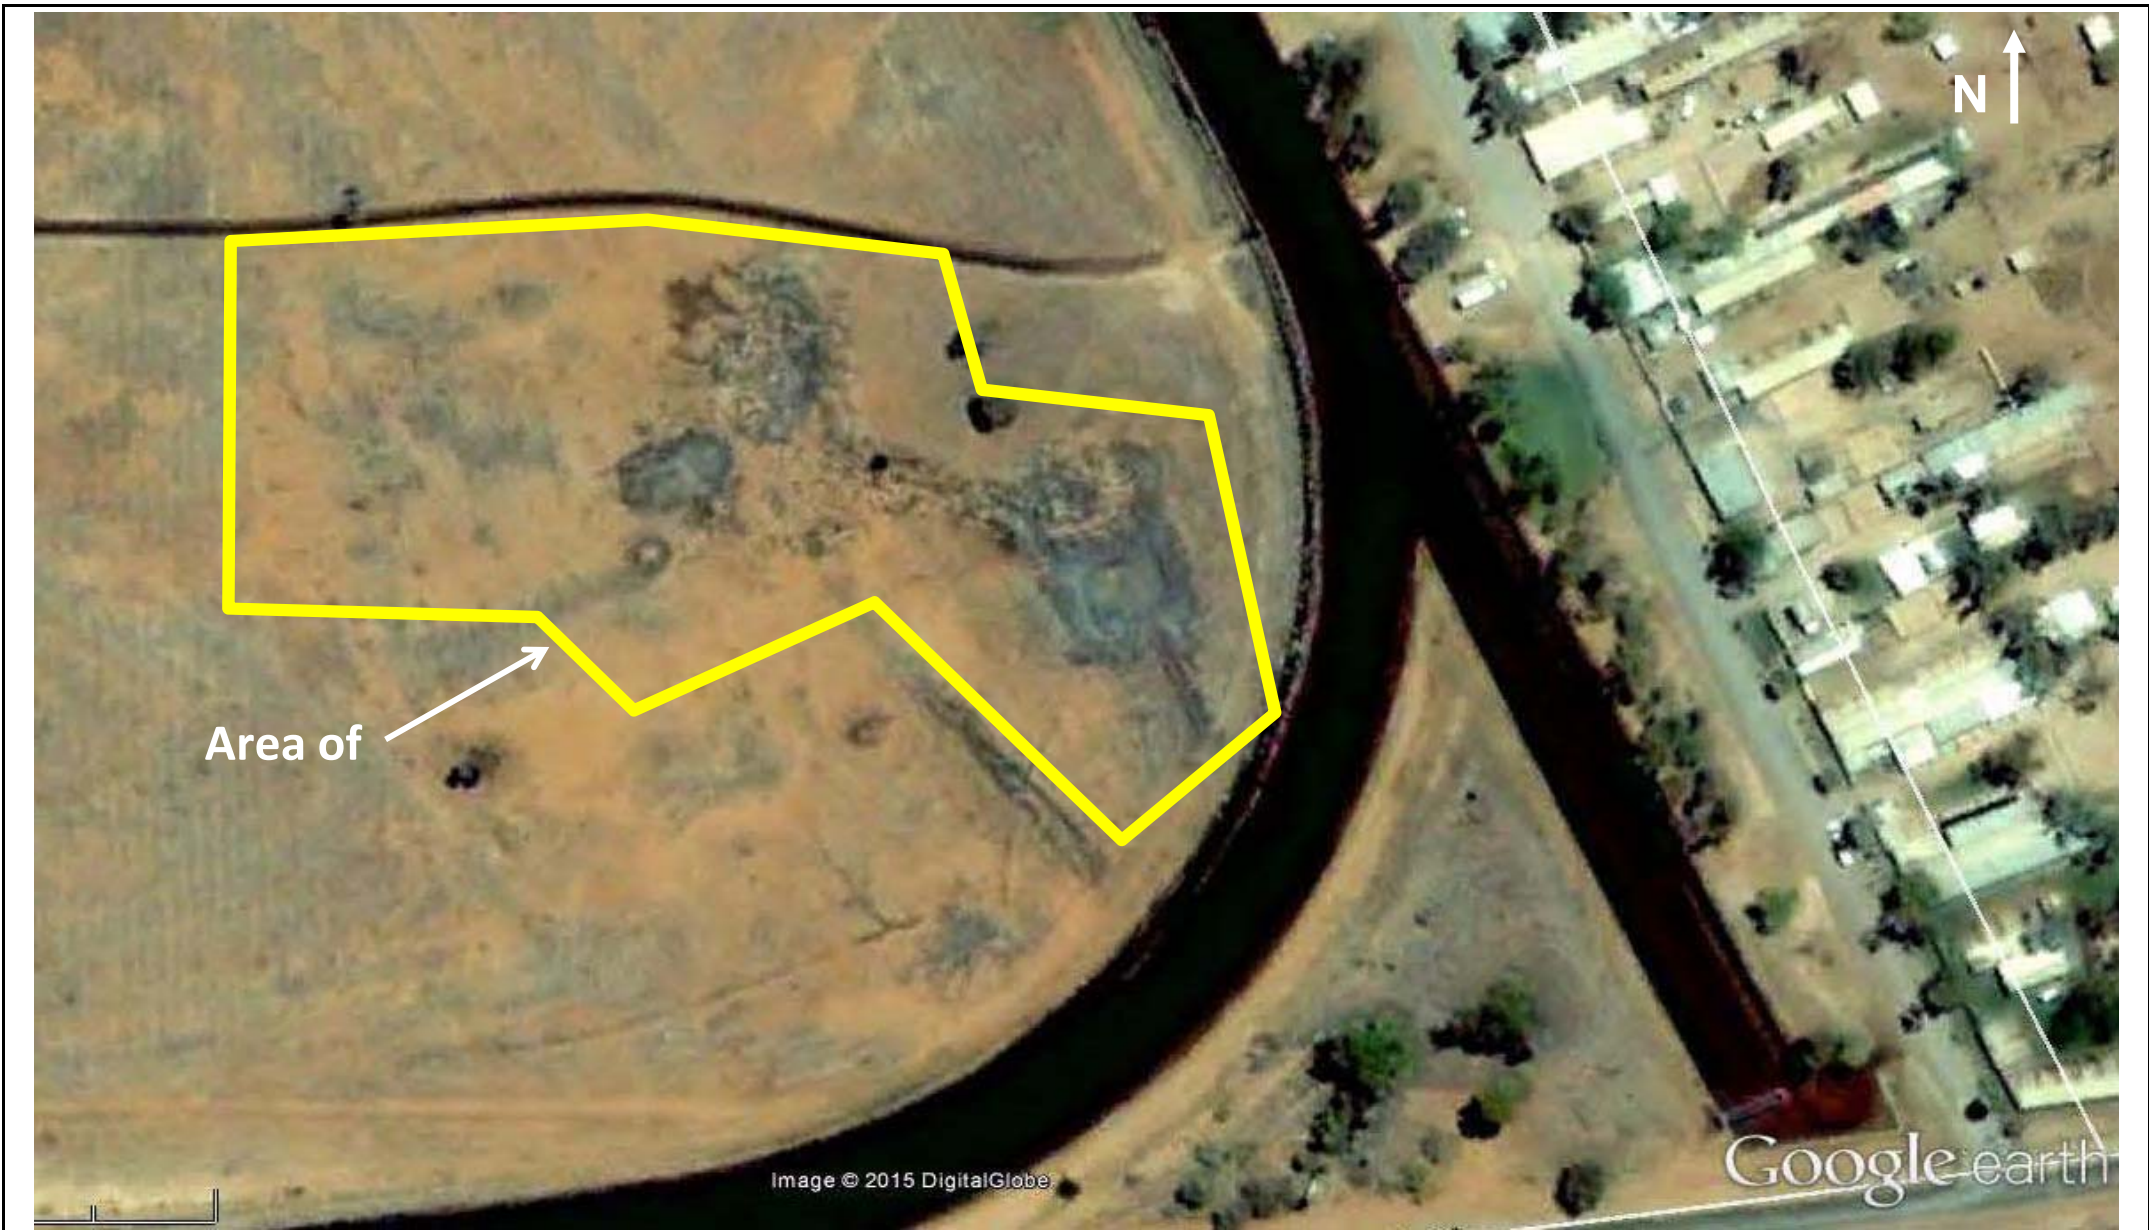
FIGURE - September 2004 Aerial Photograph

The September 2004 aerial photograph shows areas of disturbed soil in the western portion of the area of interest. It appears that the disturbance is related to excavations in this area. The western portion of the area of interest appears undisturbed. The race track and stables to the east of the area of interest are visible. A track is visible to the north of the area of interest. The photograph suggests the track is consistent with the material used for the race track itself.

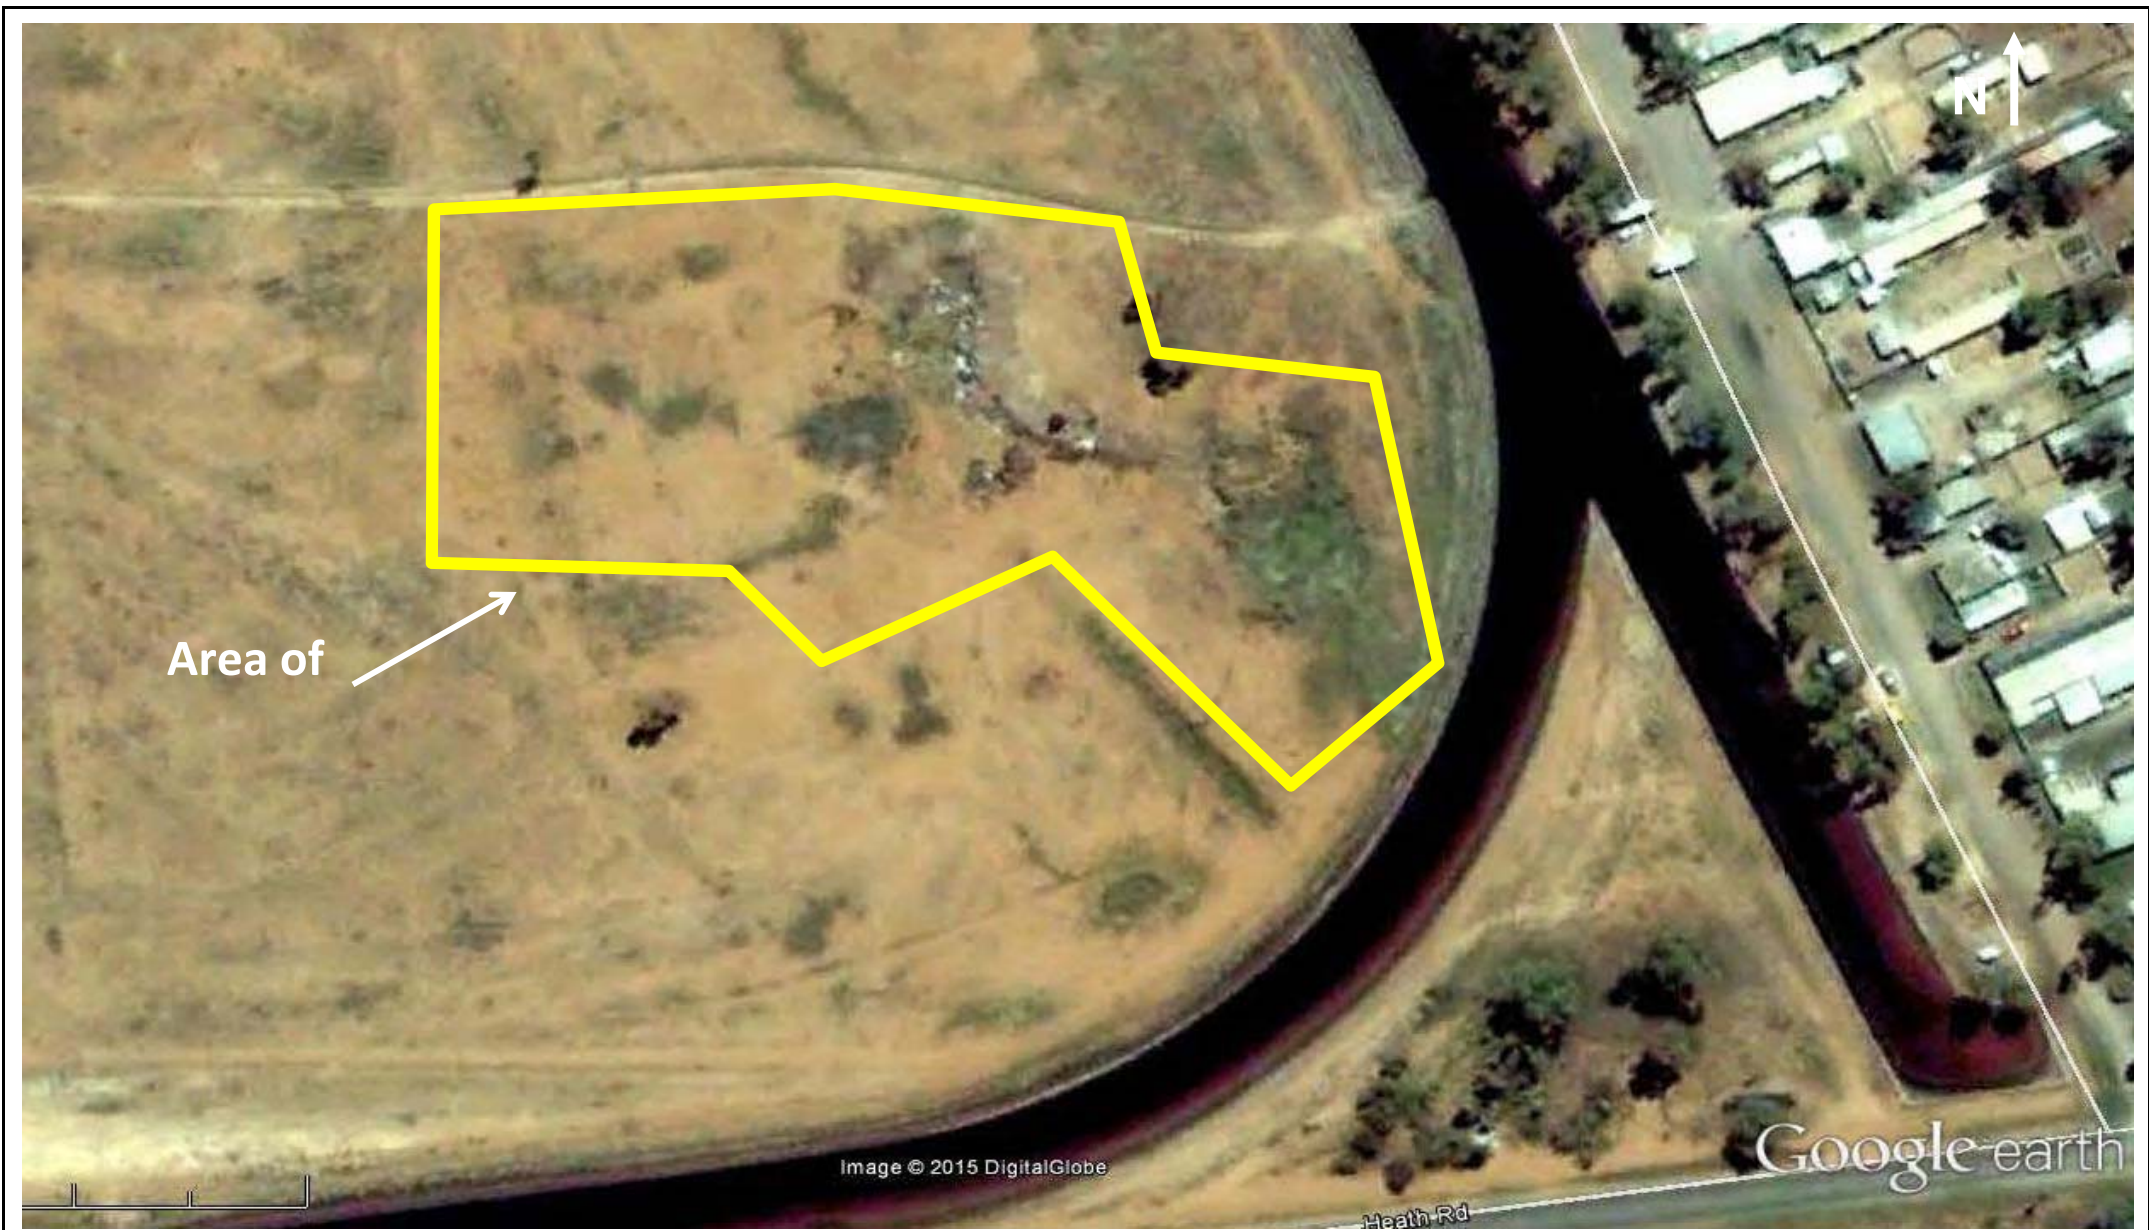
FIGURE - March 2007 Aerial Photograph

The March 2007 aerial photograph does not show any significant changes to the western portion of the area of interest. The photograph suggests the excavation in the central portion of the area appears to have been backfilled with unknown materials/objects. The excavation in the eastern portion of the area of interest appears unchanged from 2004.

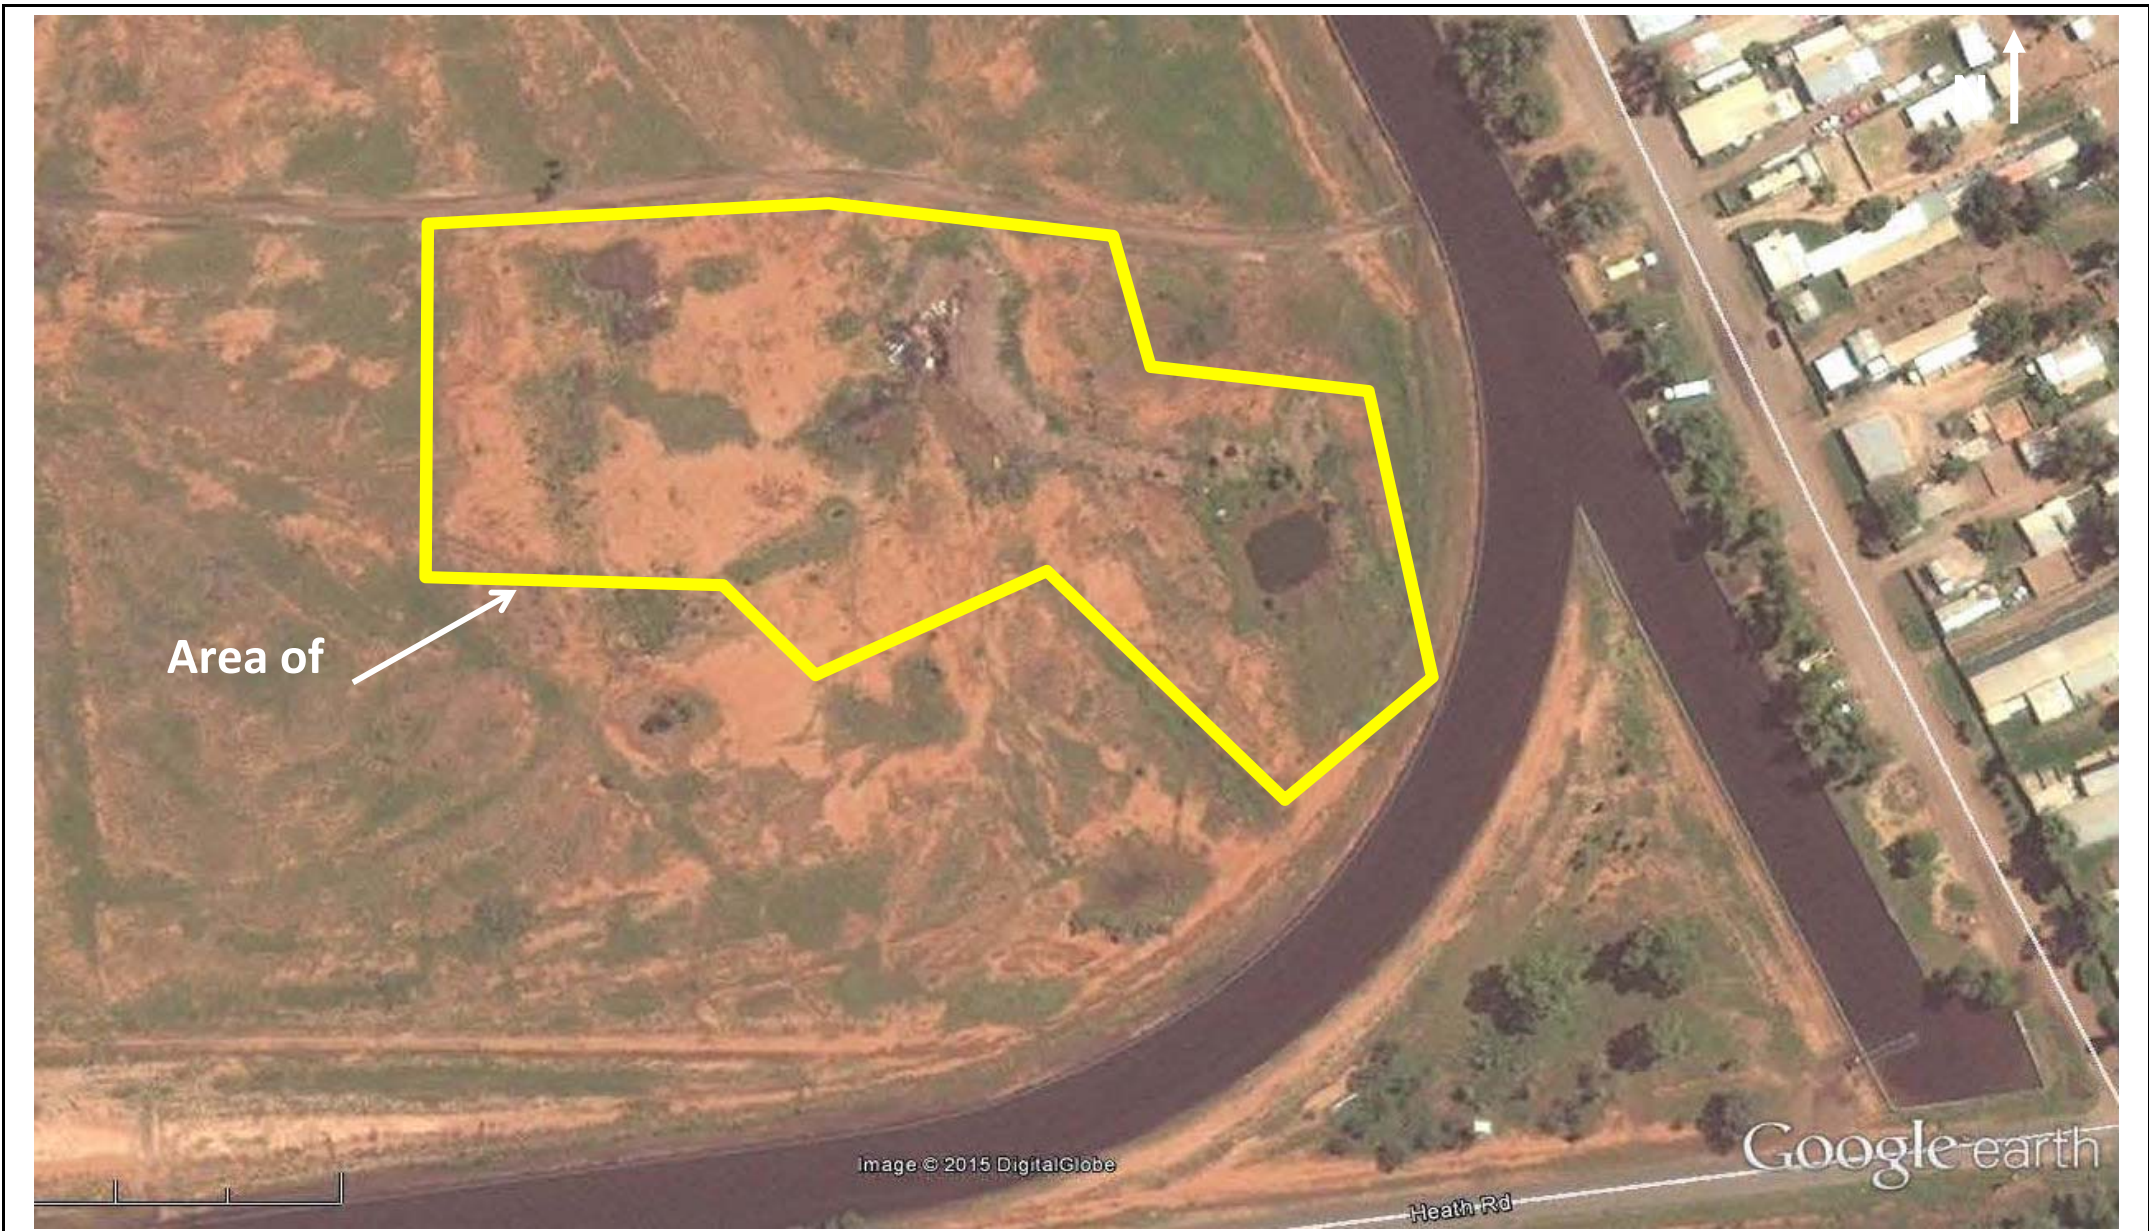
The March 2010 aerial shows some minor changes within the area of interest. It appears as though some part of the excavation may have been backfilled. The stockpiles visible in the 2009 photographs are no longer present but additional material is evident stockpiled in the north western portion of the area of interest. Darker material is evident in the eastern most portion of the excavated area. It is likely that this is material used to backfill the excavation in this area, but this is not completely clear from the photograph.

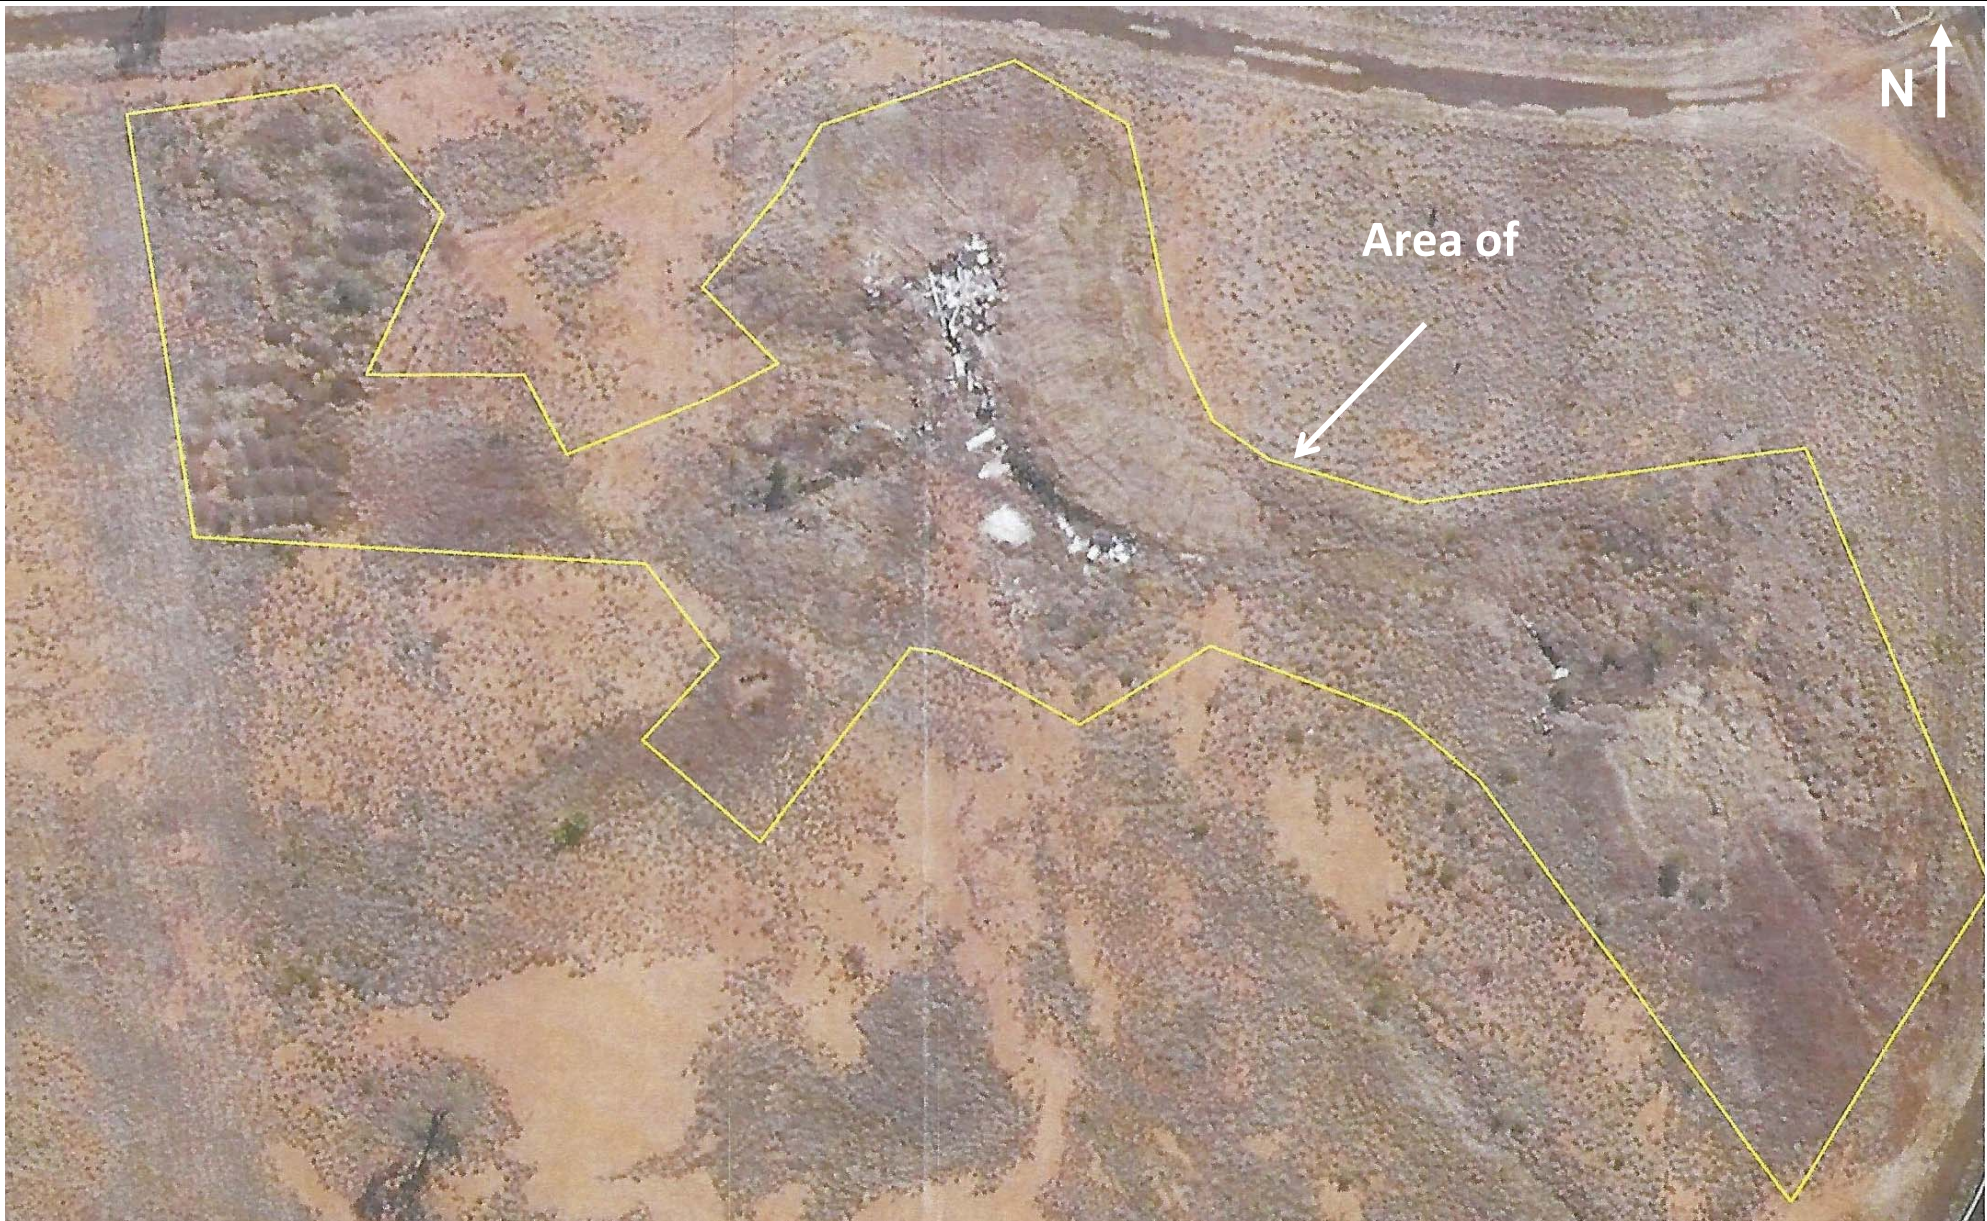
A 2012 aerial photograph provided by the NT EPA shows the eastern portion of the excavation appears to have been backfilled. A lighter area is visible in the easternmost extent. Additional items appear to have been placed within the central portion of the excavation and disturbed soil is evident to the north and east of this area. A number of stockpiles are now visible in the western portion of the area of interest.

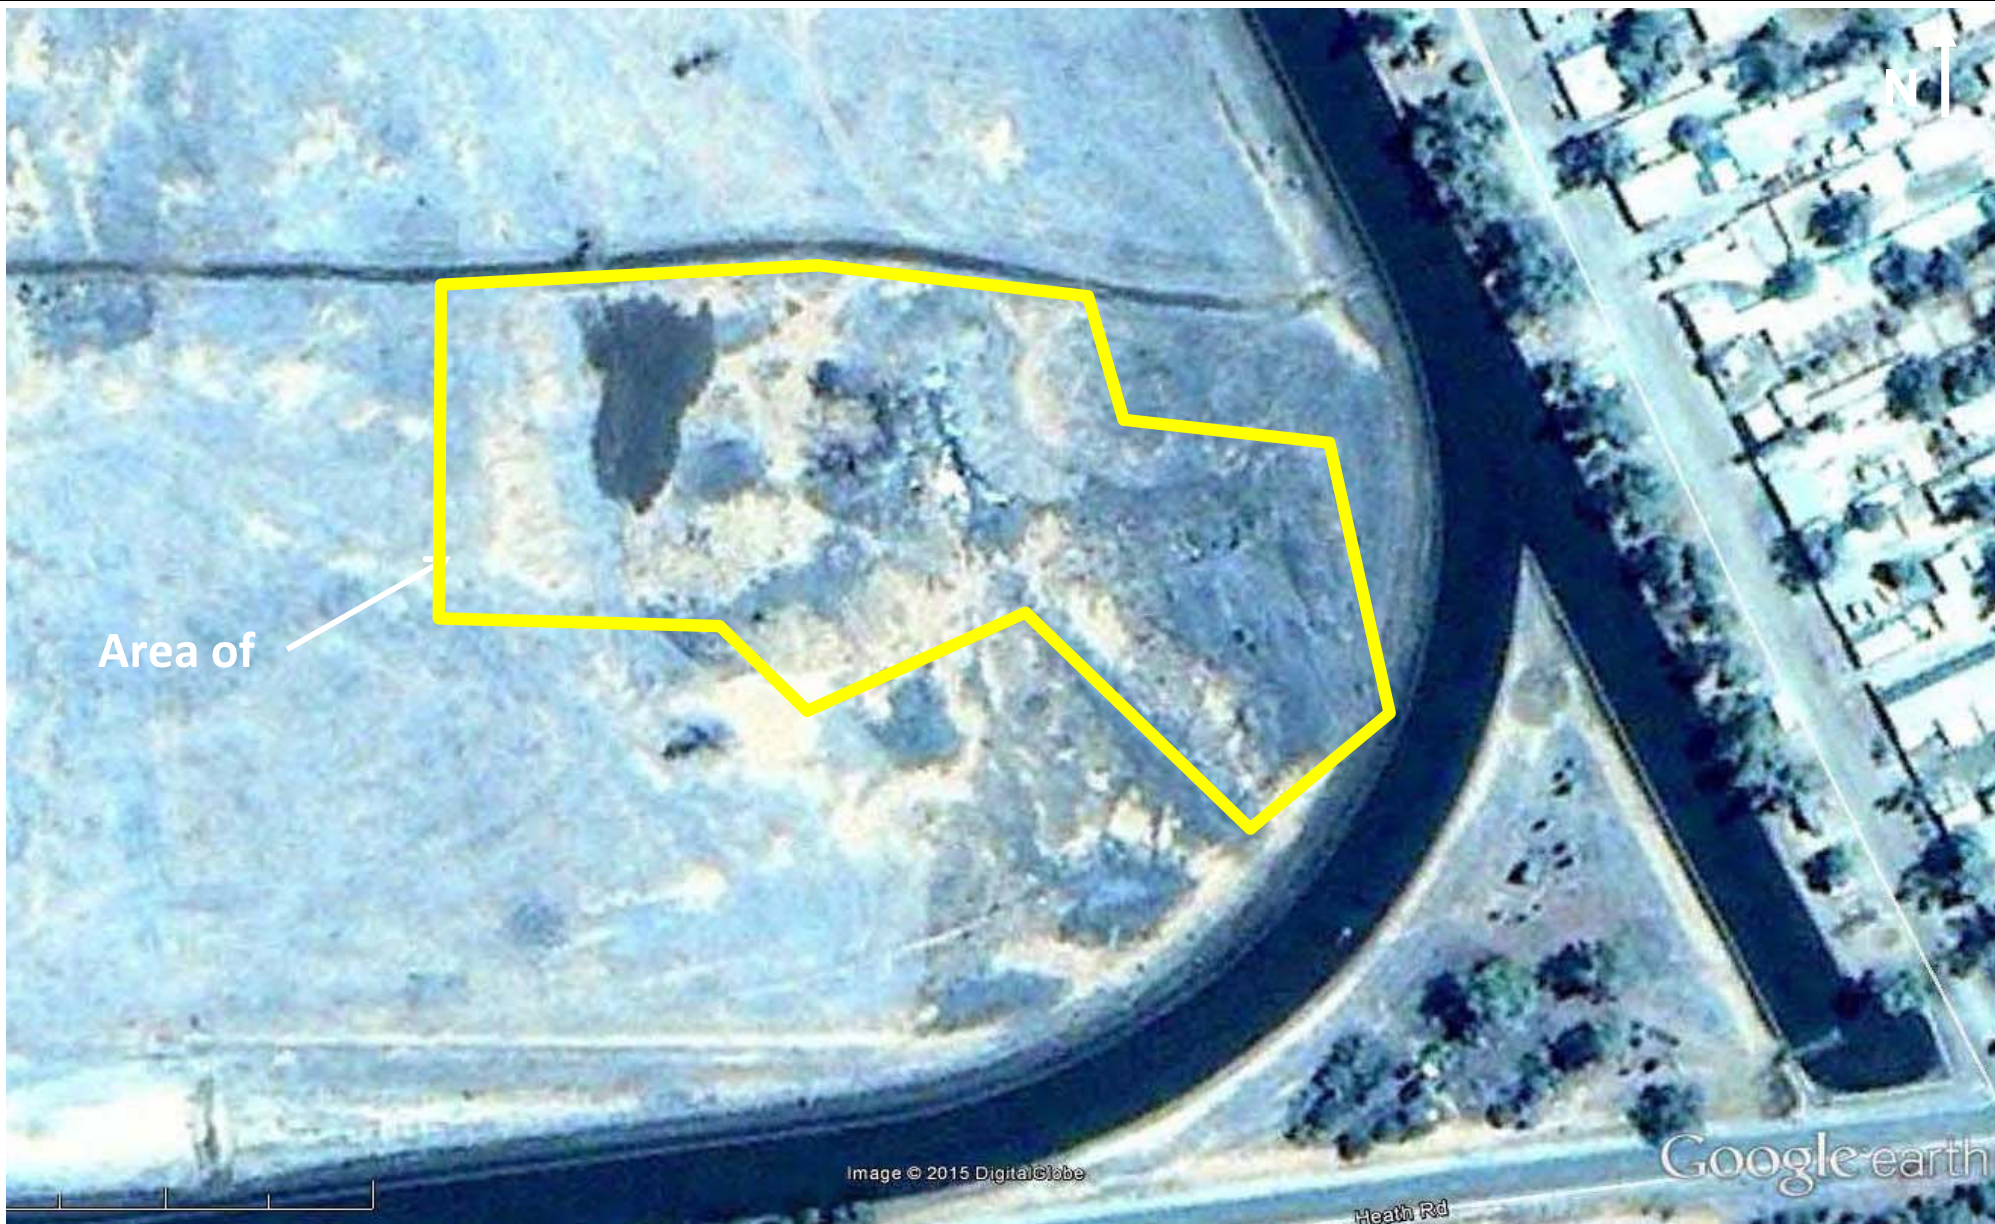
The March 2013 aerial photograph is of poor quality, but disturbed areas (location of previous excavation) are visible in the central portion of the area of interest. A dark shape is also visible in the western portion of the area of interest. It is not clear from the photograph what this is.

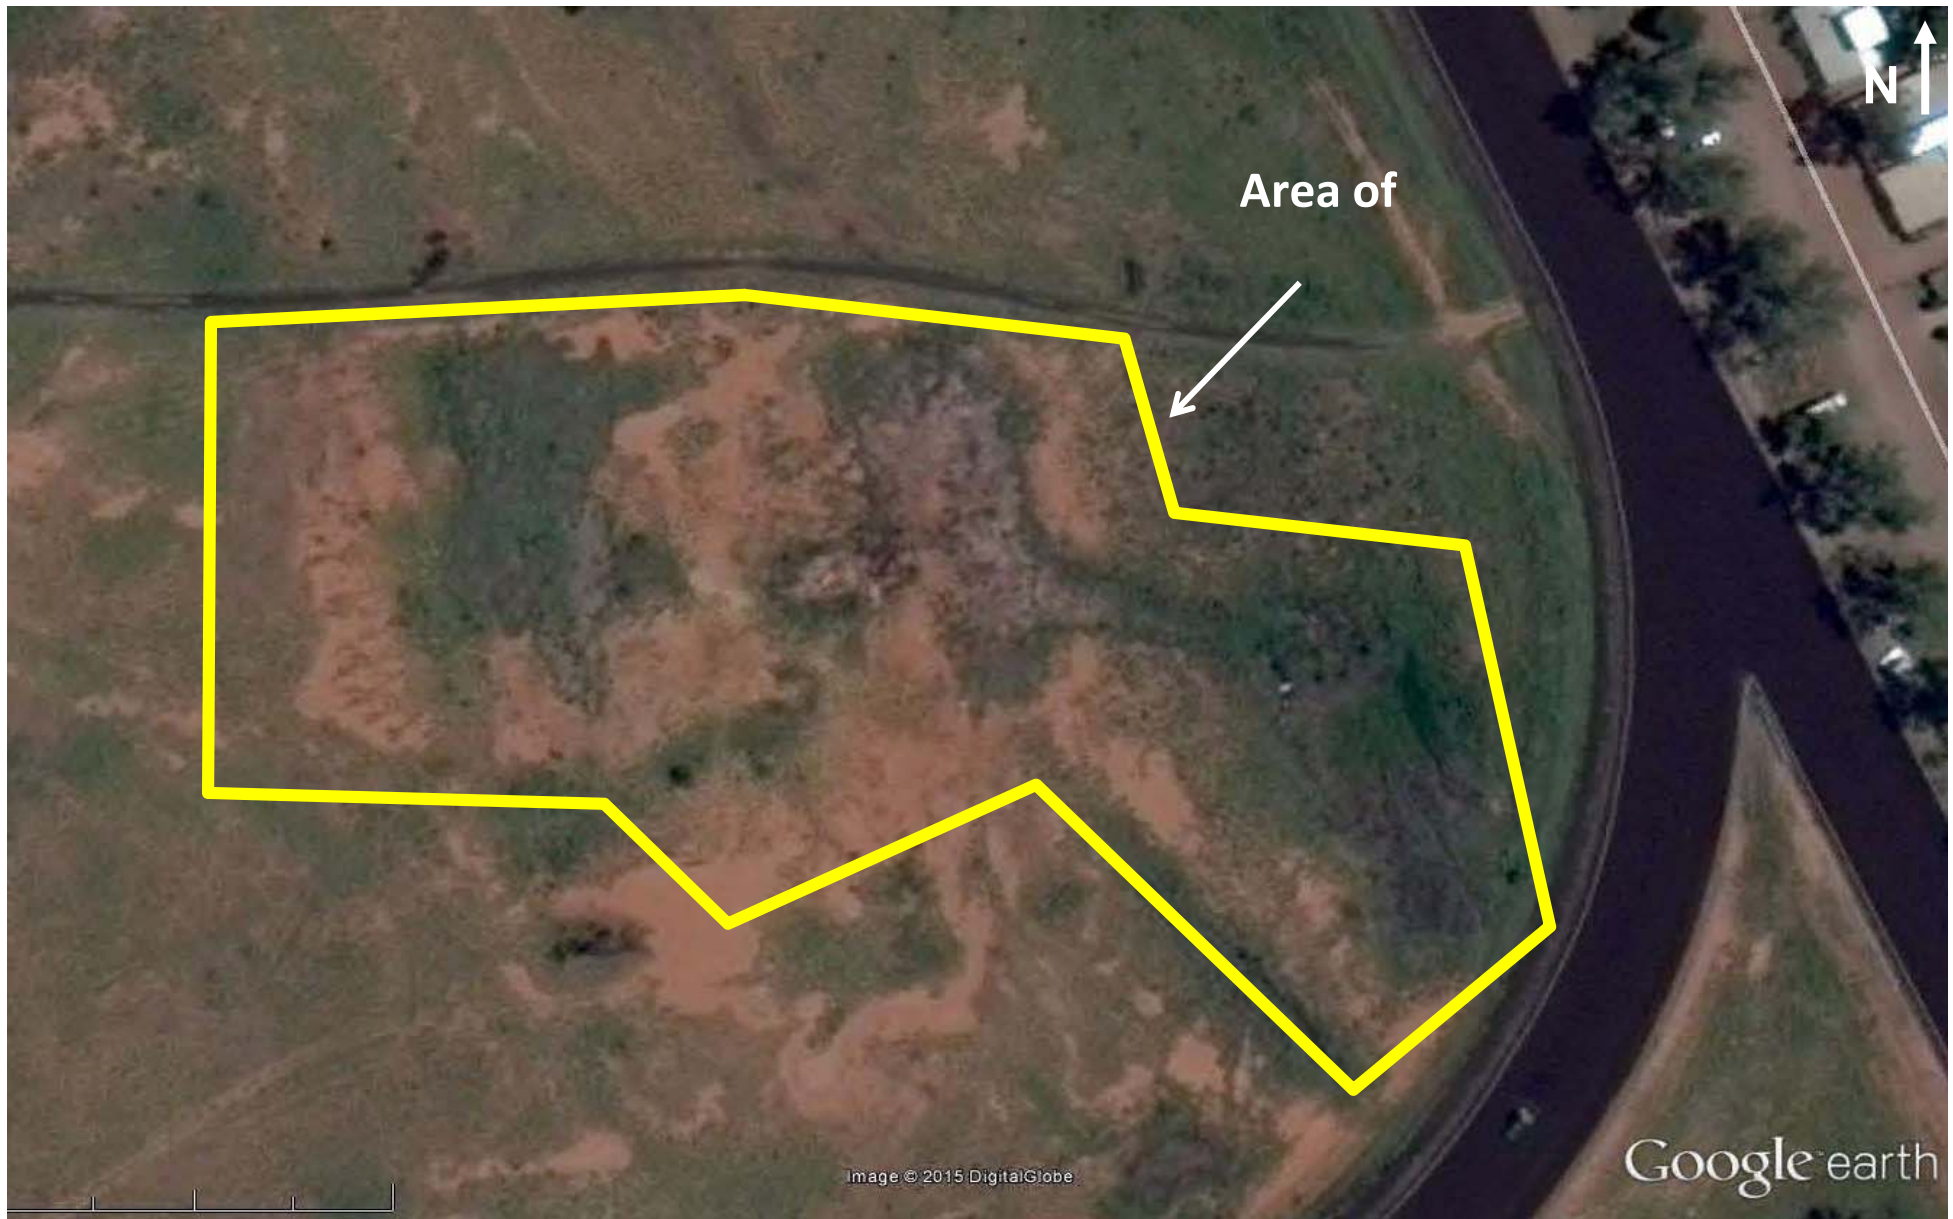
The March 2014 aerial photograph suggests there is (or was recently) a disturbance in the location of the dark shape visible in the 2013 aerial. Vegetation growth in this area has a different pattern to the balance of the area. It appears that most of the excavated areas visible in previous photographs have been backfilled, but in the central portion of the site there is some evidence of dumped waste.
