**Re: Conditions 2(i) to (iv) of Development Permit DP17/0371A – N.T. Portion 03192 (Bynoe)**

The Land Management Unit (LMU) provides the following advice regarding development permit conditions relating to preparation and implementation of an Erosion and Sediment Control Plan (ESCP) for the Seafarms development at Bynoe.

*seafarms* engaged Dr Ian Hollingsworth CPESC 8254, Horizon Environmental Soil Survey & Evaluation (HESSE) to develop an ESCP for Project Sea Dragon Breeding and Maturation Facility 2019 civil works, Point Ceylon, NT (the Project). The ESCP was prepared to address the requirements of condition 2 of Development Permit issued under the NT Planning Act (DP17/0371) for this work, namely:

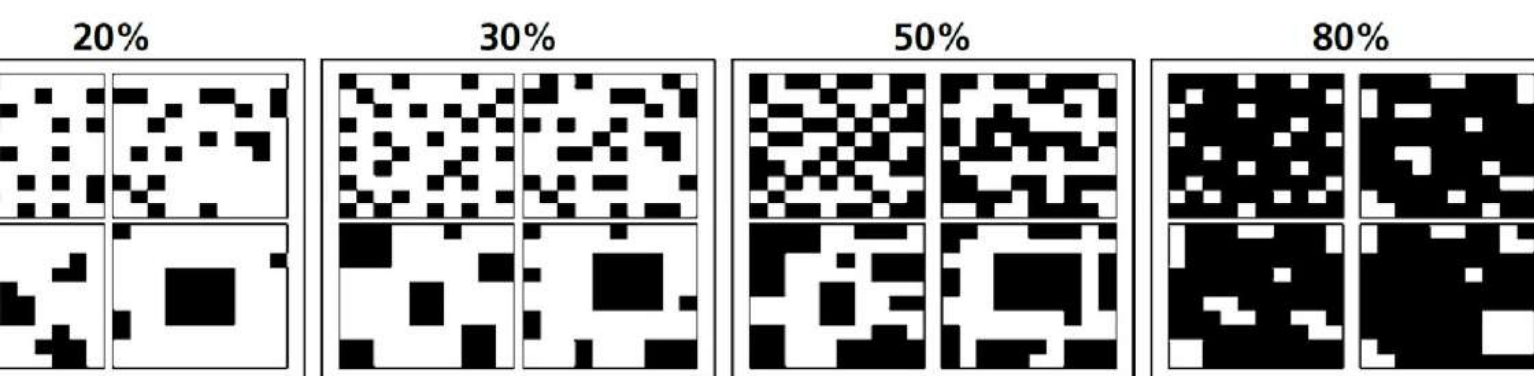
#### Temporary revegetation parameters.

cover of dead or living vegetation and gravel as a visual guide. Each quarter of any one quarter has the same percent cover.
