# EPL233 Monitoring Report

## Archer Waste Transfer Station

*For annual reporting period ending 31 May 2022*

City of Palmerston

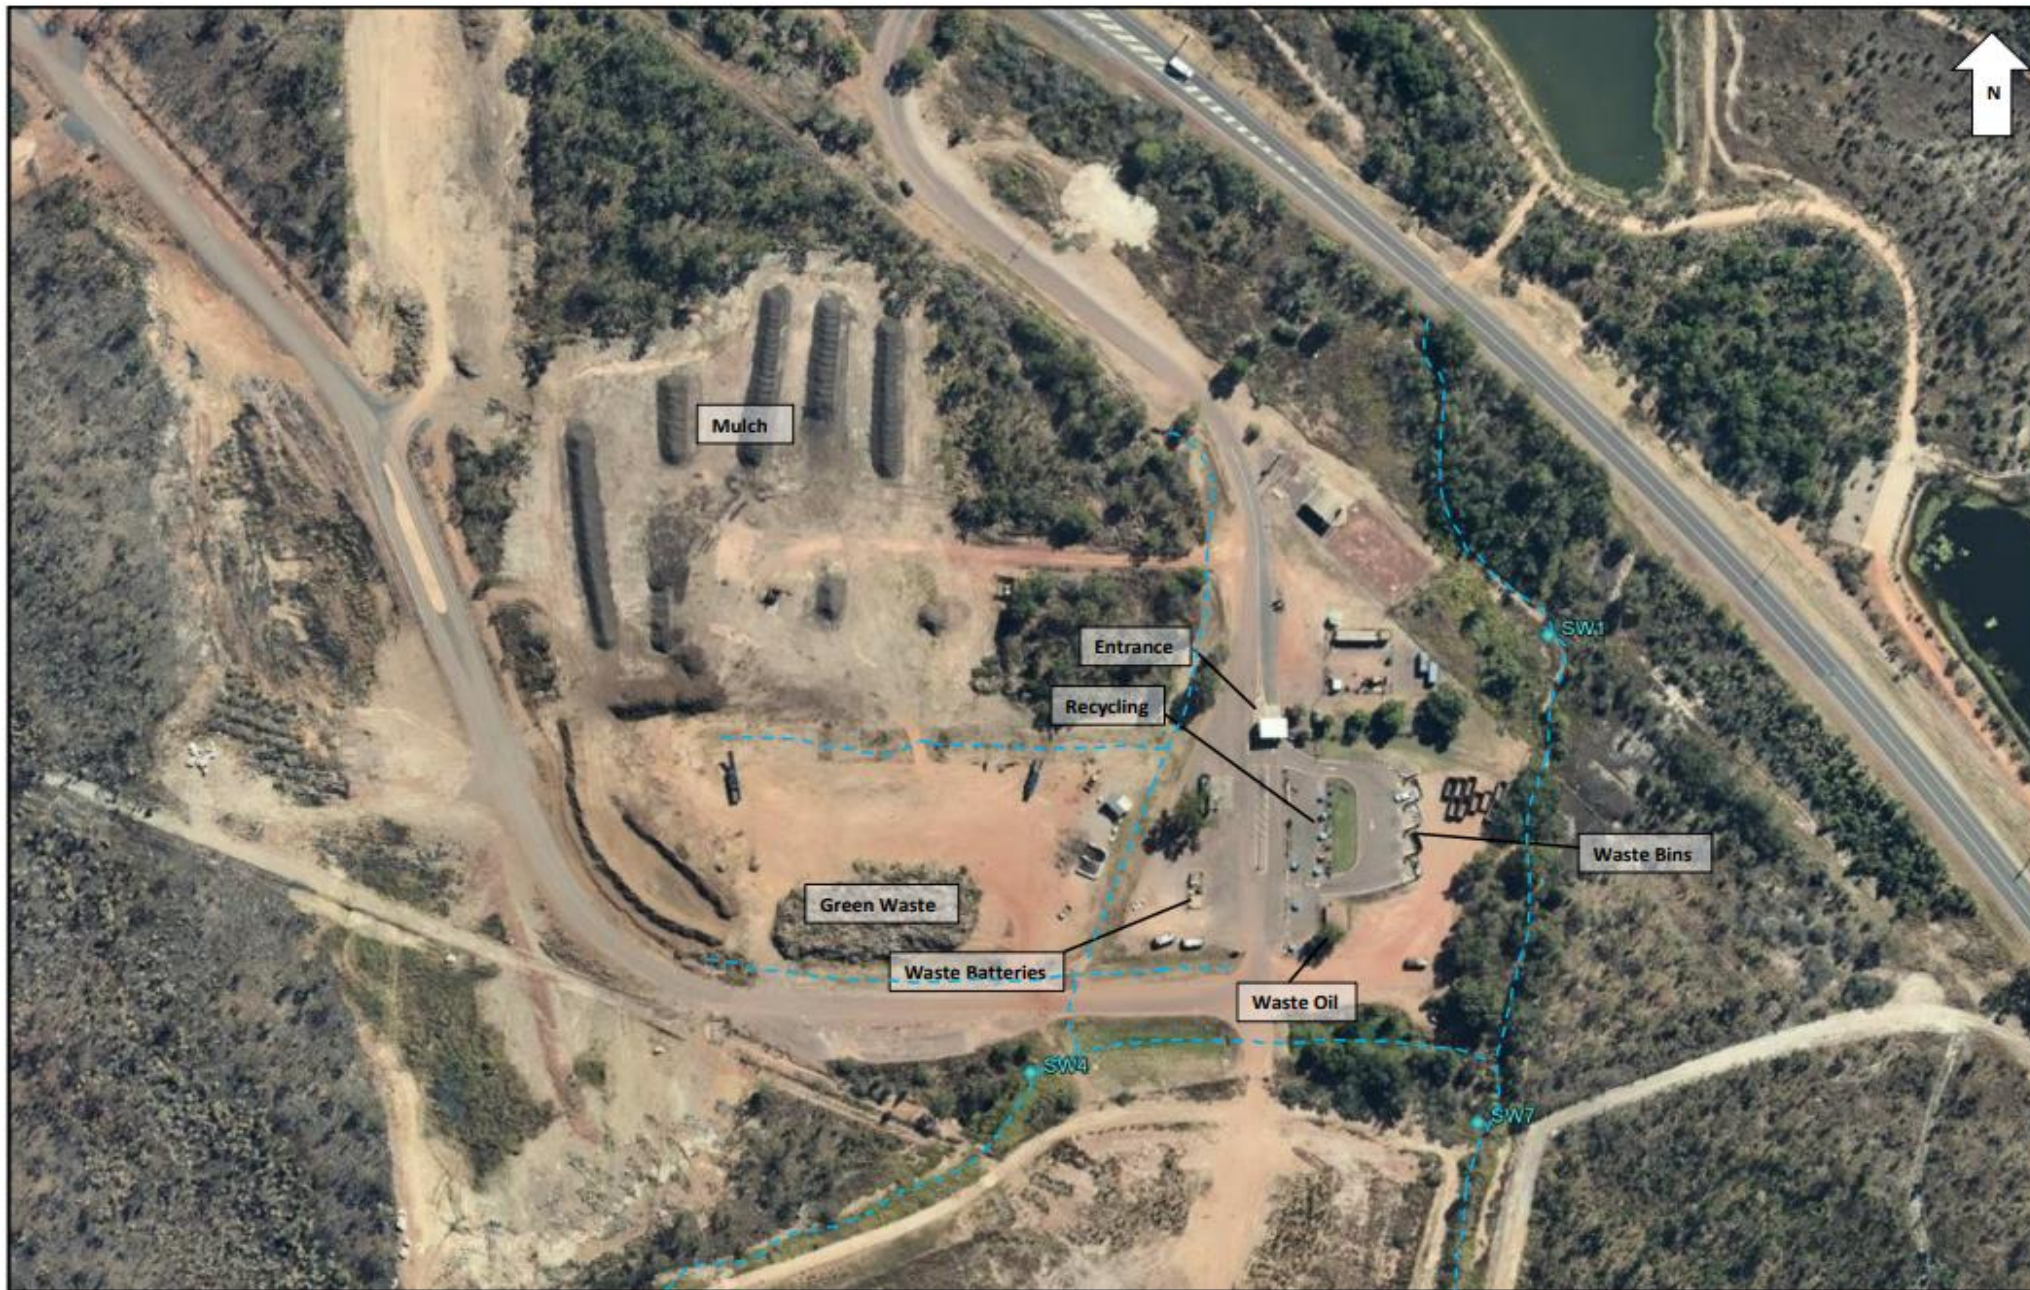
**Figure 1-1. Map of Archer WTS layout, surface water drainage and sample site locations**

The site is located on a relatively flat area, with a gradient of <3%. The area is well-drained with a combination of bitumen, compacted gravel/dirt, and grassed areas allowing for some infiltration but mostly surface water runoff. Existing constructed drains located on site collect and direct overland flows towards the eastern property boundary, where they enter an ephemeral stream (see Figure 1-1).

Green waste is accepted and mulched onsite for sale to the general public. Refer to site layout in Figure 1-1.
