# Landfill Monitoring Report

## May 2023

### Yulara Landfill

Voyages Indigenous Tourism Pty Ltd

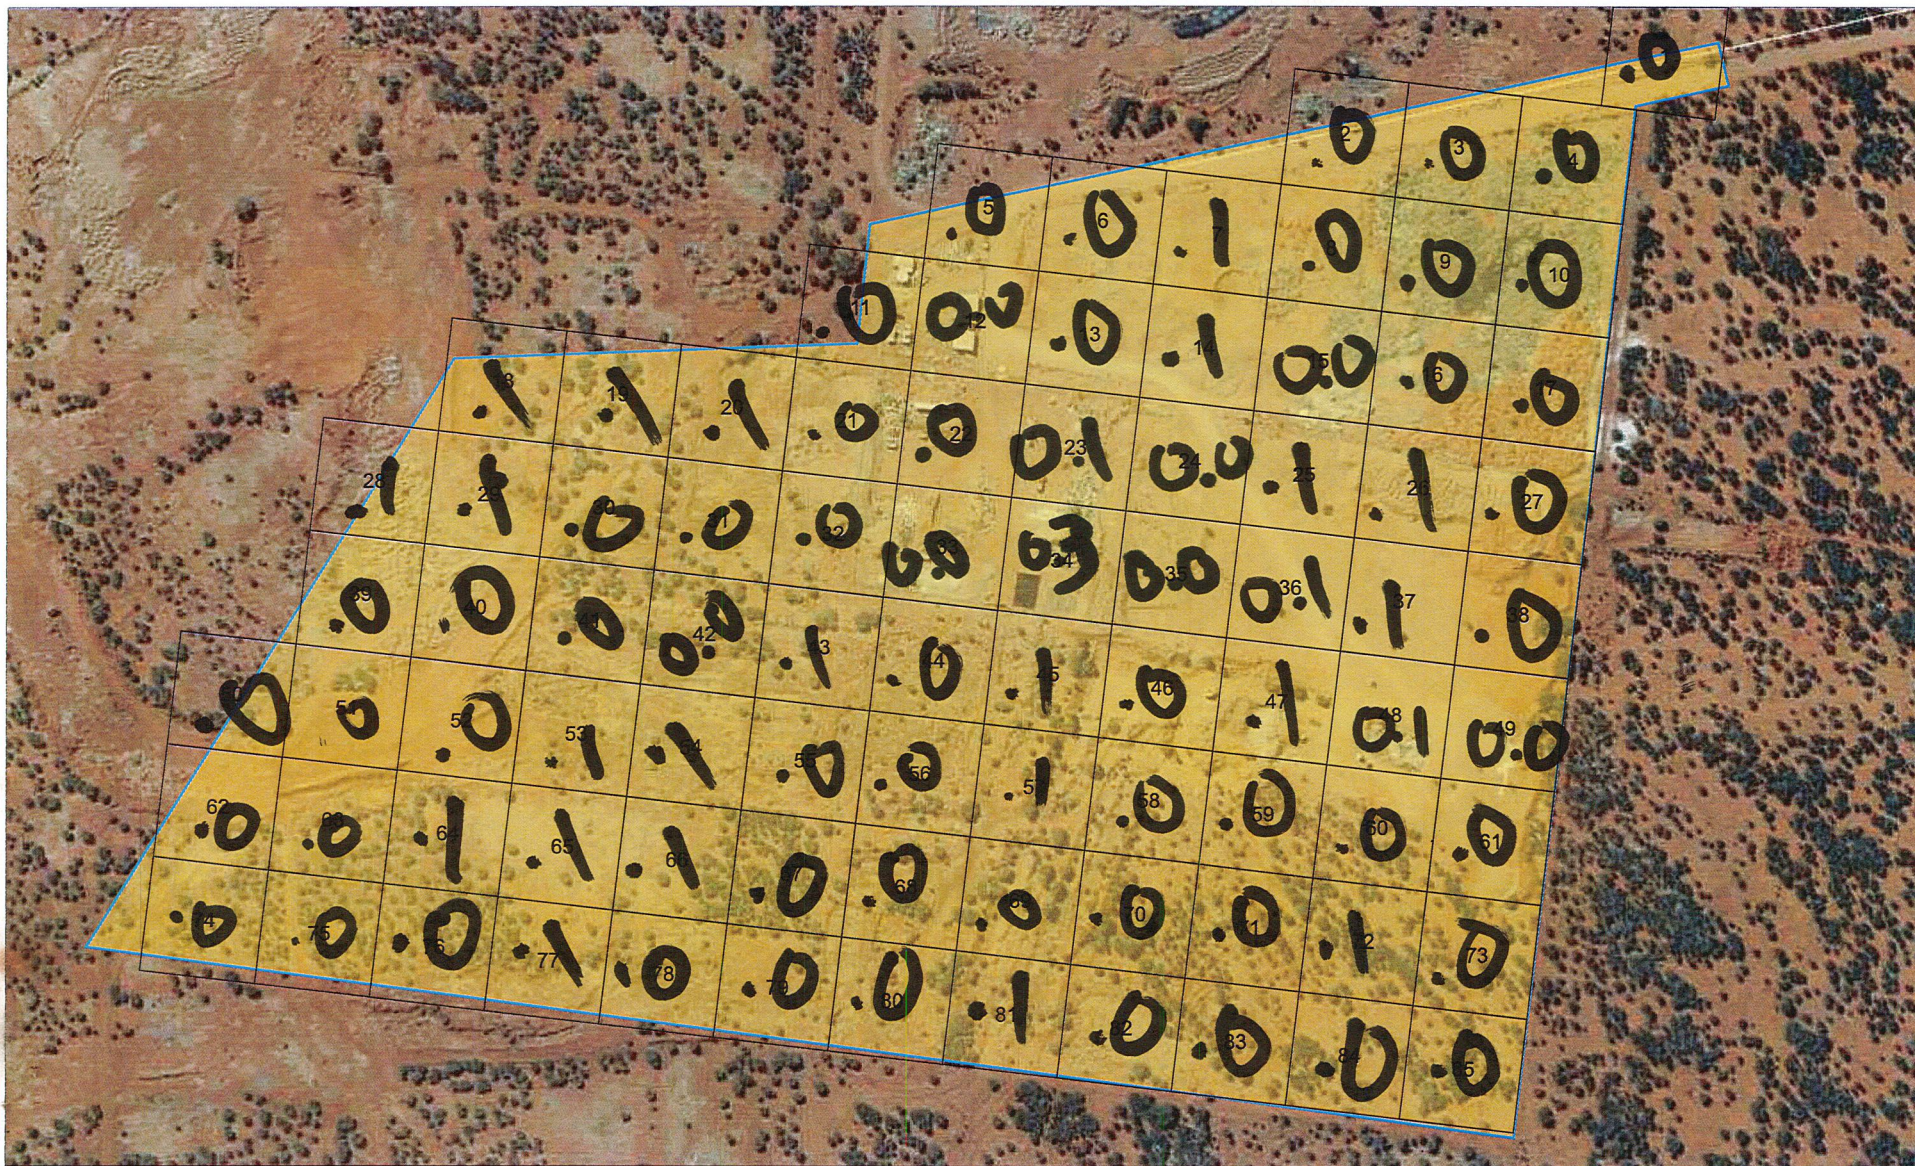
## **APPENDIX B RELATIVE METHANE FIELD SHEET**

LFG levels were generally low, with most values recorded between 0 to 0.1 ppm. One location (34, located adjacent to an oil waste pit) recorded a slightly higher maximum methane reading of 0.3 ppm. The field readings are provided in a table in **Error! Reference source not found.** The Yulara Landfill was inactive while sampling which provided access to all required sampling sites.

Surface gas monitoring detected very low concentrations of methane gas (0.1 ppm) at approximately half of the sites, with the highest concentrations of 0.3 ppm recorded at site 34.
