Project No. 1918
FEBRUARY 2020

Environmental Management Plan

Milingimbi Waste Management Facility

East Arnhem Regional Council

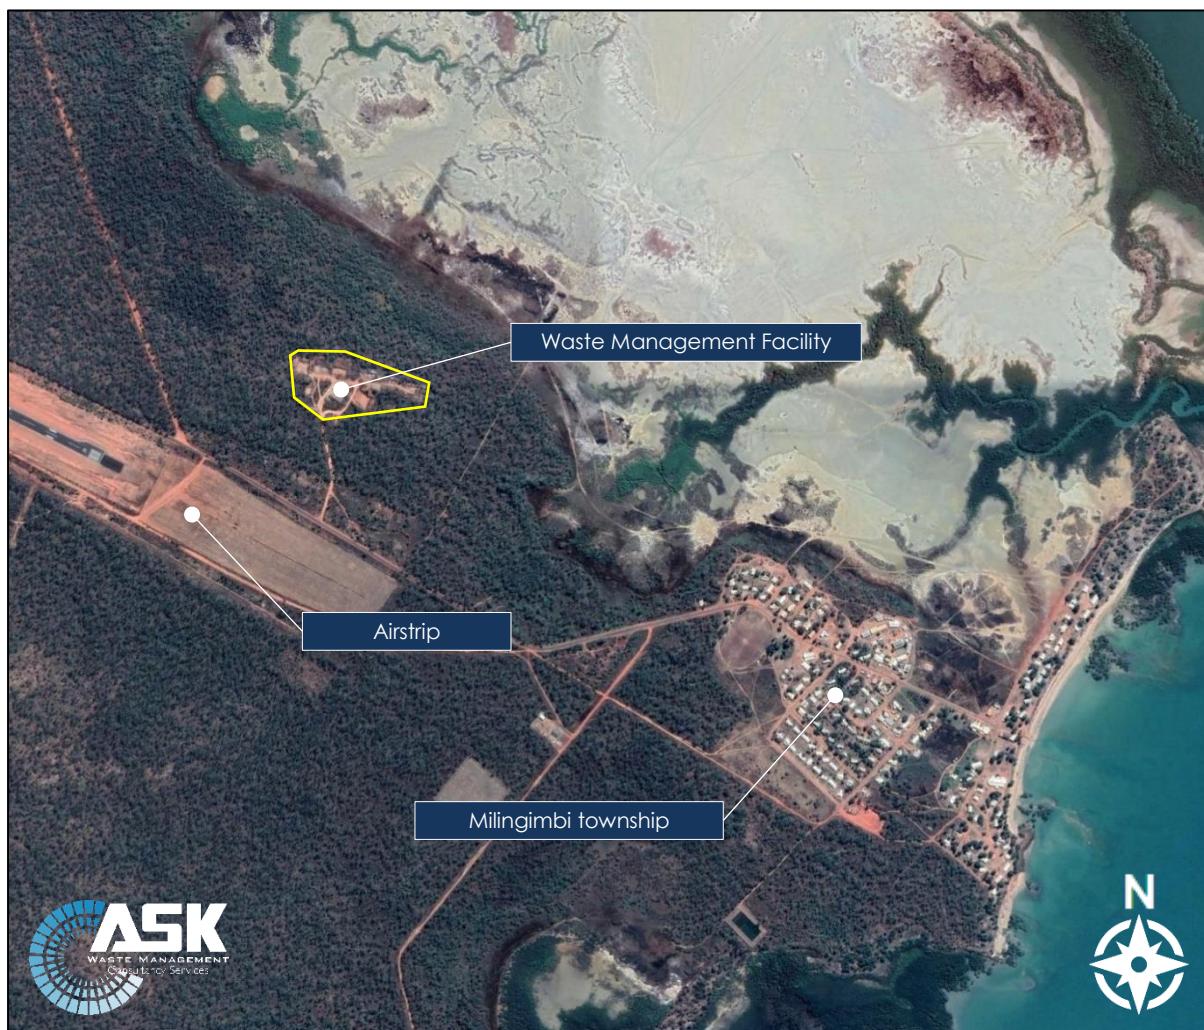
Figure 4.1 - Facility location

The Facility is located on a large parcel of land identified as NT Portion 1647 that is owned by the Arnhem Land Aboriginal Land Trust. The site is located approximately 1,100 metres northwest of the Milingimbi township, and 300m north of the Milingimbi airstrip as is shown in **Figure 4.1** below. The whole site covers an area of approximately 4.3 hectares.

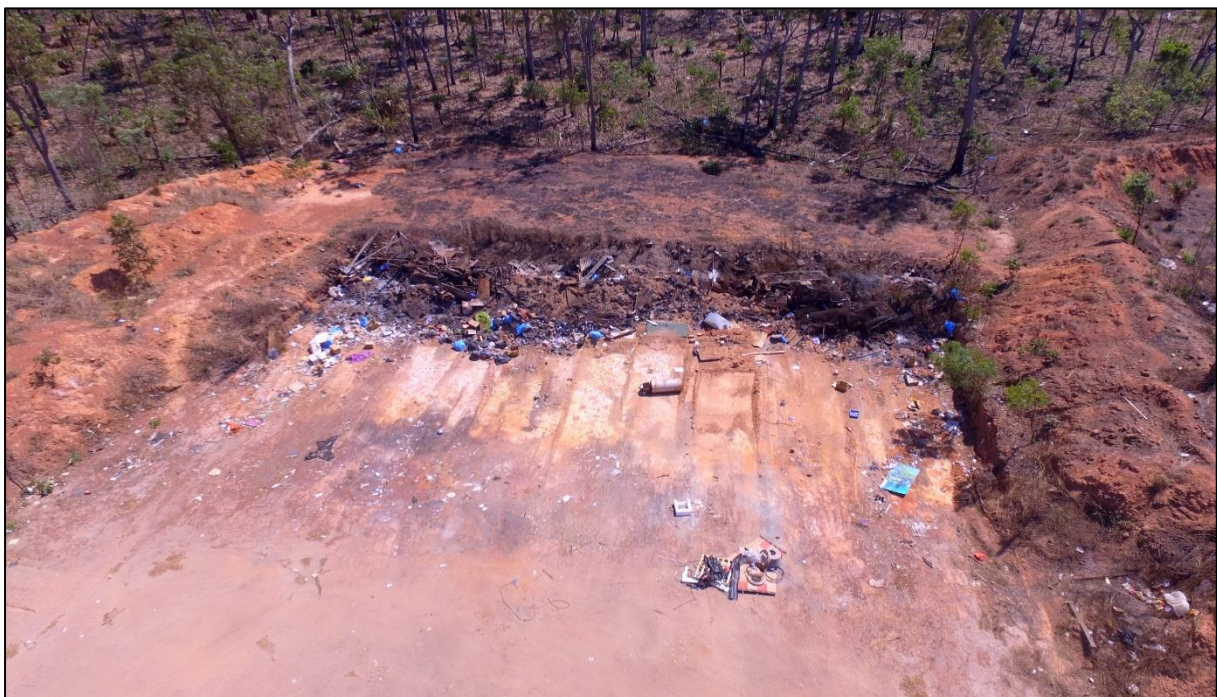
Figure 4.2 - Aerial photo of Cell 1 (29/08/2019)

As of October 2023, the Cell was being used for the disposal of commercial waste and was approximately 80% full. Waste was filled to a height of approximately 0.5 metres above the natural ground level.

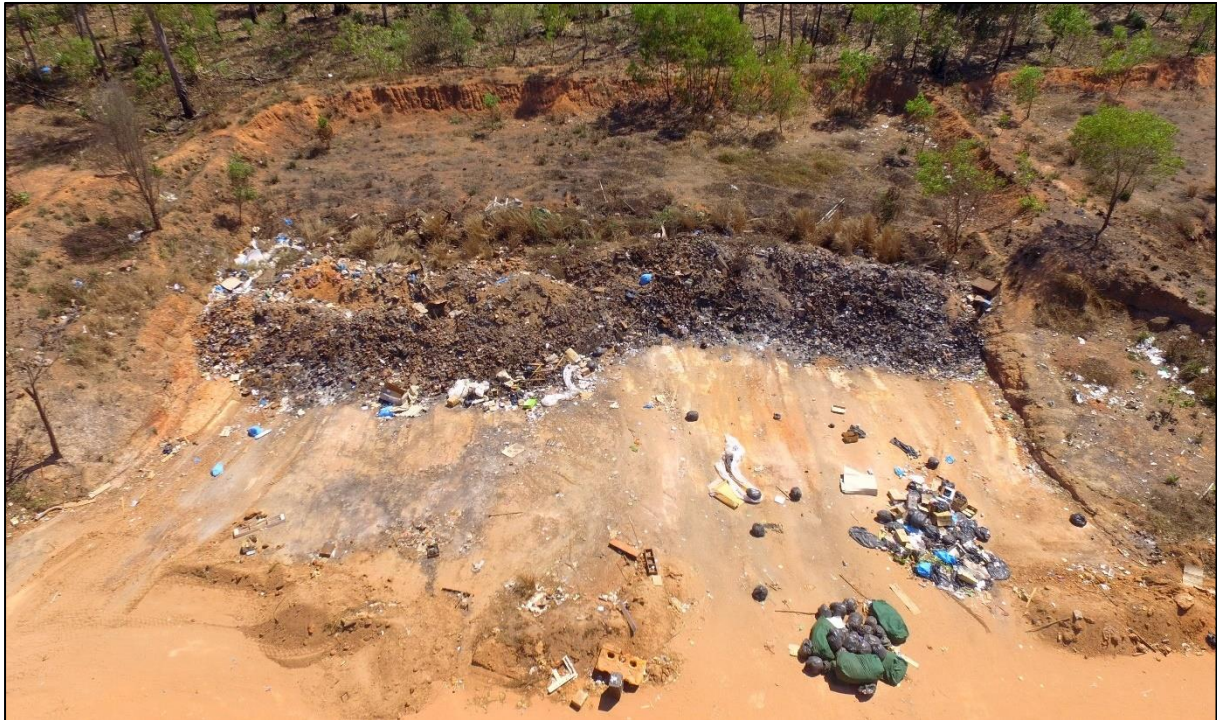
Figure 4.4 - Aerial photo of Cell 2 (29/08/2019)

Cell 2 is located immediately east of Cell 1 and is approximately 45m long and 40m wide. Like Cell 1 it has been excavated to a depth of 1.5m bgl with the excavated soil stored in bunds on three sides of the cell. At the time ASK visited the Facility, the Cell was being used for the disposal of domestic waste and was approximately 50% full. Waste was filled to a height of approximately 0.5 metres above the natural ground level.

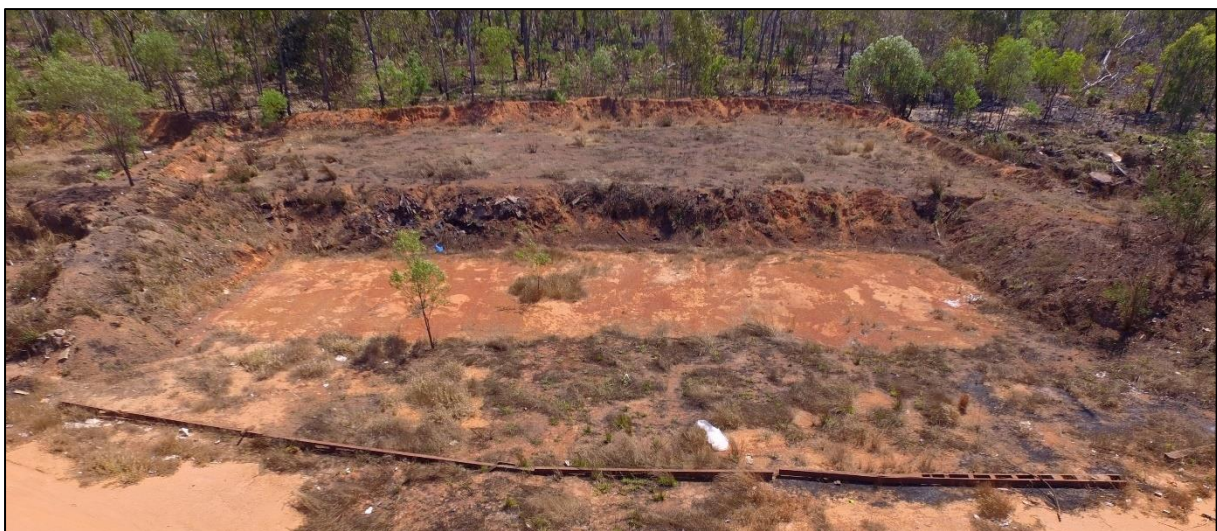
Figure 4.5 - Aerial photo of Cell 3 (29/08/2019)

Cell 3 is located immediately east of Cell 2 and has the same approximate dimensions. When ASK visited the Facility, it was not actively being used for waste disposal, was filled to approximately 70% of its total capacity, and all waste had been covered with approximately 300mm of soil. Waste was filled to a height of approximately one metre above the natural ground level.

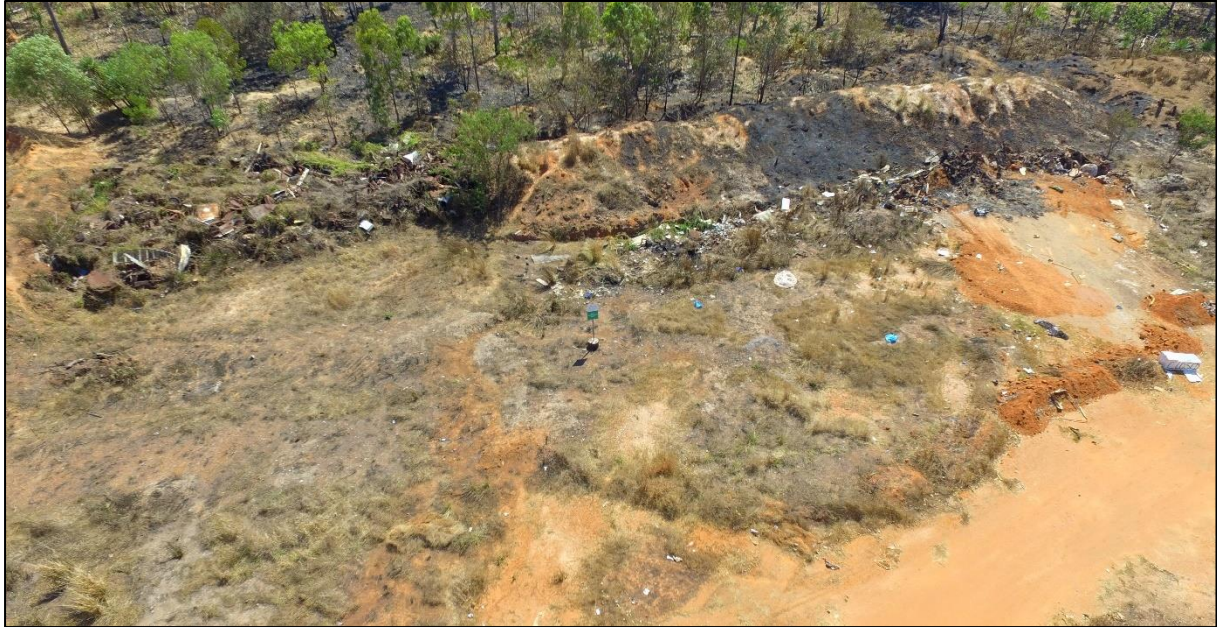
Figure 4.6 - Aerial photo of Cell 4 (29/08/2019)

Cell 4 is located immediately east of Cell 3 and is approximately 80m long and 45m wide. Waste has been filled to ground level in most areas and slightly above it in others. Although most waste has been covered with soil, some remains exposed as shown in **Figure 4.6**.

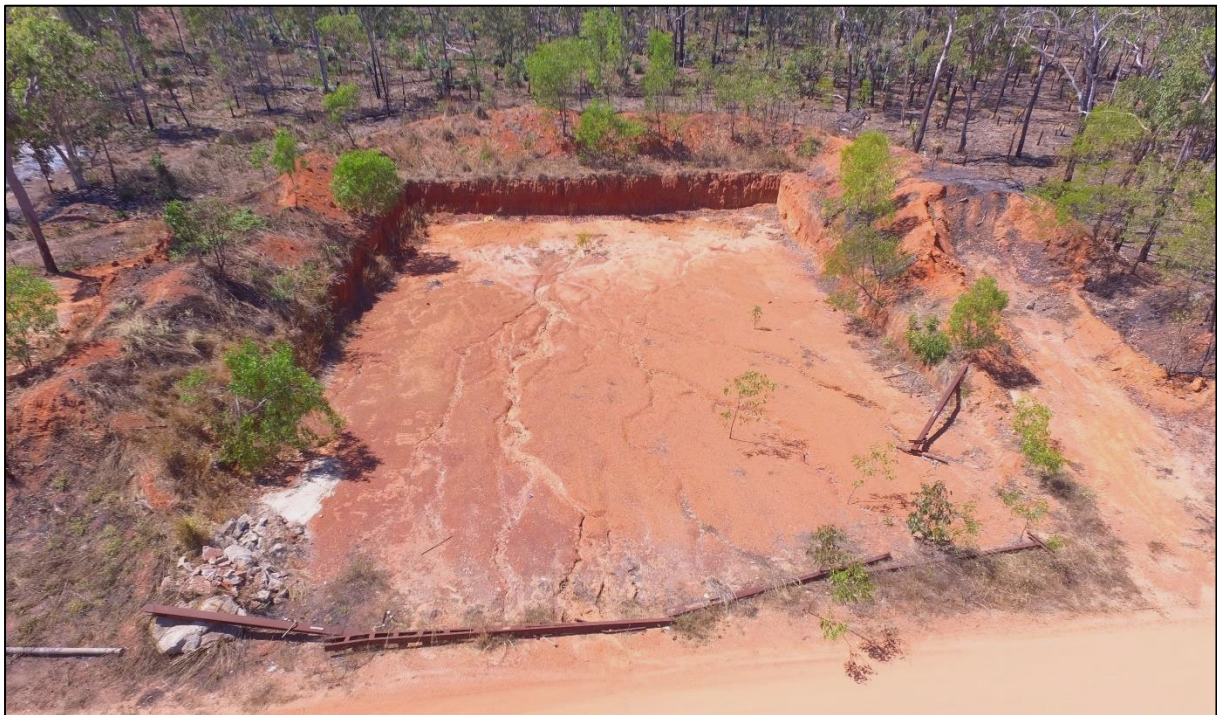
Figure 4.7 - Aerial photo of Cell 5 (29/08/2019)

Cell 5 is located to the south of Cell 4 and has not yet been used for the disposal of any waste. It is approximately 45m by 35m and has been excavated to a depth of 2m at its eastern edge. Soil removed during the excavation works has been stored in bunds surrounding the cell on three sides.

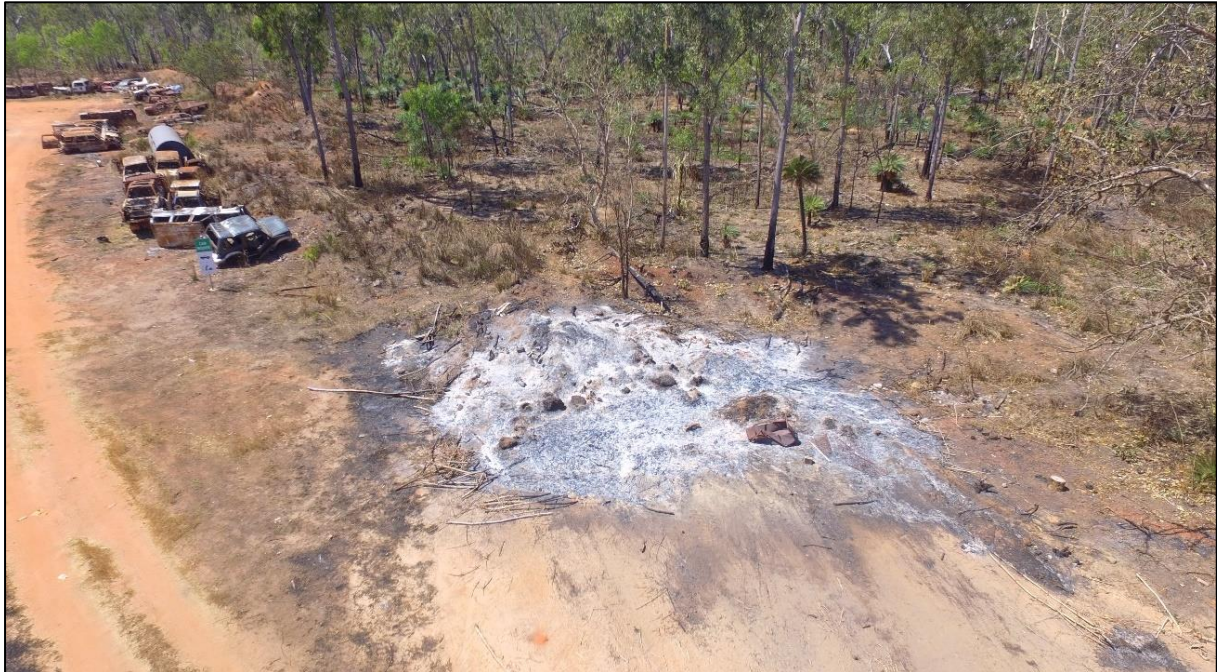
Figure 4.8 - Photo of greenwaste storage area (29/08/2019)

Greenwaste is stockpiled in an area adjacent to the ELV Storage Area.

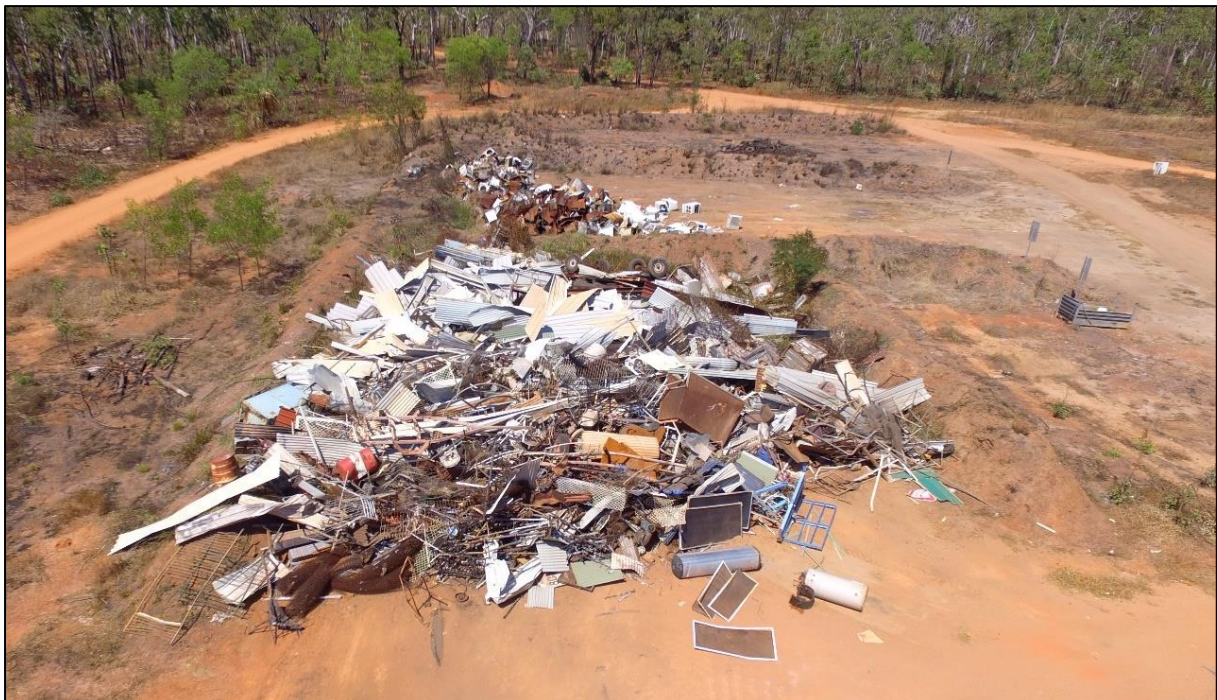
Figure 4.9 - Photo of scrap metal storage area (29/08/2019)

Scrap metal is stored in a designated area south of the Cells 3 and 4 for removal and recycling by a scrap metal business engaged by the Council to collect metals from all of the EARC communities. It is expected that the existing stockpile will be removed in 2020.

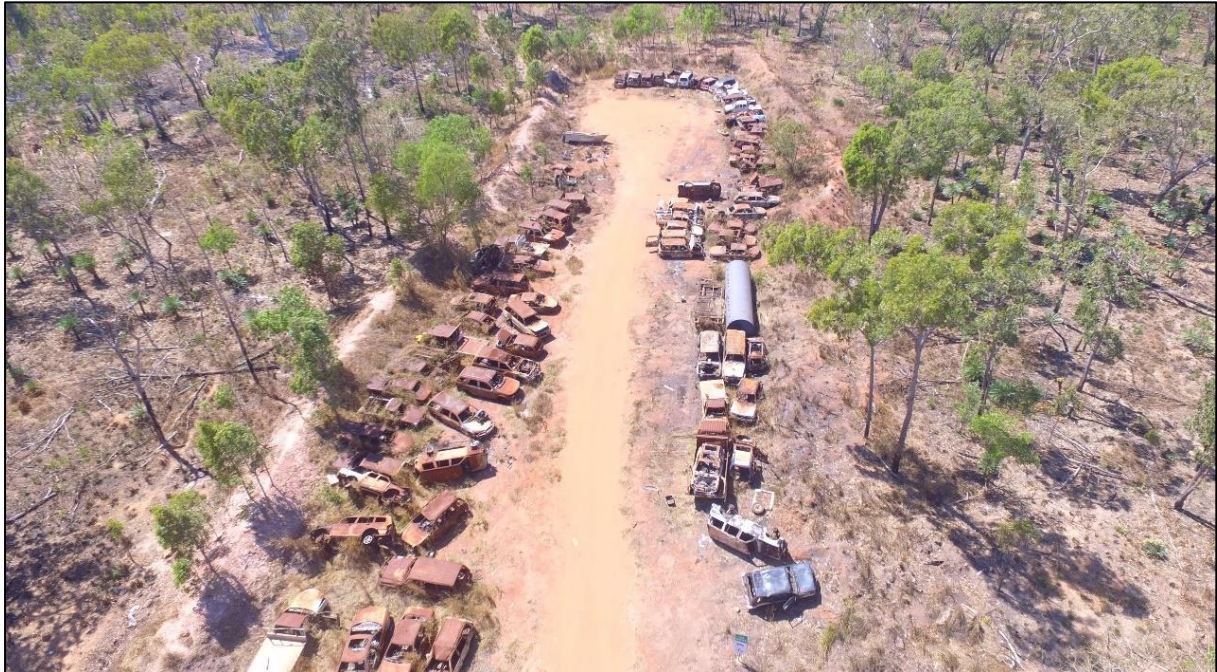
Figure 4.10 - Photo of ELV storage area (29/08/2019)

End of life vehicles (ELVs) are stored in a cleared area to the east of Cell 4.

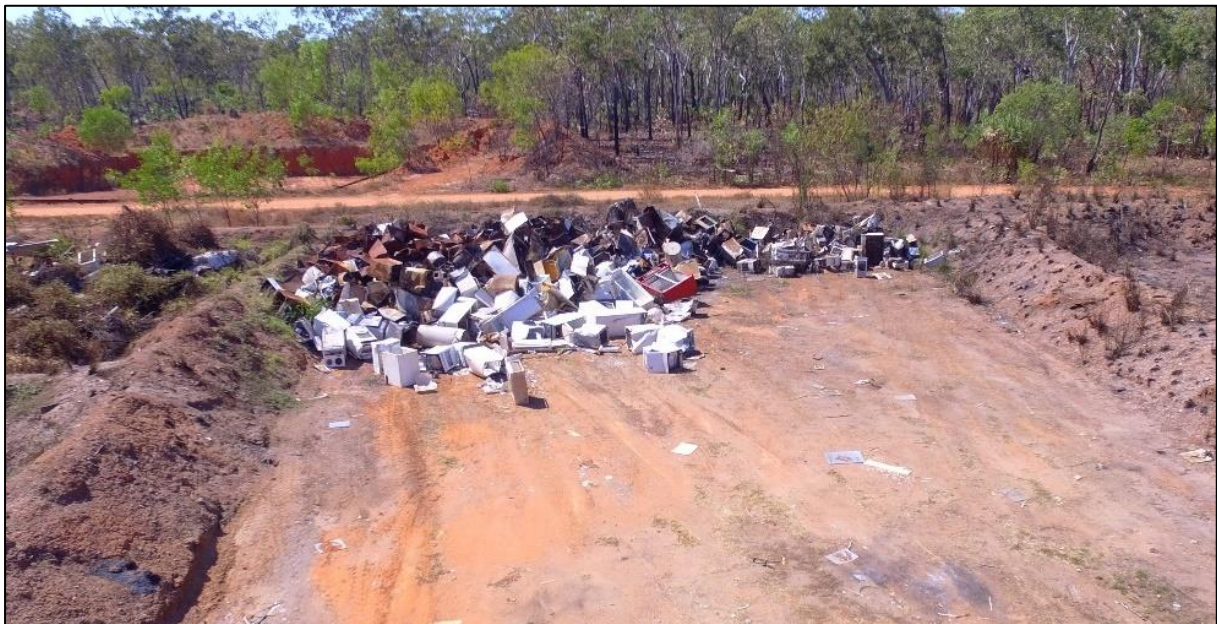
Figure 4.11 - Photo of whitegoods storage area (29/08/2019)

A whitegoods storage area is located between the battery and tyre collection areas. A contractor periodically visits the Facility to degas fridges and recover the refrigerants.

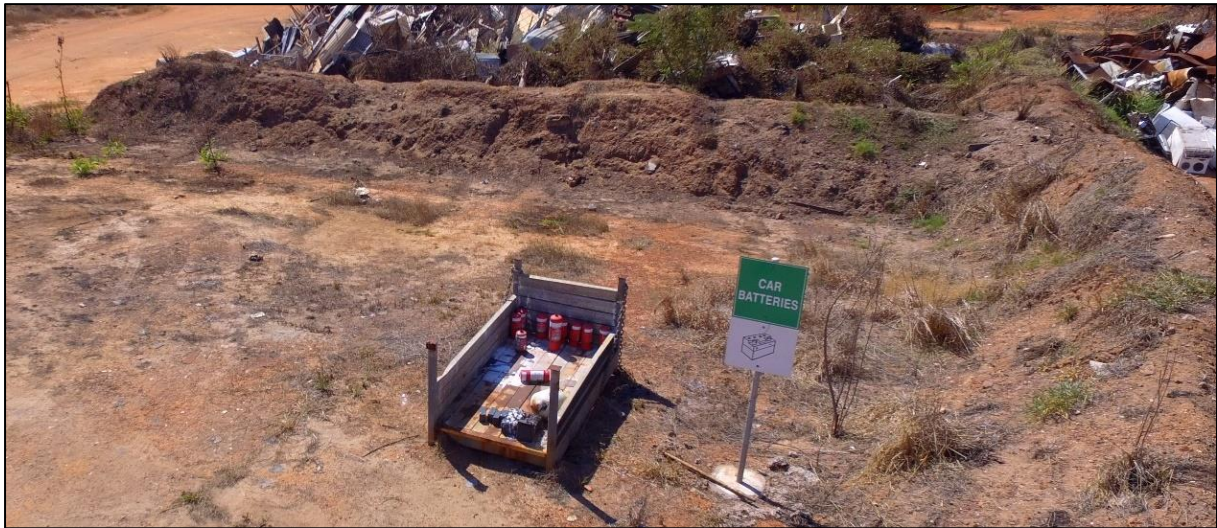
Figure 4.12 - Photo of battery collection area (29/08/2019)

The Facility currently has designated areas for the collection of listed wastes including tyres and vehicle batteries.

Council personnel collect these items on a regular basis and transfer them to the Council Depot for packing and storage prior to them being transported to appropriately licenced disposal facilities in Darwin.

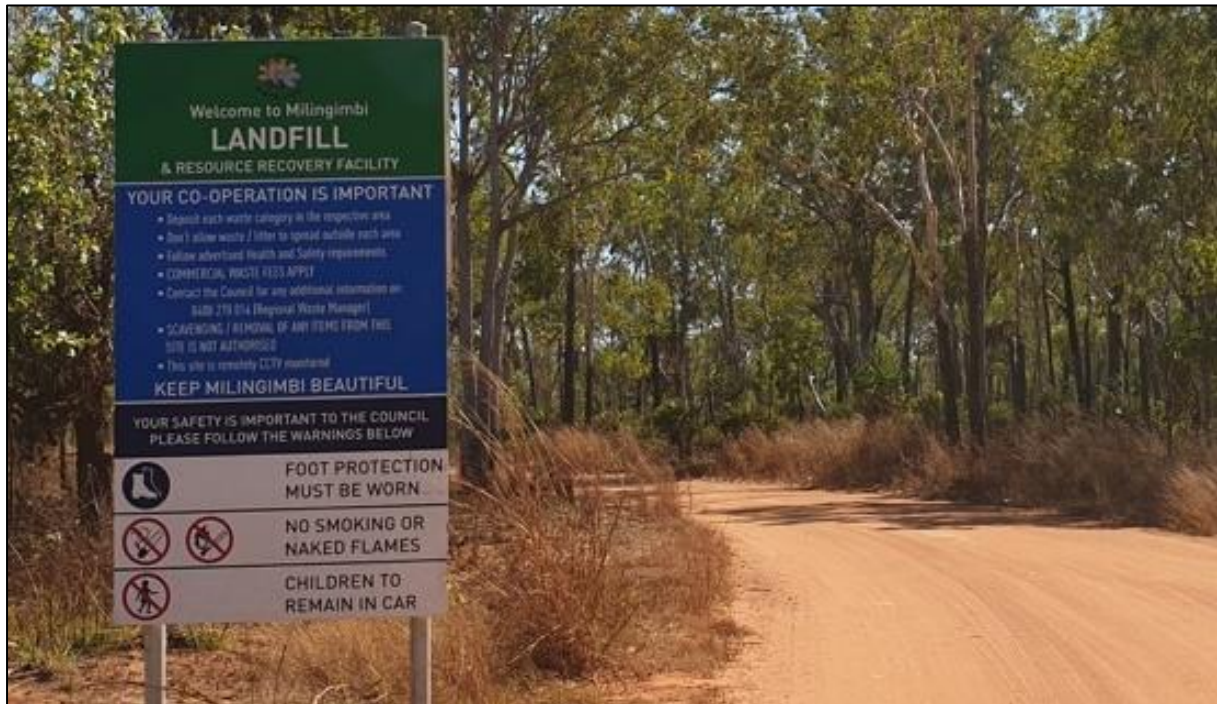
Figure 4.14 - Facility entrance sign

Infrastructure at the Facility is currently limited to the excavated waste disposal cells, unsealed site access roads, and limited entry and instructional signage.

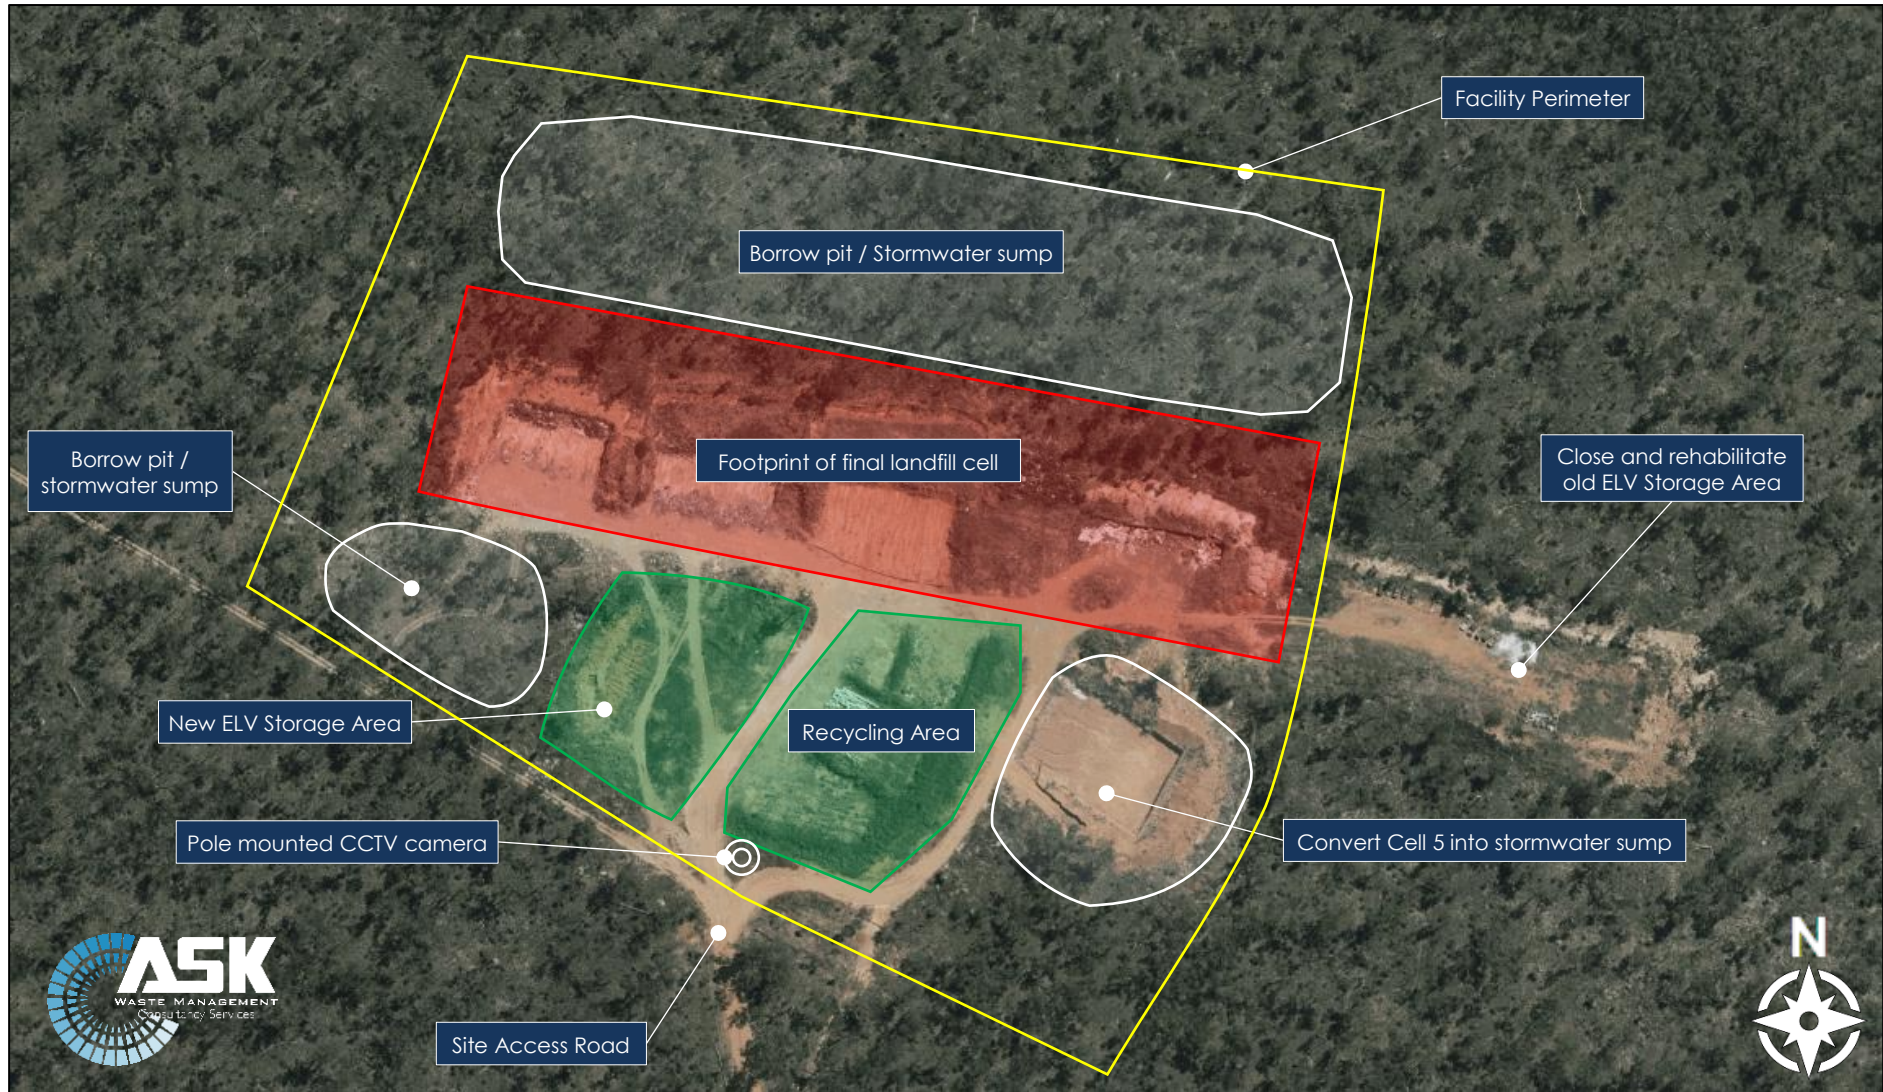
Figure 4.15 - Proposed Facility layout

The purpose of Stages 1, 2 and 3 is to ensure that all areas of the Facility containing buried waste are covered by above ground cells with capping that prevents water from entering the waste body and generating landfill leachate.

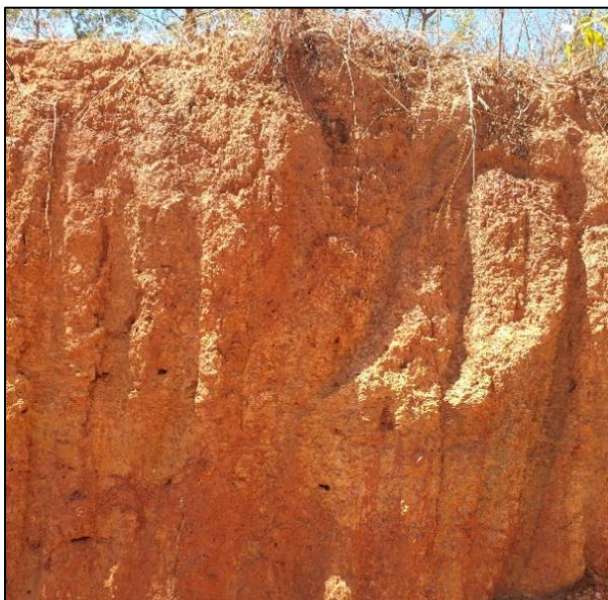
Figure 5.2 - Photo of lateritic soil profile typical at the site

Construction and lithology log charts for bore RN38234 which is located approximately 320 metres southwest from the Facility show the lateritic clay rich profile extending to depth of 7 metres, sitting atop a sandstone layer which extends to a depth of 16 metres, beneath which lies siltstone (**Figure 5.2**).

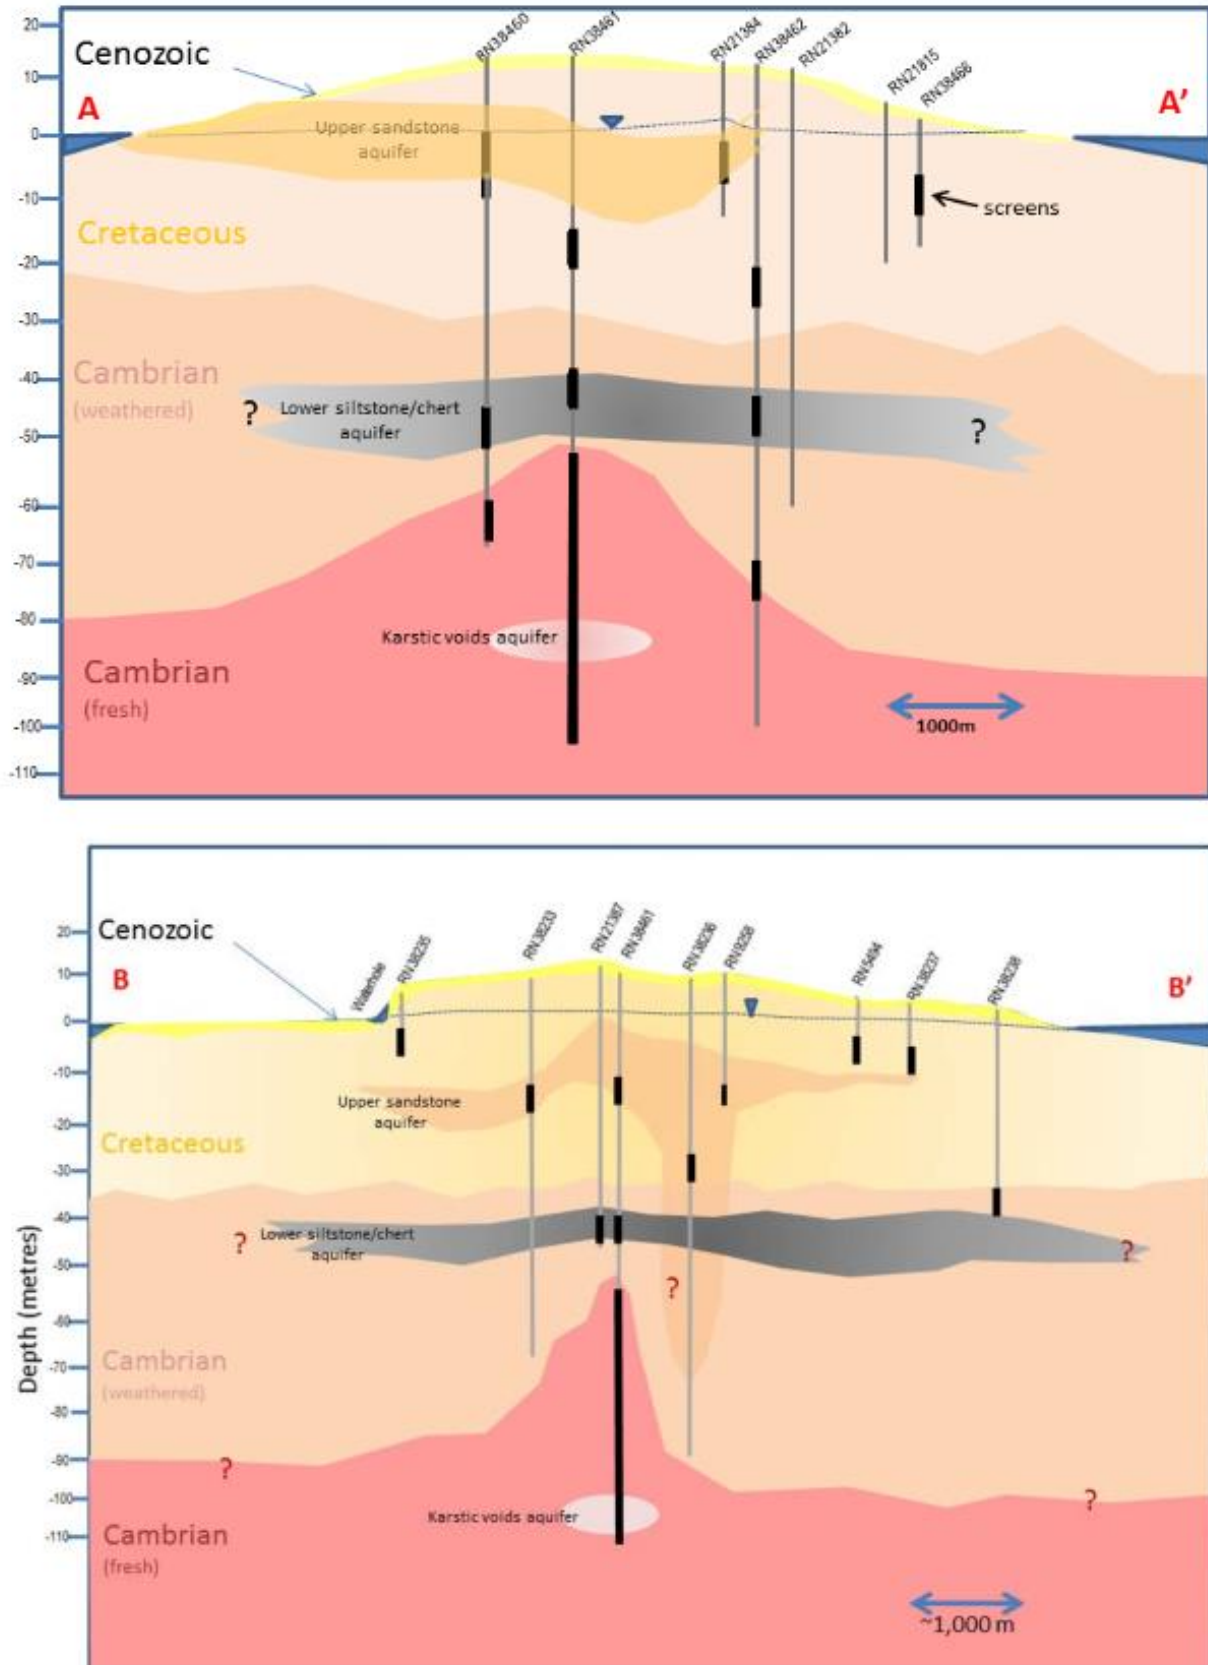
Figure 5.3 - Hydrogeological cross section of Milingimbi Island, (a) south to north, and (b) west to east (Batelaan et al, 2015)

The current conceptual hydrogeological model of Milingimbi Island (**Figure 5.3**) is largely based on the initial studies by Yin Foo (1982) and refined by Maria Woodgate (2014) following the provision of additional

- "an upper near-surface aquifer (sandy clay, clay, claystone and laterite, average thickness 10 m; too small and shallow to exploit)";
- "a first aquitard consisting of fine sand, sandstone, and clay (average thickness 10 m)";
- "a central aquifer consisting of sand, gravel and sandstone (current community water supply, average thickness 8 m)";
- "a second aquitard of clay and siltstone (average thickness 6 m)"; and
- "a deep aquifer of fractured siltstone, chert, and siltstone (average thickness 13 m)".

Batelann et al (2015) report that the areal extent of the central and deep aquifers is currently understood to be limited to the central portion of the island, and that the two underlying aquifers are recharged by infiltration of seasonal rainfall through the overlying shallow aquifer.

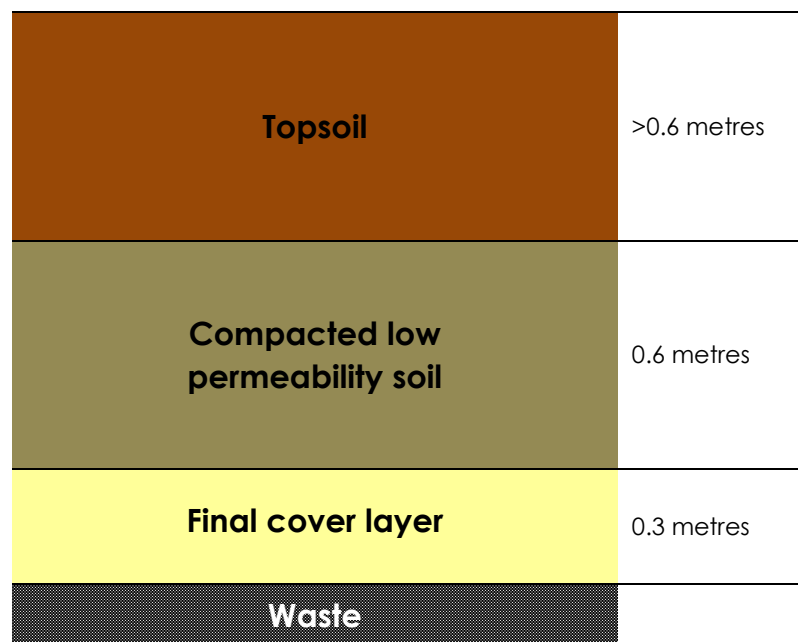
Figure 10.1- Proposed structure of the cap

The final landform is proposed to be developed in accordance with **Section 4.6.1** with gradients in the range of 11 to 14%. The capping design detailed in **Figure 10.1** would then be constructed over the waste.

The cap would comprise of the following layers:

- Topsoil layer. The surface layer should replicate the type and depth of topsoils found in the vicinity of the Facility and be capable of sustaining vegetation. It is recommended that this layer be at least 600mm thick.

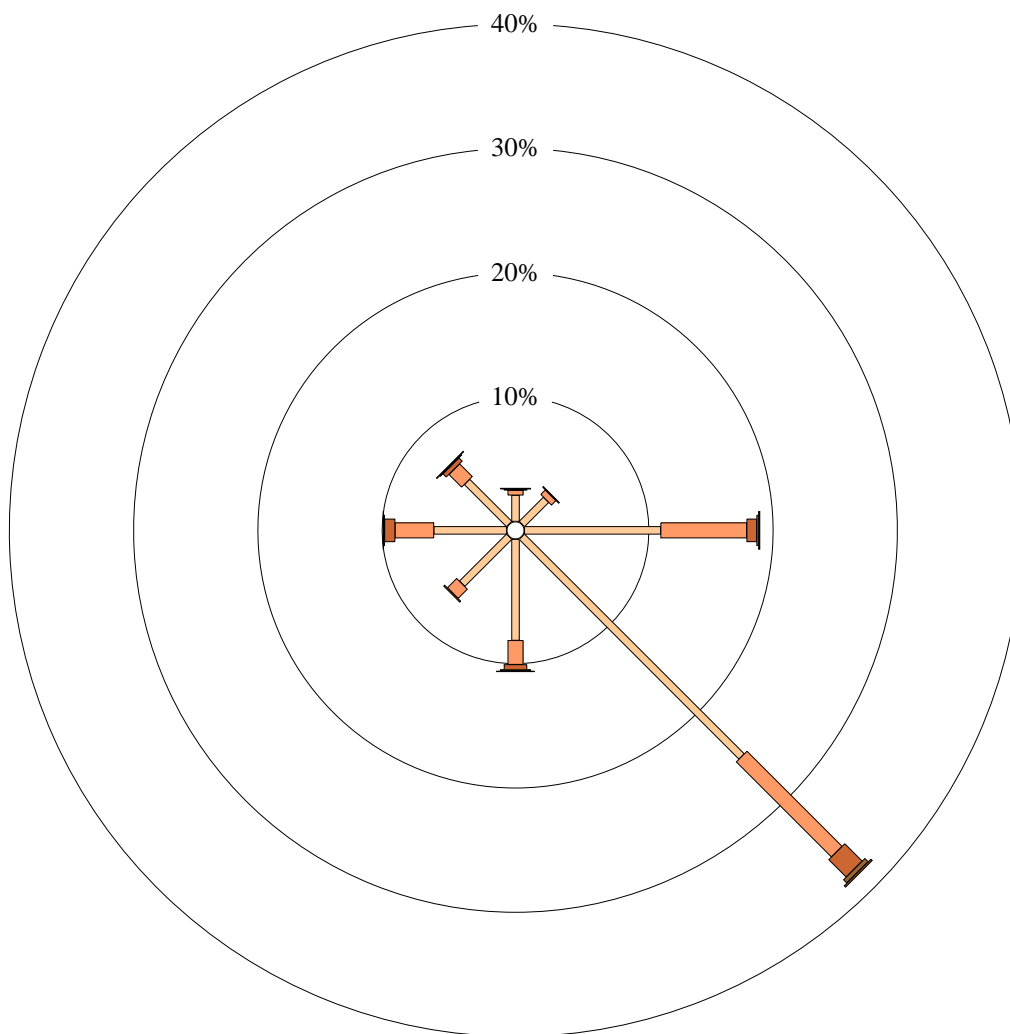
9 am
11829 Total Observations

Annual and monthly average wind Rose data for Milingimbi (Site 014402) is presented in Appendix A for 9am and 3pm conditions. The annual averages show that south easterly winds are predominant in the mornings with the wind swinging to the northeast in the afternoons.

Rose of Wind direction versus Wind speed in km/h (01 Jan 1962 to 28 Feb 2003)

The monthly average wind roses were reviewed by ASK and summarised in **Table 5.4** that shows the predominant wind direction for each month at 9am and 3pm. It can be seen that the Northern Dry season is dominated by easterly biased wind direction whereas the Northern Wet Season has a higher predominance of northerly and westerly wind conditions.
