# EPL297 Monitoring Report Darwin Crocodile Farm

*Reporting Period: 1 June 2022 – 31 May 2023*

Porosus Pty Ltd

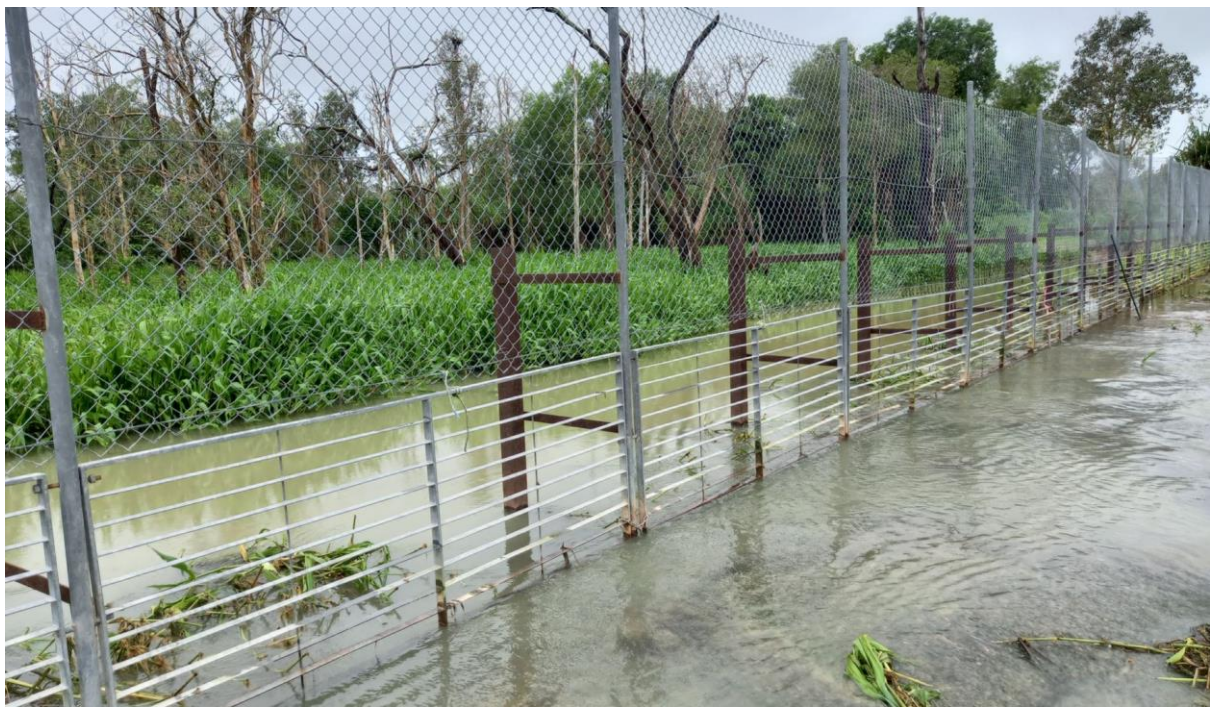
*Figure 1 - Spillway and boundary fence*

The spillway design is a 60m low cut section of the southern earthen embankment wall which has been covered in rough concrete to prevent scouring. The boundary chainmesh fence and steel gates (to facilitate water flow through the fence) transect the spillway surface.

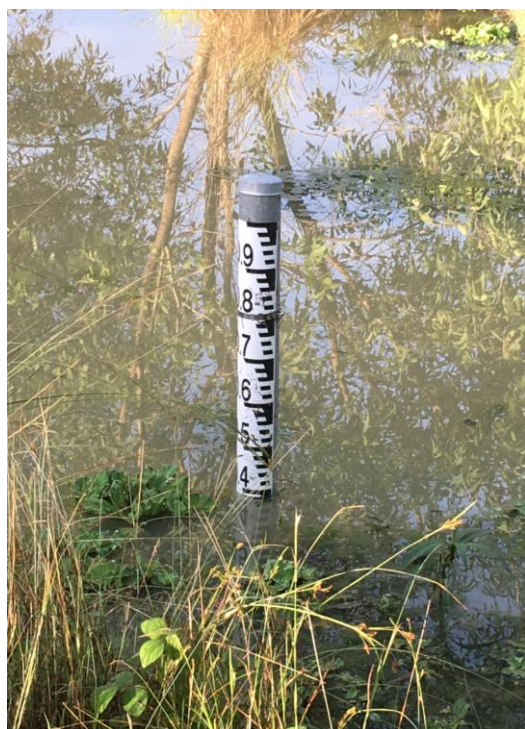
*Figure 3 – Main pond staff gauge*

A staff gauge was installed to the main pond in October 2020 when water levels were low. The gauge was installed on the northern side of the pond along the access road to the water supply bore located in the main pond. This location was chosen to permit ease of access for reading during the wet season by Porosus staff.

The nearby bore was utilised as a benchmark. Its local datum value at the time of installation was 1.542m. A water level logger was later installed on 30/12/2020 next to the staff gauge to collect continuous measurements of pond water level. After derivation of the rating, such logged data could then be used to calculate the annual volume of pond water discharging over the spillway.

Very few manual records were kept over the 2020-21 wet season of water levels in the pond. It is generally good practice to record manual reading of the staff gauge so such data can be used to validate the logged data, as well as act as a backup in case the pressure sensor fails.

The wetting and drying of the soil will cause the gauge to move over time. Depending on the amount of movement the water level will be in error to the rating and incorrect flows derived. The gauge should be surveyed at least once a year against the benchmark and adjusted if necessary, to ensure the rating table remains valid. The gauge was checked last on 29/4/21 and differed from installation by only 2mm.

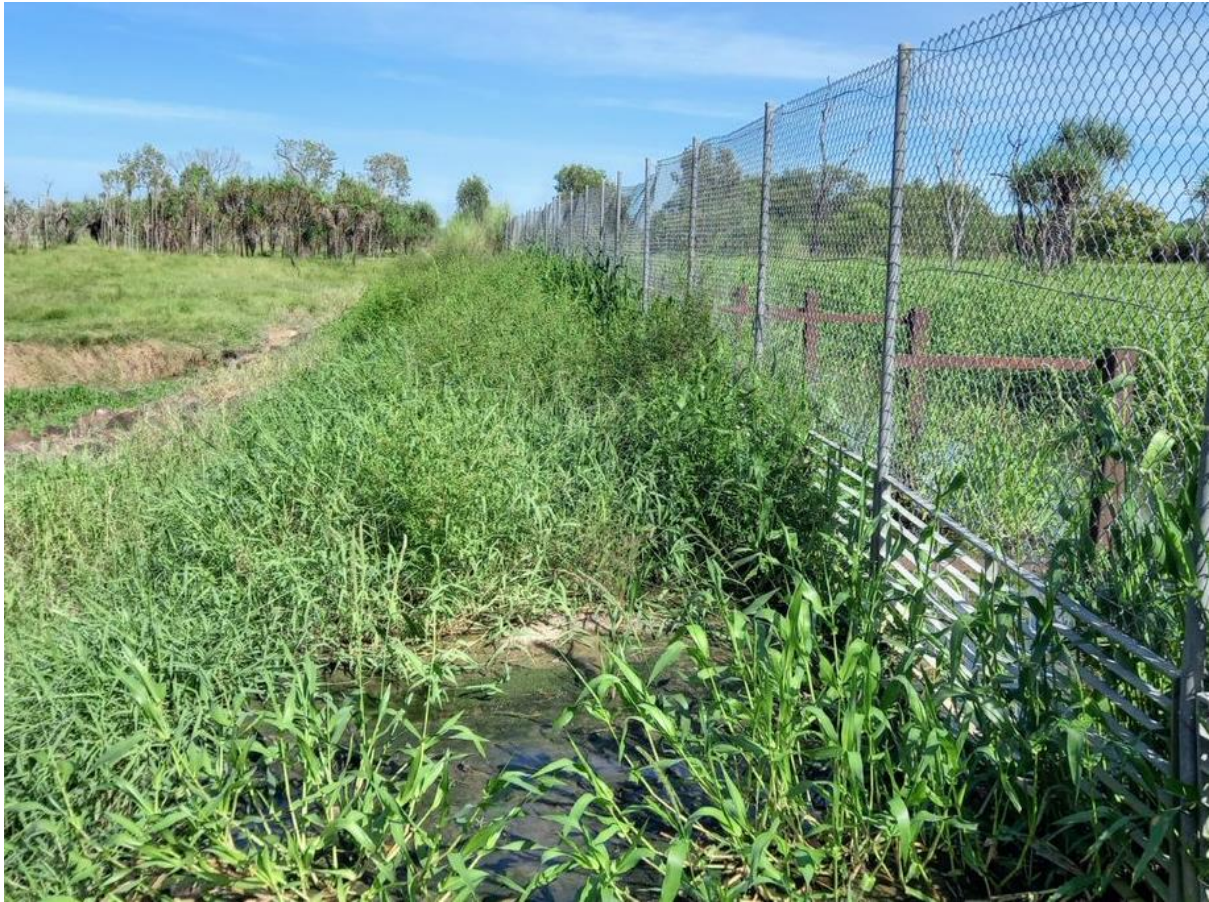
*Figure 5 - End of wet season vegetation growth along the spillway*

Whilst errors of only 5% have been specified for pond levels below 0.34m, this only holds true if the pond water level is unaffected by vegetation growth or debris. During site visits throughout the 2020-21 wet season it was regularly noted that the pond level was consistently higher than its true level by the damming effect of plant growth on the spillway.

Due to the large width of the spillway, a small increase in water level in the pond will result in a comparatively large increase in flow volume. It only takes a small amount of build-up on the fence line to inflate the pond water level. If such values are used directly against the rating table then the referenced flows have the potential to be over 100% in error of the true flow in the downstream gully.
