## SECTION 14 INCIDENT REPORT (*Waste Management and Pollution Control Act*)

| Person / Company: | Power and Water Corporation ( <b>PWC</b> ) |
| Incident: | Discharge of raw sewage from sewerage network (no gross pollutants) |

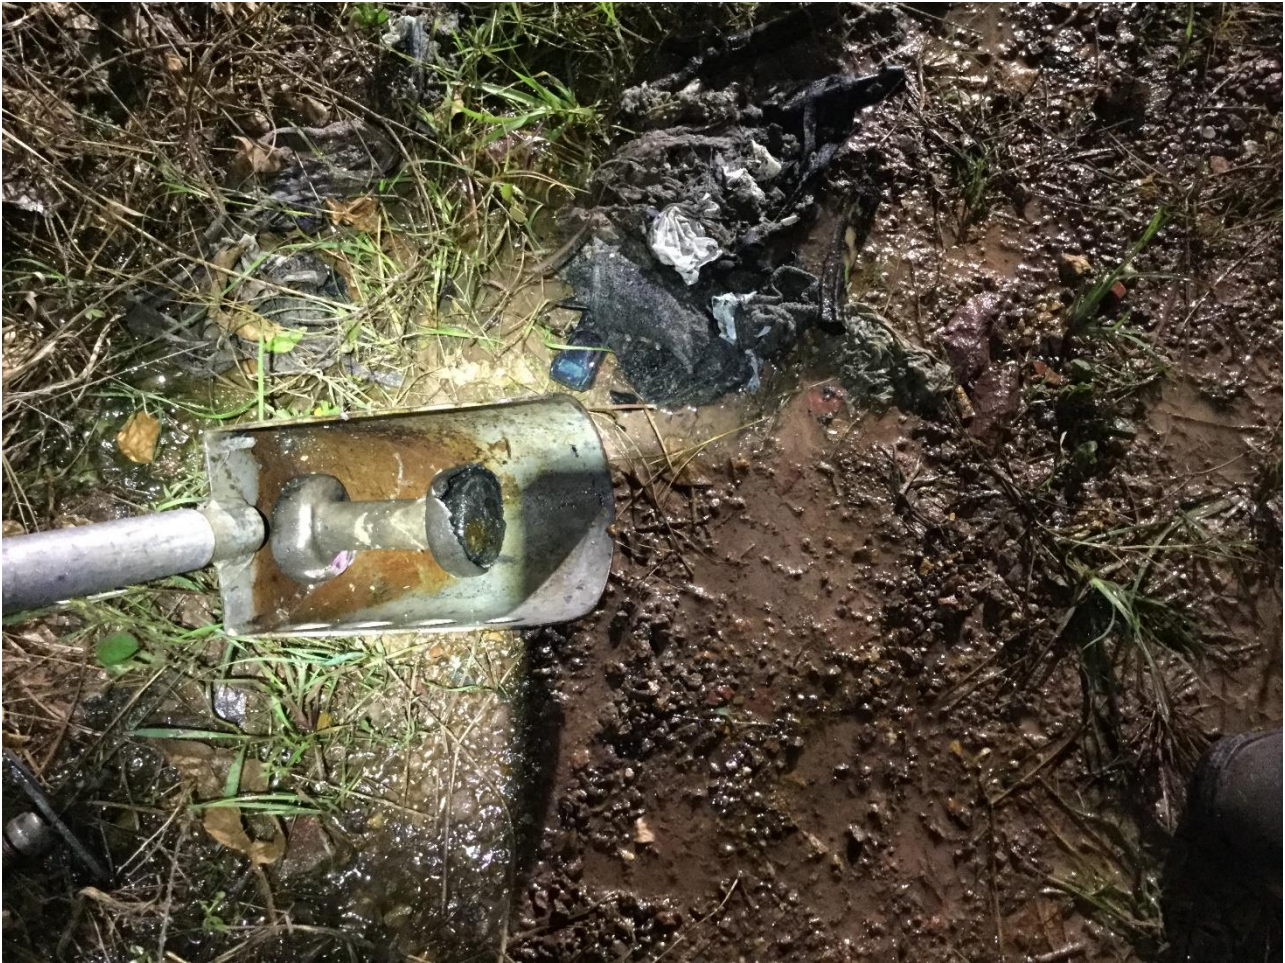
Appendix B – Photograph of some of the foreign matter found in the sewer network.

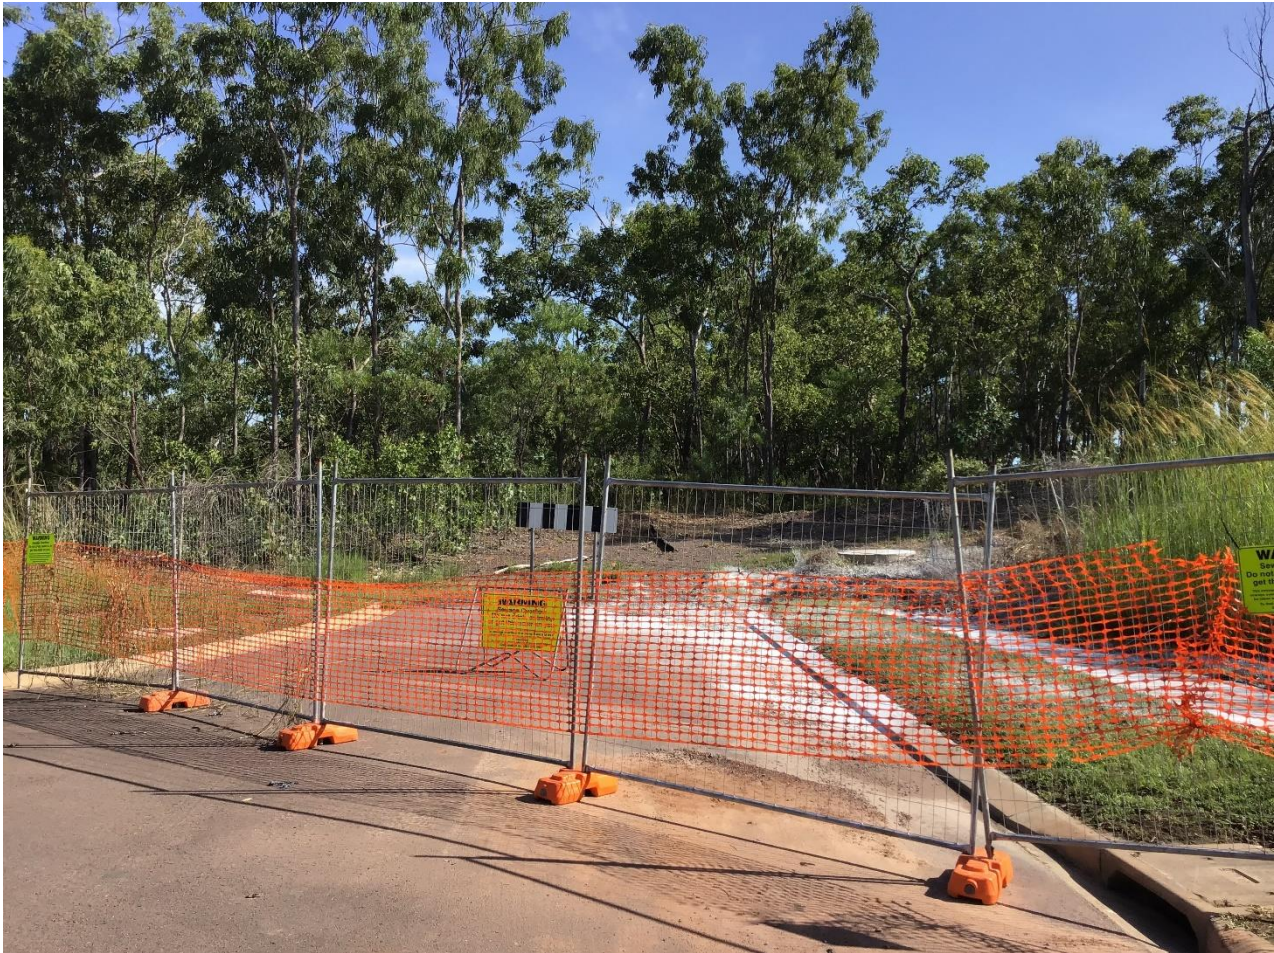
Appendix C – Photograph of barricading and signage

| <b>(e) the attempts made to prevent, reduce, control, rectify or clean up the pollution or resultant environmental harm caused or threatening to be caused by the incident</b> | <p><i>i. Confirmation signage and fencing has been erected, as appropriate.</i></p> <p>The site has had barricading and warning signage installed to alert residents, as per Sewage Spills/Overflow Response Work Instruction.</p> <p><i>ii. Decontamination of the site as appropriate.</i></p> <p>Clean up consistent with Sewage Spills/Overflow Response Work Instruction - Unsealed land (beaches, parks, open land and gardens) and public footpaths. Application of lime, installation of barrier fencing</p> |
