## SECTION 14 INCIDENT REPORT (*Waste Management and Pollution Control Act*)

| Incident: | Discharge of raw sewage from sewerage network (no gross pollutants) |

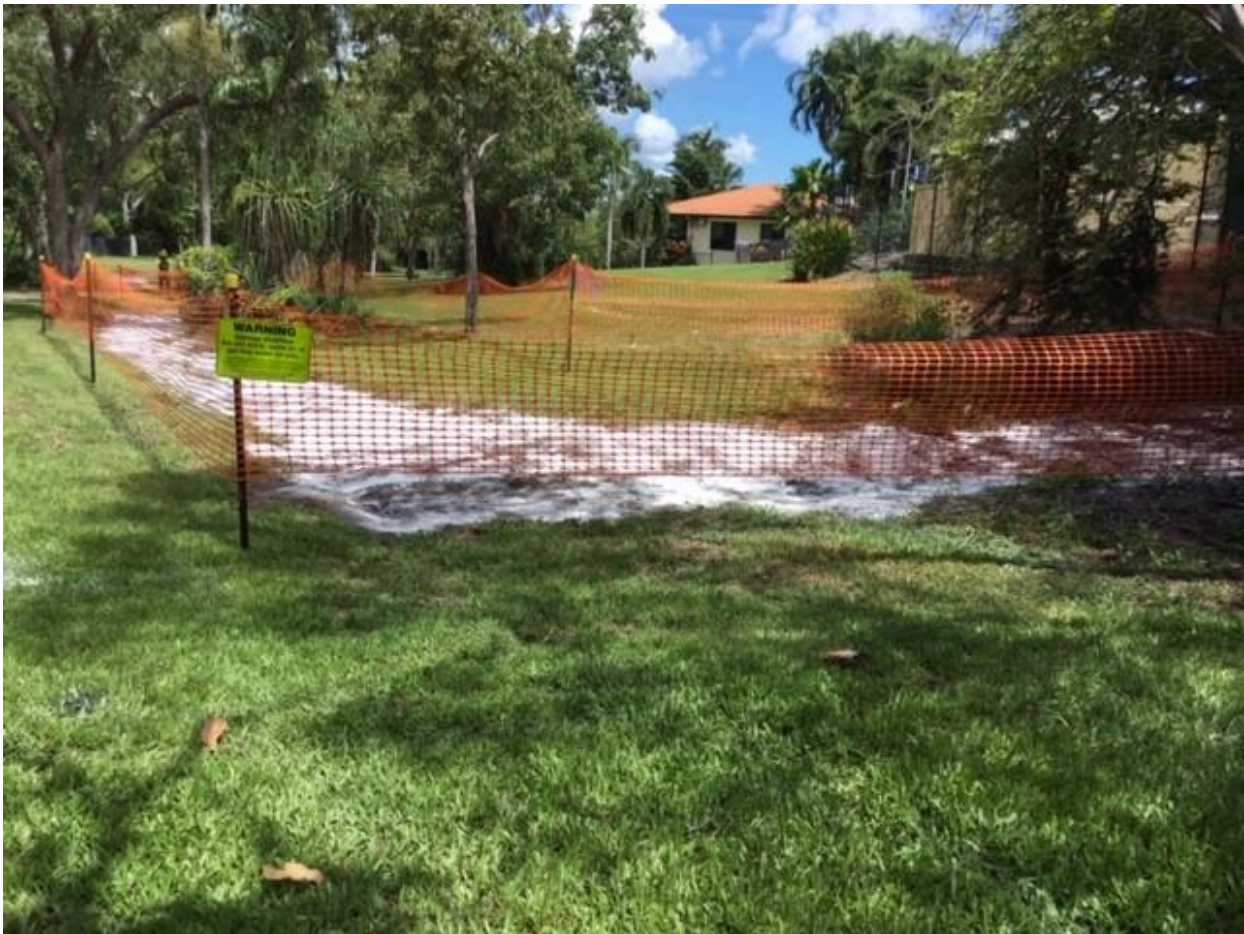
Appendix B – Photograph of spill location

| | <p><i>iii. Indicate any locations nearby to the discharge point where public can gain ready-access, such as public open spaces through which the discharge moves.</i></p> <p>Access to the public is possible, as the overflow occurred in parkland. The affected area has been disinfected and barricaded off with signage erected as per the PWC Sewage Spills/Overflow Response Work Instruction.</p> |
| <b>(c) the date and time of the incident</b> | <p><i>i. The time and date of commencement and cessation of the discharge.</i></p> <p>The commencement time of the overflow is unknown. The overflow was observed at approximately 08:00hrs by PWC staff on 10/04/2020 and the spill stopped by 08:30hrs 10/04/2020.</p> <p><i>ii. How PWC were notified, or became aware of the discharge.</i></p> <p>This overflow was reported by one of the residents to the PWC call centre, who then relayed the information to the on-call PWC operations staff. PWC personnel attended the site at 08:00hrs (10/04/20) and undertook action to resolve the situation and make it safe.</p> <p><i>iii. The process by which the discharge occurred.</i></p> <p>The cause of the spill was due to a blockage in the main line, as a result of fat build-up in the gas trap. Fat and other substances have been incorrectly disposed of into the sewer network by customers, resulting in the blockage and the overflow.</p> <p>The fats, oils, meat juices, other substances that are put down the sink or toilet have collected and built up, blocking the vacuum intake line. When fats, oils and meat juices are put down the sink it is usually as a liquid, but as it cools it can become more solid and cause build-up, resulting in bad odours and blockages in the sewerage system. This can lead to the sewage overflows into the environment, households and businesses.</p> <p>Public education about what can be disposed in sewer/is flushable: <a href="https://www.powerwater.com.au/about/what-we-do/wastewater/sewer-blockages-and-overflows/think-before-you-put-it-down-the-sink">https://www.powerwater.com.au/about/what-we-do/wastewater/sewer-blockages-and-overflows/think-before-you-put-it-down-the-sink</a></p> <p>In the aim of prevention this material is available on the PWC website and is used as an educational tool for customers. Additionally, PWC has recently been running an educational campaign on social media, print media and radio on the 3P's.</p> <p><i>iv. The reason why the discharge occurred.</i></p> <p>As per (c) iii. Sewerage network infrastructure has been designed to overflow with the best public health and environmental outcomes possible. Design focuses on not overflowing directly inside houses/businesses; rather discharge is designed to occur in a controlled manner at locations which can be accessed for infrastructure repair and clean up and with minimal public health or environmental impacts.</p> |

| <b>(e) the attempts made to prevent, reduce, control, rectify or clean up the pollution or resultant environmental harm caused</b> | <p><i>i. Confirmation signage and fencing has been erected, as appropriate.</i></p> <p>The site has had barricading and warning signage installed to alert the residents and any visitors, as per Sewage Spills/Overflow Response Work Instruction.</p> |

| <b>or threatening to be caused by the incident</b> | <p><i>ii. Decontamination of the site as appropriate.</i></p> <p>Clean up consistent with Sewage Spills/Overflow Response Work Instruction - Unsealed land (beaches, parks, open land and gardens) and public footpaths. Application of lime, installation of barrier fencing around any contaminated area (leave in place for 5 days post clean up), installation of advisory signage and then application of 50mm imported topsoil.</p> |
