## SECTION 14 INCIDENT REPORT (*Waste Management and Pollution Control Act*)

| <b>Incident:</b> | Spillage of bulk zinc-lead concentrate on the Carpentaria Highway roadside. The source of the spill is likely to have been from a road train travelling from the McArthur River Mine (the Mine) to the Bing Bong Loading Facility (BBLF). |

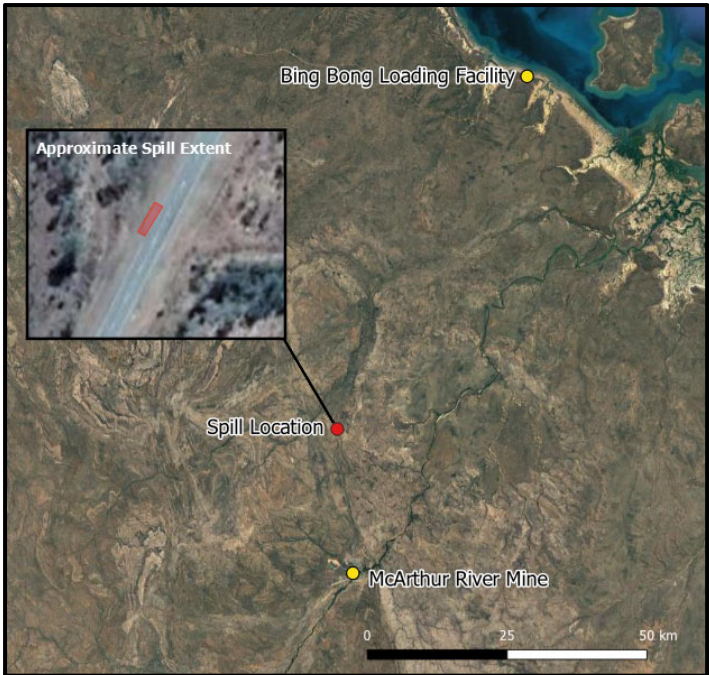
| <b>(b) the place where the incident occurred</b> | <p>The spill occurred on the Carpentaria Highway roadside between the Mine and the BBLF (Figure 1).</p> <p>The Global Positioning System (GPS) point for the spill location is:<br/>MGA Zone 53 (GDA94)<br/>Easting 631,542; Northing 8,218,585.</p> <p><i>Figure 1 – Spill Location</i></p> |

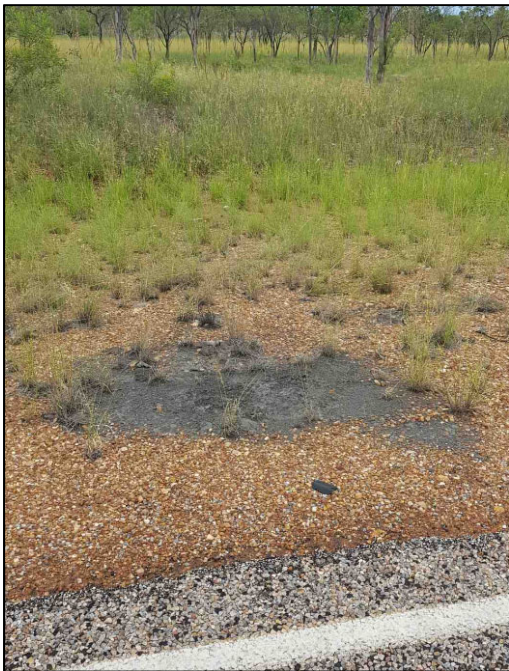
| <p><b>(d) how the pollution has occurred, is occurring or may occur</b></p> | <p>At 17:30 on 4 March 2020, MRM received communication from a local employee that a potential zinc-lead concentrate spill had occurred. The employee had identified and photographed the incident on 18 February 2020.</p> <p>On 5 March 2020, MRM Environment staff carried out an inspection of the spill area to determine the environmental risk and potential for pollution. A small mound of material with the appearance of concentrate was observed on the western side of the highway. No evidence of concentrate was observed on the bitumen.</p> <p>It was noted prior to the inspection that a total of 300 millimetres of rainfall was recorded in the Borroloola region by the Bureau of Meteorology (BOM) from 18 February 2020 (when the spill was photographed) to 4 March 2020 (when the spill was reported). Based on the photograph and initial inspection, it is estimated that a total of 15kg of concentrate could have been released initially.</p> <p>Due to the potential for the lead-zinc concentrate to have washed into the surrounding environment, the area surrounding the stockpile was also inspected; however no signs of lead-zinc concentrate were identified. No potential sensitive receptors or flow pathways to other areas were identified at the time of the inspection (Figure 2).</p> <div data-bbox="692 1258 1203 1926"> </div> <p><i>Figure 2 – Concentrate spill site prior to clean-up.</i></p> |

| <p><b>(e) the attempts made to prevent, reduce, control, rectify or clean up the pollution or resultant environmental harm caused or threatening to be caused by the incident</b></p> | <p>At 6:00 on 6 March 2020, an excavator was deployed to clean-up contaminated material from the roadside. The remediation involved scraping and removal of all impacted material which was then transported back to the mine for permanent disposal. The remediated area was back-filled with clean material to restore the road to its original surface (Figure 3).</p> <p><i>Figure 3 – Concentrate spill site post clean-up activities.</i></p> <p>Following completion of the remedial works on 6 February 2020, MRM Environment staff reinspected the remediated area and visually confirmed that the extent of the concentrate spill had been removed.</p> |

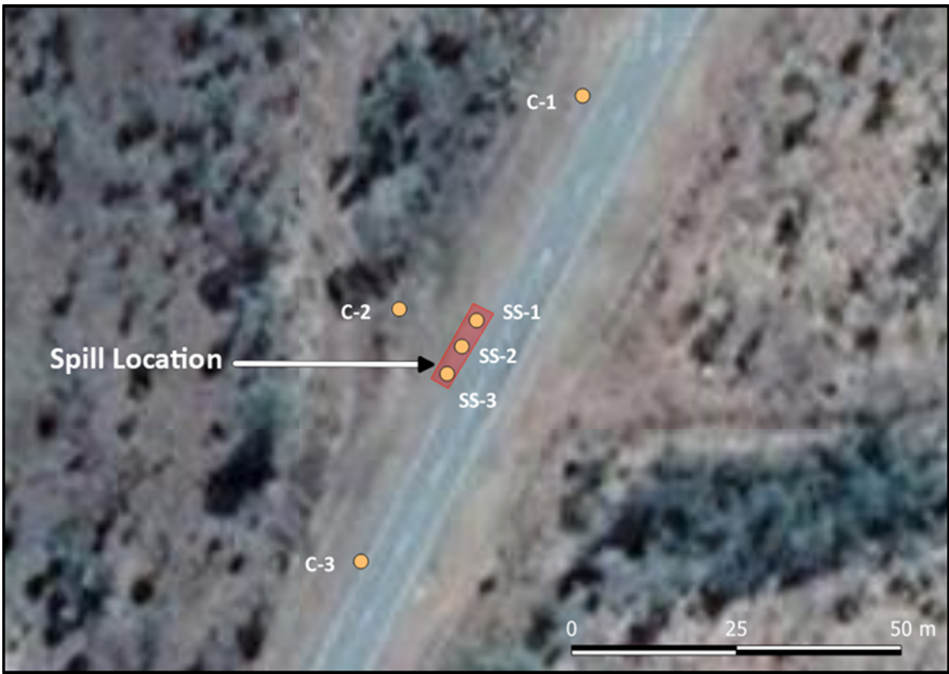
| | <p><b>Validation Assessment</b></p> <p>MRM have undertaken validation sampling of the potentially impacted area in accordance with Schedule B2 of the National Environment Protection (Assessment of Site Contamination) Measure 1999 (NEPM, 1999).</p> <p>The following soil samples were collected (Figure 4):</p> <ul style="list-style-type: none"> <li>○ Three impact sites (SS-1, SS-2 and SS-3);</li> <li>○ Three control sites (C-1, C-2 and C-3).</li> </ul> <p>All samples will be analysed for relevant contaminants of potential concern (i.e. zinc and lead) at a NATA accredited laboratory and results will be compared against relevant NEPM (1999) guidelines to confirm whether remediation works have been successful. Impact site samples will also be compared with control samples.</p> <p><i>Figure 4 – Validation sample locations.</i></p> |
