## SECTION 14 INCIDENT REPORT (*Waste Management and Pollution Control Act*)

| <b>Person / Company:</b> | Power and Water Corporation ( <b>PWC</b> ) |
| <b>Incident:</b> | Discharge of raw and highly diluted sewage from sewerage network, Sewage Pumping Station, (no gross pollutants) |

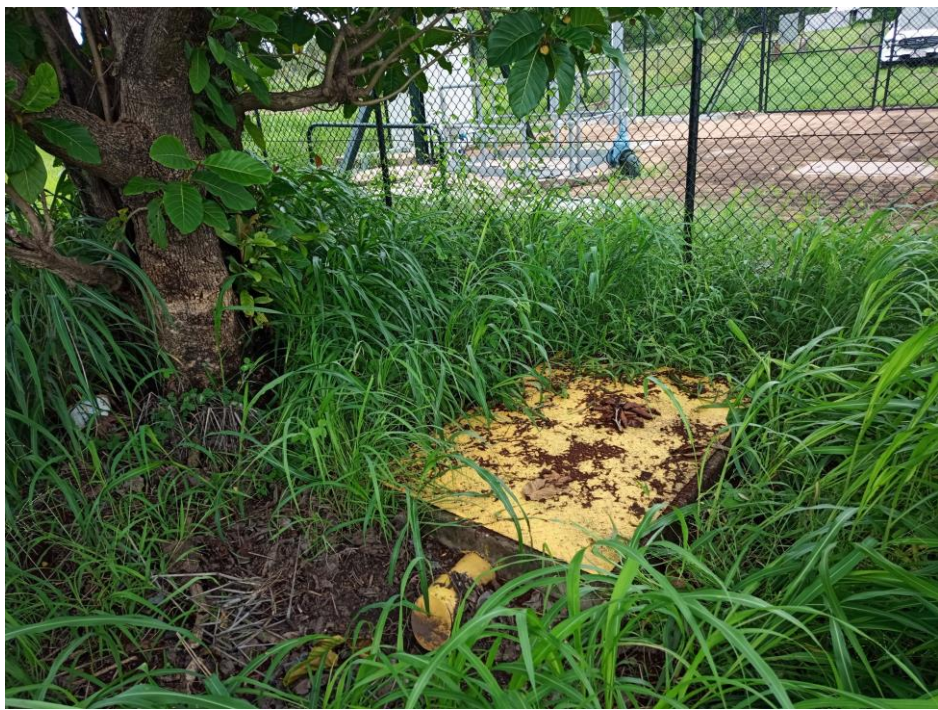
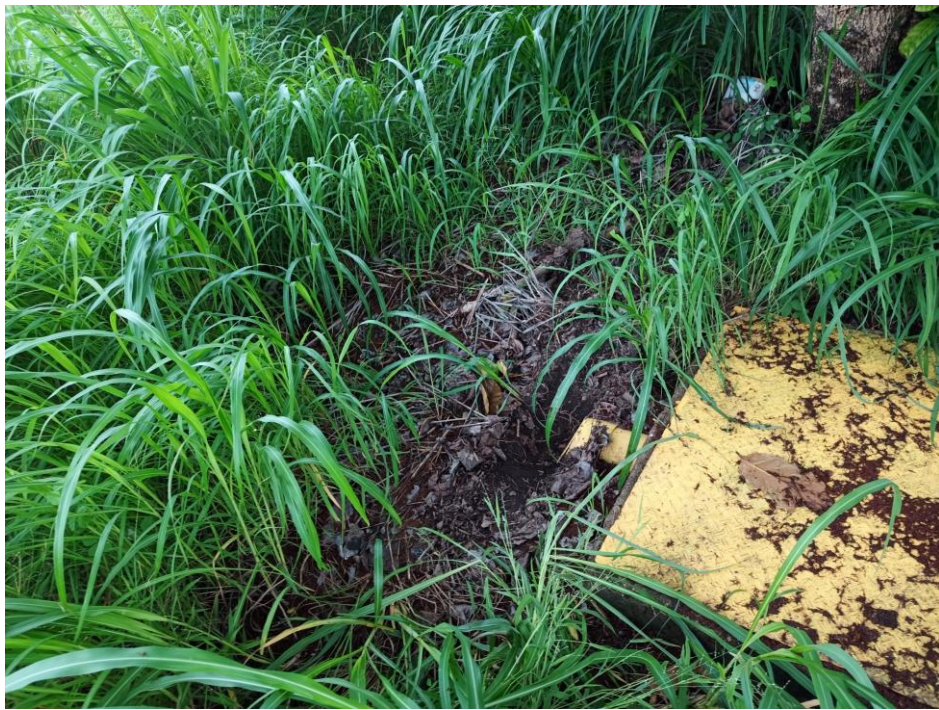
Appendix B – Photographs of the discharge location, evidencing no gross pollutants

| | <p><i>iii. Indicate any locations nearby to the discharge point where public can gain ready-access, such as public open spaces through which the discharge moves.</i></p> <p>Access to the public is possible but unlikely, as the discharge point is behind a pedestrian fence. Due to weather conditions likelihood of people visiting this area is low. Signs were erected deterring access by the public.</p> |

| <b>(e) the attempts made to prevent, reduce, control, rectify or clean up the pollution or resultant environmental harm caused or threatening to be caused by the incident</b> | <p><i>i. Confirmation signage and fencing has been erected, as appropriate.</i><br/>Signage was erected in this instance; no additional fencing was erected, as the spill occurred behind a fence.</p> <p><i>ii. Decontamination of the site as appropriate.</i><br/>Clean up consistent with Sewage Spills/Overflow Response Work Instruction as appropriate to the location, and to minimise risk to the Environment. Site was inspected for any gross pollutants of which none were observed.</p> |
