## SECTION 14 INCIDENT REPORT (*Waste Management and Pollution Control Act*)

| <b>Incident:</b> | Discharge of raw sewage from sewerage network (manhole) |

| <b>(b) the place where the incident occurred</b> | <p>67 Wellington Parade, Alawa – Manhole</p> <p><i>i. Description of the PWC asset from which the discharge occurred.</i></p> <p>Manhole located at 67 Wellington Parade, Alawa – as per map below.</p> <p><i>ii. GPS coordinates of the discharge point from the PWC asset, and the final coordinates of the final discharge point.</i></p> <p>Discharge Point: 130.8735665, -12.3770594<br/>Final Discharge Point: 130.8735665, -12.3770594</p> <p><i>iii. Indicate any locations nearby to the discharge point where public can gain ready-access, such as public open spaces through which the discharge moves.</i></p> <p>Public access is generally available to the overflow site, however upon clean-up of the area fencing and signage has been installed to prevent access. The land was checked for gross pollutants of which none were visible, due to the manhole lid trapping them within the sewer system. Clean up was undertaken as per Sewage Spills/Overflow Response Work Instruction.</p> |

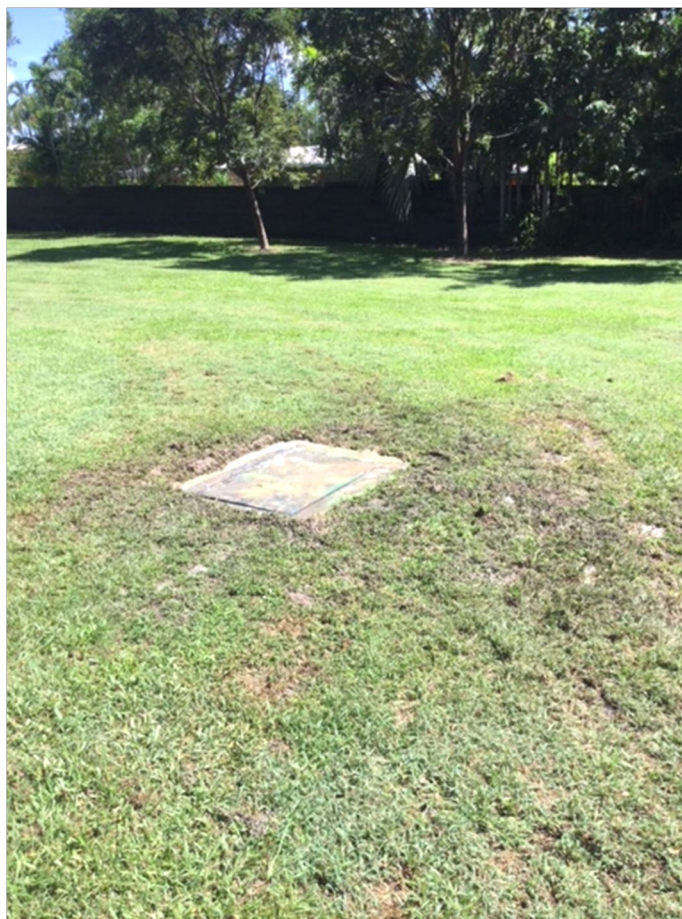
Photo 1 – Prior to Clean-up

| | <p>Discharge of raw sewage to land directly beside the manhole was associated with a fat build-up, blocking the sewer line, resulting in the overflow from the nearby manhole. Fat and other substances have been incorrectly disposed into the sewer network by customers resulting in a blockage.</p> |

| <b>(e) the attempts made to prevent, reduce, control, rectify or clean up the pollution or resultant environmental harm caused or threatening to be caused by the incident</b> | <p>The fat build up was cleared and the overflow was stopped. Clean up undertaken as per Sewage Spills/Overflow Response Work Instruction.</p> <p><i>i. Confirmation signage and fencing has been erected, as appropriate.</i></p> <p>Upon arrival to site by PWC officer and completion of clean-up of the area, fencing and signage has been installed to prevent access by the public.</p> <p><i>ii. Decontamination of the site as appropriate.</i></p> <p>Clean up consistent with Sewage Spills/Overflow Response Work Instruction as appropriate to the location, and to minimise risk to the environment.</p> <p>Vacuum truck was used to remove the wastewater from the manhole and surrounds, followed by cleaning of the surrounding surface. Area was observed for gross pollutants of which none were detected. The manhole lid appeared to have trapped these only allowing liquid to overflow. The area was then limed and fencing and warning signage installed.</p> <p>Public education about what can be disposed in sewer/is flushable:<br/> <a href="https://www.powerwater.com.au/_data/assets/pdf_file/0003/91578/Think_before_you_put_it_down_the_sink.pdf">https://www.powerwater.com.au/_data/assets/pdf_file/0003/91578/Think_before_you_put_it_down_the_sink.pdf</a><br/> In the aim of prevention this material is available on the PWC website and is used as an educational tool for customers.</p> |
