## SECTION 14 INCIDENT REPORT (*Waste Management and Pollution Control Act*)

<b>Date and Time of Notification:</b>	EPA was notified via phone call to the Pollution Hotline on 6 <sup>th</sup> October 2021, 1:30pm.
<b>Person / Company:</b>	GEMCO Mining Pty Ltd.
<b>Incident:</b>	While loading a ship with manganese, some manganese fines have spilled from GEMCO's conveyor system into the ocean, resulting in a dark plume which has spread to the north of the harbor with the tide.  Refer Figure 2.
<b>(a) the incident causing or threatening to cause pollution</b>	Manganese spill into ocean (GEMCO port/harbor), resulting from a build-up of manganese fines below the conveyor system (Figure 2 and Figure 3).
<b>(b) the place where the incident occurred</b>	GEMCO Port - Ship Loading Facility. See Figure 1 below.  Spillage Location: E649387.7; N8442081.5.
<b>(c) the date and time of the incident</b>	The incident occurred on Sunday 3 <sup>rd</sup> of October, at approximately 1pm. The incident was reported internally via Global 360 – EVT #49513. GEMCO's environment department was first made aware of the incident the 6 <sup>th</sup> October.

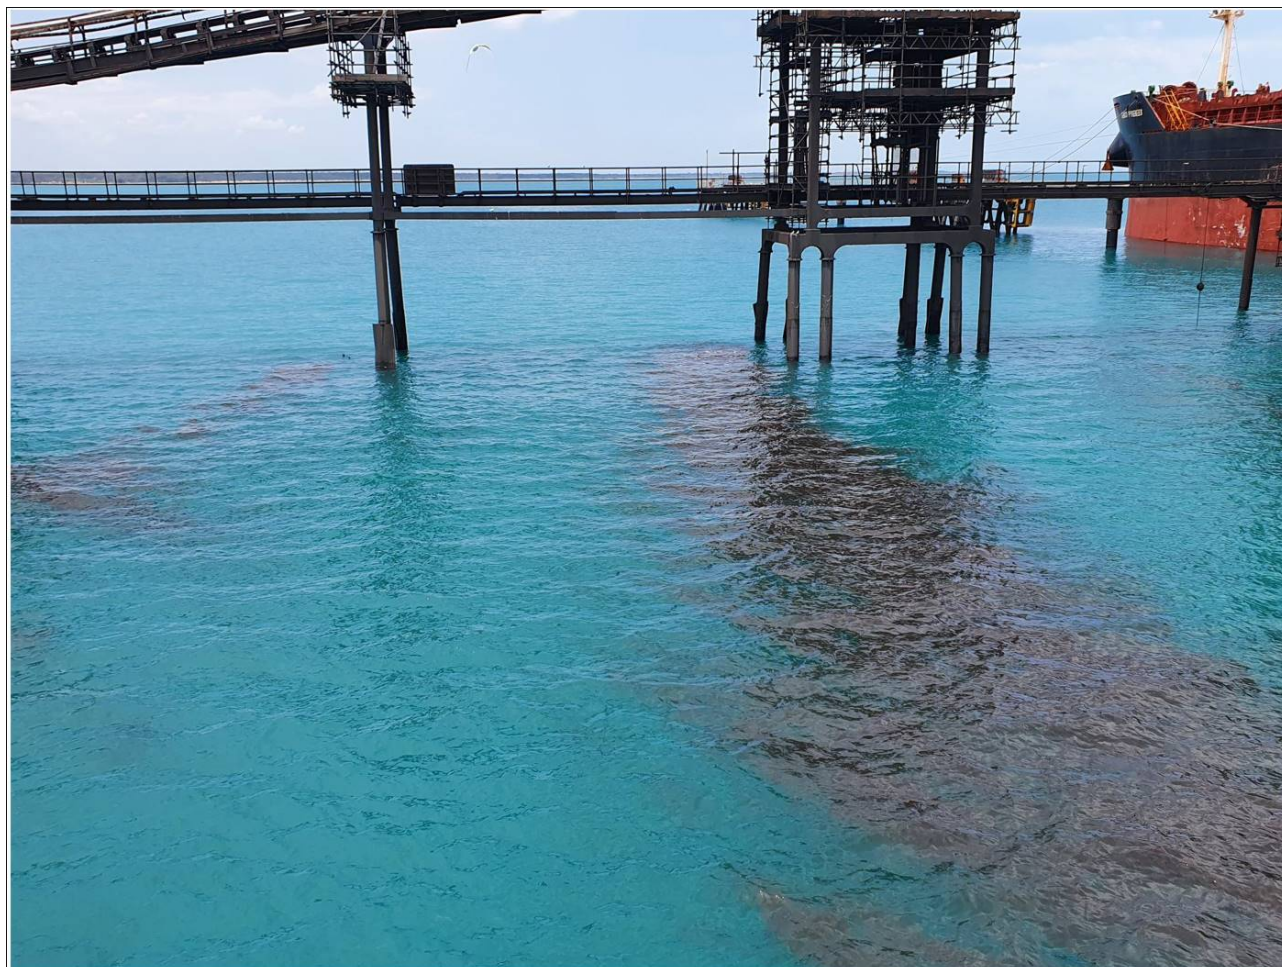
<b>(d) how the pollution has occurred, is occurring or may occur</b>	While loading a ship with manganese, product has spilled from below GEMCO's conveyor system into the ocean, resulting in a dark plume which has spread to the north of the harbor with the tide. The spill resulted from a build-up of manganese fines below the conveyor system (Figure 2 and Figure 3).
<b>(e) the attempts made to prevent, reduce, control, rectify or clean up the pollution or resultant environmental harm caused or threatening to be caused by the incident</b>	Port team stopped ship loading activities and cleaned up a build-up of material that was causing the spillage from under the conveyor.  While the aesthetics of Milner Bay may be temporarily impacted, it is anticipated that there will be no ongoing environmental impact from this release.
<b>(f) the identity of the person notifying the NT EPA</b>	David Gregory (Environment Specialist)

**Figure 2:** Manganese spillage and plume inside GEMCO's harbor facility (SPL382) – Photo taken 3rd October 2021.

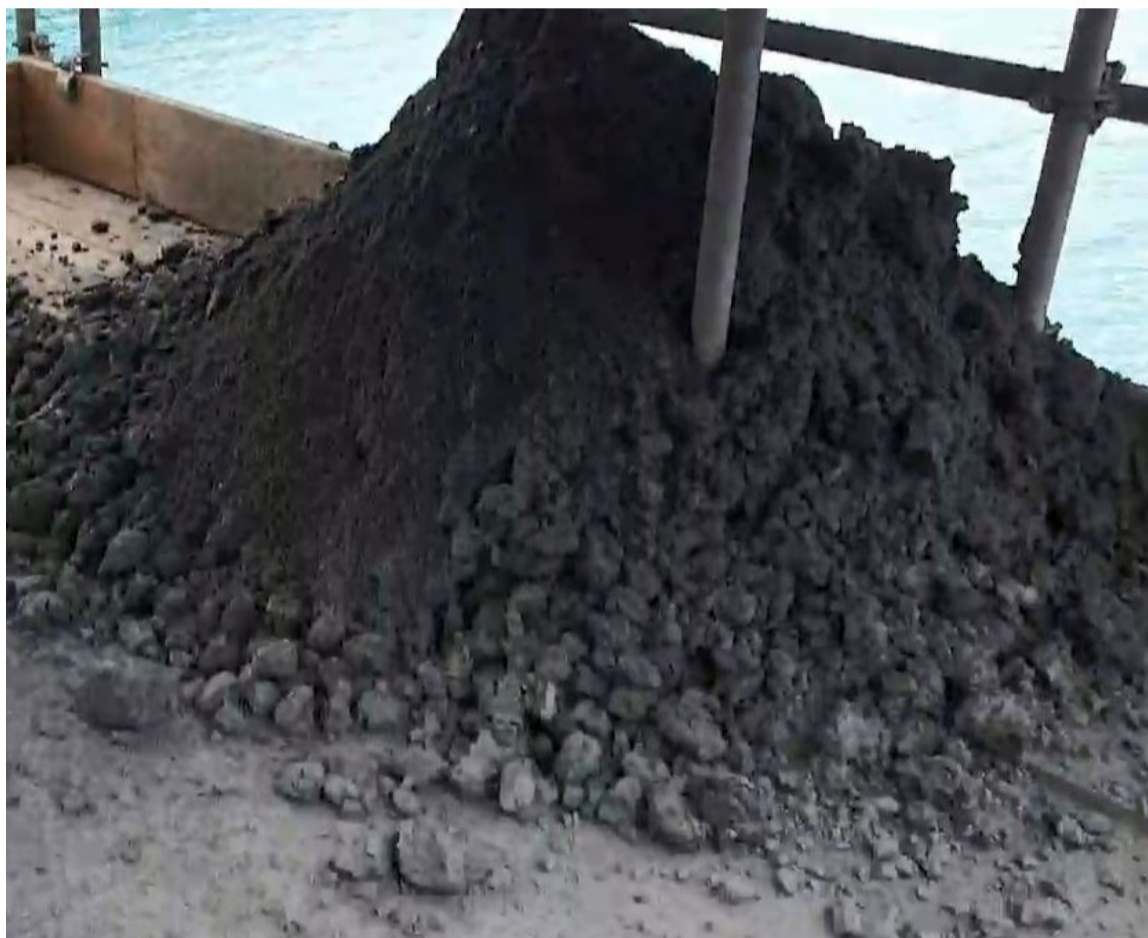
**Figure 3:** Build-up of material (manganese fines) on scaffold, located below the conveyor system. Some of the material has breached the walls of the scaffold and entered the ocean.
