## SECTION 14 INCIDENT REPORT (*Waste Management and Pollution Control Act*)

| <b>Person / Company:</b> | GEMCO Mining Pty Ltd. |
| <b>(a) the incident causing or threatening to cause pollution</b> | Sediment-laden runoff from the construction area into two ephemeral branches of the Emerald River. |

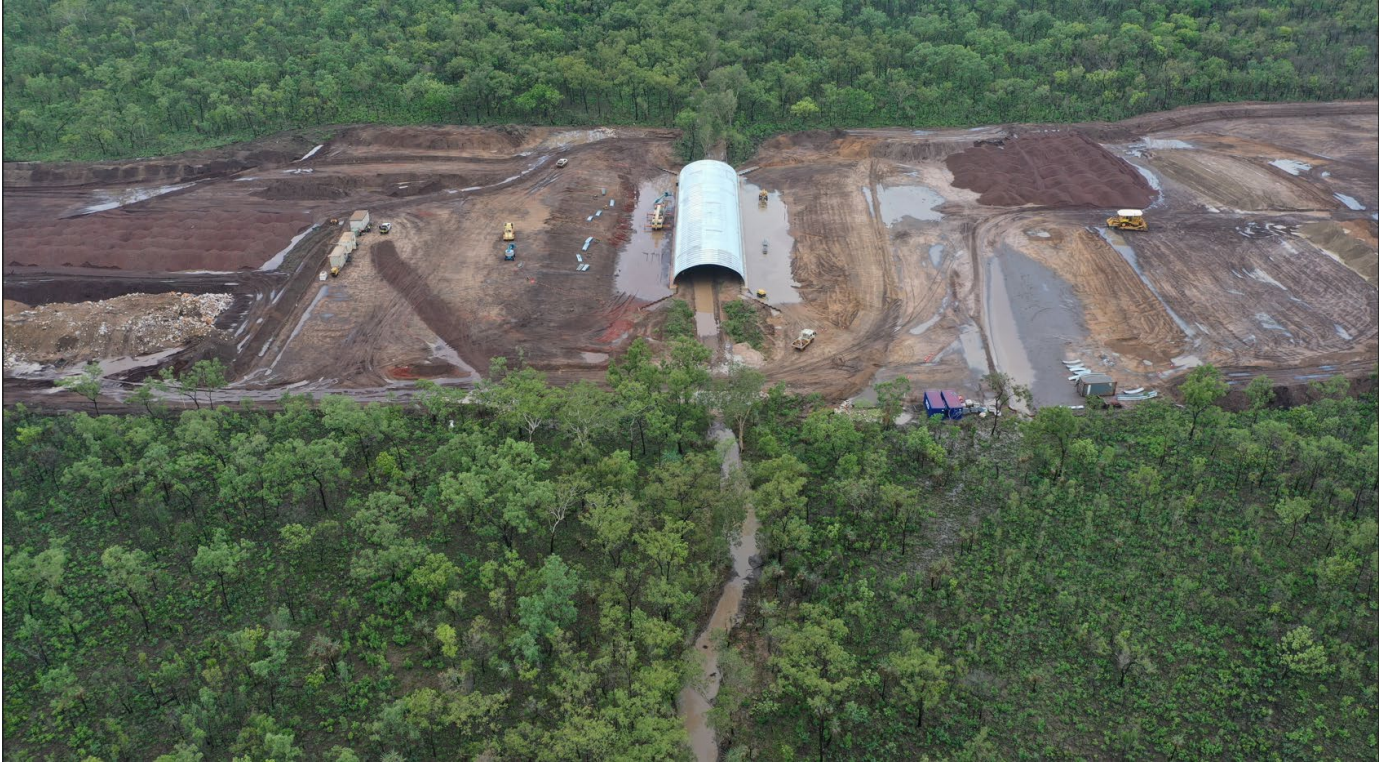
**Figure 2:** Sediment event in Emerald River main channel. 14 November 2022. Photograph taken facing east (upstream) across the access authority.

| <b>Incident:</b> | The Eastern Leases Project Area experienced rain events on Saturday the 12 <sup>th</sup> , Monday the 14 <sup>th</sup> and Tuesday the 15 <sup>th</sup> of November. This resulted in water with contained sediments running into the tributary of the Emerald River and the main Emerald River channel (Refer figure 1-3). |

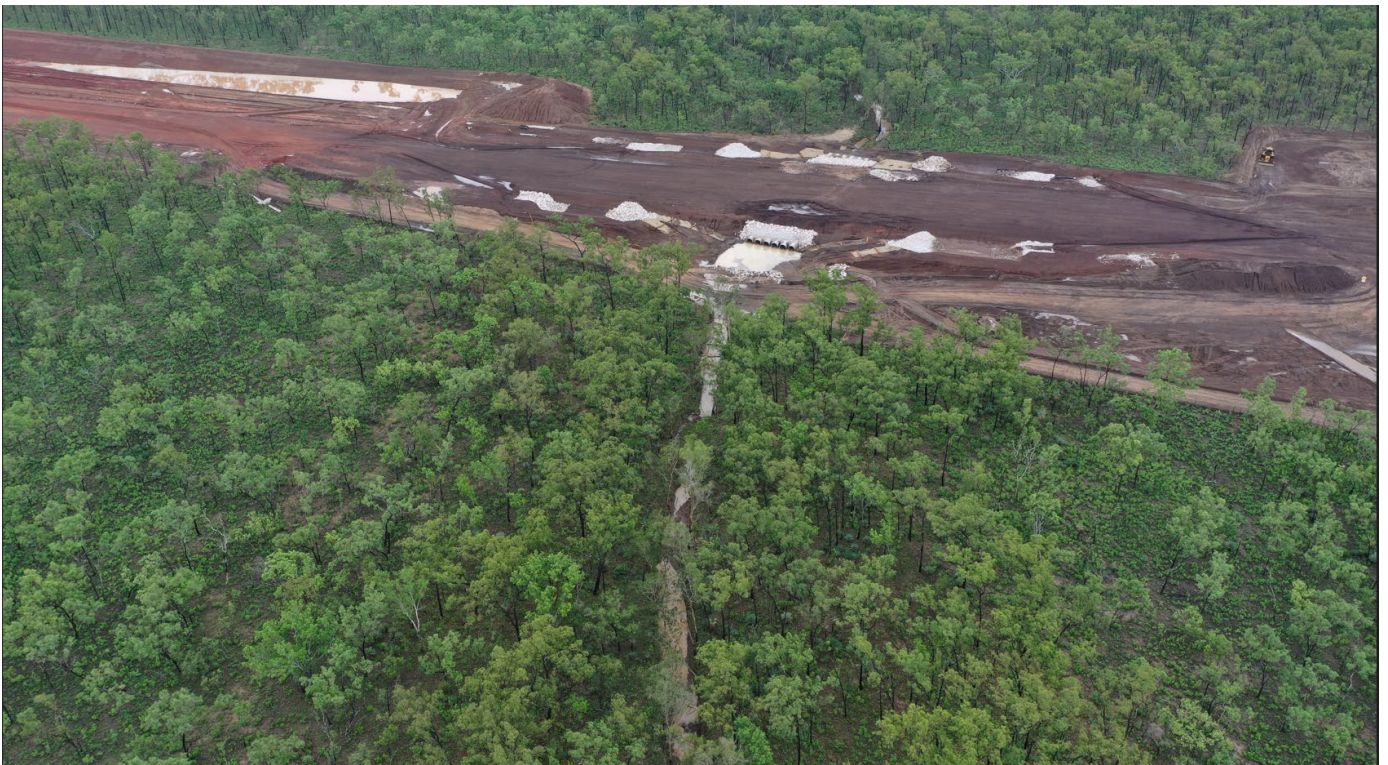
**Figure 3:** Sediment event in Emerald River Tributary. 14 November 2022. Photograph taken facing north (upstream) across the access authority.

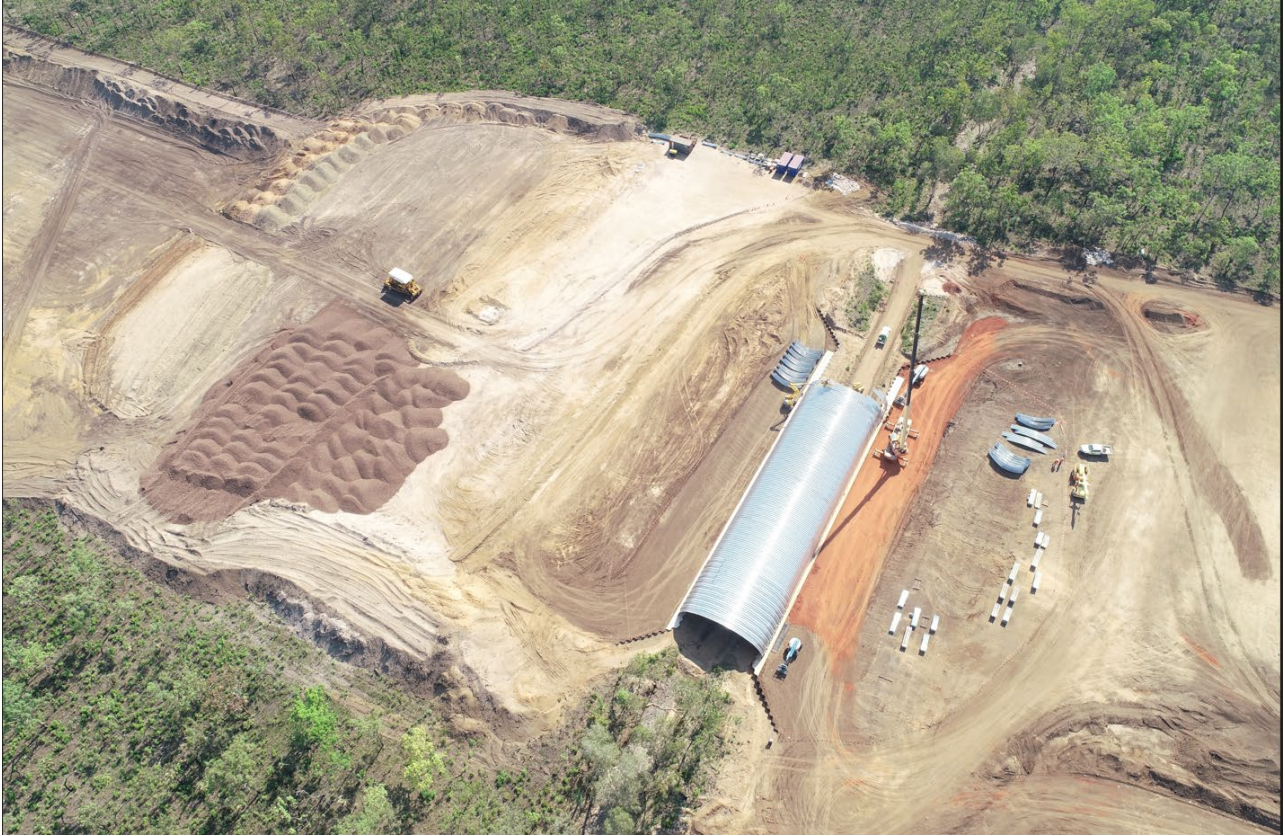
**Figure 4A:** Sediment controls in place at the Emerald River main channel prior to the sedimentation events.

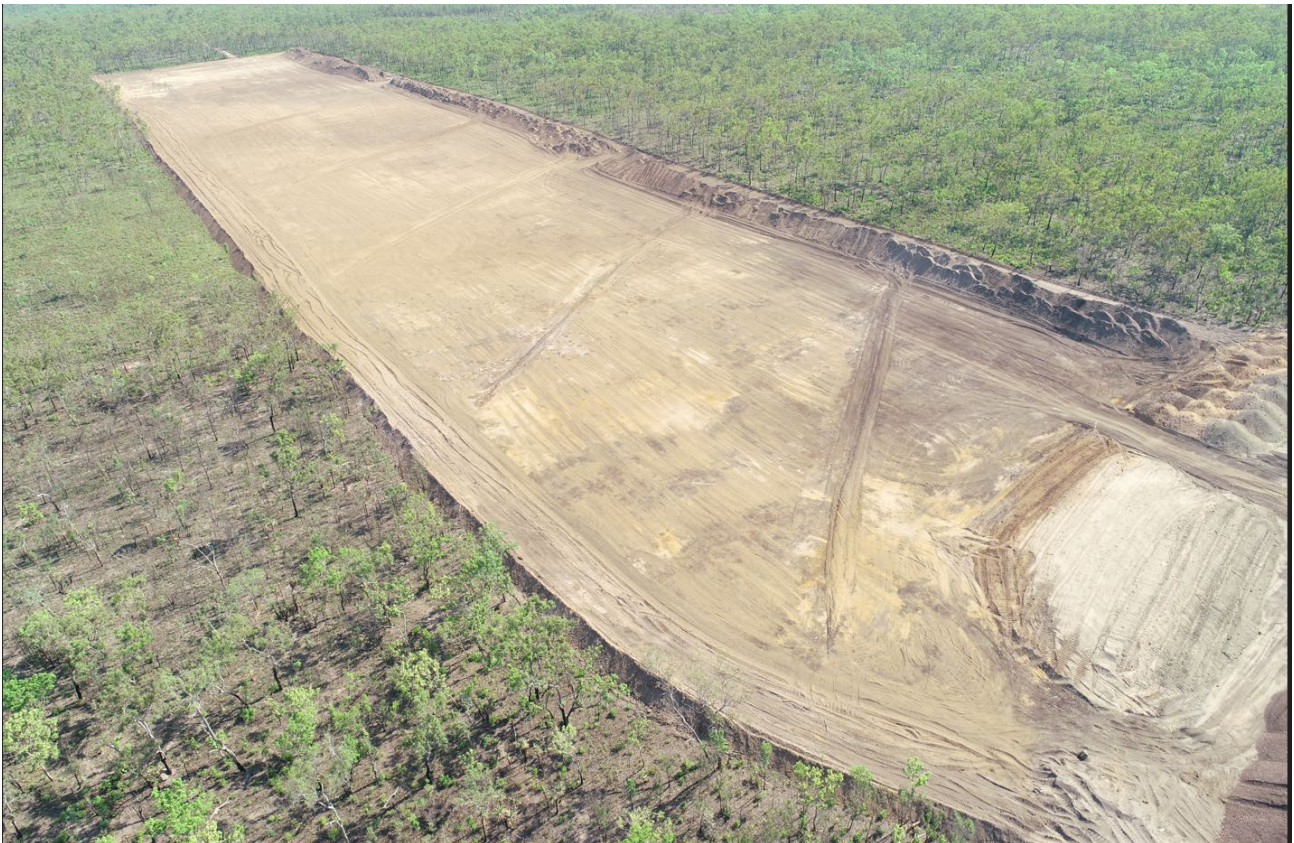
**Figure 4B:** Sediment controls in place at the Emerald River main channel prior to the sedimentation events.

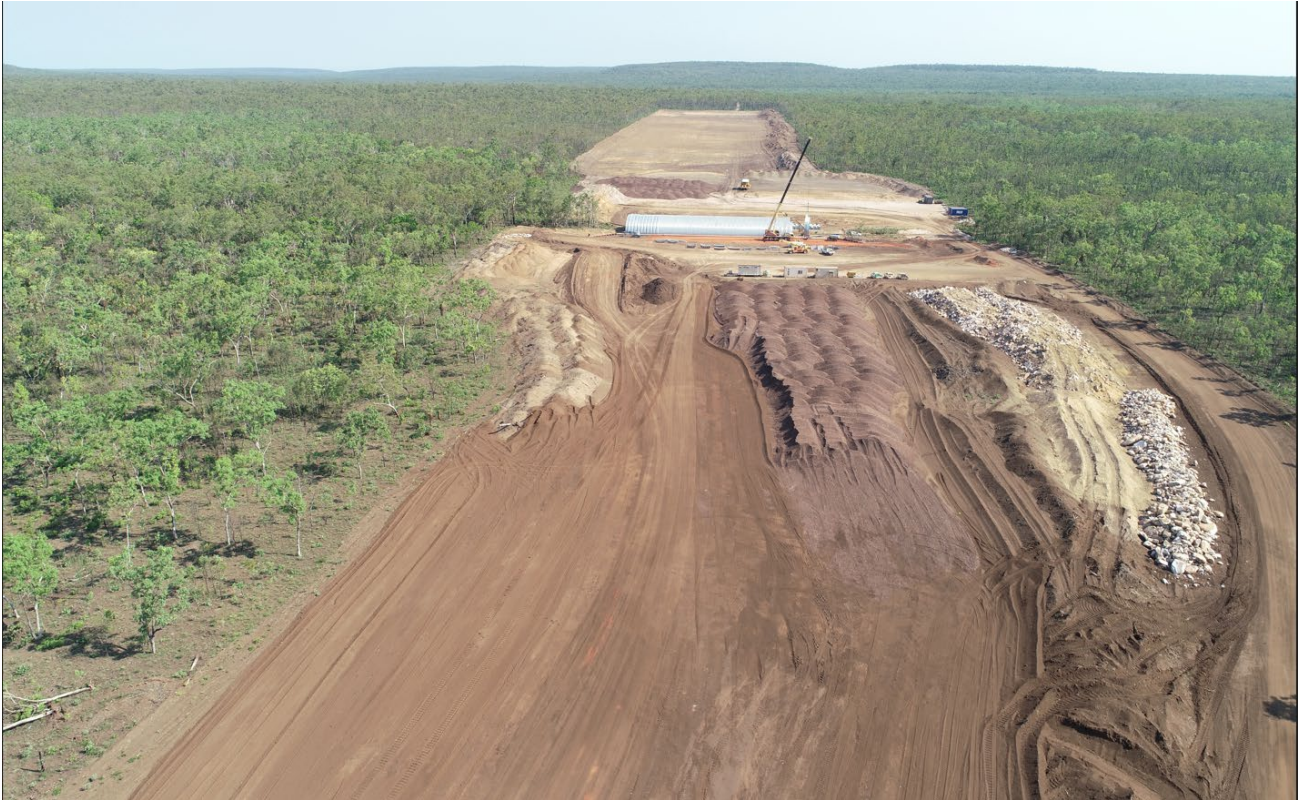
**Figure 4C:** Sediment controls in place at the Emerald River main channel prior to the sedimentation events.

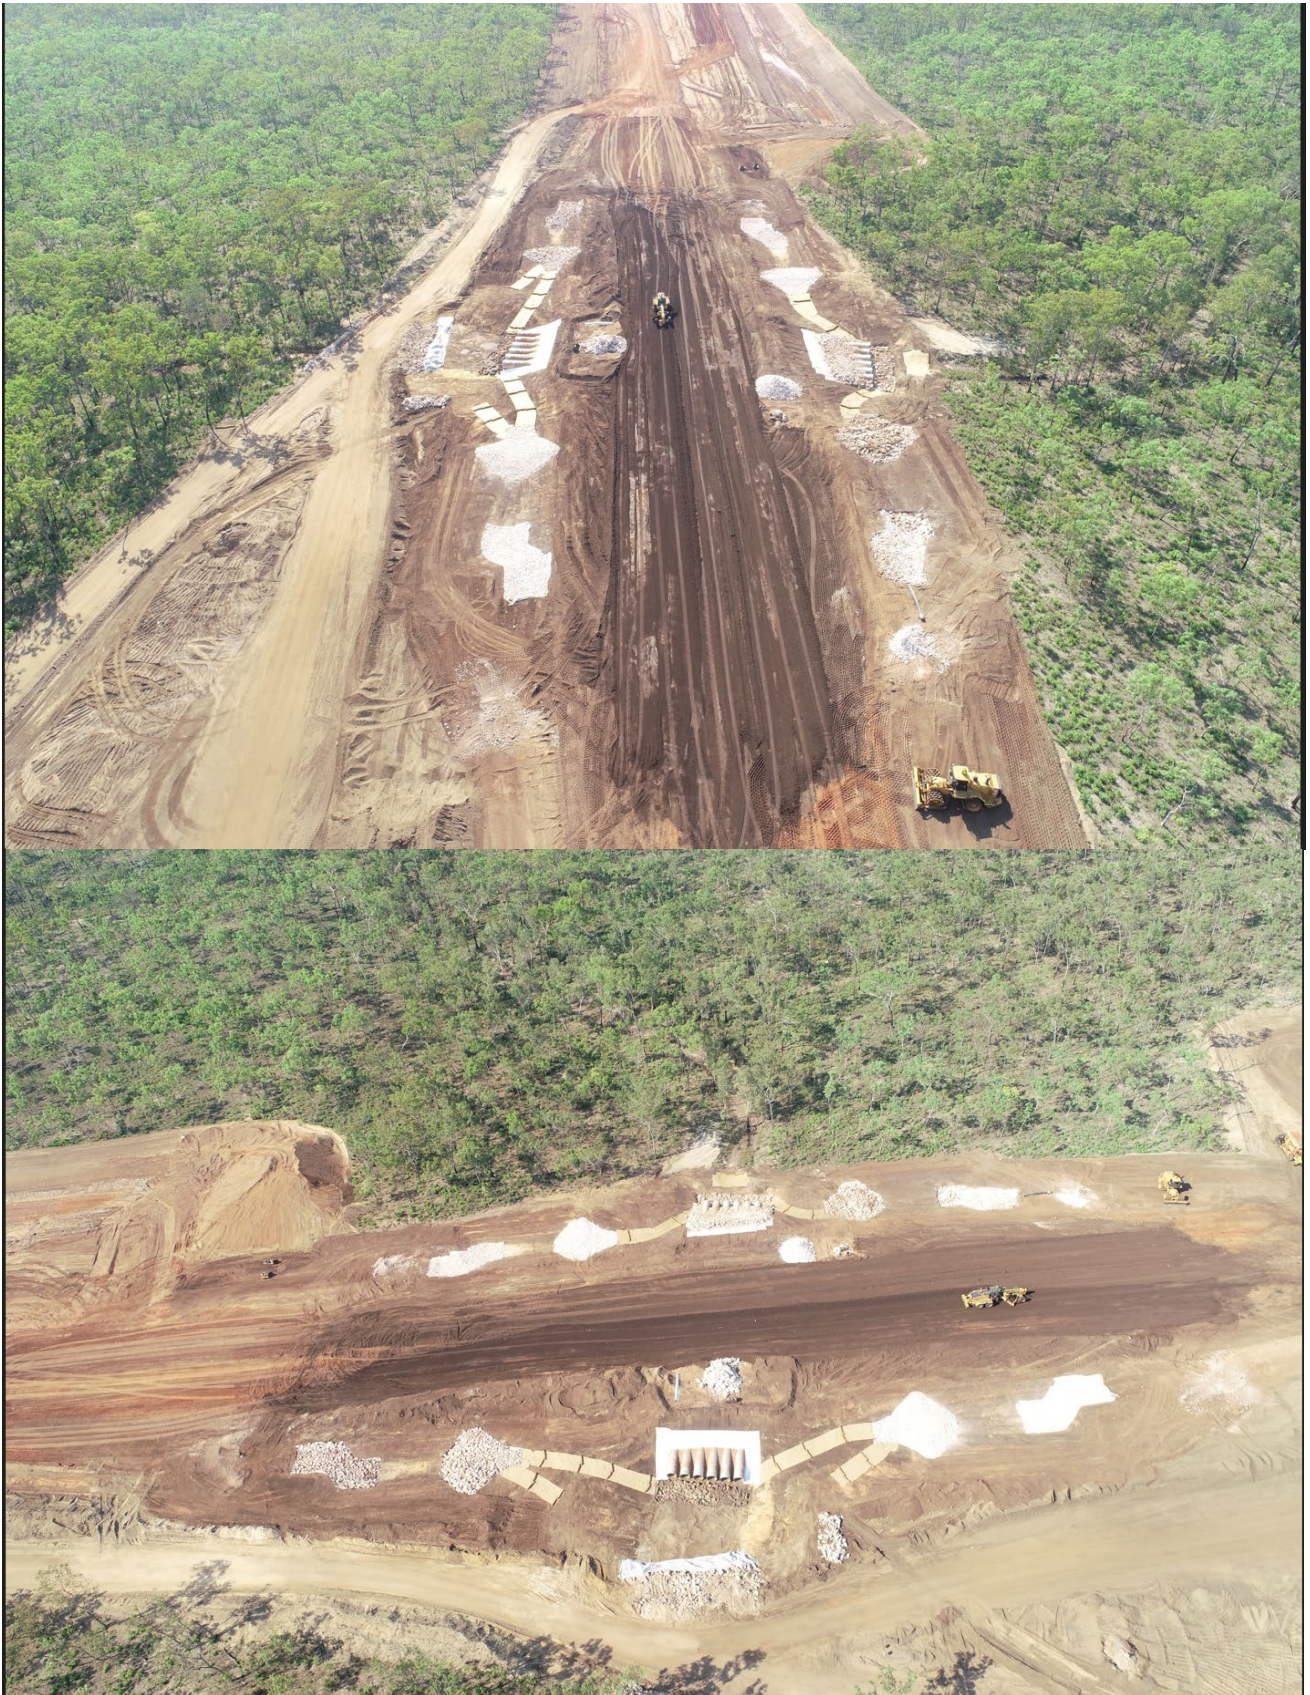
**Figure 5:** Sediment controls in place at the Emerald River tributary prior to the sedimentation events.

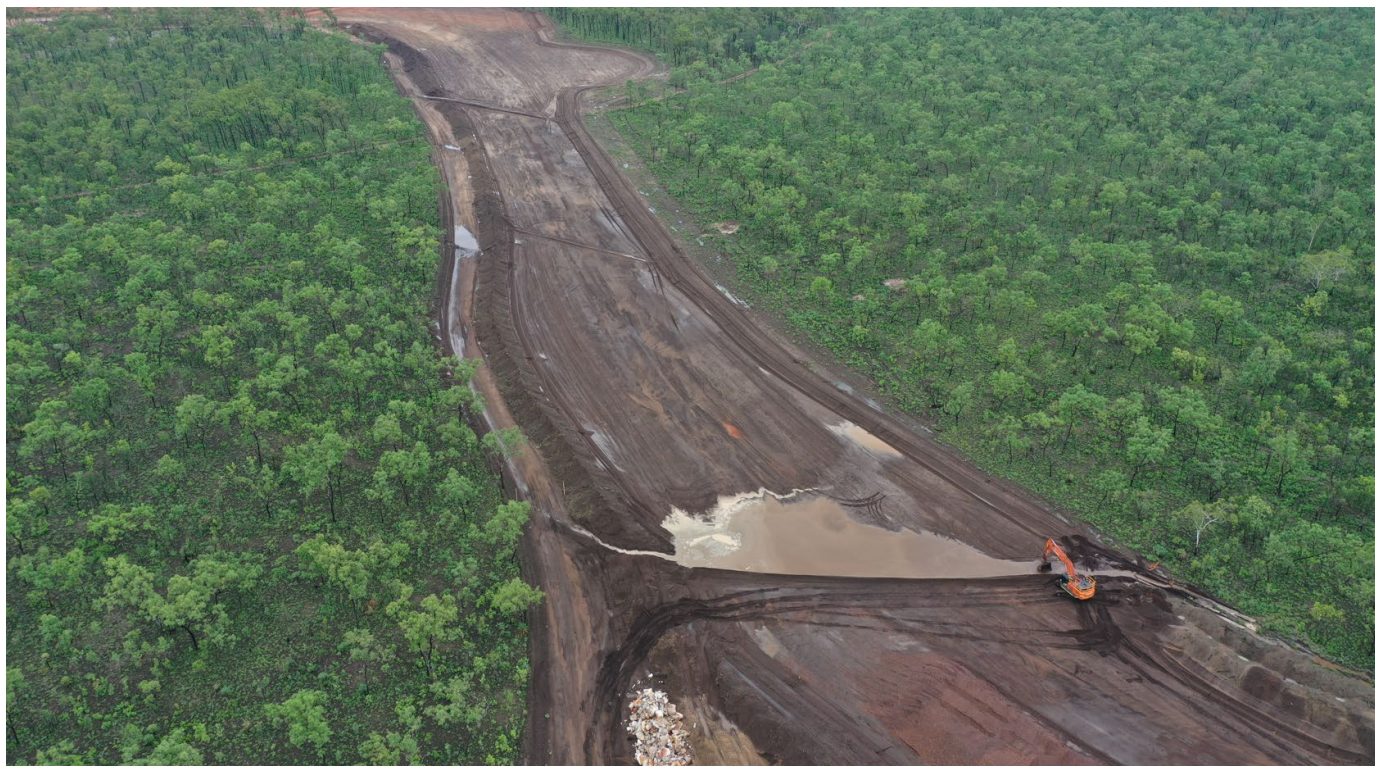
**Figure 6:** Improved frequency and size of diversion bunds in the catchment to the main Emerald River channel in response to the rainfall event on the 12/11/22.

| <b>(e) the attempts made to prevent, reduce, control, rectify or clean up the pollution or resultant environmental harm caused or threatening to be caused by the incident</b> | Following the rainfall event on Saturday 12 <sup>th</sup> of November, a number of actions were carried out to reduce/minimise sediment runoff within the construction areas. These included the installation of additional diversion drains, reducing the size of runoff catchments, reinstatement of diversion bunds that were damaged by the rainfall event and diverting greater runoff volumes into sediment basins. An example is shown in Figure 6. |
