## SECTION 14 INCIDENT REPORT (*Waste Management and Pollution Control Act*)

| Incident: | Discharge of highly diluted sewage from sewerage network due to wet weather |

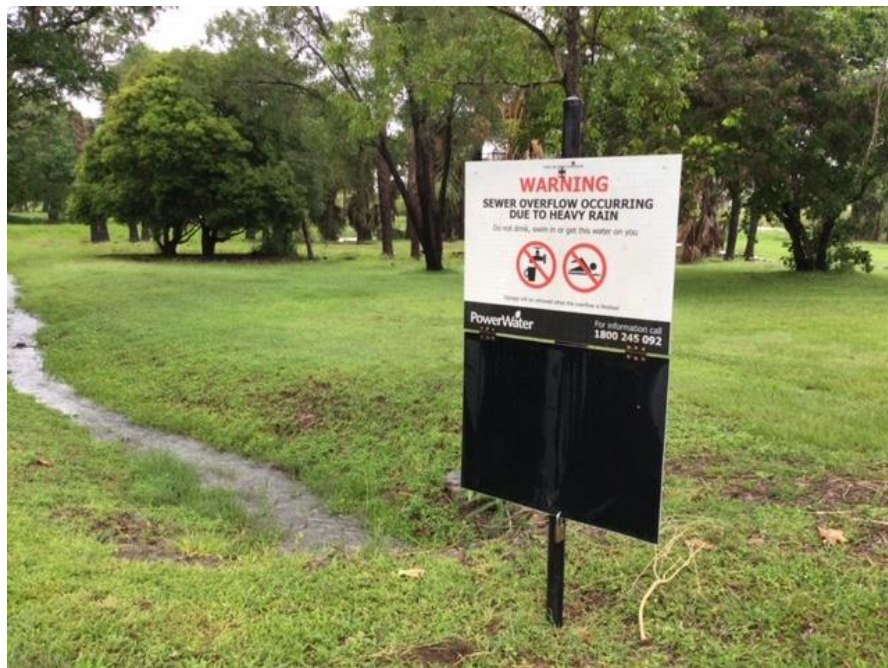
24 East Point Road, Parap

Signage being displayed at sewer overflow relief points
