**SECTION 14 INCIDENT REPORT (*Waste Management and Pollution Control Act*)**

| <b>Incident:</b> | Sewage overflow due to Sewerage lift station<br>Pump failure |

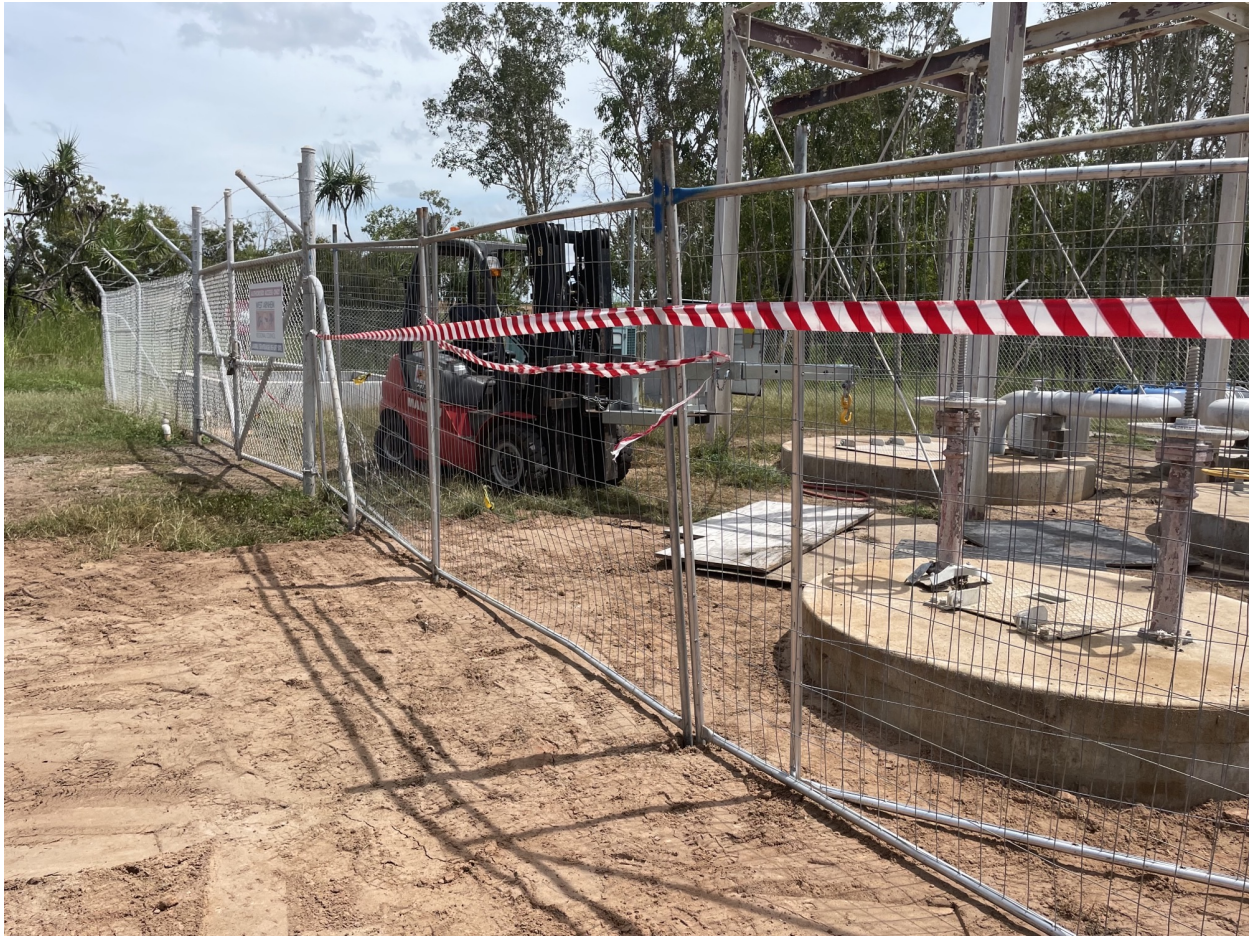
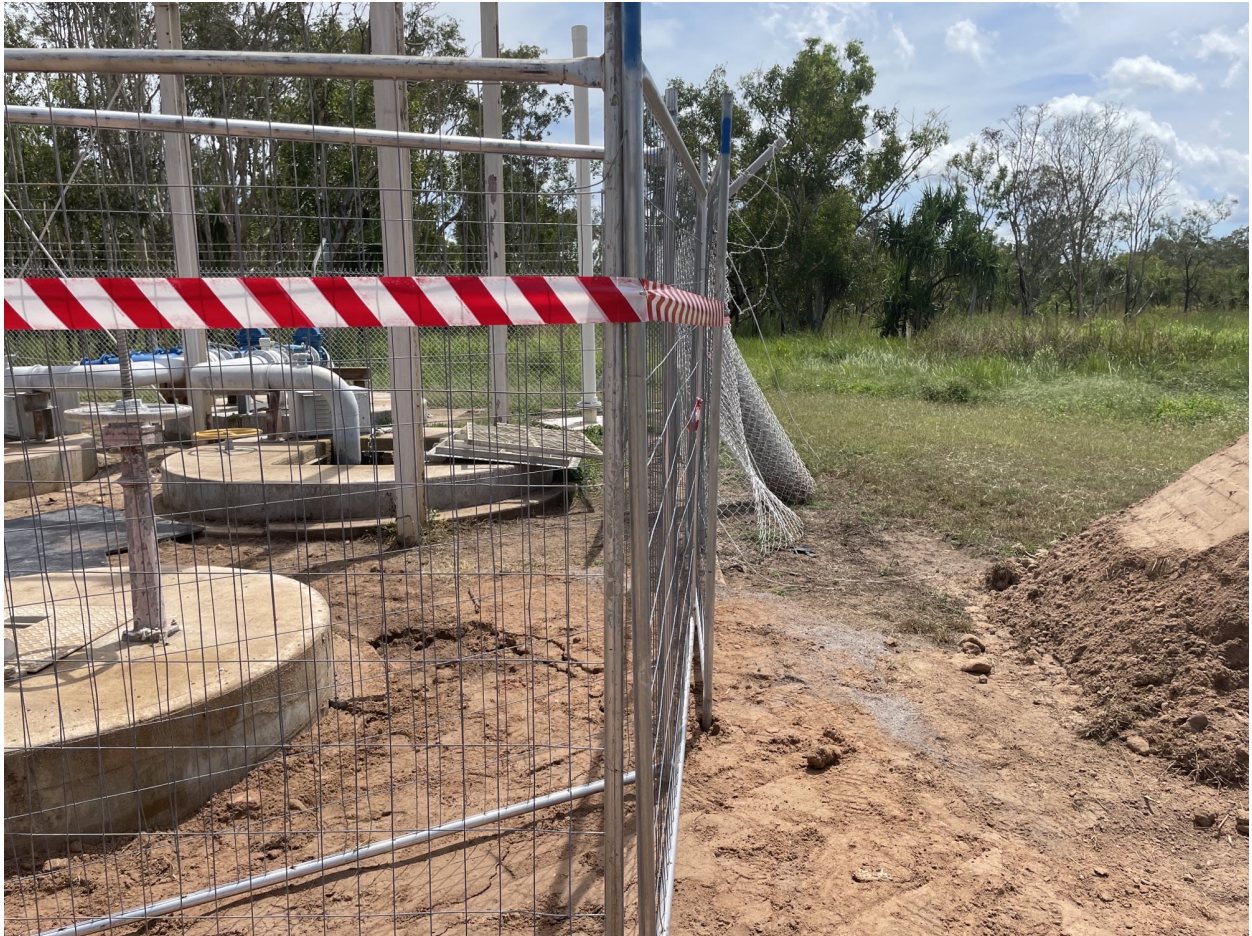
| <p><b>(a) The incident causing or threatening to cause pollution</b></p> | <p>Due to a recent pump failure at the sewerage lift station in jabiru, the sewage overflowed into the nearby surroundings. WARC engaged a contractor on urgent basis to install a temporary pump to stop the overflow and in the meantime fix the issue.</p> <p>The site has been fenced and repair works are in progress.</p> |

| <p><b>(d) How the pollution has occurred, is occurring or may occur</b></p> | <p>Due to the pump failure at the sewerage lift station overflow occurred and spilled into the surroundings and since the pollution has been contained and a new pump has been installed</p> |
