## SECTION 14 INCIDENT REPORT (*Waste Management and Pollution Control Act*)

| Company: | GEMCO Pty Ltd |
| Incident: | Vegetation impacts associated with site dewatering. |

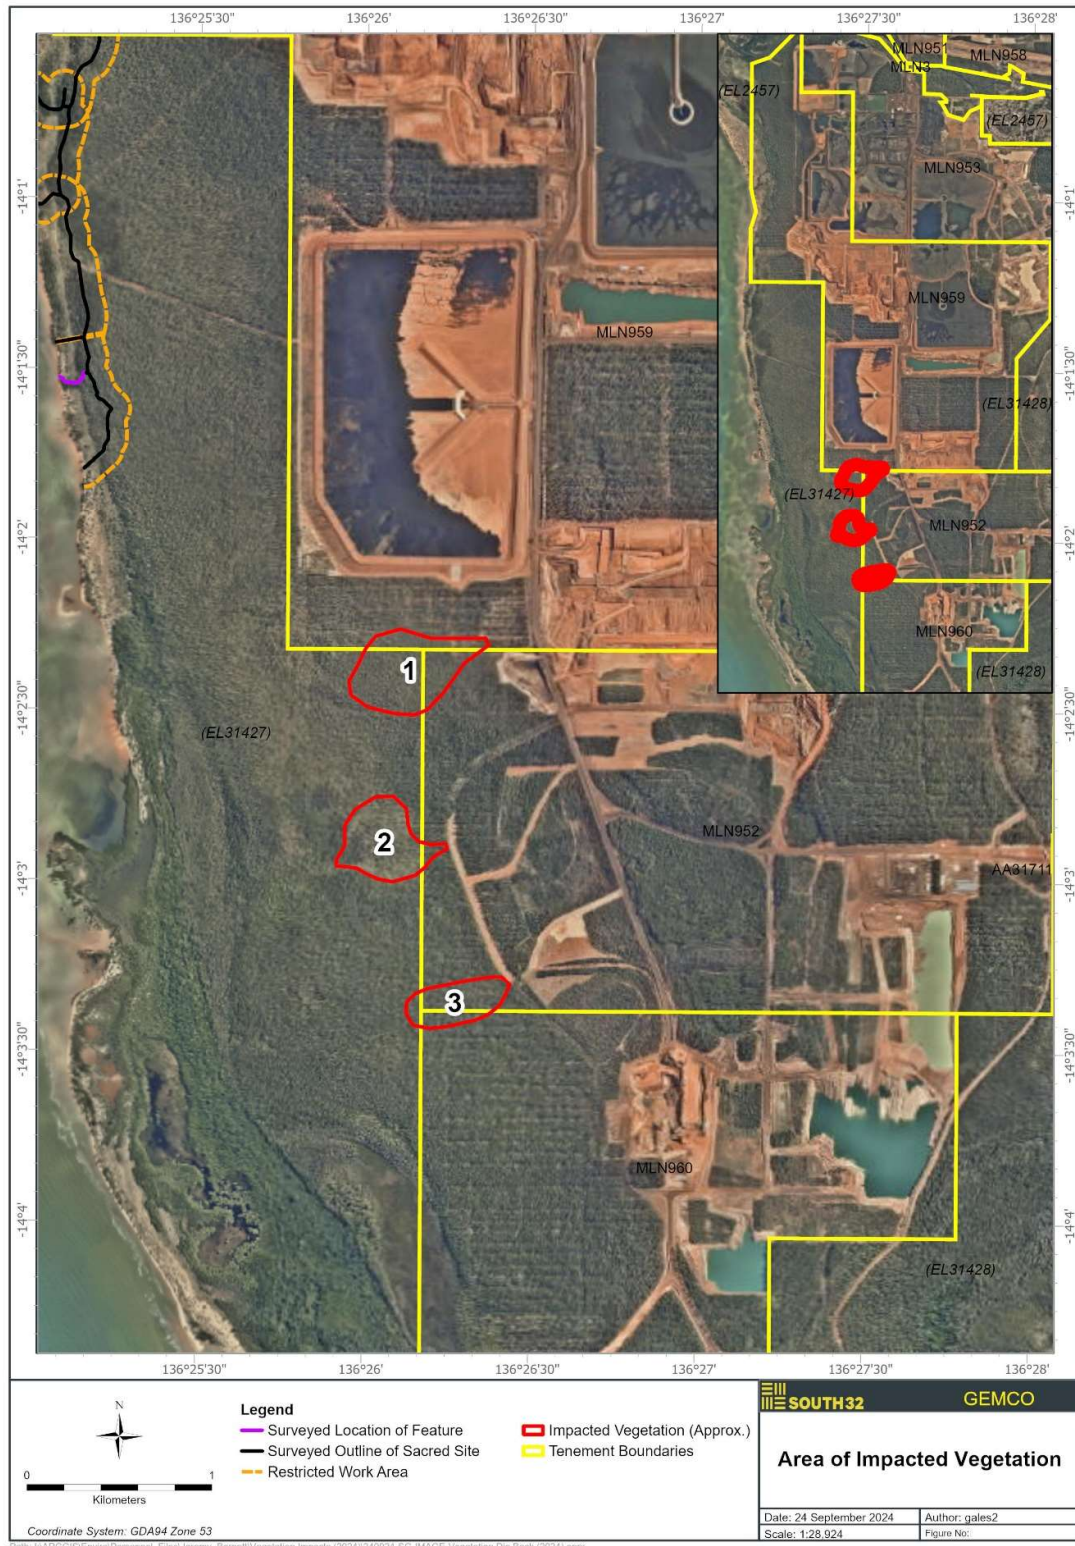
Figure 1: Areas of vegetation dieback

| (b) the place where the incident occurred | Areas of vegetation adjacent, to the west of GEMCO's D Quarry ( <b>Figure 1</b> ). Drone photographs and example field photographs are provided in <b>Figures 2 to 6</b> . |

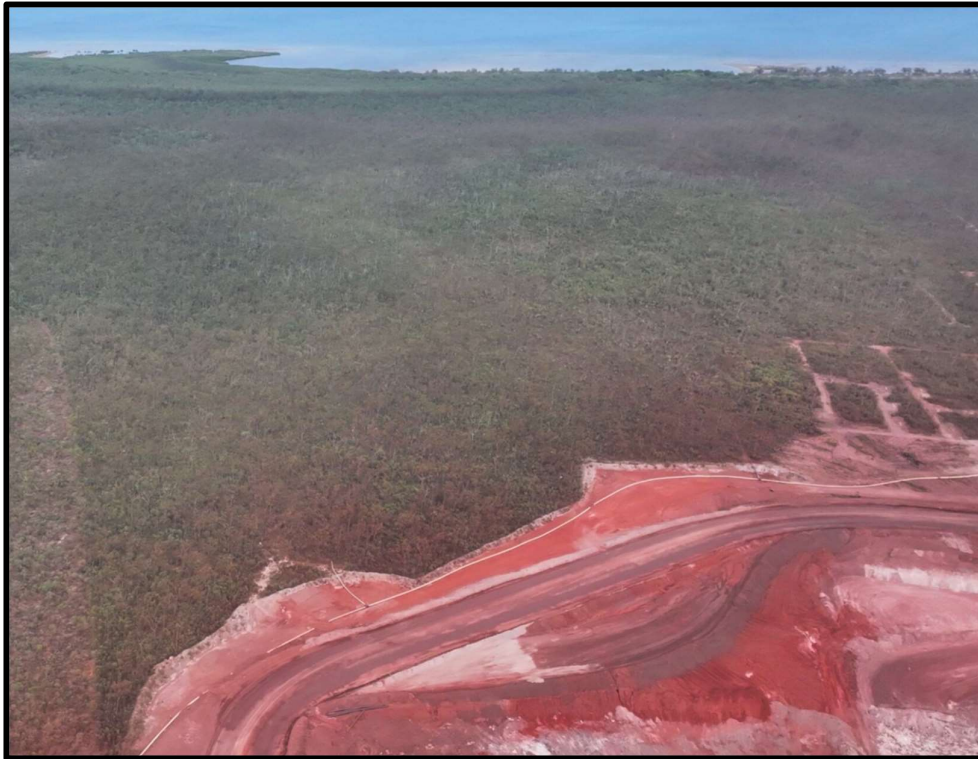
| (a) the incident causing or threatening to cause pollution | Vegetation dieback has been observed following Tropical Cyclone Megan in catchments subject to dewatering discharge activities by GEMCO. |
| (d) how the pollution has occurred, is occurring or may occur | Vegetation impacts may have been exacerbated as a result of mine dewatering discharge activities. Regular water quality monitoring indicates the dewatered mine water is of good quality (essentially rain water / run-off rain water) and there are no contaminants of concern. Vegetation impacts are believed to be due to soil saturation. In-field inspection verified areas of dieback vegetation on lease that extend off-lease. Some areas of local sedimentation were also observed. |

**Figure 2:** Drone footage of vegetation dieback Area 1 (East to West perspective)

| (e) the attempts made to prevent, reduce, control, rectify or clean up the pollution or resultant environmental harm caused or threatening to be caused by the incident | Site dewatering has ceased into the identified areas, to mitigate further potential impacts. |

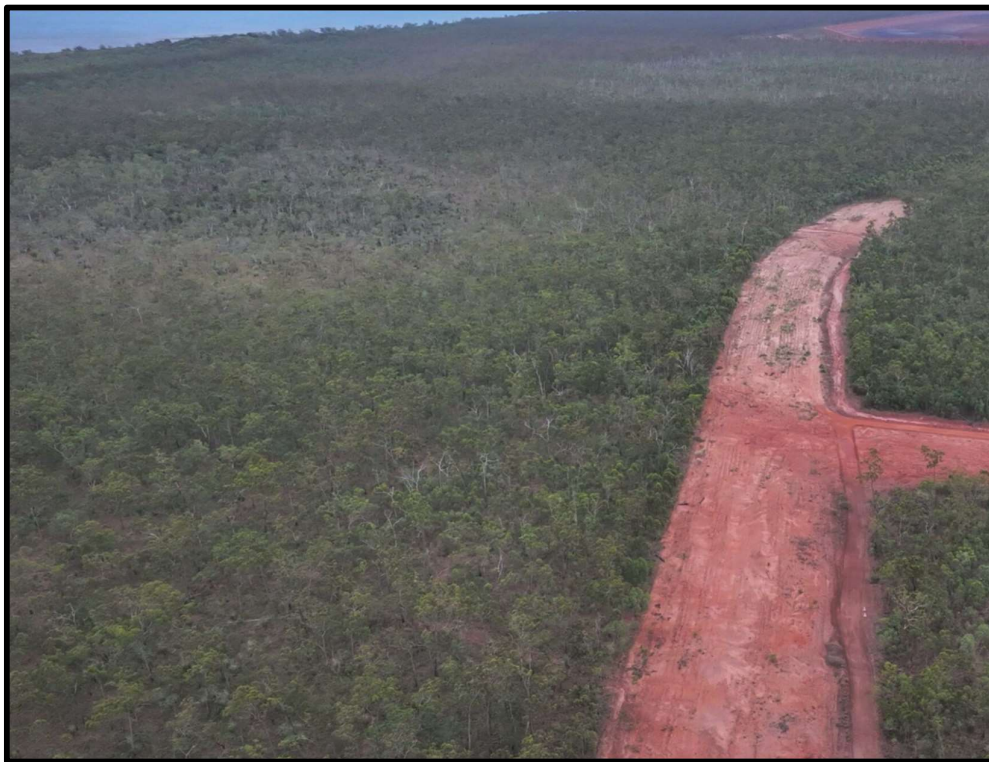
**Figure 3:** Drone footage of vegetation dieback Area 2 (South to North perspective)

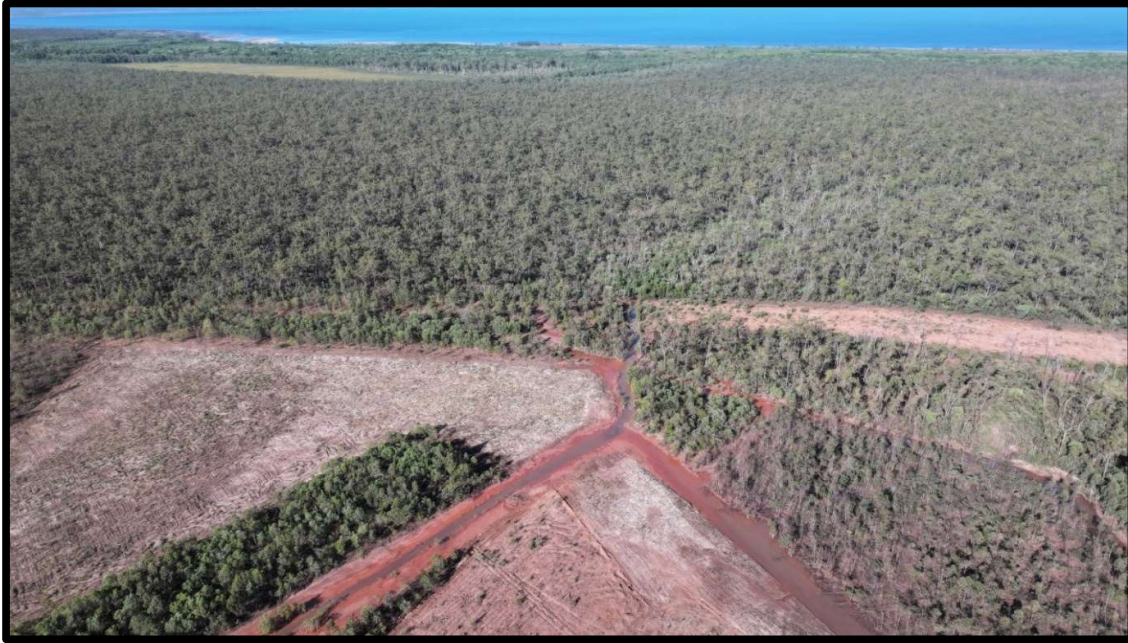
**Figure 4:** Drone footage of vegetation dieback Area 3 (East to West perspective)

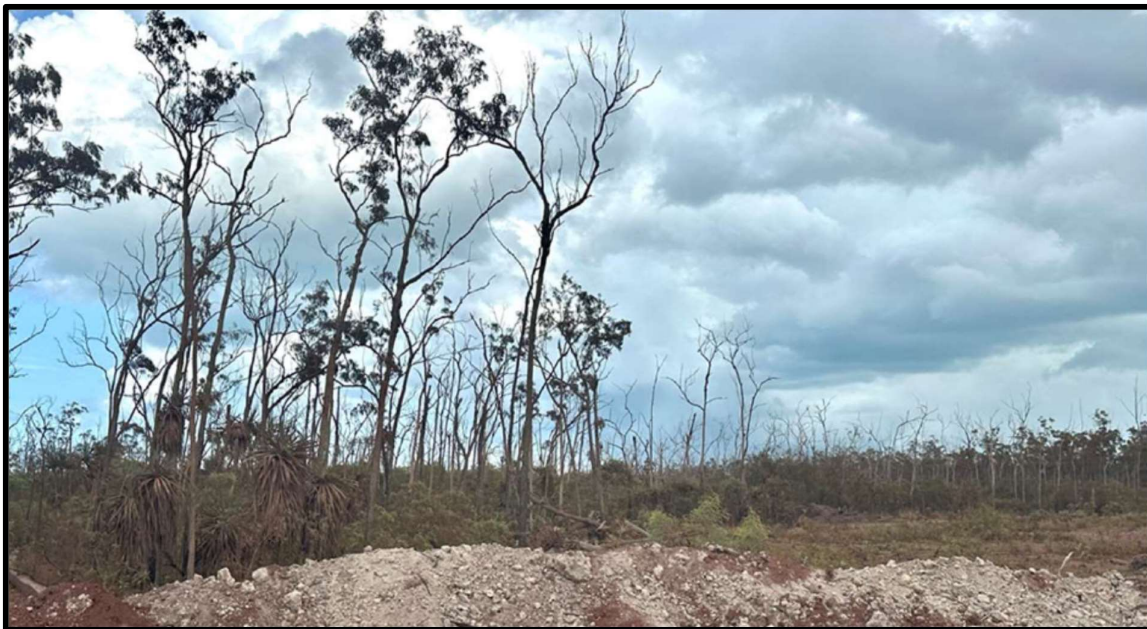
**Figure 5:** Example area of vegetation dieback

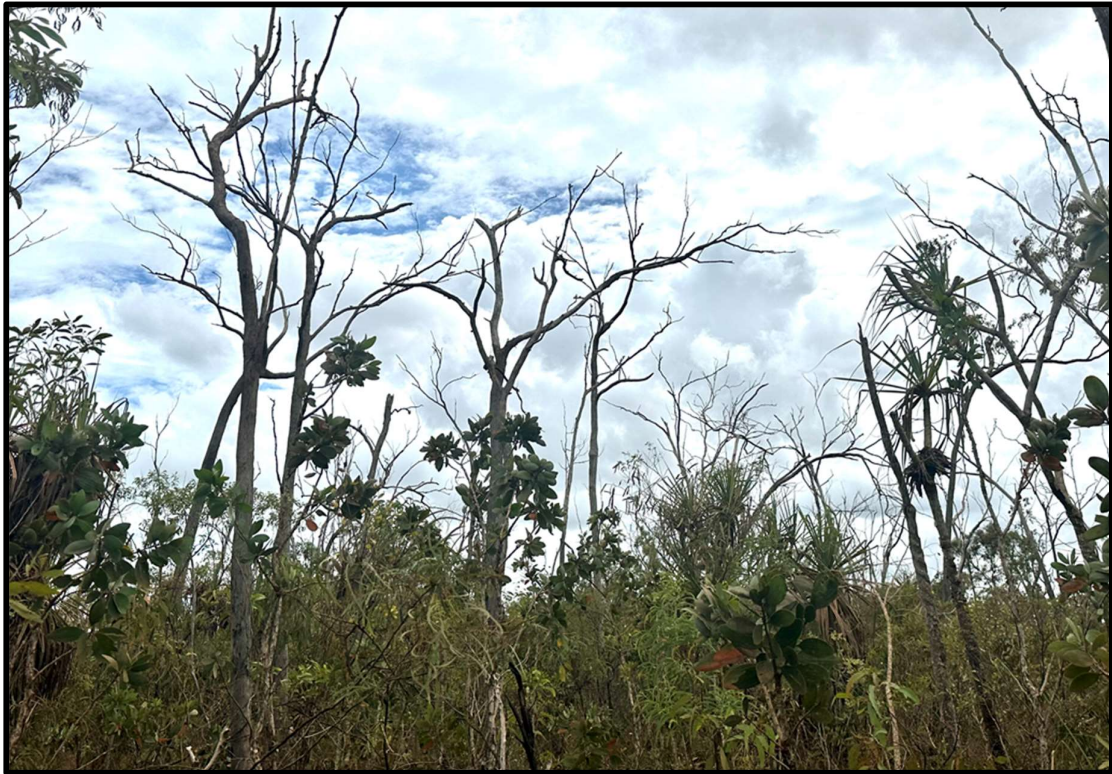
**Figure 6:** Example area of vegetation dieback
