SECTION 14 INCIDENT REPORT (*Waste Management and Pollution Control Act*)

Date and Time of Notification:	Initial notification (Phone) – 28 January 2025; 11:56am						
Person / Company:	Lana Treasure McArthur River Mining Pty Ltd (MRM)						
Incident:	A total of approximately 5 tonnes (ton) of bulk concentrate was inadvertently released along the Carpentaria Highway.						
(a) the incident causing or threatening to cause pollution	A total of approximately 5 t of bulk concentrate was released at one location on the Carpentaria Highway, between the Mine and the BBLF. All concentrate was confined to the road and roadside and no cause or threat to cause pollution.						
(b) the place where the incident occurred	<p>The Global Positioning System (GPS) points for the length of the spill is provided in Table 1 below and shown in Figure 1.</p> <p style="text-align: center;"><i>Table 1 – GPS Coordinates of spill end and start.</i></p> <table border="1" style="margin-left: auto; margin-right: auto;"> <thead> <tr> <th>Site ID</th> <th>Easting*</th> <th>Northing*</th> </tr> </thead> <tbody> <tr> <td>Concentrate Spill Location</td> <td>644002</td> <td>8257249</td> </tr> </tbody> </table> <p><sma

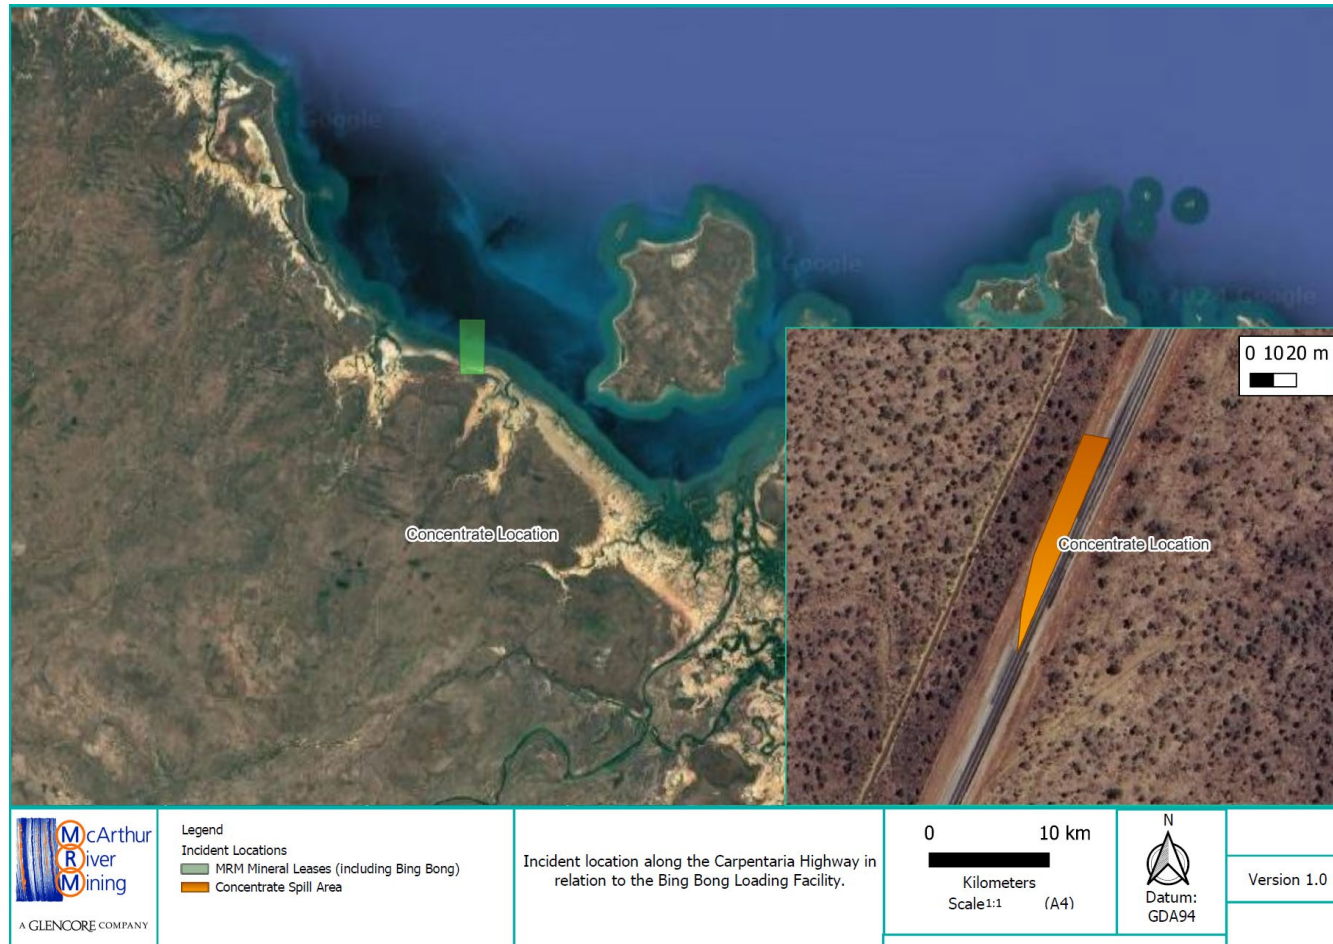
Figure 1: Approximate spill location in relation to the BBLF

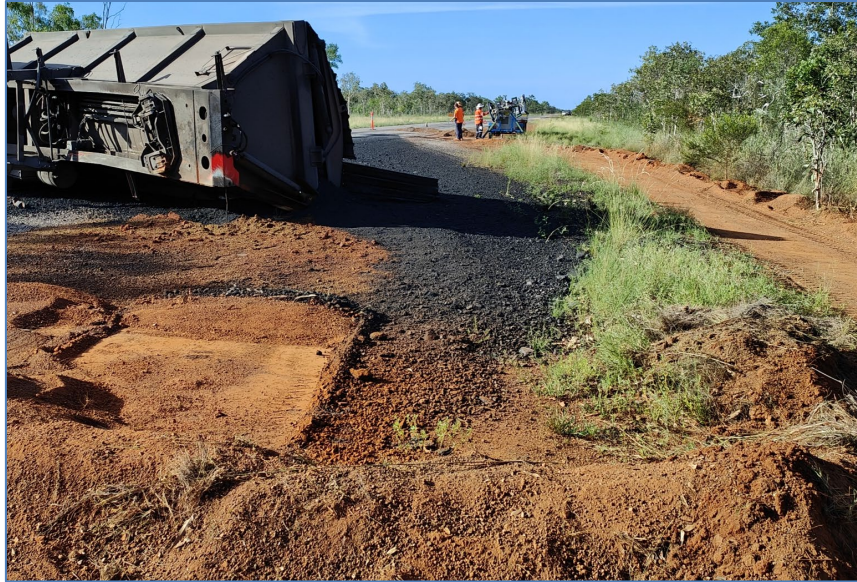
A bunded system has been implemented along the highway as a preventative measure to mitigate the risk of bulk concentrate runoff during potential rainfall (See Figure 3).

Figure 3: The bunded system around the concentrate spill area.

A pressure hose and bobcat will be used to collect the concentrate from the road and roadside at the incident locations. A grader will then be used to collect all potentially contaminated material on the immediate roadsides.

All spilled concentrate and contaminated soil will be transported back to the Mine and disposed of at Tailings Storage Facility.
